PROJECT REFERENCE: 19.1170

# PHASE 2 ENVIRONMENTAL RISK ASSESSMENT REPORT

20-23 Greville Street, London

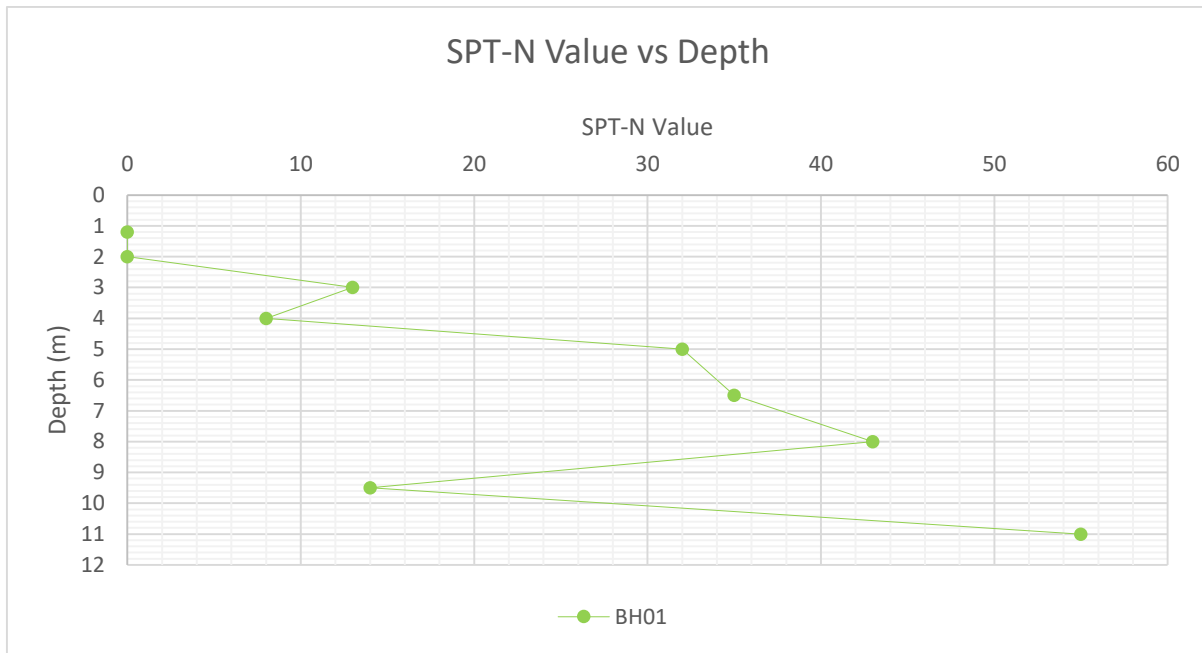
This form of testing is completed using a 63.5kg drop hammer weight, over a 750mm drop, measuring the blow counts for six, 75mm increments. The first two values are recorded as seating blows, with the remaining four values, added together to provide an 'N-value'. Results are presented in the graph below:

Two tests were carried out within Made Ground soils returning N values of N=0.

Within the underlying London Clay Formation, SPT N-values show initial values in the order of N=8 to N=55 with a general trend of increasing N value with depth. An N-value of 14 was recorded at 9.5mbgl, this was considered an anomaly.

Two SPT tests completed in Made Ground material indicated N values of 0 indicating that these materials are of very low strength and not suitable for use as a founding medium.

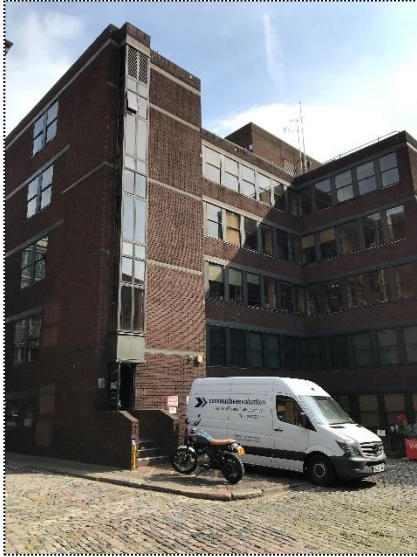
1.

- 1) The site from Bleeding Heart Yard
- 2) WS1 concrete core
- 3) WS1 completed location
- 4) Window sampling at WS2

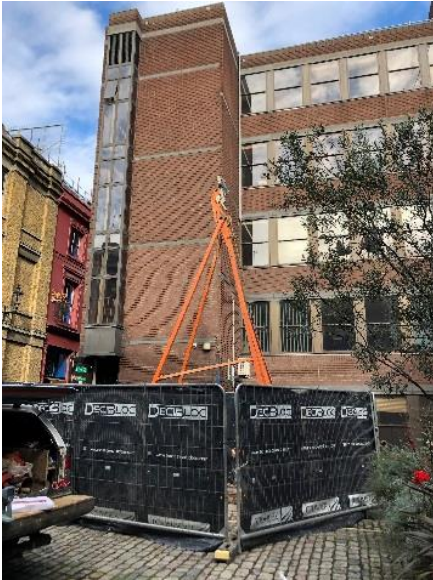
5.

5) Cable Percussive Rig at BH1

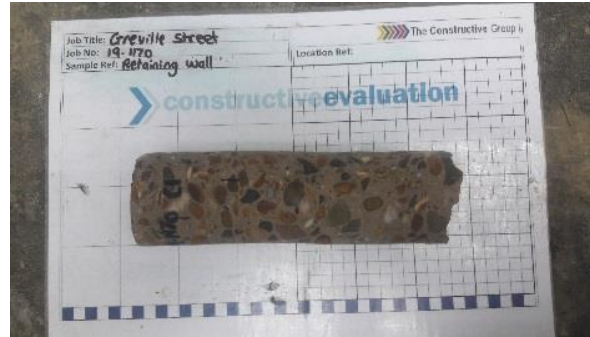
6.

The retaining wall was found to be composed of an engineering brick veneer covering 850mm concrete. A red brick backing layer was inferred from the results of the Hilti probe drill carried out.

6) Concrete core through retaining wall

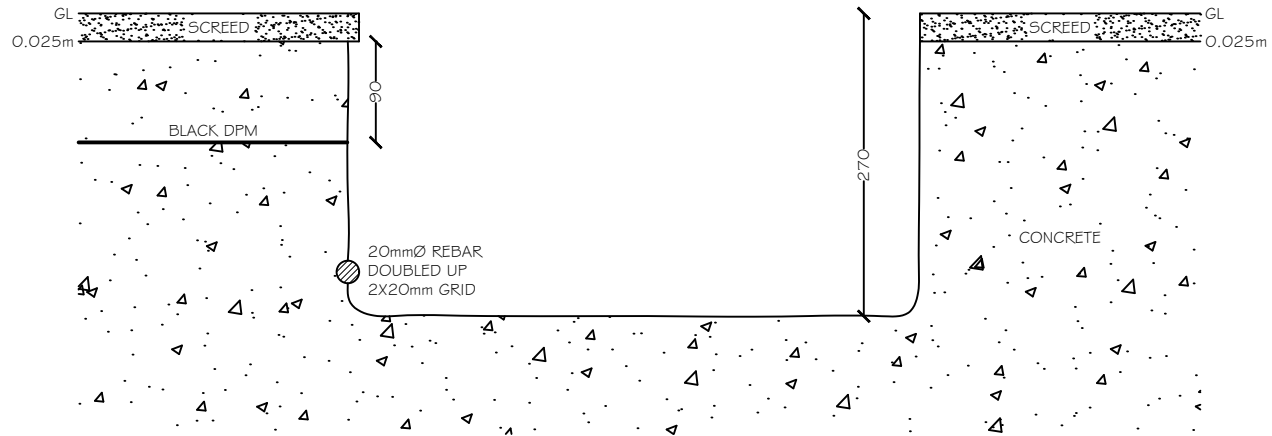
TRIAL PIT 1 SECTION

In total, three hand excavated foundation pits were excavated in both internal and external areas at basement level and one concrete core was excavated through the external retaining wall. Internal pits TP1 and TP1A refused in extremely high strength reinforced concrete and the maximum thickness of the slab was not proven.

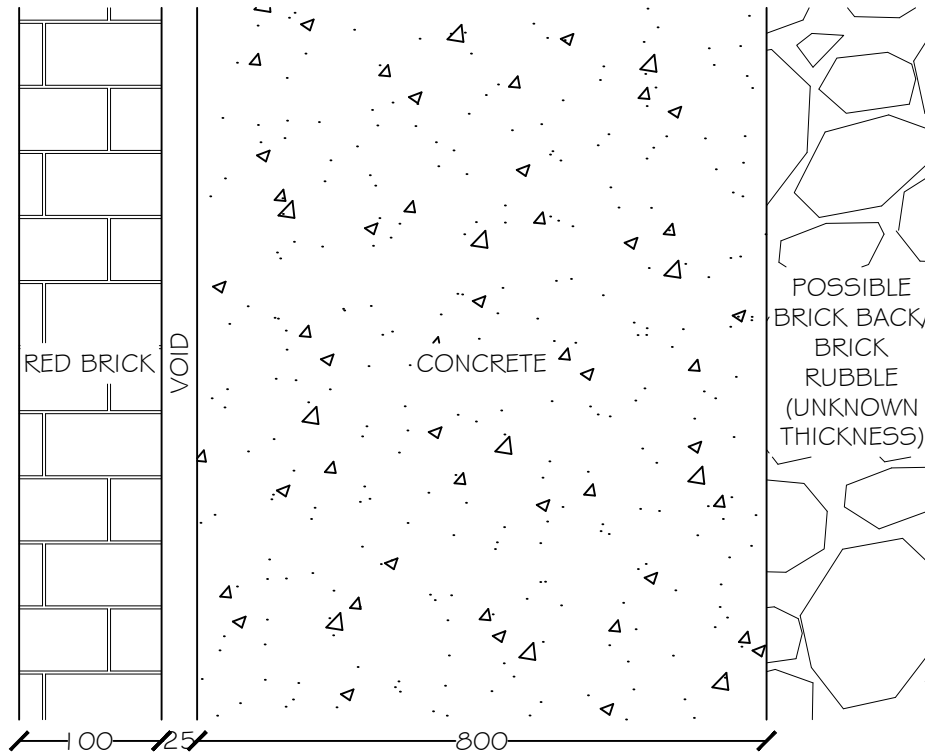
RETAINING WALL DETAIL

CORED TO 800mm (800mm THICK CONCRETE)  
 PROVEN TO 850mm WITH HILTI DRILL  
 POSSIBLE BREAKTHROUGH INTO SOFTER/LOOSE BACKFILL AT 850mm

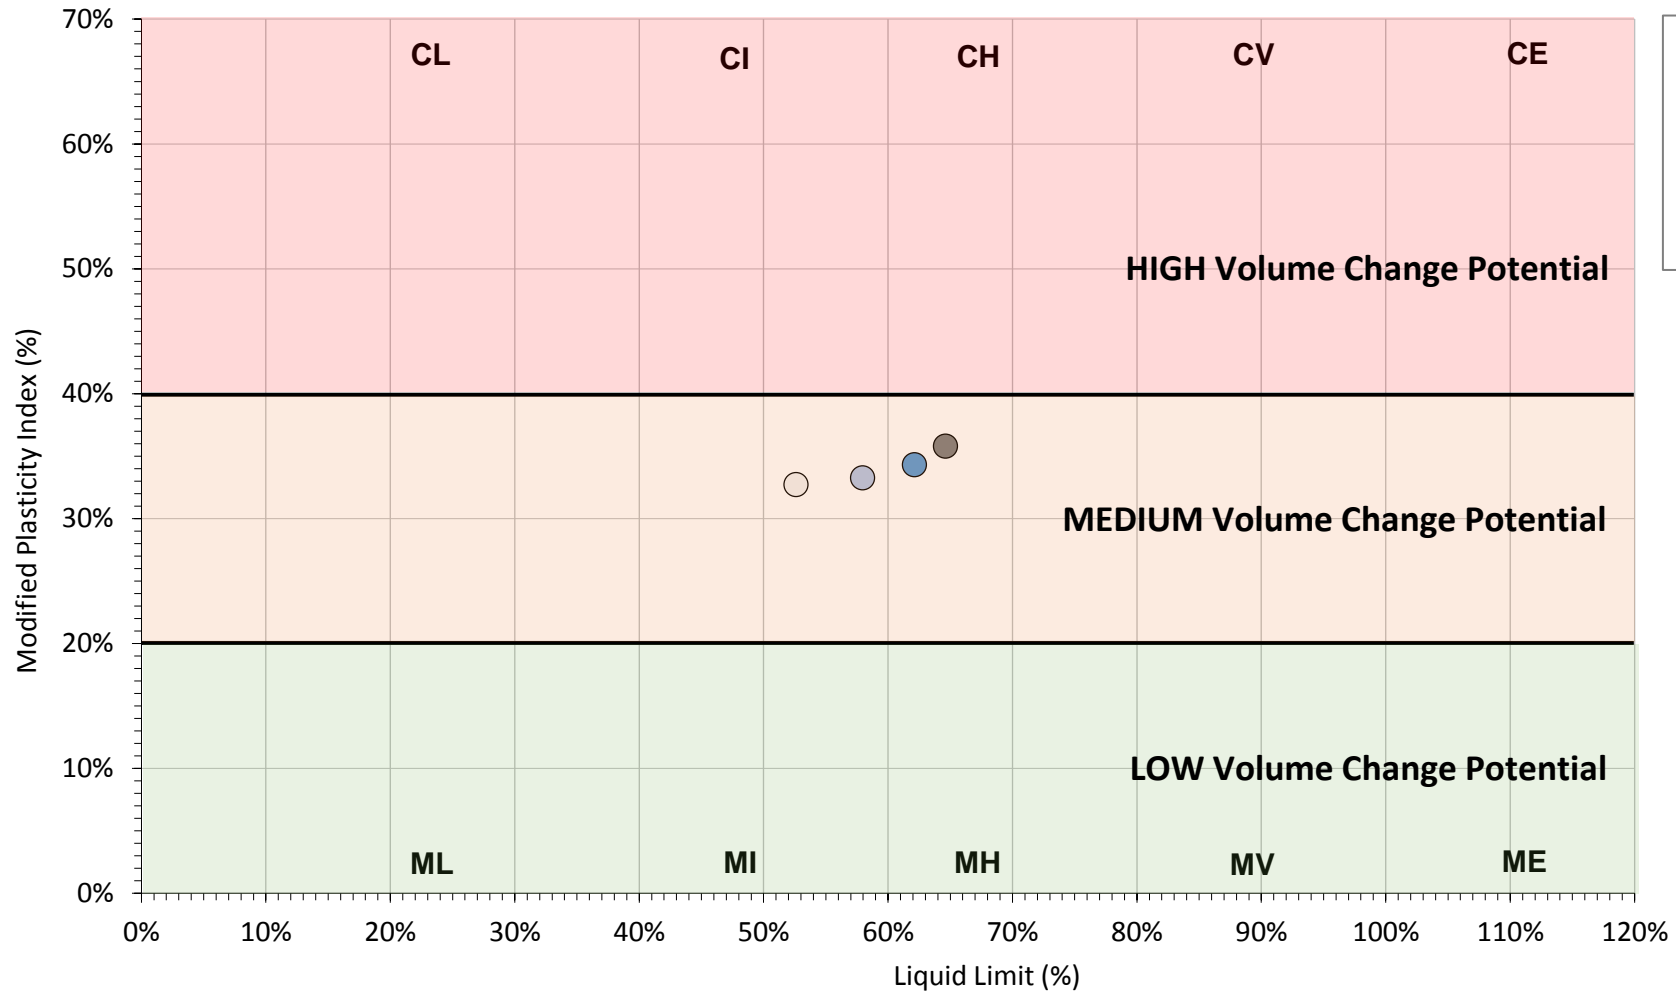
Sample ID	Moisture Content (%)	Modified Plasticity Index (%)	Plasticity	Volume Change Potential
BH1 – 5.00mbgl	32	34	Moderate	Medium
BH1 – 7.00mbgl	33	36	Moderate	Medium
BH1 – 9.00mbgl	24	33	Moderate	Medium
BH1 – 11.50mbgl	26	33	Moderate	Medium

- BH1 5.00m
- BH1 7.00m
- BH1 9.00m
- BH1 11.50m

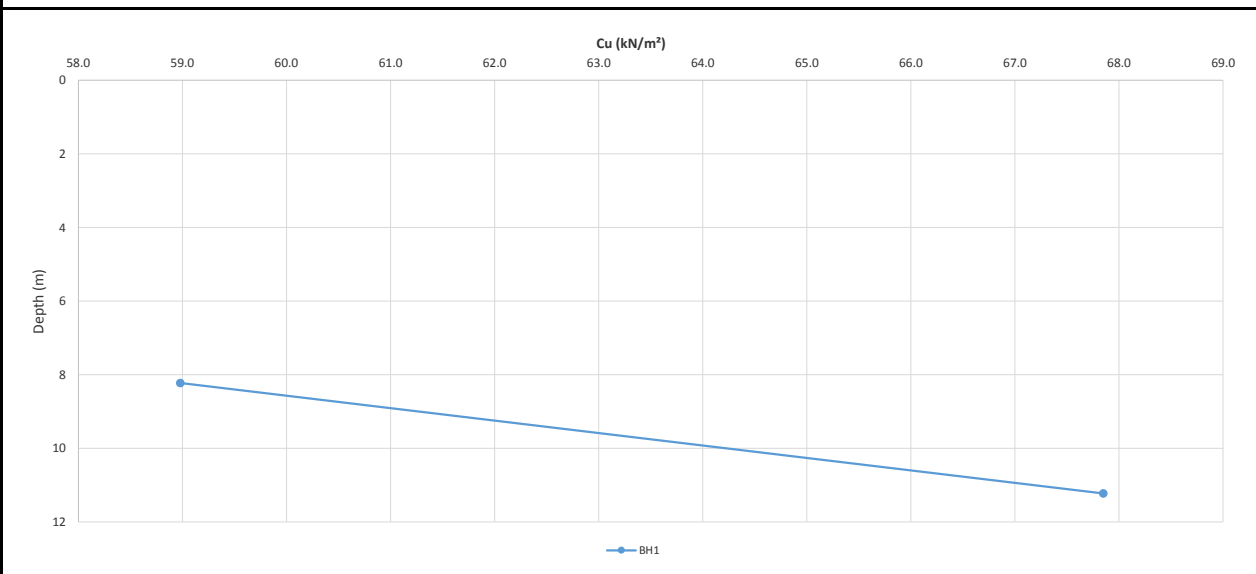
Sample ID	Bulk Density (Mg/m <sup>3</sup> )	Moisture Content %	Undrained Shear Strength (kN/m <sup>2</sup> )	Strength
BH1 – 8.00mbgl	2.02	32	59.0	Medium Strength
BH1 – 11.00mbgl	2.11	26	67.8	Medium Strength

Hole ID	Depth (m)	Sample Description	Cell Test Pressure (kN/m <sup>2</sup> )	Bulk Density (Mg/m <sup>3</sup> )	BS 1377 Moisture Content (W%)	Undrained Shear Strength (kN/m <sup>2</sup> )	Strain at Failure	Strength Term	Failure Mode
BH1	8.00-8.45m	Firm to stiff closely fissured locally greyish brown locally sandy silty CLAY. Pockets of fine gravel-sized pyritised wood. Occasional pockets of medium-sand sized selenite crystals.	160	2.02	32%	59.0	12.5%	Medium Strength

BH1	11.00-11.45m	Firm to stiff locally very stiff closely fissured greyish brown locally gravelly locally sandy silty CLAY. Occasional Foraminifera. Pockets of fine gravel sized pyritised wood and nodular pyrite.	220	2.11	26%	67.8	6.0%	Medium Strength

It is recommended that the values of undrained shear strength obtained from laboratory triaxial testing be used for the purpose of any further design.
