Report No: 371944

PHOTOGRAPHIC LOG

Client name: Rocco Ventures Ltd

Site Location: Royal College Street

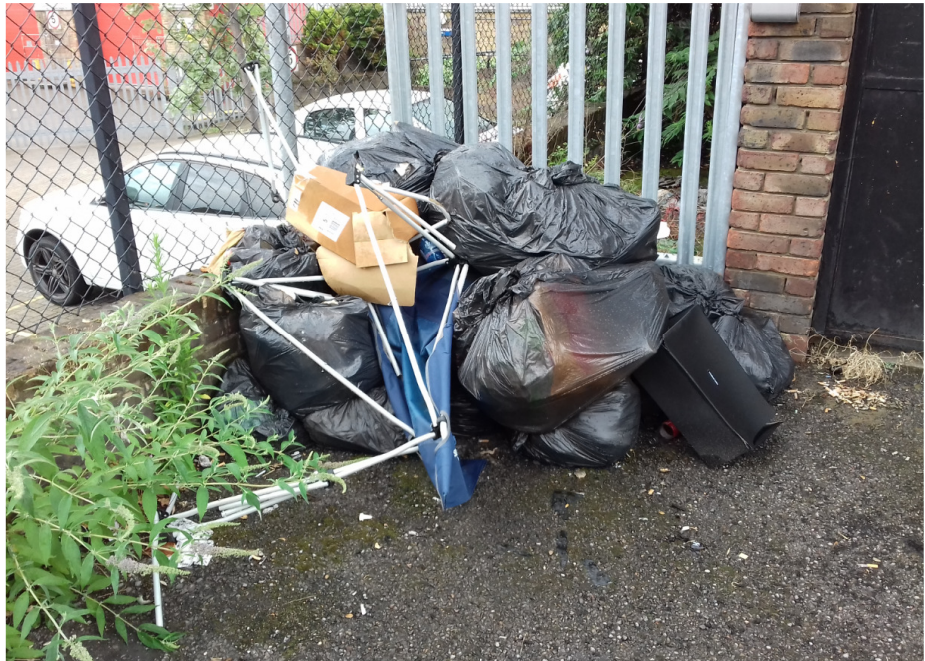
Photo No.  
12

Description:  
Rubbish adjacent to  
tyre store

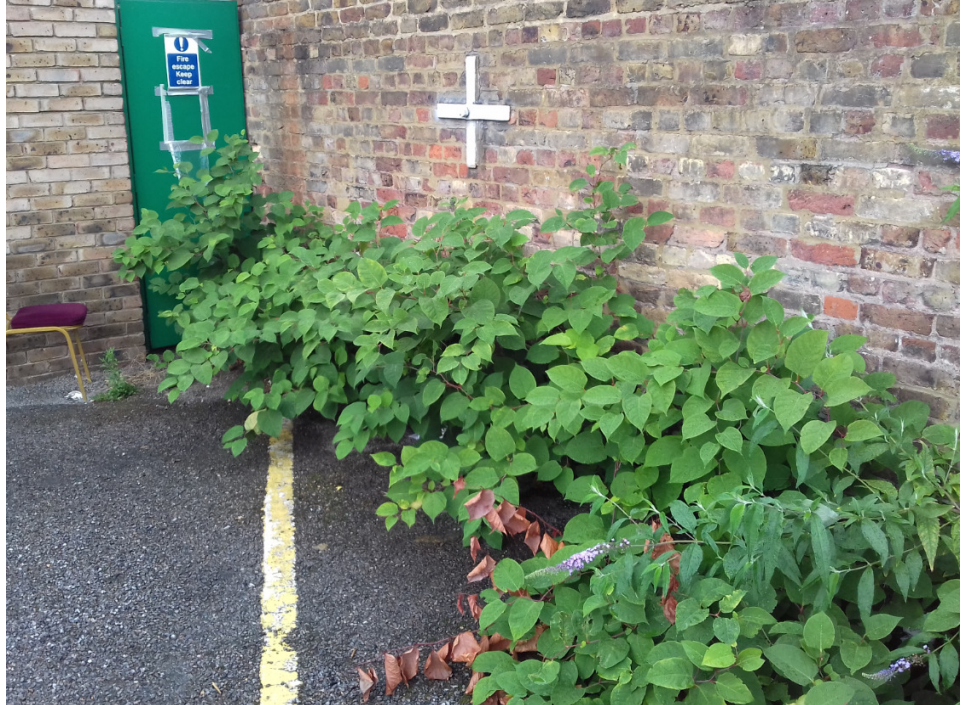
Photo No.  
13

Description:  
Japanese Knotweed  
on central eastern  
site boundary.

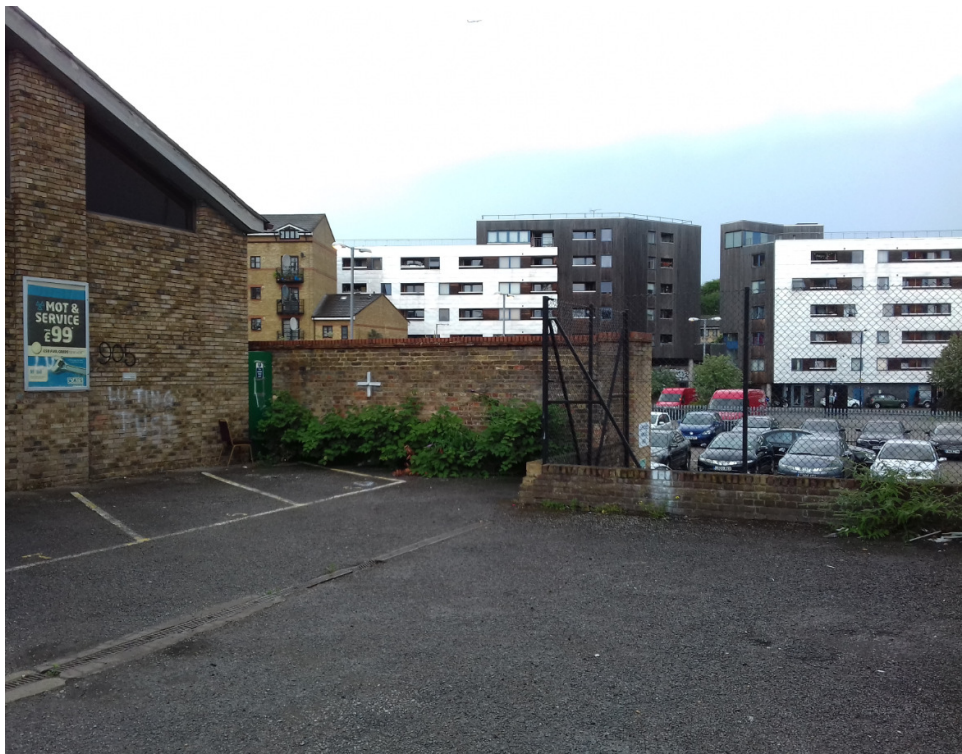
Photo No.  
14

Description:  
Japanese Knotweed  
on central eastern  
site boundary.

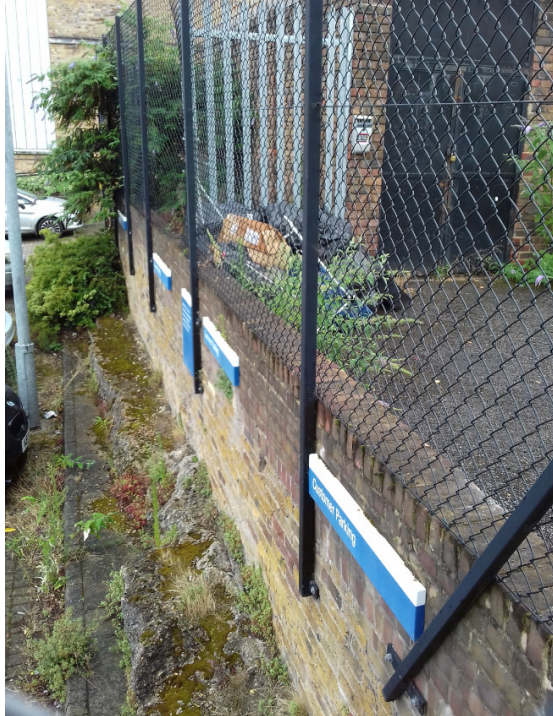
Photo No.  
15

Description:  
Retaining wall to car  
park outside eastern  
site boundary

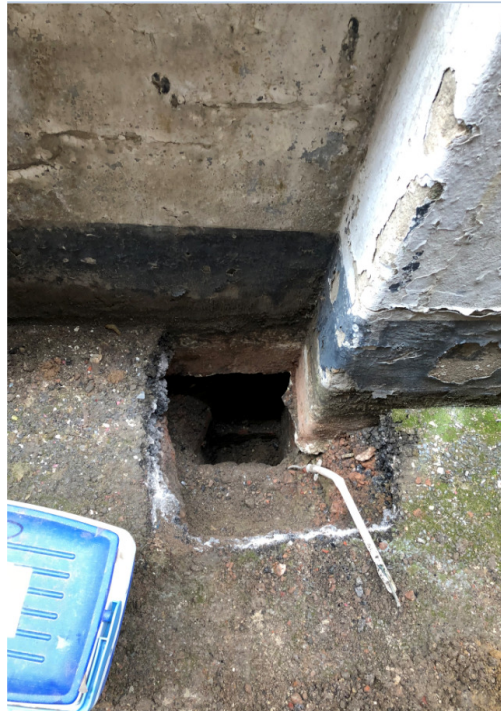
Photo No.  
16

Description:  
TP1 – Golden Lion  
Public House.  
Masonry wall to  
public house to the  
north. Possible  
footing to northern  
ATS building to the  
south.

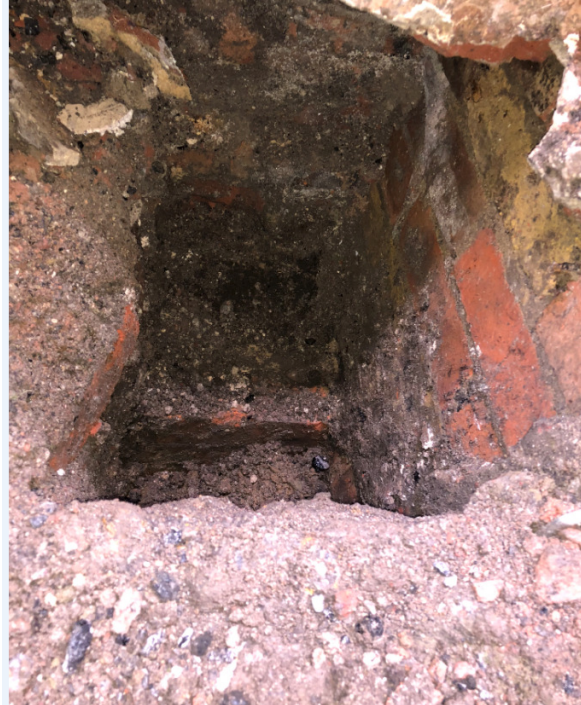
Photo No.  
17

Description:  
TP1 – Golden Lion Public House.  
Masonry wall to public house to the north. Possible footing to northern ATS building to the south.

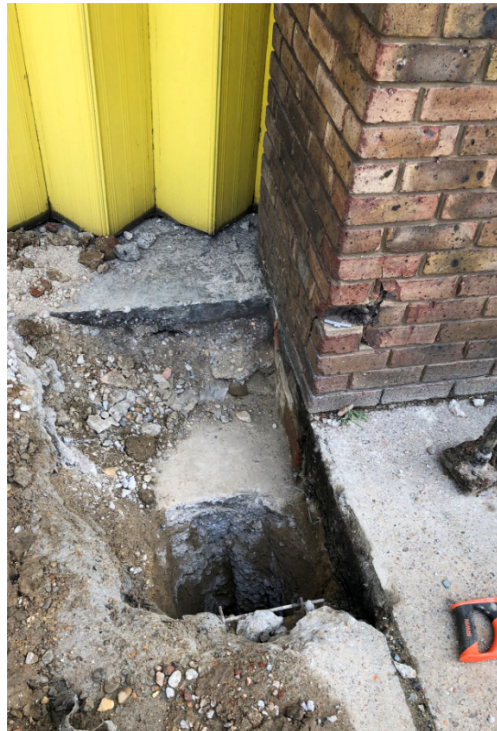
Photo No.  
18

Description:  
TP2 – Central ATS building to the top of the picture

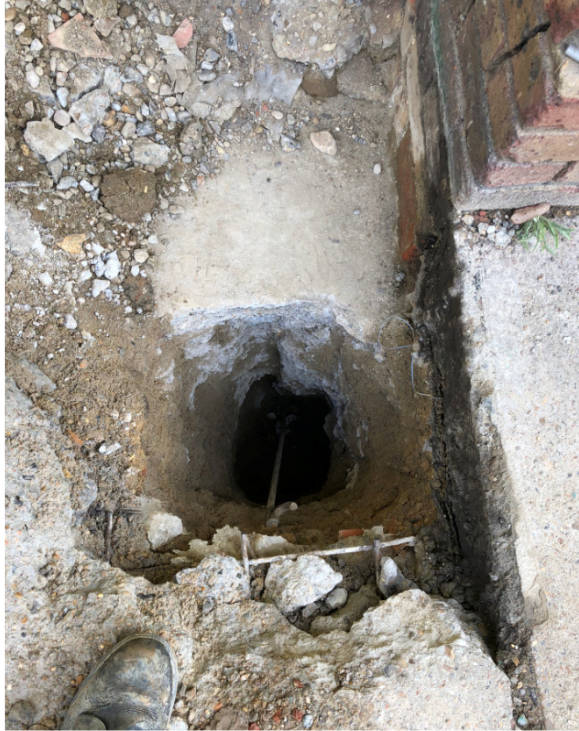
Photo No.  
19

Description:  
TP2 – Central ATS  
building to the top of  
the picture

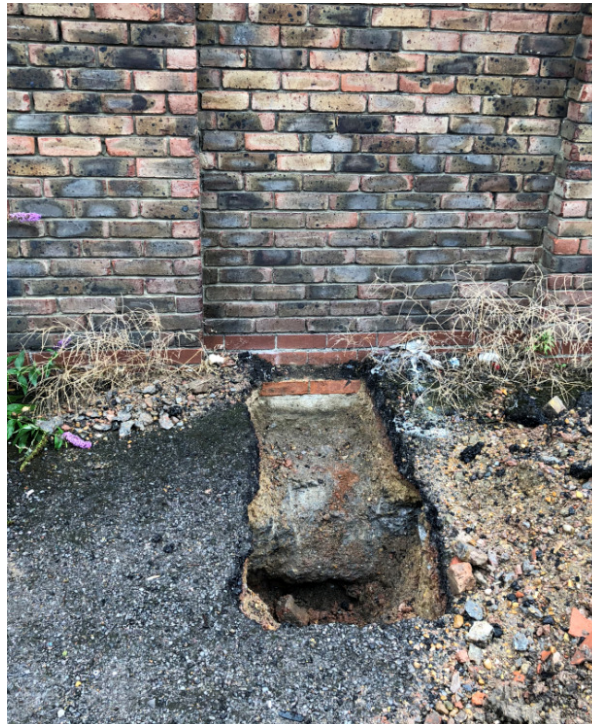
Photo No.  
20

Description:  
TP3 – Tyre centre  
mass concrete  
footing exposure
