Arboricultural Survey (BS5837:2012) & Impact Assessment Report

25 Dartmouth Park Hill
London
NW5 1HP

22nd April 2015

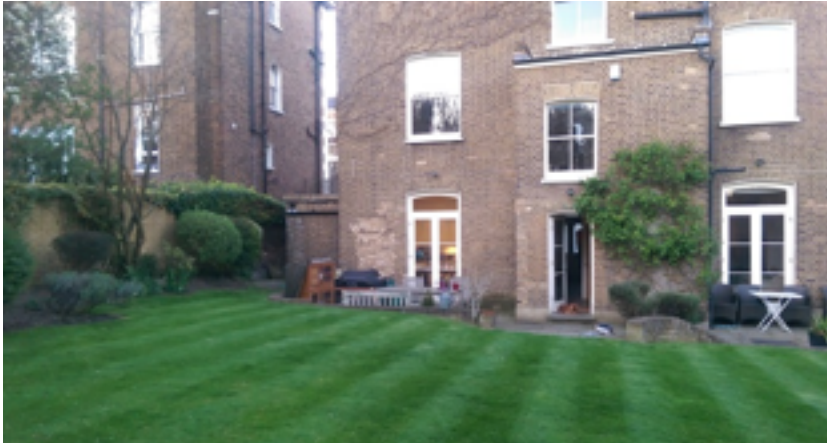
4.10 Tree T1 is an over mature Laburnum (*Laburnum spp*) tree located within a raised border on the northern boundary which has poor form and is in significant decline. The tree is multi-stemmed at the base with congested form and rubbing stems. Significant deadwood in the mid and upper canopy along with a stunted crown shows the tree to be in decline. The tree is rated as a 'U' category tree (BS5837: 2012) due to these characteristics and is therefore proposed for removal.

C.1 Photograph of tree T1 proposed for removal and rear elevation of existing property, 25 Dartmouth Park Hill, London, NW5 1HP as viewed in a north easterly direction

4.11 The tree's location within very close proximity of the proposed extended hard landscaping area and rear extension means that a replacement tree is proposed to be re-planted to the rear of the property, close to the south western boundary (as depicted within *Appendix B.2*). The specifications of the replacement planting which will improve the treescape at the rear of this property for the long term is outlined in *Section 5.3*.

Fell to ground level

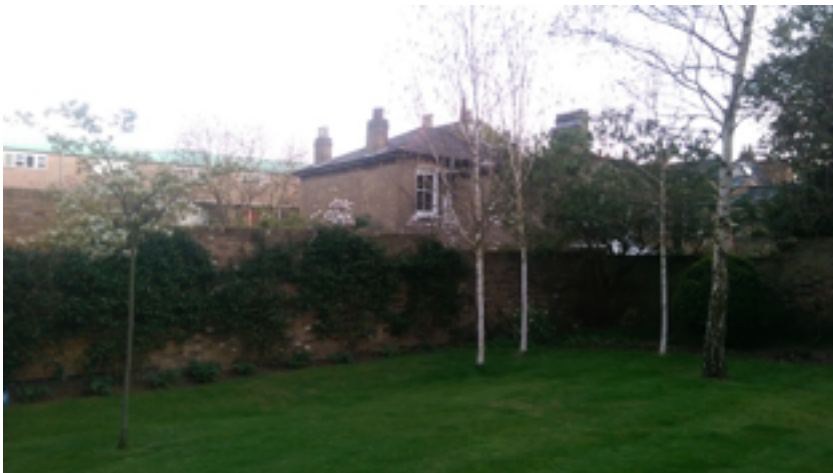
4.12 Tree T2 is a young snowy mespil tree (*Amelanchier canadensis*) which has reasonable form and is generally structurally sound. Currently a very small tree, T2 was likely planted within the past 2 years and offers limited amenity value at present. The tree is rated as a 'C.1' category tree (BS5837: 2012) and is proposed for retention, albeit in a revised location, at a greater and more appropriate distance from the property in order to facilitate the proposed development.

4.14 Trees T3-T5 comprise a small group of Himalayan Birch trees (*Betula utilis 'Jacquemontii'*) which are all structurally sound and offer excellent form with good vigour. The trees are currently young to early mature specimens which have been planted within the past 5 years. The trees collectively , alongside T6 provide amenity value for this rear garden area and this will be enhanced in the long term as the trees mature.

4.15 These trees although offering good amenity value are also categorised as 'C.1' (BS5837:2012) taking into account their relative young age and rear garden location. The tree closest to the proposed extension, T3, has a recommended protection distance of 1.2m which will be fully achieved with the fencing constructed as recommended within *Appendix B.3* (to specifications accounting for tree T6 in this area - see below) allowing for this tree and T4 - T5 to remain fully protected from the development. The 2.0m protection distance from this tree will also provide full protection from the canopy extending towards the proposed development.

4.16 Tree T6 is a mature Birch tree (*Betula pendula*) which has good form, is structurally sound and has a balanced canopy shape despite a slight lean to the north east. The tree is rated as 'C.1' (BS5837:2012) taking into account the rear garden location and relatively limited life span. This tree is at its closest point 9.5 metres from the proposed development and taking into account its recommended root protection distance of 2.9m, its comprehensive protection is fully achievable. The protection fencing that is specified (*Appendix B.3*) will allow for a 3 metre distance of protection from the main stem affording protection for this tree and all those remaining within the garden.

C.2 Photograph of tree T2 proposed for removal and trees T3-T6 within rear of property, 25 Dartmouth Park Hill, London, NW5 1HP as viewed in a south westerly direction

Prune to give 2m clearance from property

5.5 Recommended Transplanting of Tree T2

It is recommended that this tree is transplanted with adherence to the following guidelines if its proposed location is to be outside of the root protection area of the remaining trees / within the construction site where damage would inevitably occur during the development process:

- The tree should be removed from the ground with a minimum rootball of 30cm surrounding the main stem on each side ensuring the retention of fibrous roots where possible
- The tree is potted up into an approx size 50 litre pot with *John Innes No.3 Compost* and watered regularly during the growing season
- The tree should be replanted in its newly proposed

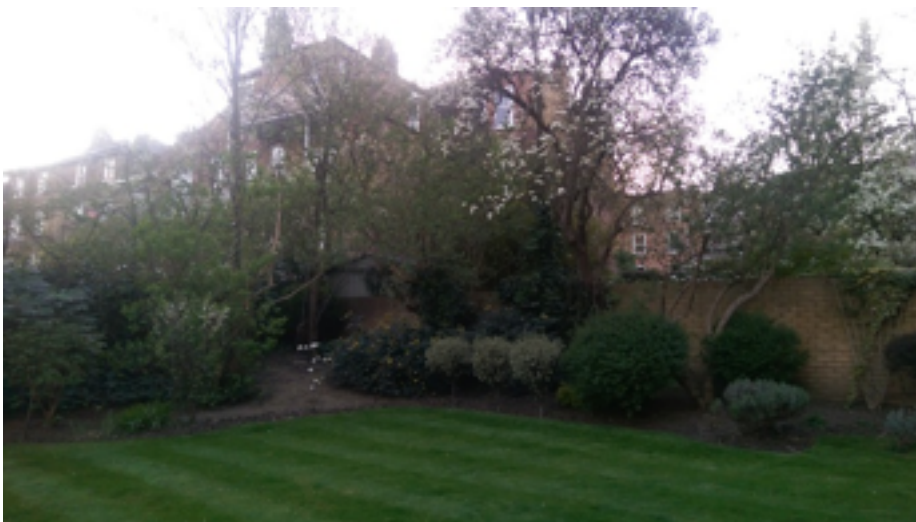
4.17 Trees T7 and T8 are mature Plum trees (*Prunus spp*) which provide a combination of ornamental and amenity value at the rear of the property close to the western boundary. The trees will remain fully protected from all construction site activities by virtue of their location over 12 metres from the closest point of proposed works and a significantly greater distance than the recommended root protection distance of 2.0m from tree T7.

4.18 Tree T9 is a mature Pear tree (*Pyrus domestica*) which is located on the northern boundary and provides good ornamental value to this area of the rear garden. The tree is generally structurally sound although has fair vigour only with some deadwood throughout. The tree is rated as 'C. 1' (BS5837:2012) taking into account the rear garden location and mainly ornamental value provided. This tree is at its closest point is sited 6.9 metres from the proposed development and taking into account its recommended root protection distance of 3.0m, its comprehensive protection is fully achievable; the protection fencing is specified at least 3.0m from the east of the main stem.

C.2 Photograph of trees T7-T9 within rear of property, 25 Dartmouth Park Hill, London, NW5 1HP as viewed in a westerly direction

4.19 The protection fencing that is specified for trees T3-T6 to the south is therefore recommended to extend across the width of the garden (see *Appendix B.3*) ensuring that full protection is provided for the entire western section of the rear garden, therefore also incorporating trees T7-T9.
