Rear Garden Pergola at 41 Frognal
Additional material

Planning Ref 2019/1979/FUL

Planning Submission

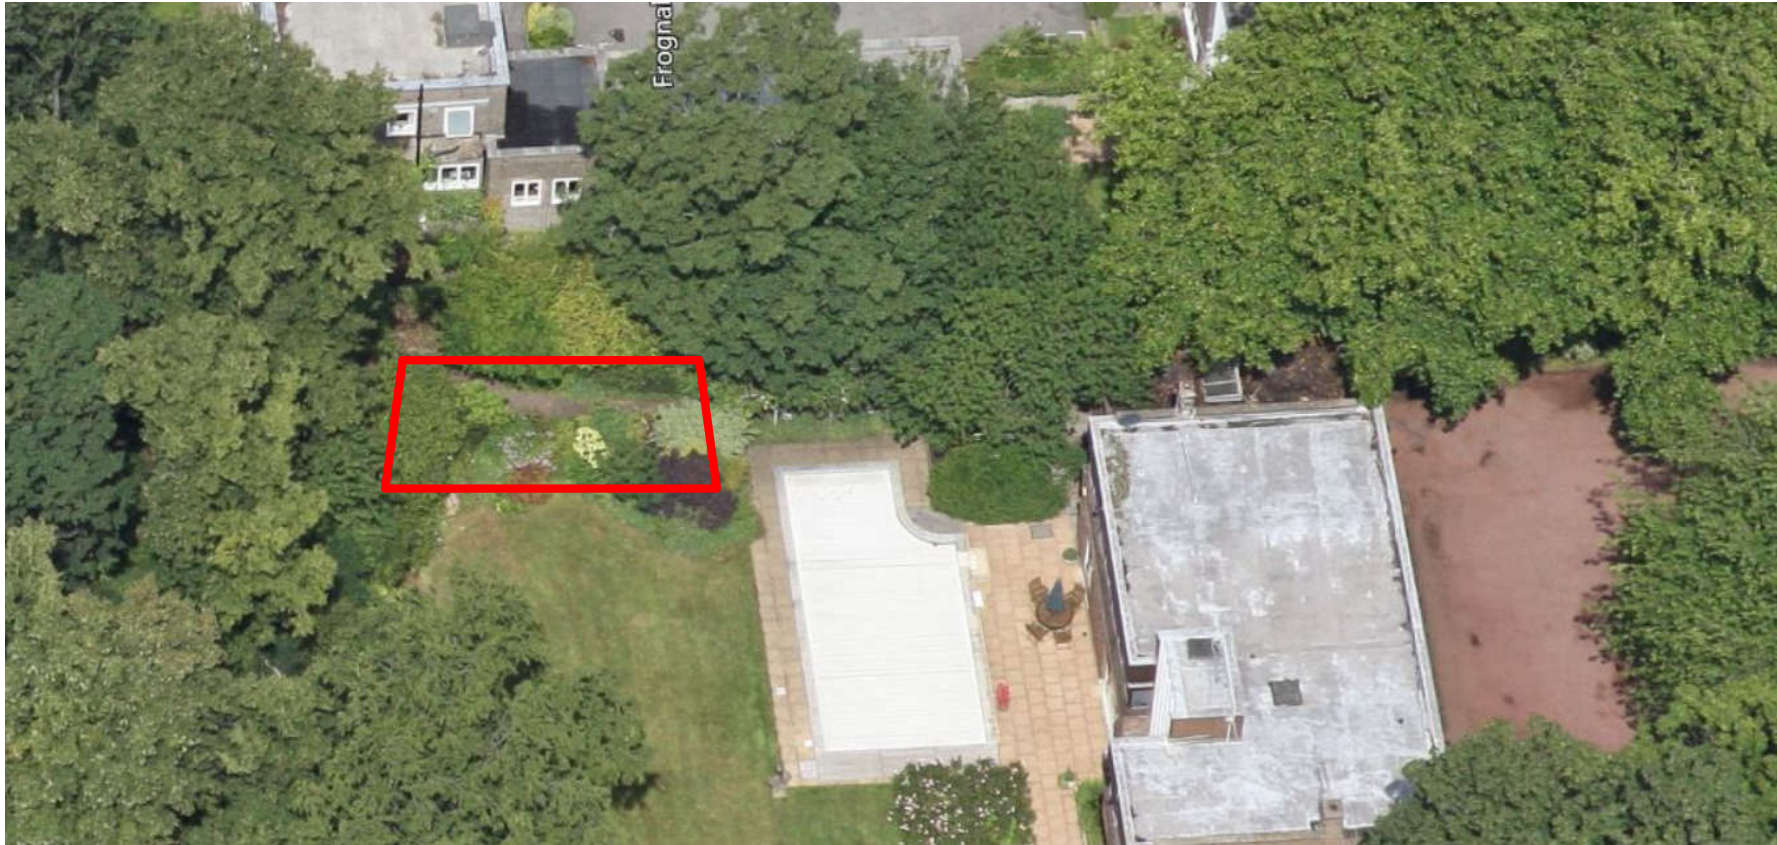
Left:
Aerial photograph showing the site context prior to works on site. The red outline shown is approximate and shows roughly where the raised pergola terrace sits in relation to the original lawn and hard surfacing

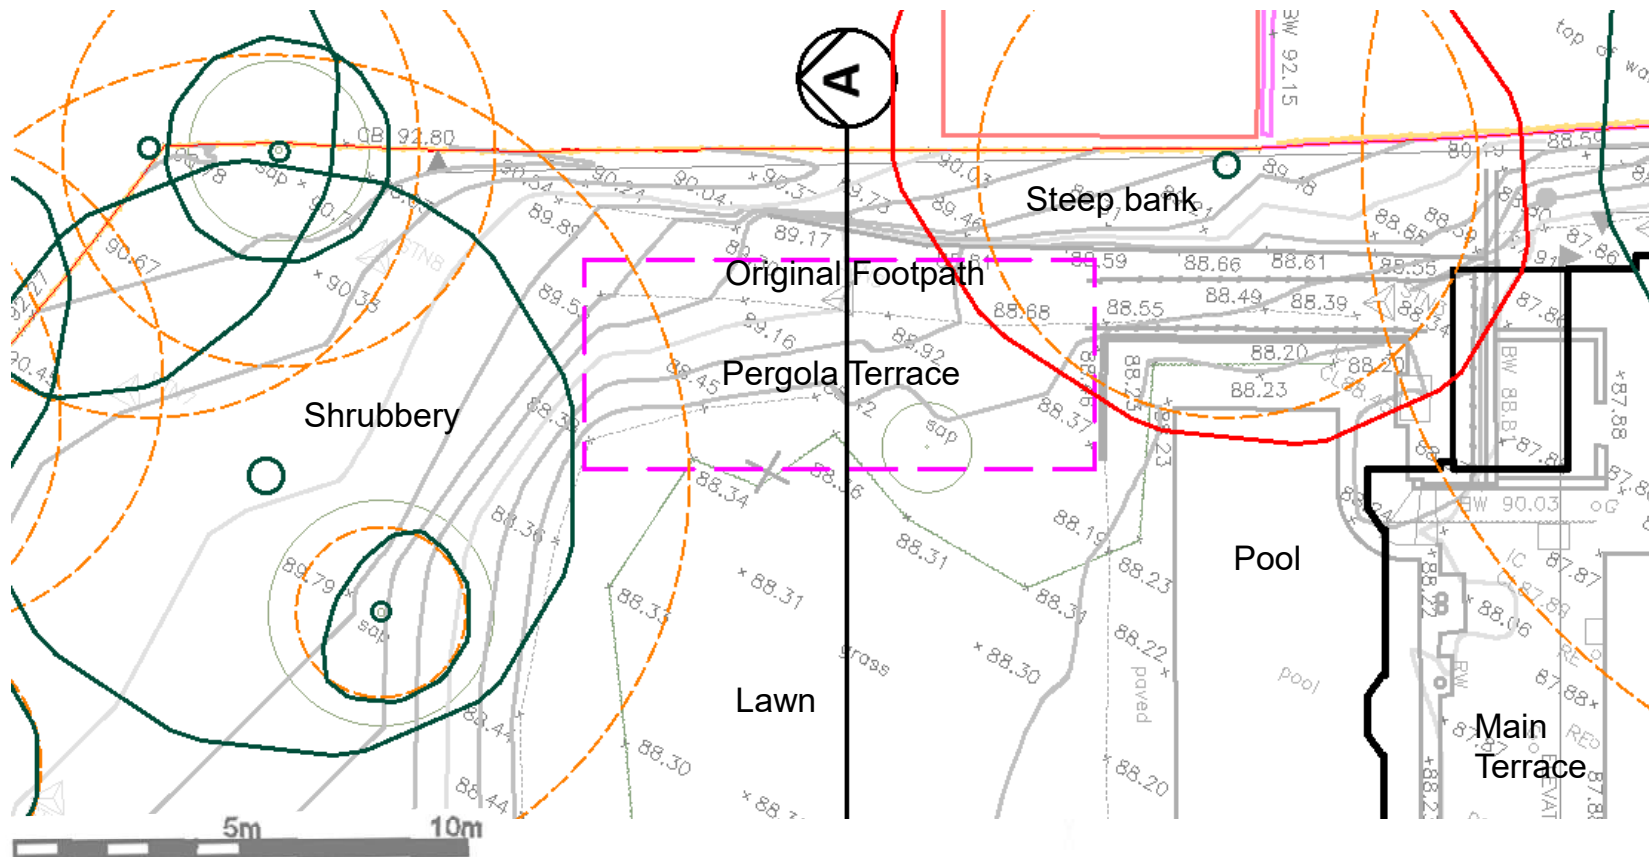
Left:
Topographical survey showing existing levels, contours, extent of hard surfacing and vegetation for context. Pink dotted line shows extent of pergola terrace on plan.

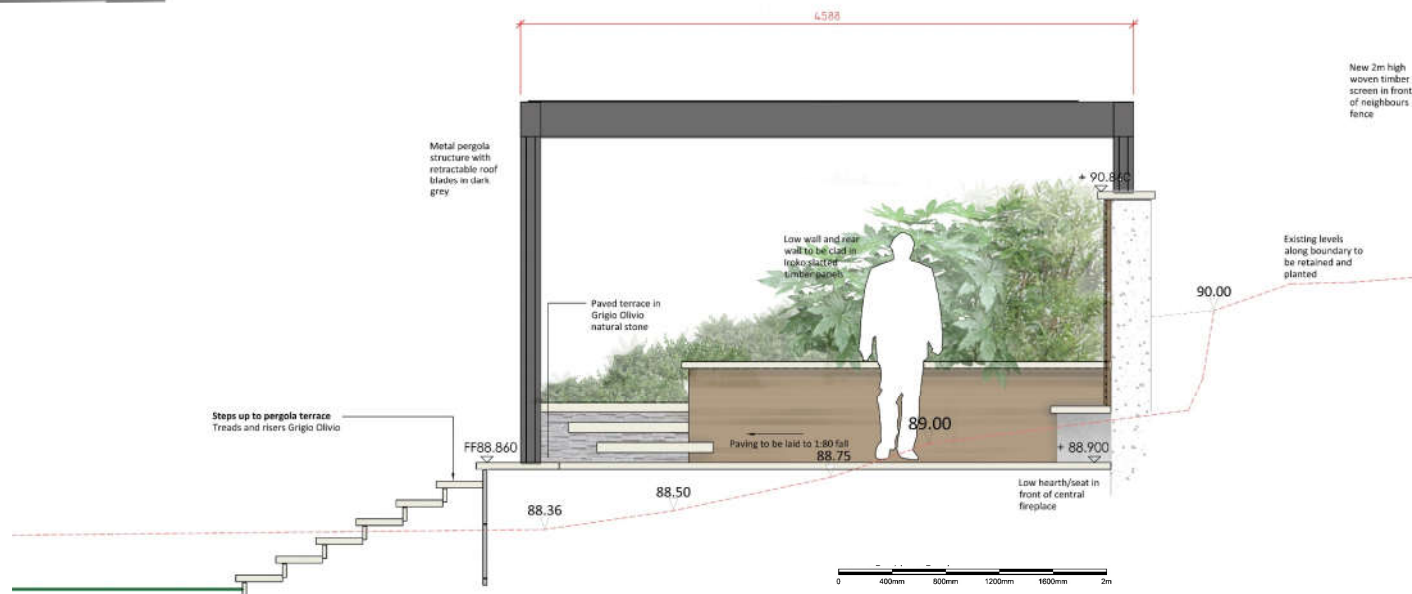
Left:
Section AA through centre of pergola terrace – red dashed line shows existing ground level.

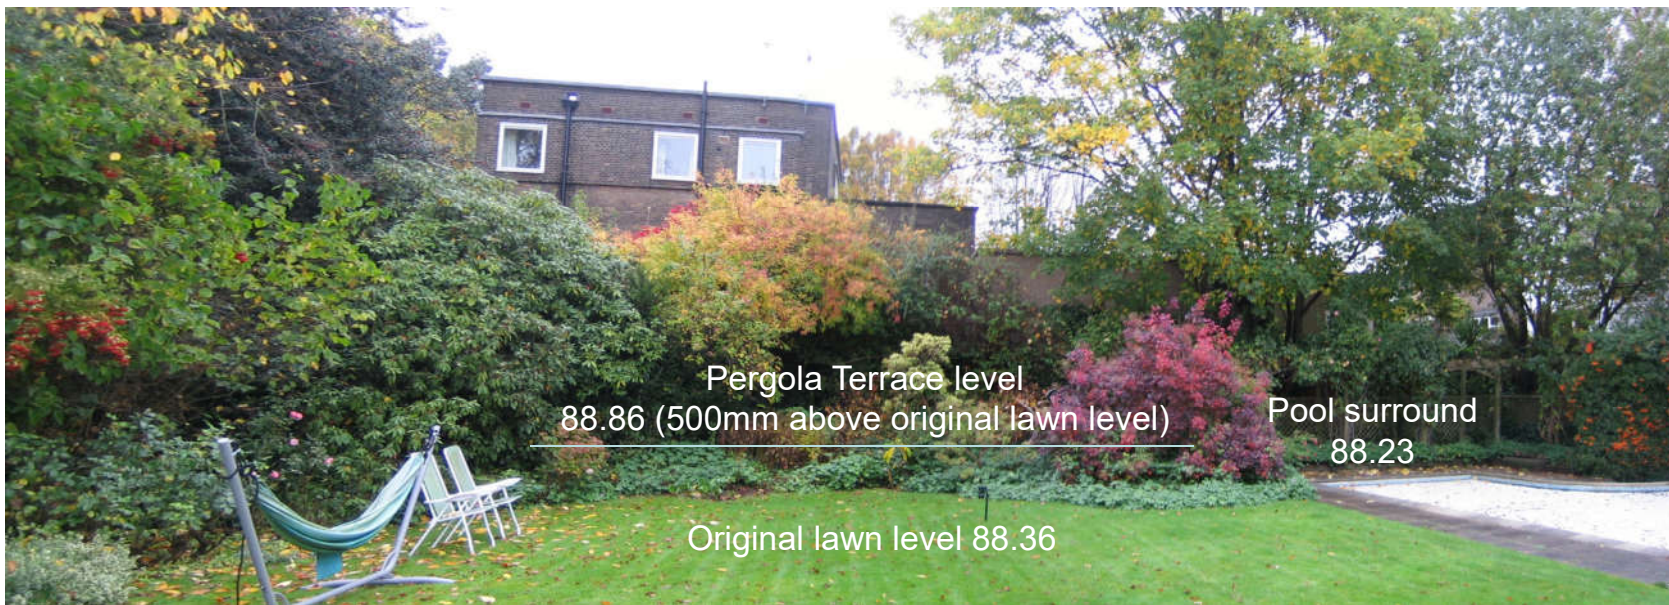
Left:
 Photograph taken from the lawn looking north showing the site context prior to works on site. The line shown is approximate and shows roughly where the raised pergola terrace sits in relation to the original lawn and hard surfacing

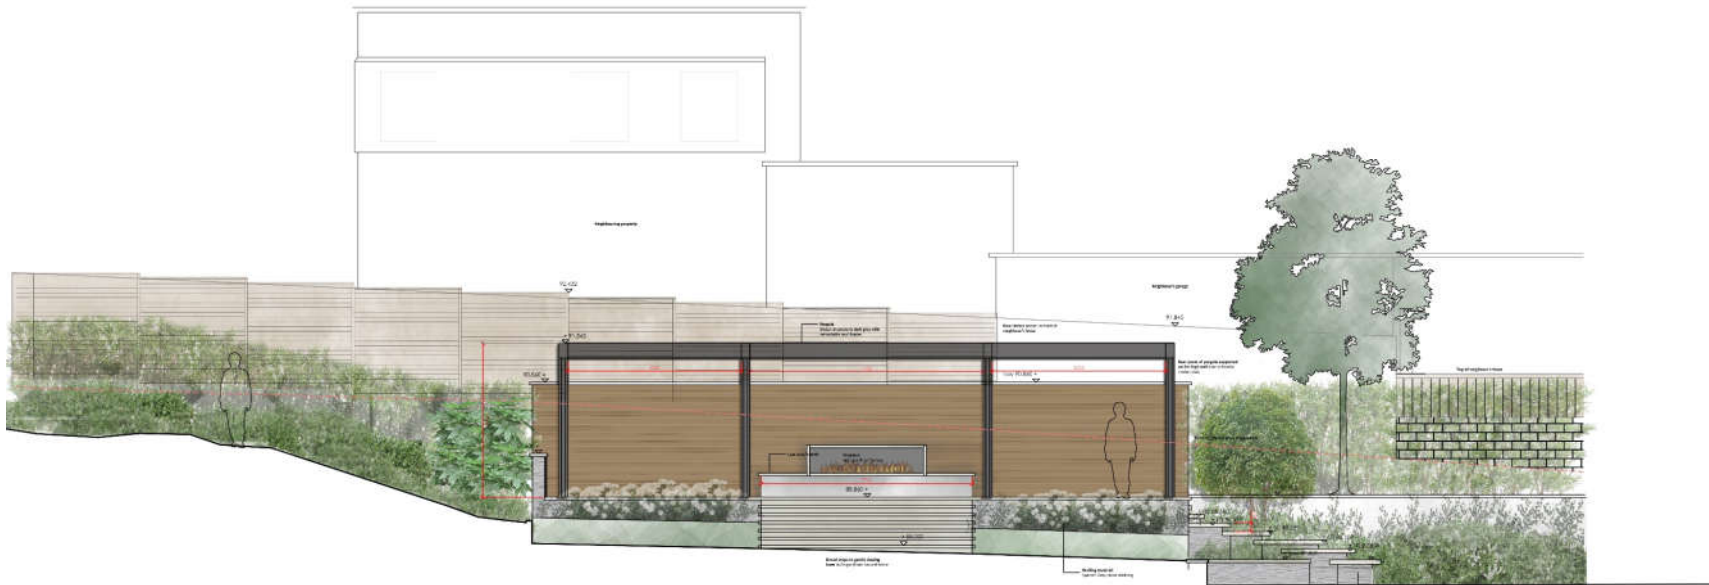
ELEVATION OF PERGOLA TERRACE SHOWING CONTEXT

Left:
 Elevation showing raised pergola terrace at 88.86 (500mm above original lawn level)
