**BASEMENT IMPACT ASSESSMENT ADDENDUM**  
20A FERNCROFT AVENUE  
LONDON  
NW3 7PH

JOB NO: P19-461

DATE: 12<sup>th</sup> March 2020 – Rev 0

This Addendum to Taylor Whalley Spyra Basement Impact Assessment (BIA) dated 12th December 2019 has been prepared in response to comments received from Campbell Reith's Basement Impact Assessment Audit ref 13398\_02 revision D1 dated February 2020.

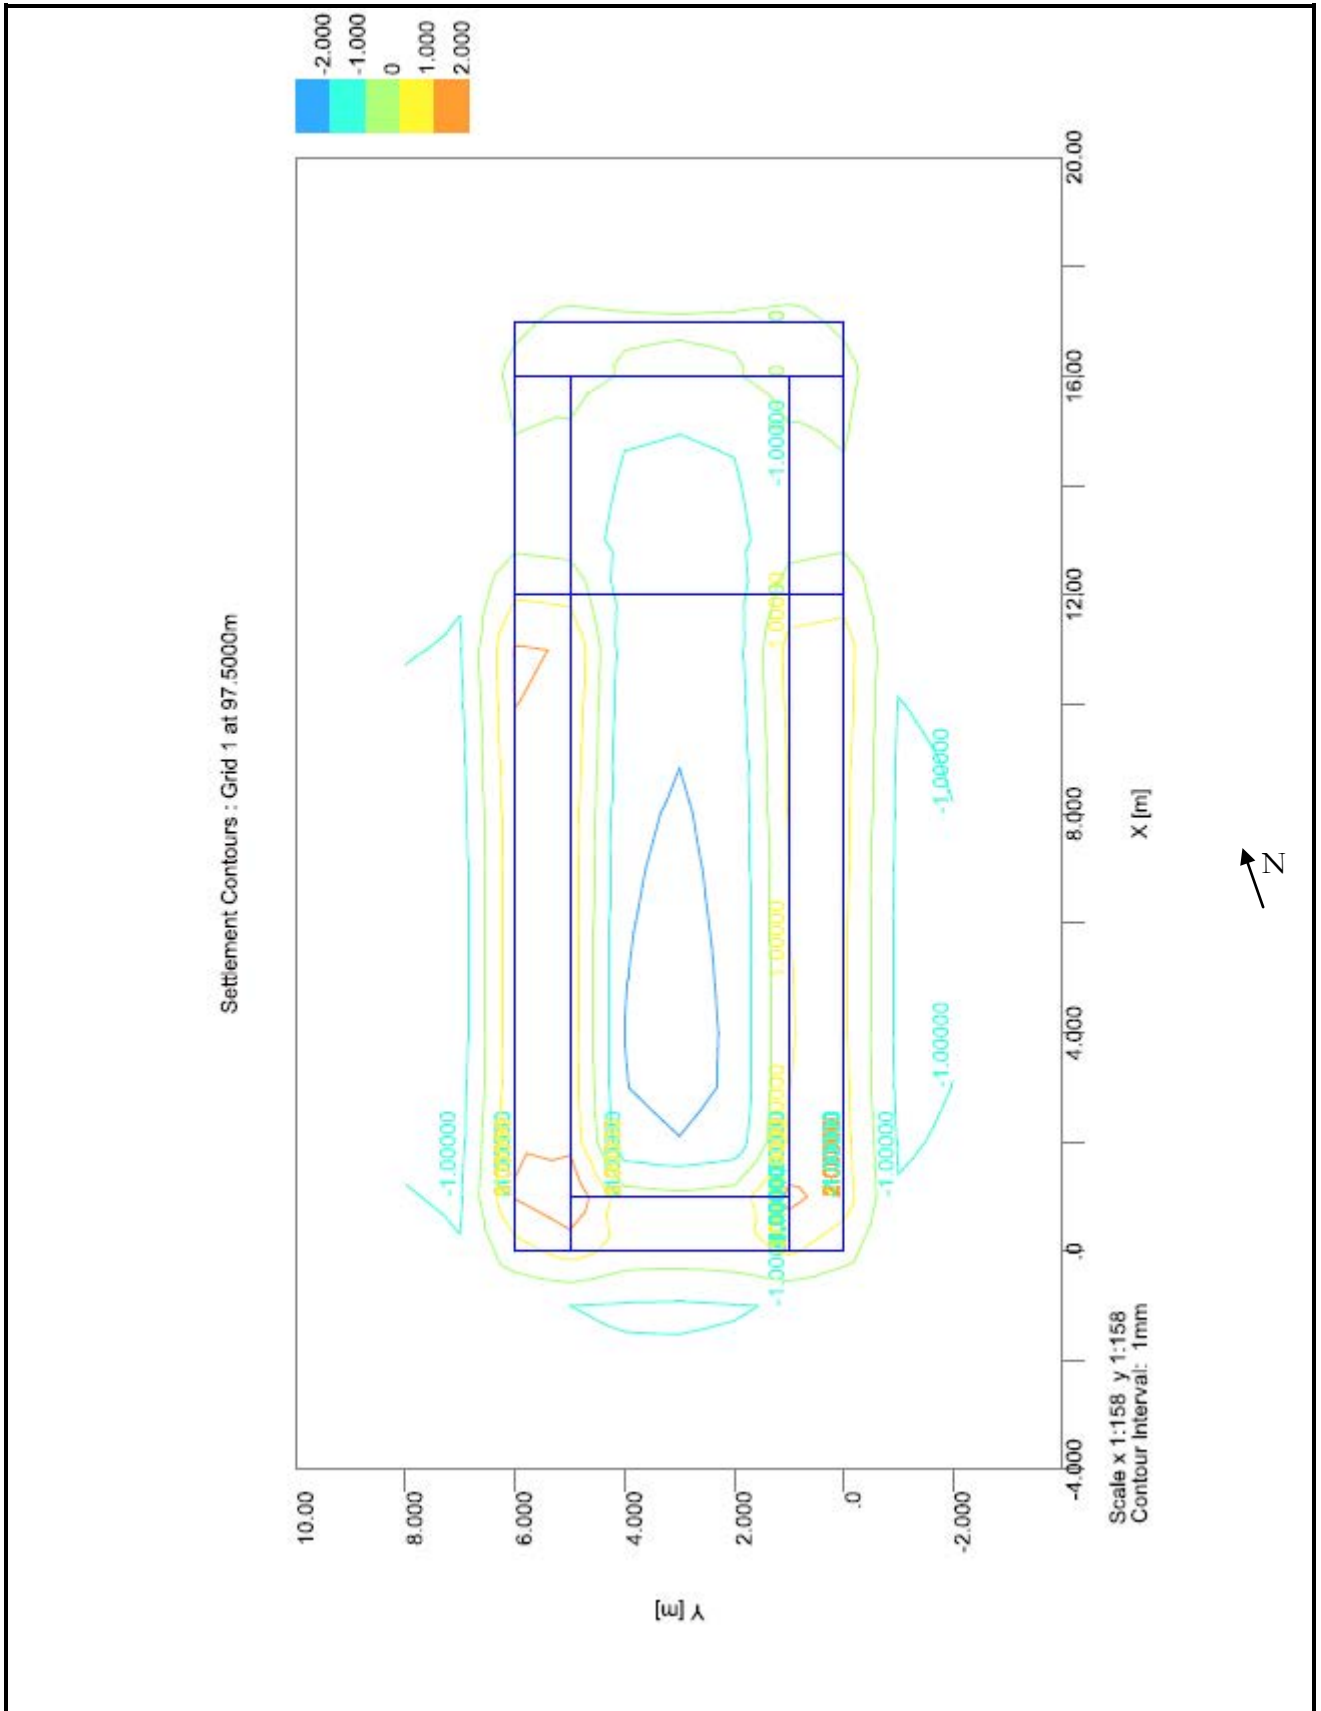
**Figure**  
**6**

**Predicted ground movements due to transfer of loads during underpinning**

The loads transferred from the existing to the new foundation levels during the underpinning process are in the order of 110kN/m to 135kN/m along the party walls and 25-29kN/m along the front and rear walls. The ground movements due to this load transfer have been estimated using PDisp.

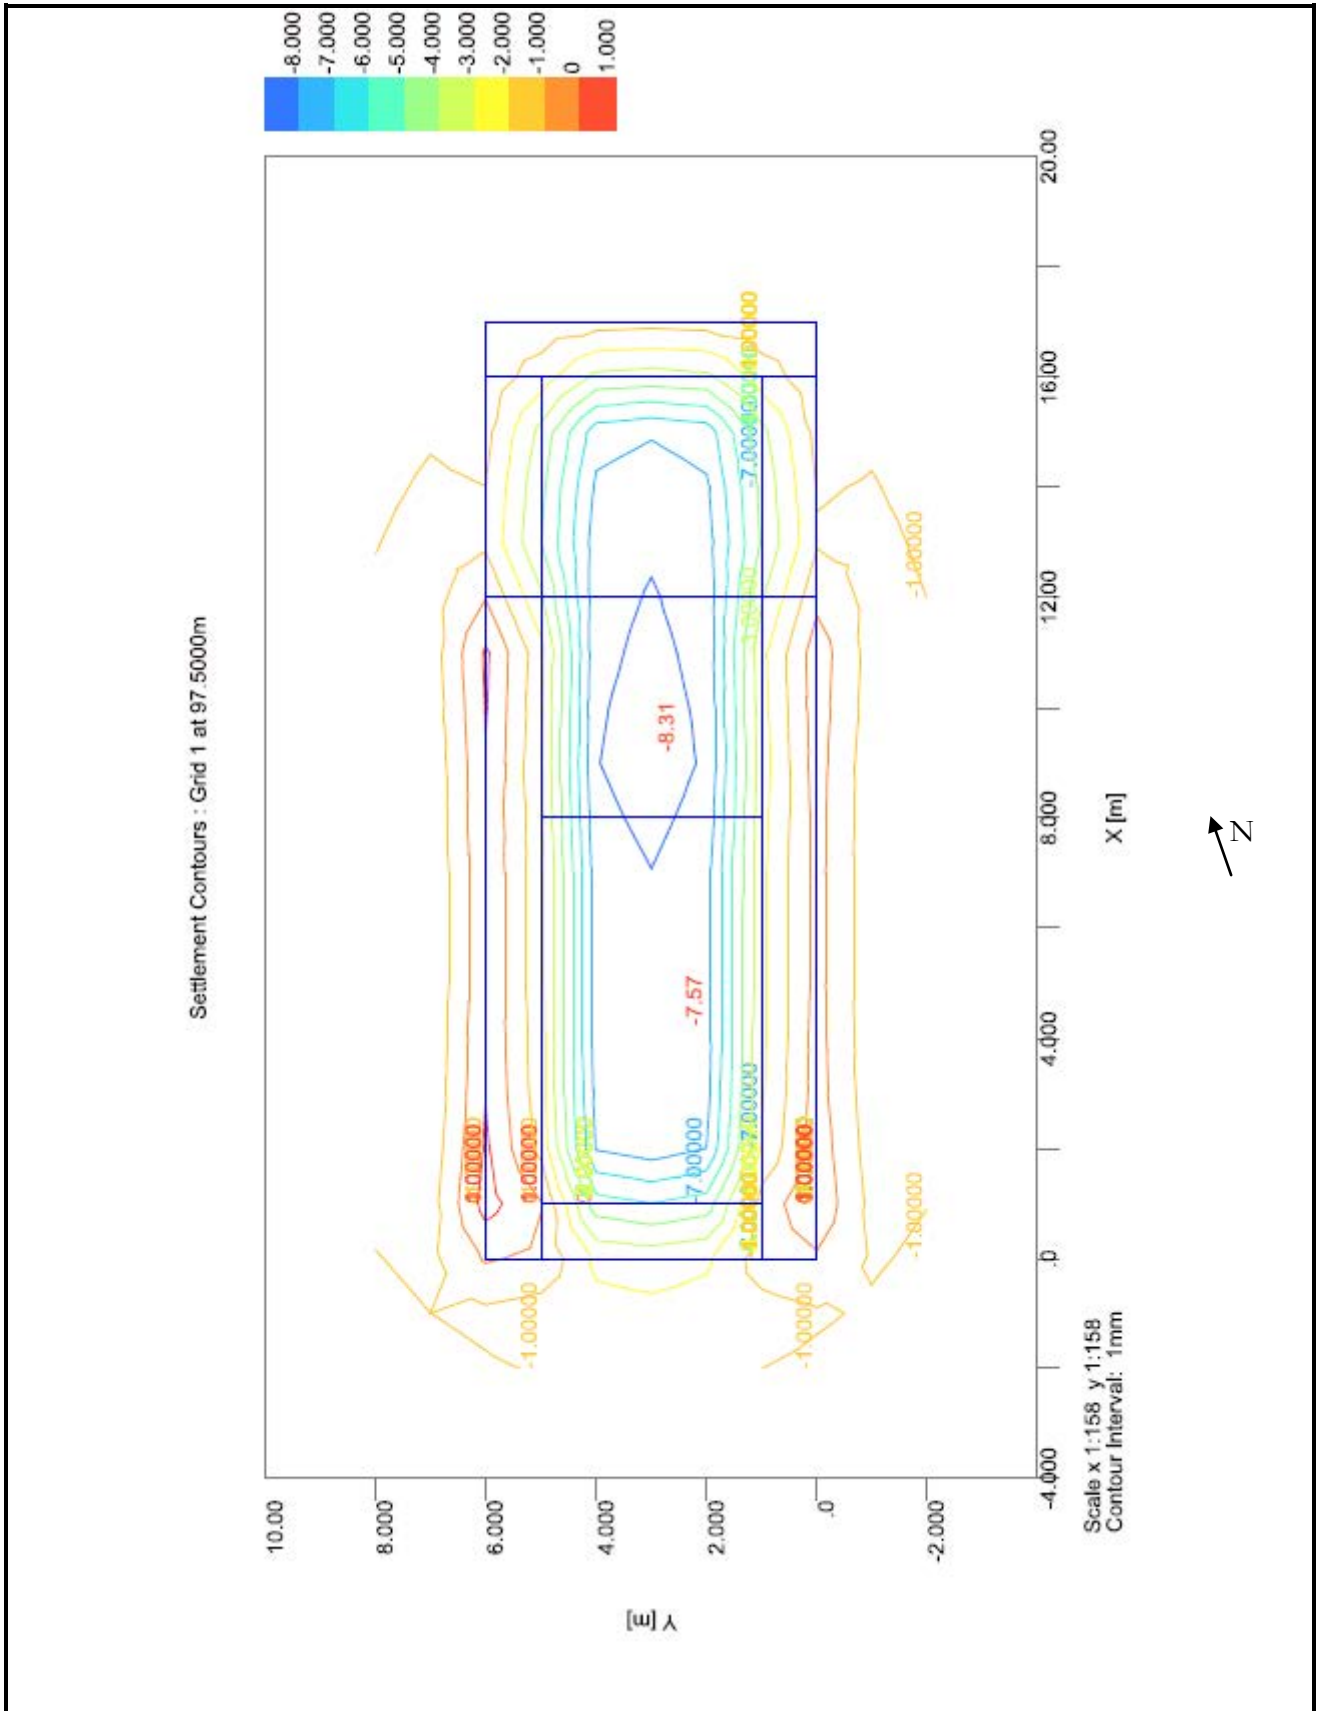
Figure  
7

Estimated ground movements at completion of excavation for the new basement

The pressures removed as a result of excavation are approximately 60kPa across the front of the house and 70kPa across the rear. The results of the analyses show that at the end of the excavation the ground would move upwards by 4-5mm in the central part of the site and 1-2mm along the edges (Figure 7). It should also be noted that the loads of the internal walls will be transferred onto the underpinnings as excavation proceeds. This will increase the loads on the underpinning causing some additional settlements of the walls and reducing the global swelling of the ground. Conservatively, these movements are not considered in this stage.

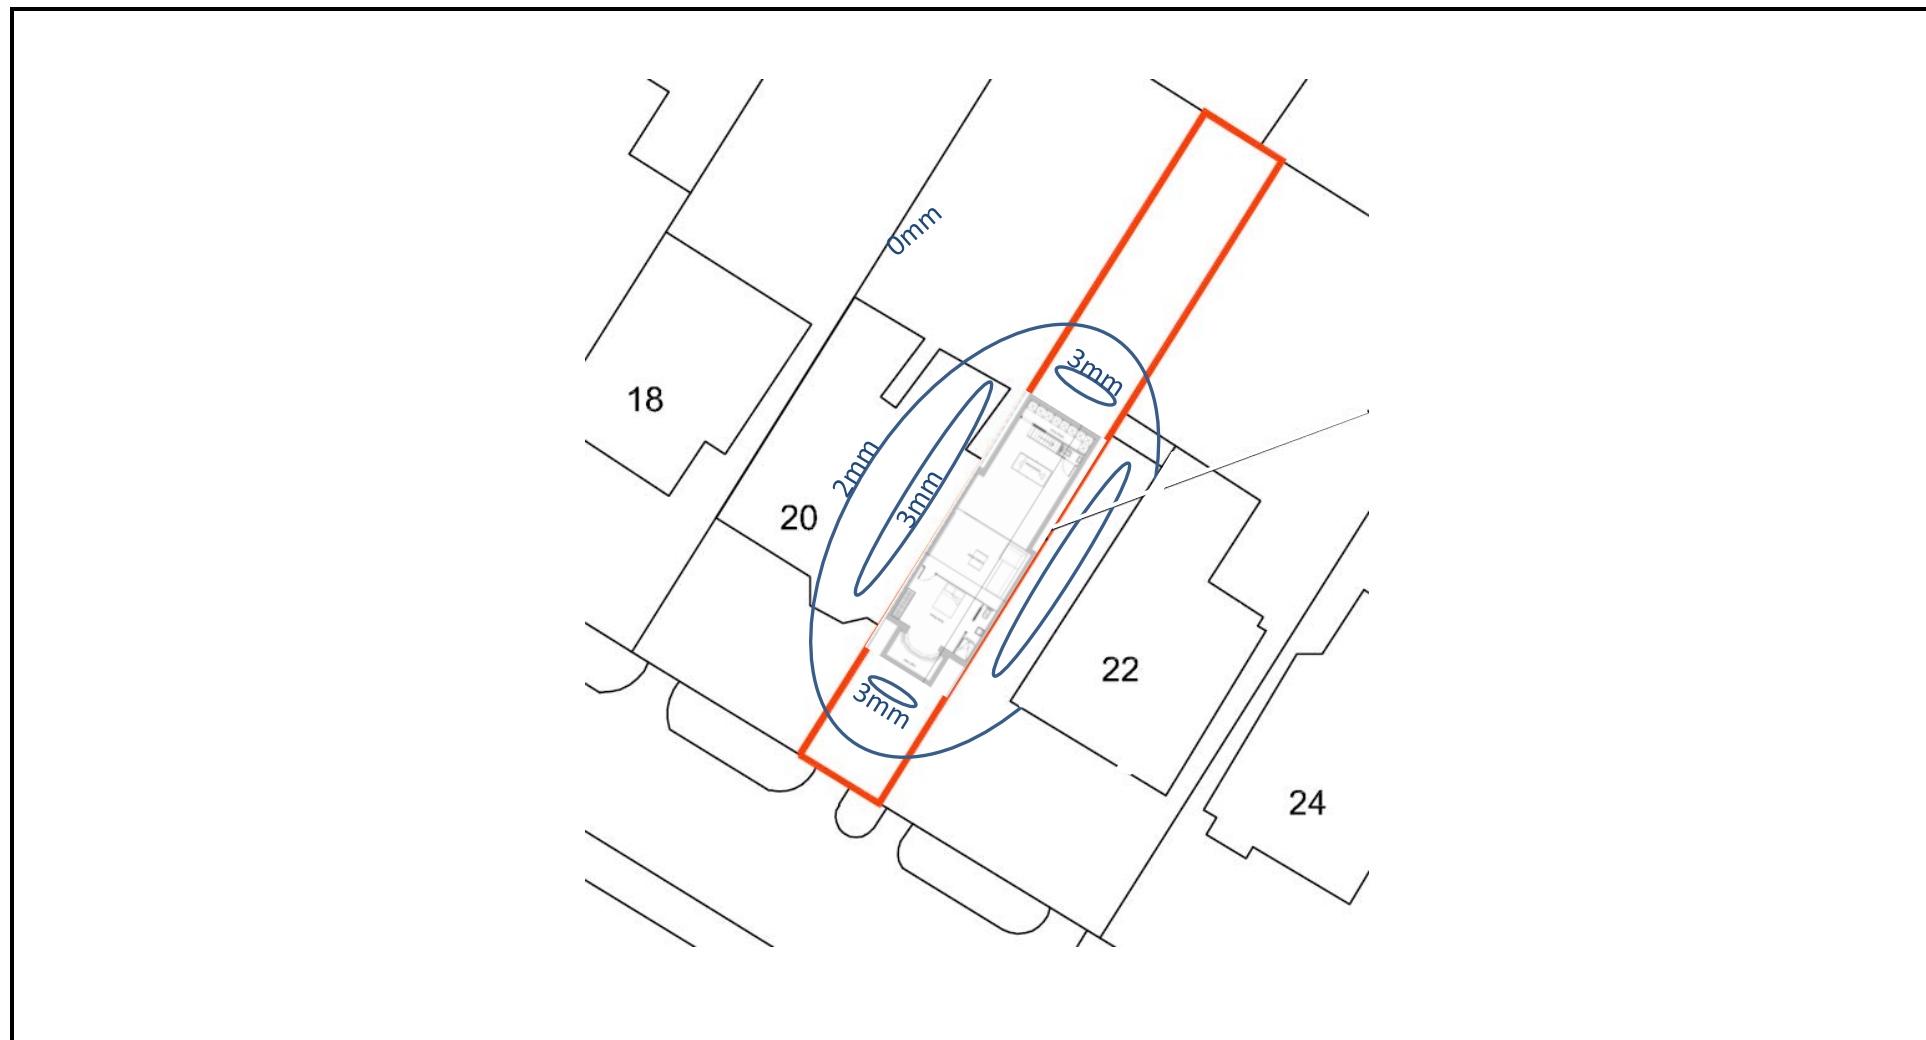
| | <b>Mr and Mrs Graff</b><br>20a Ferncroft Avenue | <b>Figure</b><br><br><b>10</b> |

| | <b>Ground movements induced around the site</b><br>Total vertical movements | |

The building damage assessment accounts for the predicted ground movements, which include settlements of the perimeter walls due to the underpinning process (i.e. 5-10mm localised under the walls) and settlements and horizontal movements due to excavation (i.e. up to 5mm and reducing with distance from the retaining walls – see figures 9 and 10).

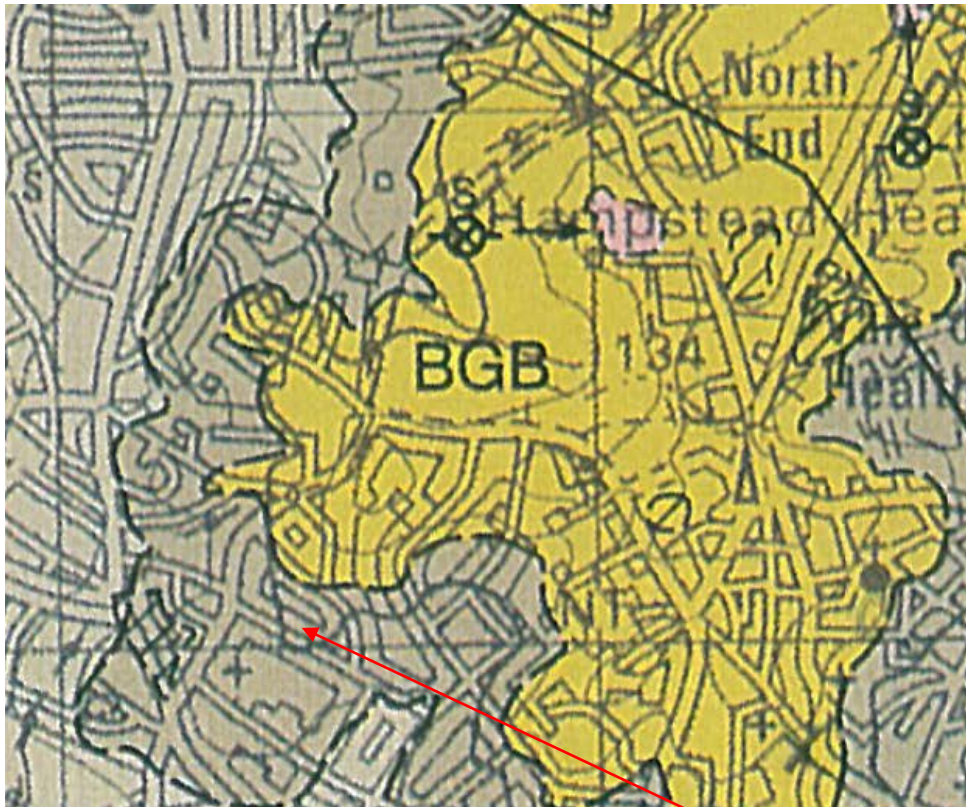
**Figure**  
**4**

**Mr and Mrs Graff**  
20a Ferncroft Avenue  
**BGS Geological map, 1992**

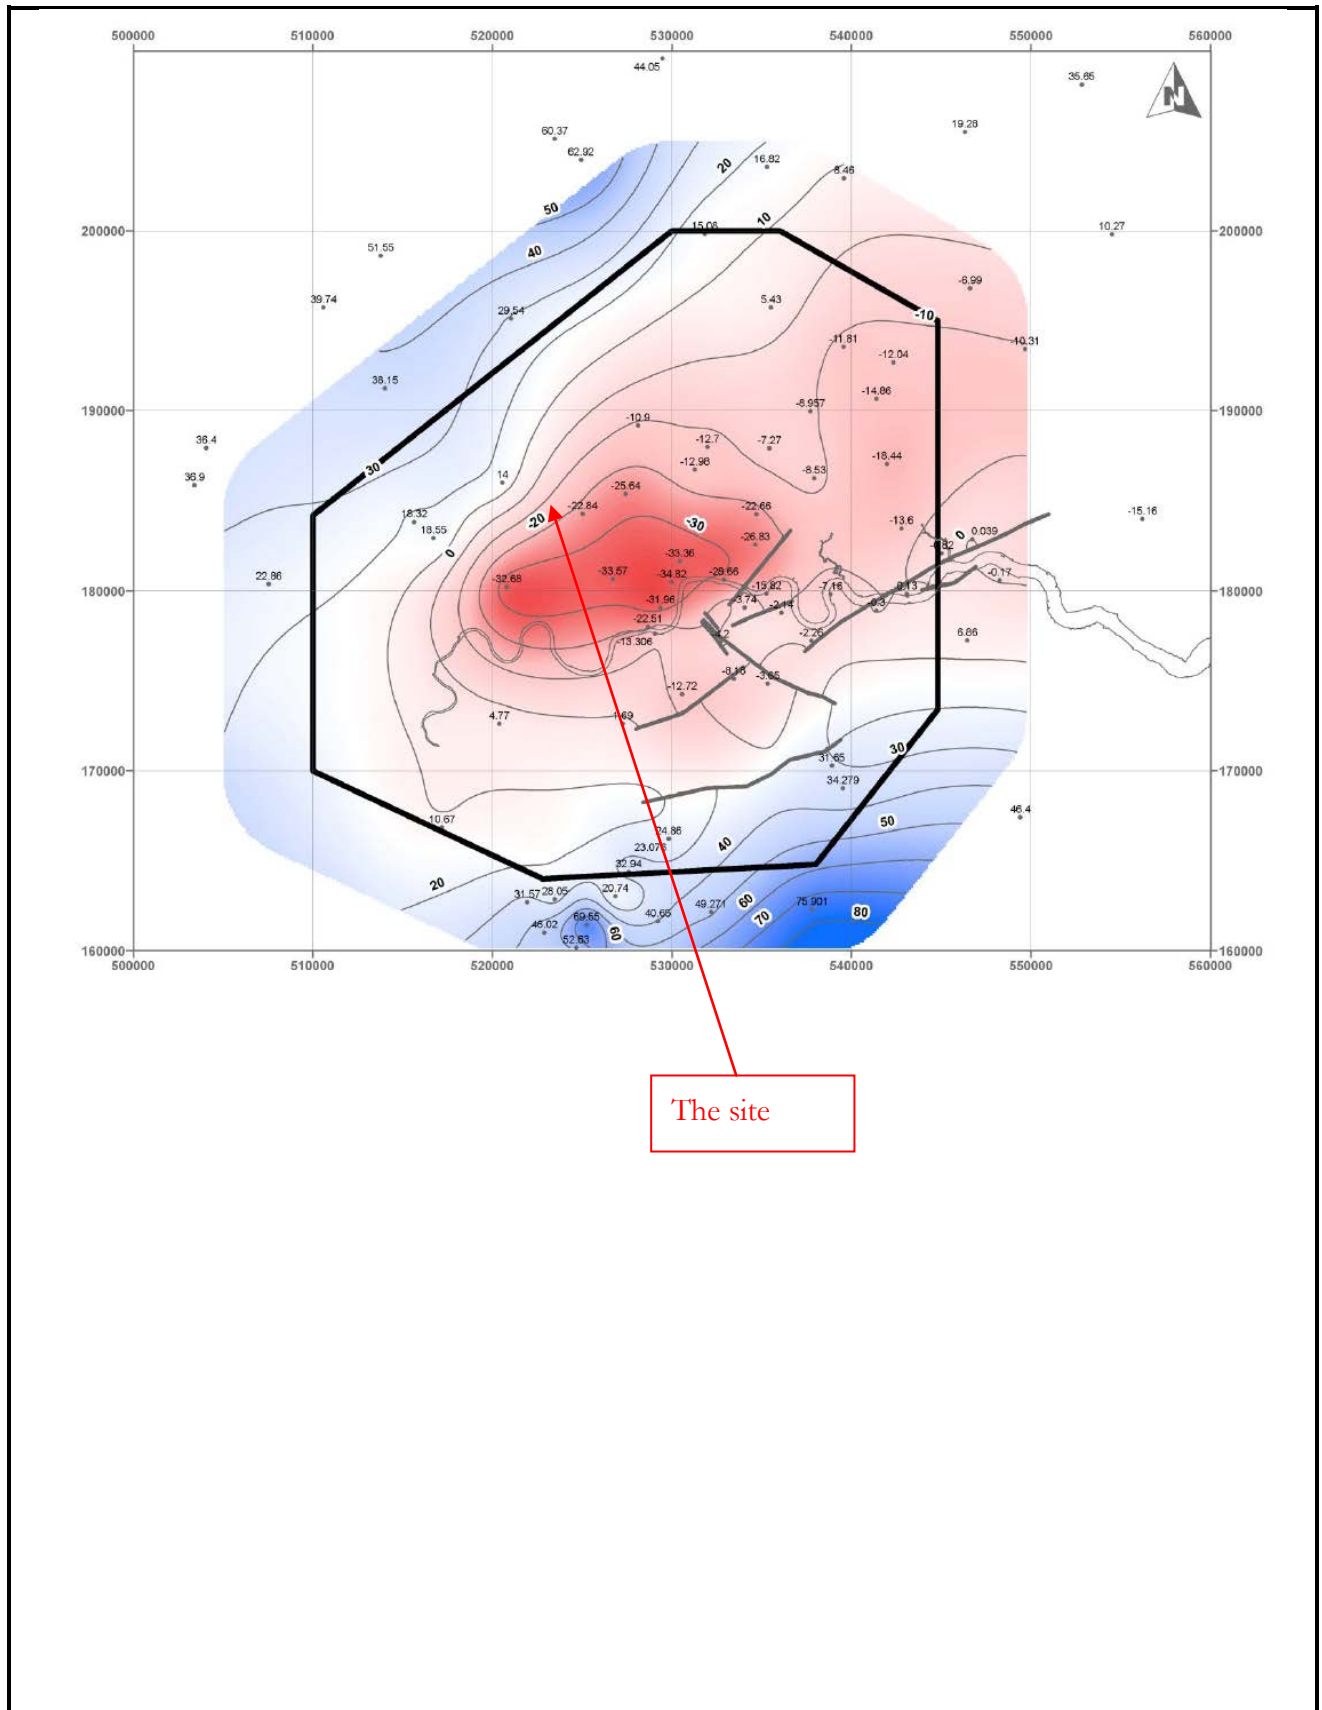
**Figure**  
**7**

**Level of deep aquifer**  
Environment Agency 2016

The deep aquifer lies within the Chalk and Thanet Sand Formation that extends under the London Basin. Historically, extraction of water from this aquifer for drinking and industrial purposes has caused a significant drop in the aquifer level. Since the mid-1960s, extraction of water from the deep aquifer has declined greatly, and as a result the water level has been recovering. Due to the implications that this rising groundwater level has for the infrastructure of London, the aquifer level is now monitored and the rise in its level is controlled by pumping (as described by the Environment Agency, 2017).

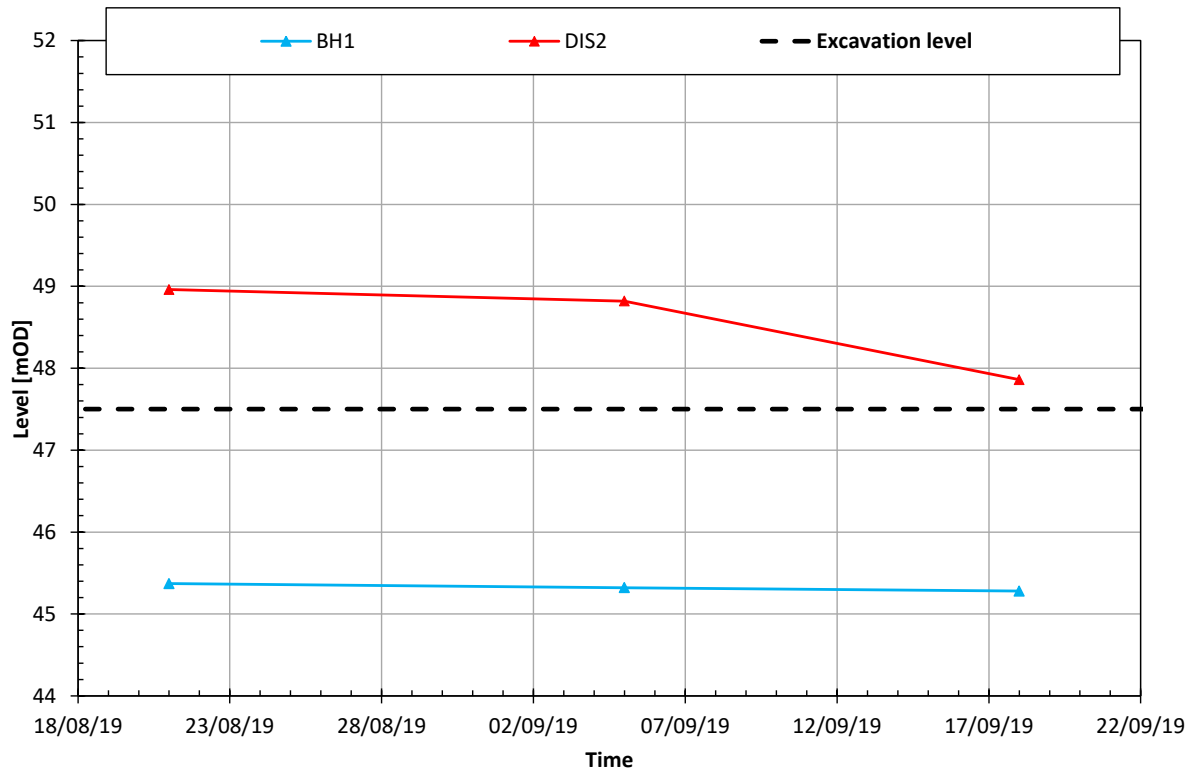
**Figure 8**

**Mr and Mrs Graff**  
20a Ferncroft Avenue  
**Groundwater levels across the site**

Perched water has been found to be present from 2.3m below ground level, although discontinuous water ingress might be encountered also at shallower depths. The groundwater level has been measured at approximately 5m depth and is expected to flow southwards and eastwards following the topography of the ground.
