DESK STUDY, GROUND INVESTIGATION, BASEMENT IMPACT ASSESSMENT & GROUND MOVEMENT ASSESSMENT REPORT

**35 TEMPLEWOOD AVENUE
LONDON
NW3 7UY**

Report Title: Geotechnical Desk Study, Ground Investigation, Basement Impact Assessment & Ground Movement Assessment for 35 Templewood Avenue, London, NW3 7UY

Job No: P1019J1129

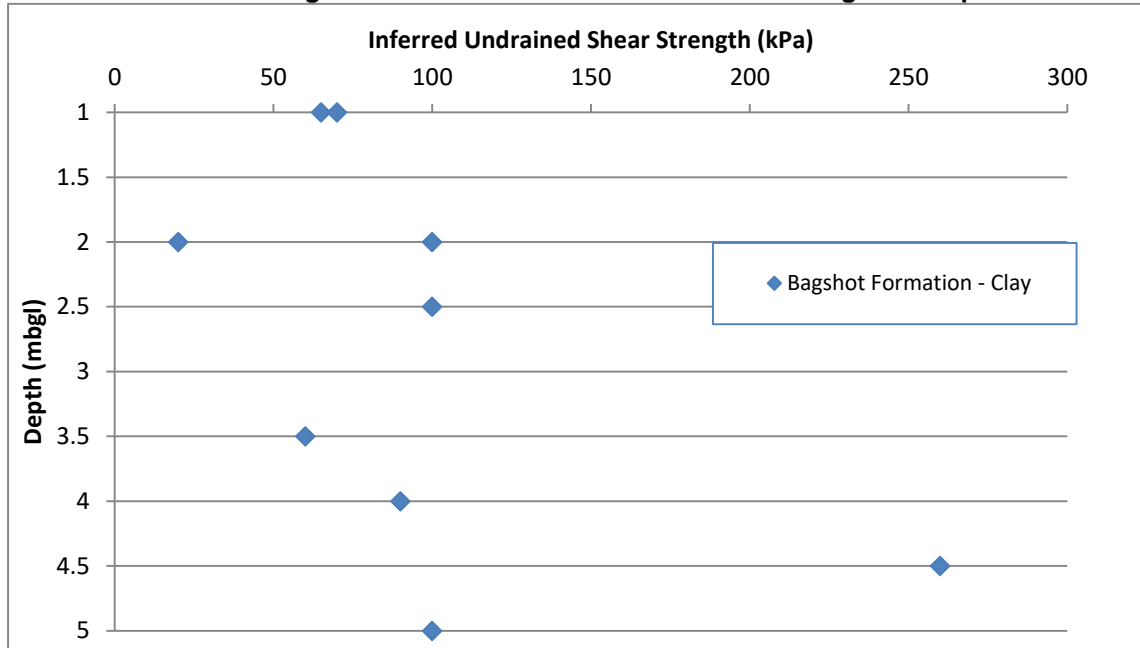
Figure 14.1: Inferred Undrained Shear Strength vs Depth

14.3.3 The graph below shows the shear strength profile of the Bagshot Formation - Clay encountered at the site, based on the SPT to shear strength correlation described above.

- 14.3.4 An SPT 'N' value of 22 was reported for the layer of Bagshot Formation - Sand at 3.50mbgl. This is slightly higher than the values recorded in the clay at around the same depth.

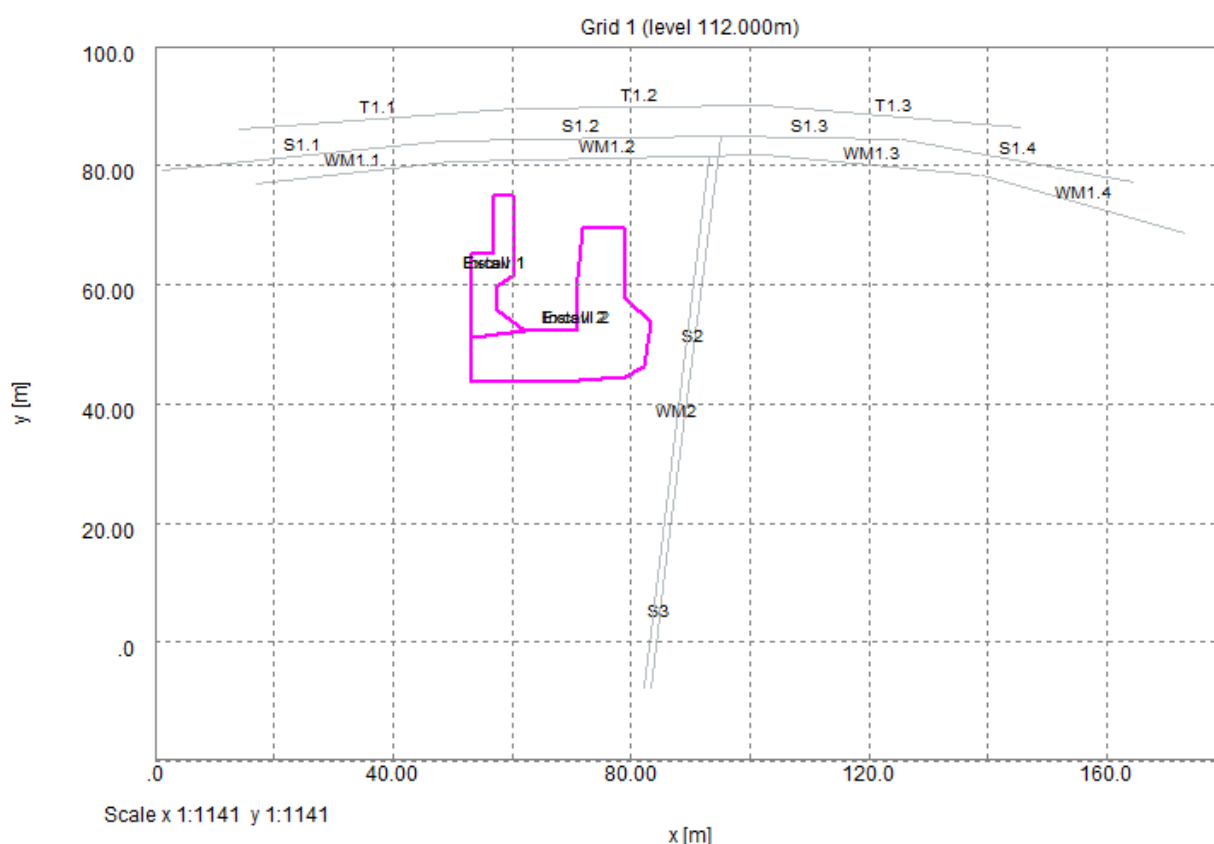
Figure 16.9: Xdisp model indicating the proposed excavation works (outlined in magenta) and the TW assets analysed (blue lines)

- 16.6.8 Details of the material and size of each asset were input in accordance with Table 16.1 for XDISP to calculate curvature, compressive and tensile strains due to the assessed movements. All utilities were assumed to be *near surface assets*.

- 16.6.9 A maximum allowable tensile strain of $500\mu\epsilon$ has been used for masonry sewer (S1). For the assumed concrete sewer (S2 & S3), an allowable limit of 3mm has been used for pull-out checks, 2° for rotation checks and $40\mu\epsilon$ and $400\mu\epsilon$ for tensile and compressive strain checks, respectively.

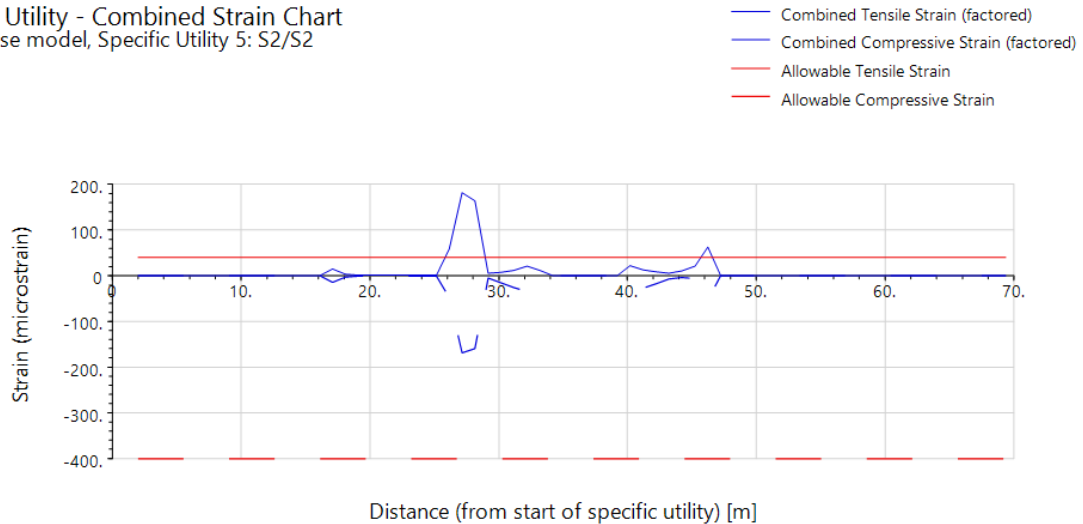
Figure 16.16: Combined strain profile of Sewer S2 – Method 2 CIRIA Excavation and Installation - based on raw deflection profile

Specific Utility - Combined Strain Chart
Stage: Base model, Specific Utility 5: S2/S2

- 16.8.2 Sewer S2 that runs below Templewood Avenue has recorded spikes in the data which exceed the tensile strain limit value. These spikes also occur in the compression strain profile due to flexural strain, related to bending of the asset. These spikes result from the modelling simplifications described previously in this report and are attributed to the displacement discontinuities.
- 16.8.3 In light of the above, a smoothing exercise has been undertaken to evaluate more realistic deflections. This was undertaken by adjusting polynomial curves to the raw deflection data shown in Figure 16.15. The resulting smoothed deflection profiles were imported in XDISP and the strains were re-calculated. The strain plots resulting by the raw and smoothed deflection profiles are depicted in Figure 16.16 and Figure 16.17, respectively.

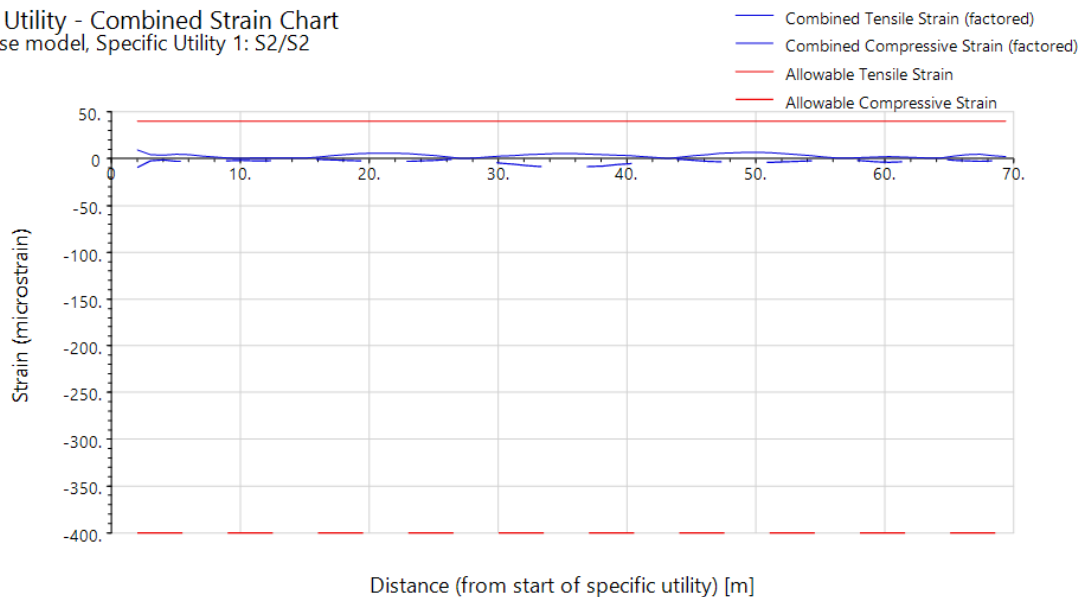
Figure 16.17: Combined strain profile of Sewer S2 – Method 2 CIRIA Excavation and Installation - based on smoothed deflection profile

Specific Utility - Combined Strain Chart
Stage: Base model, Specific Utility 1: S2/S2

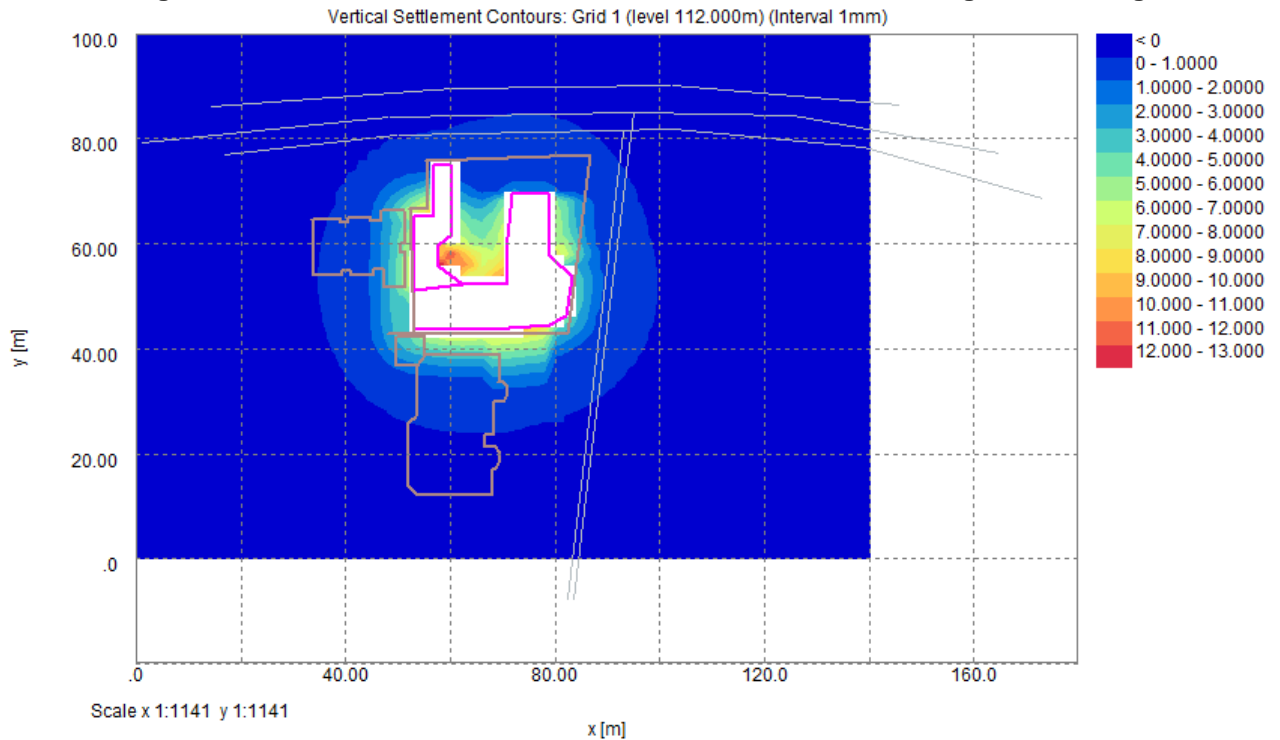
Figure 16.18: Vertical Movement – Method 2 – CIRIA curves + Long-term loading

- 16.8.4 The horizontal movements at this stage are the same as the previous stage (Figure 16.14) since the movements of the PDISP long-term movements are only vertical movements (settlement). The figure below shows the cumulative vertical movements of XDISP using CIRIA curves and the PDISP Long-term loading.

Assets	Tensile Strain [me]		Compressive Strain [me]		Pull-out [mm]		Rotation [degrees]	
	Maximum	Limit	Maximum	Limit	Maximum	Limit	Maximum	Limit
S1.1	0	500	0	-625	-	-	-	-
S1.2	0	500	0	-625	-	-	-	-
S1.3	0	500	0	-625	-	-	-	-
S1.4	0	500	0	-625	-	-	-	-
S2	9*	40	10	-400	0.05	3	0.003	2.0
S3	0	40	0	-400	0.00	3	0.000	2.0
WM1.1	0	100	0	-1200	0.00	3	0.000	0.1
WM1.2	0	100	0	-1200	0.00	3	0.000	0.1
WM1.3	0	100	0	-1200	0.00	3	0.000	0.1
WM1.4	0	100	0	-1200	0.00	3	0.000	0.1
WM2	66	100	168	-1200	0.25	3	0.021	0.1
T1.1	0	100	0	-1200	0.00	3	0.000	0.1
T1.2	0	100	0	-1200	0.00	3	0.000	0.1
T1.3	0	100	0	-1200	0.00	3	0.000	0.1

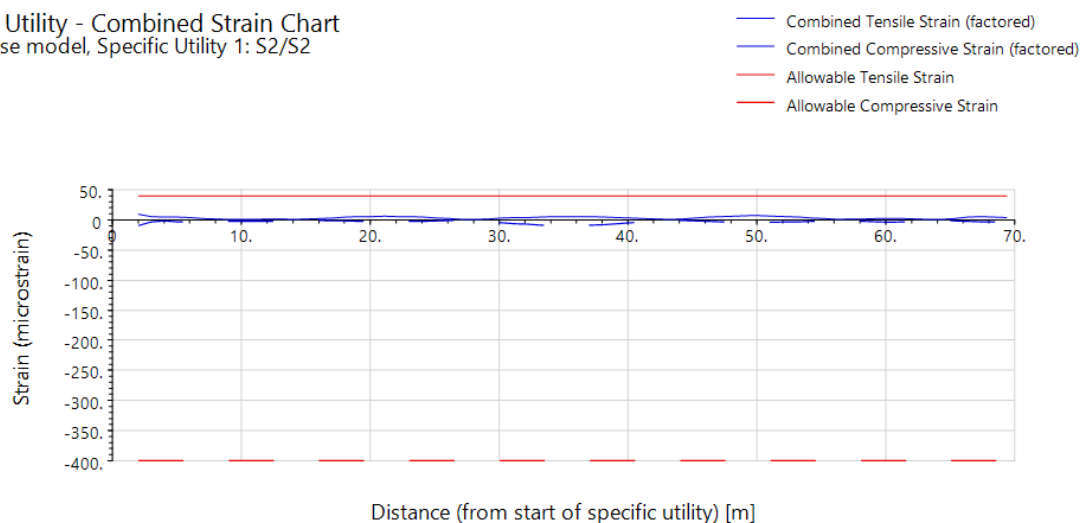
Figure 16.21: Movement profile of Sewer S2 – Method 2 – CIRIA curves + Long-term loading – based on smoothed deflection profile

Specific Utility - Combined Strain Chart
Stage: Base model, Specific Utility 1: S2/S2

in Method 2 - Short-term). A smoothing exercise has been undertaken and the raw/smoothed deflection profiles are shown Figure 16.19. The combined strains of Sewer S2 resulting from both raw and smoothed deflection profiles are presented in Figure 16.20 and Figure 16.21
