Langdale House Exterior Walkways

Feasibility Report

Flats 1-25, Langdale House, 4-12 Dorrington Street, EC1N 7TB

For **Origin Housing**
Prepared by **BPG Architects + Surveyors**

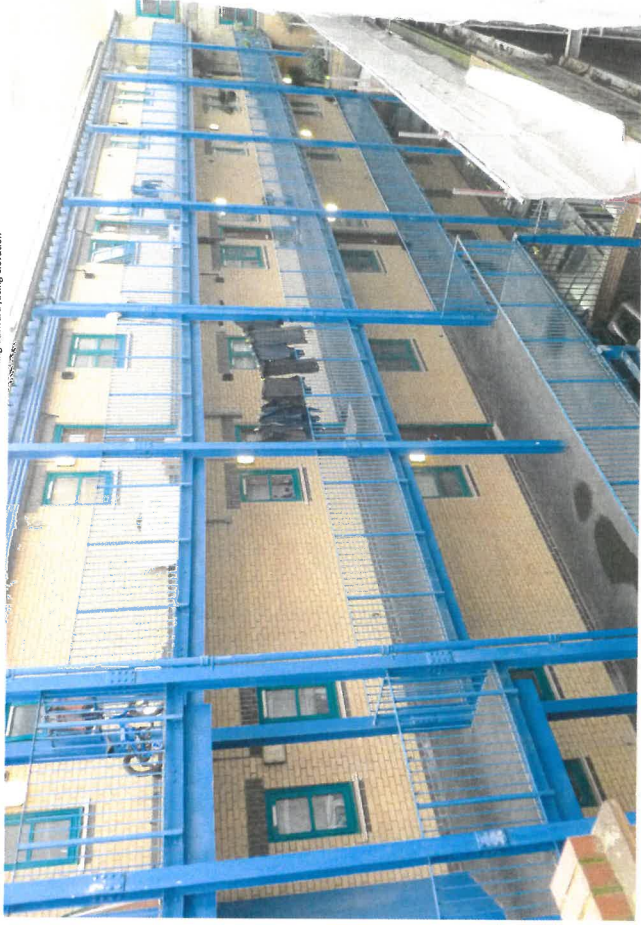
1.c - Existing inward facing elevation

Both the outward and inward facing elevations comprise of brick façade, timber casement windows. The inward facing elevation also has open external metal deck walkways complete with vertical bar railings providing access to the flats. The existing walkways are prone to problems with standing water, owing to poor drainage.

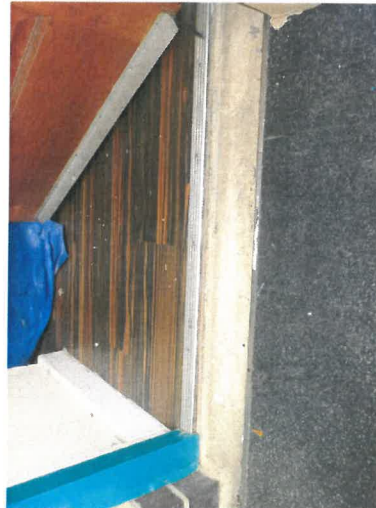
2.a - Typical threshold

- There are ramps within the existing walkway deck, which would mean that it would not be possible to create the required falls within these areas to enable the deck to drain effectively.
- Existing threshold levels to flat entrances are too low to accommodate any additional coverings, without changing the level of the existing deck and/or resolving further weathering and waterproofing issues at these junctions. (Photograph 2.a)
