Appendix F
Condition Survey Drawings

Client: **UGLE**
 Project: **FREEMASONS HALL GREAT QUEENS STREET LONDON WC2B 5AZ**

Drawing Title: **DEFECTS: ELEVATION B.1**

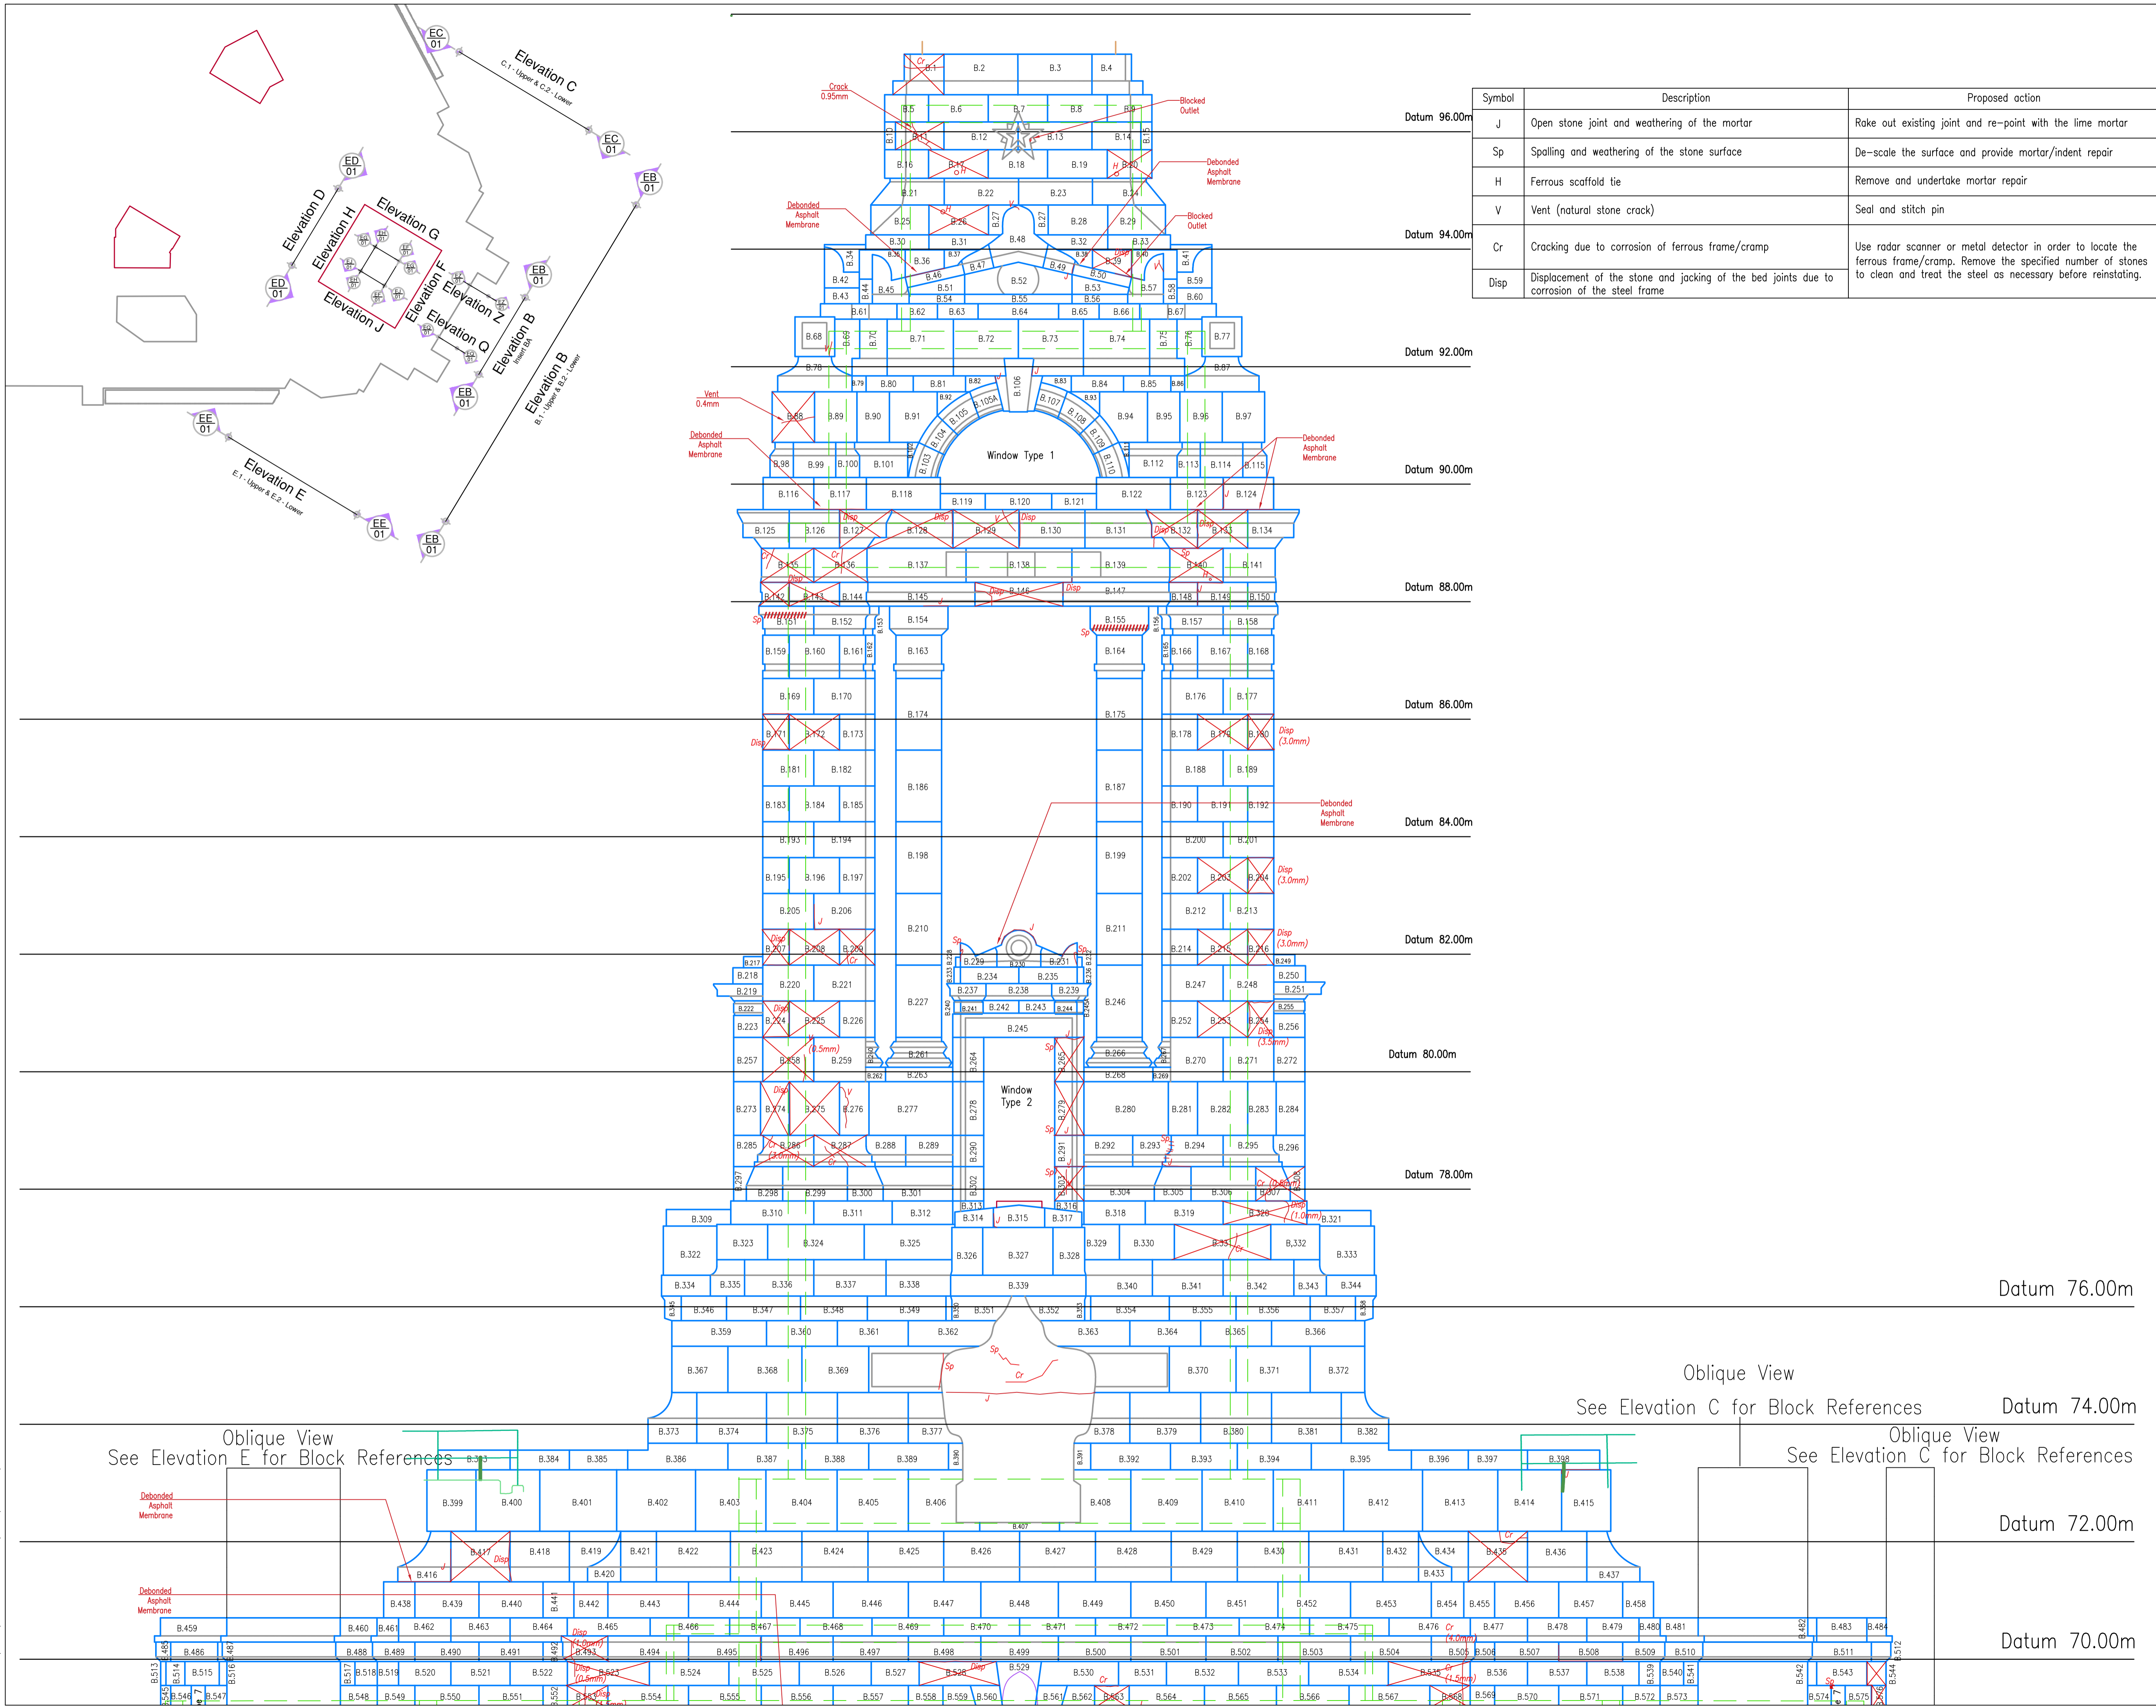
Symbol	Description	Proposed action
J	Open stone joint and weathering of the mortar	Rake out existing joint and re-point with the lime mortar
Sp	Spalling and weathering of the stone surface	De-scale the surface and provide mortar/indent repair
H	Ferrous scaffold tie	Remove and undertake mortar repair
V	Vent (natural stone crack)	Seal and stitch pin
Cr	Cracking due to corrosion of ferrous frame/cramp	Use radar scanner or metal detector in order to locate the ferrous frame/cramp. Remove the specified number of stones to clean and treat the steel as necessary before reinstating.
Disp	Displacement of the stone and jacking of the bed joints due to corrosion of the steel frame

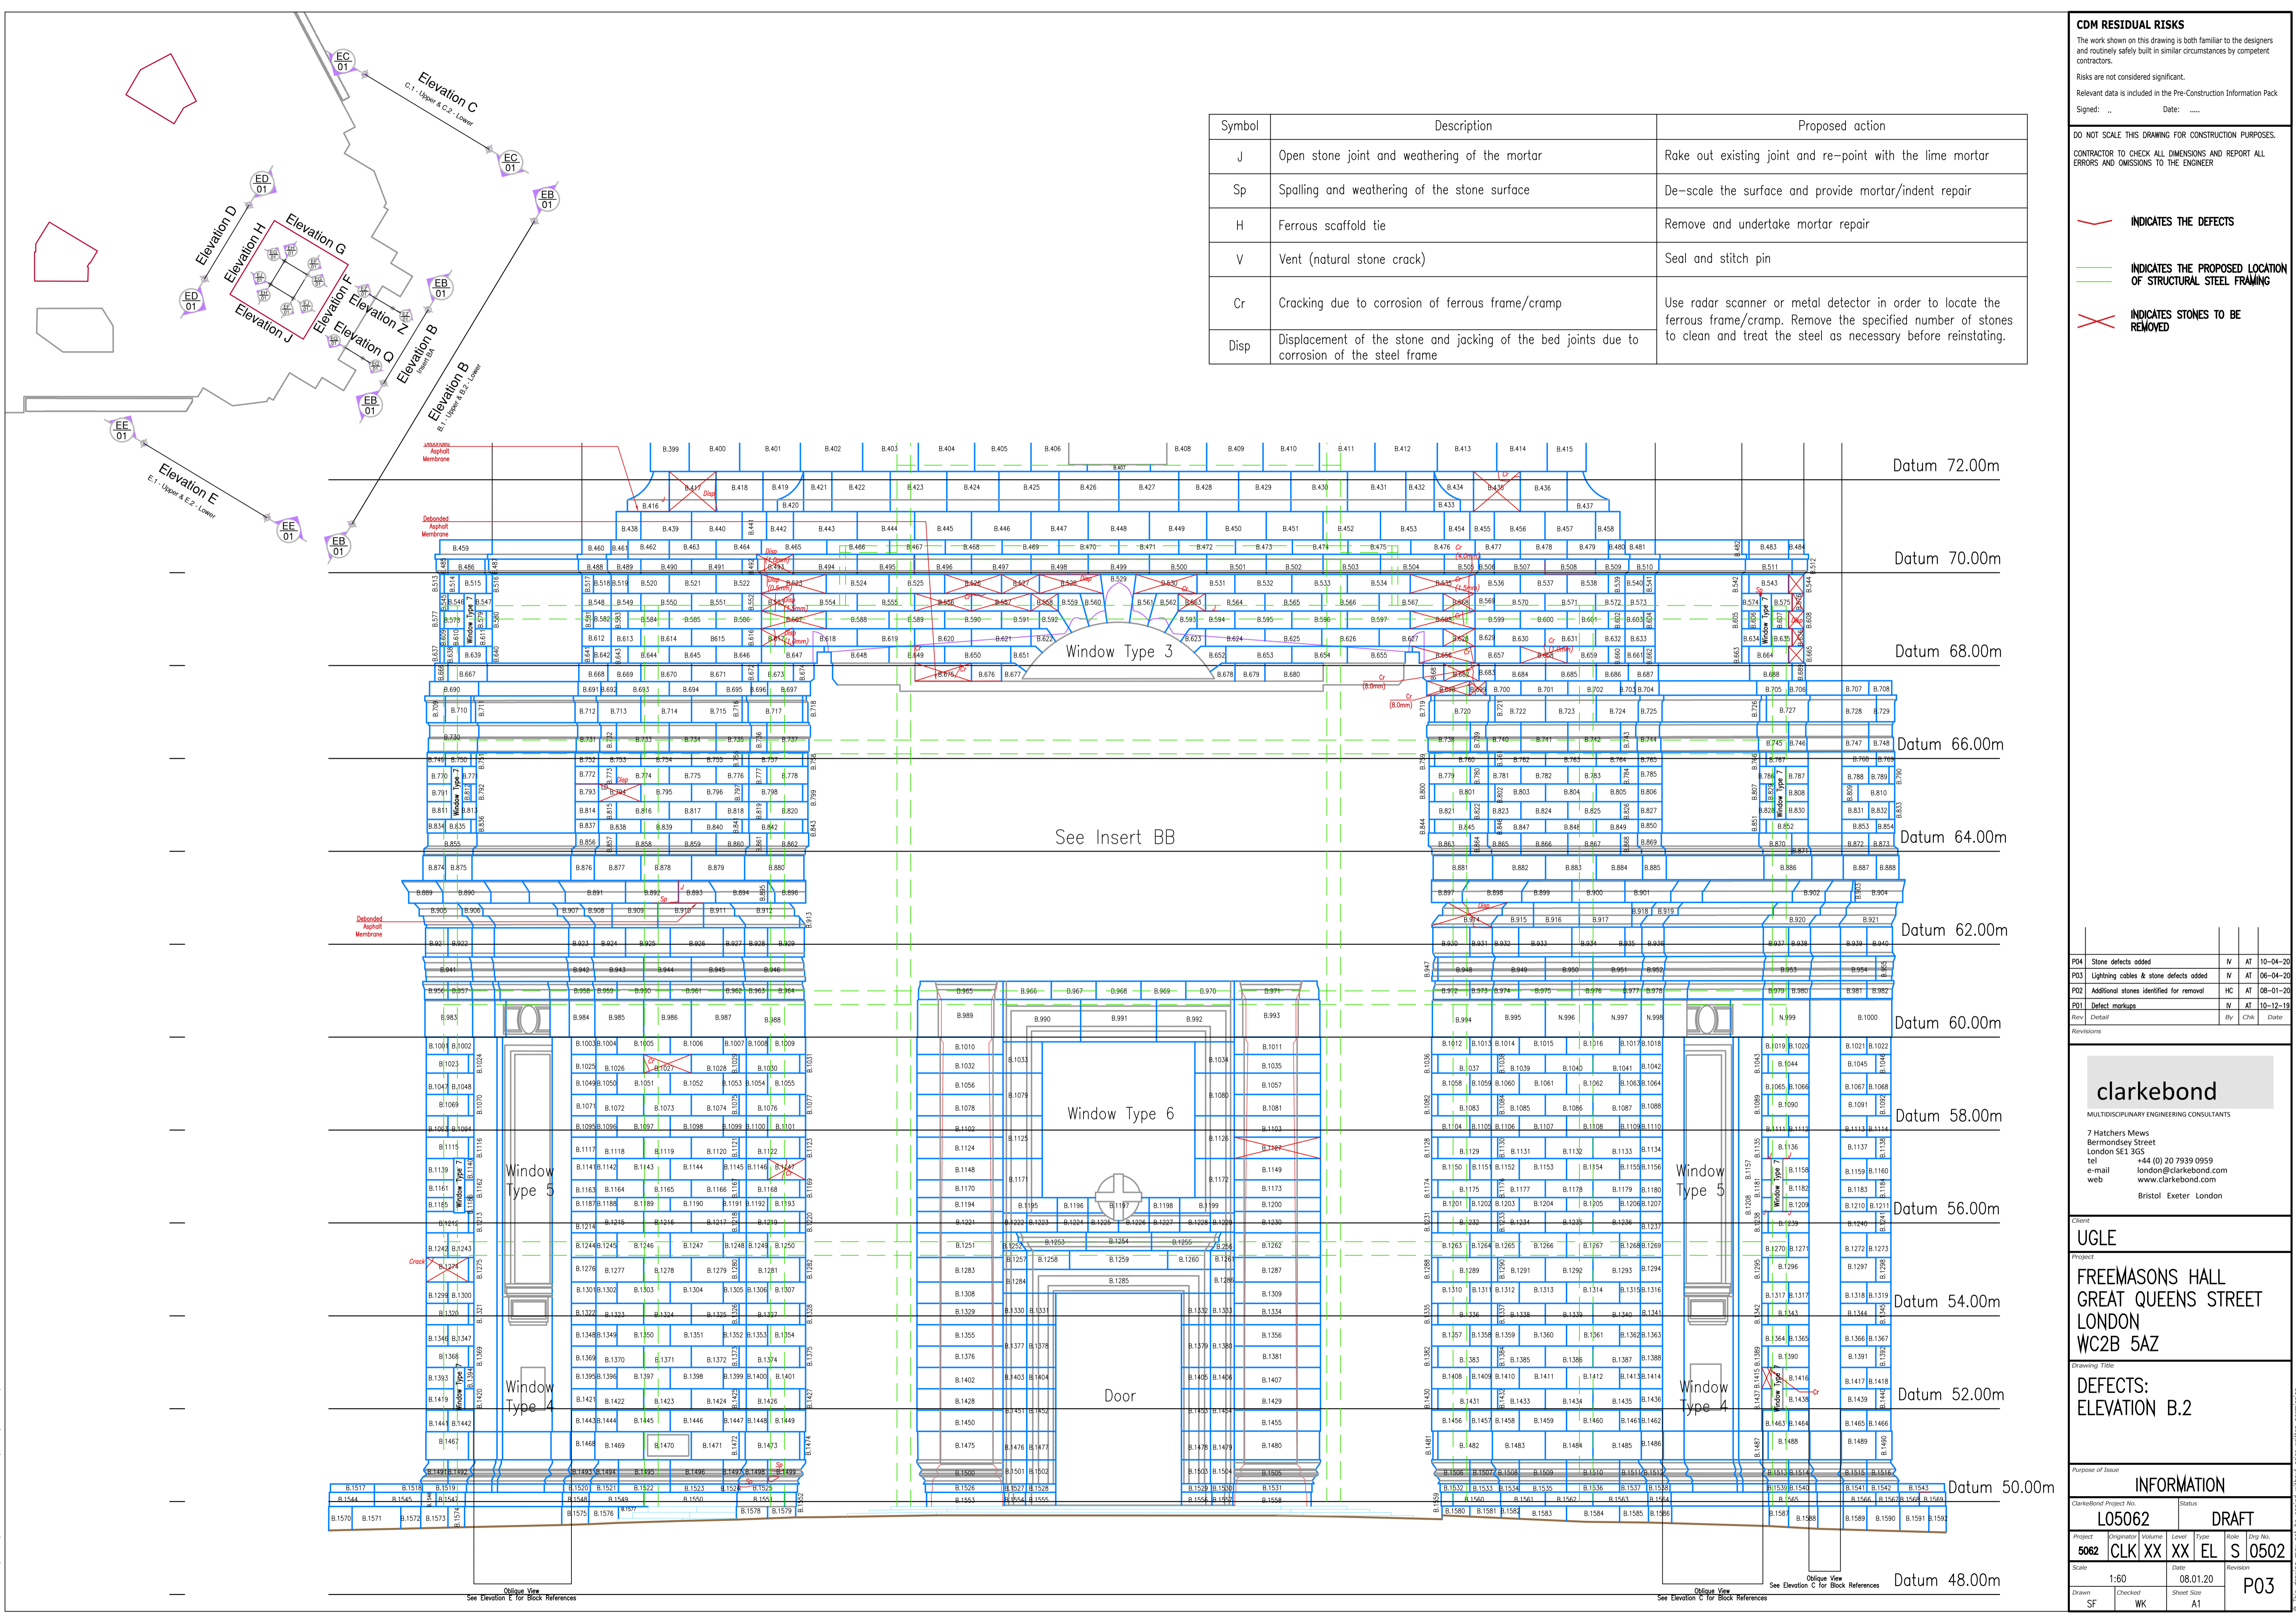
Drawing Title: **DEFECTS:
ELEVATION B.2**

Symbol	Description	Proposed action
J	Open stone joint and weathering of the mortar	Rake out existing joint and re-point with the lime mortar
Sp	Spalling and weathering of the stone surface	De-scale the surface and provide mortar/indent repair
H	Ferrous scaffold tie	Remove and undertake mortar repair
V	Vent (natural stone crack)	Seal and stitch pin
Cr	Cracking due to corrosion of ferrous frame/cramp	Use radar scanner or metal detector in order to locate the ferrous frame/cramp. Remove the specified number of stones to clean and treat the steel as necessary before reinstating.
Disp	Displacement of the stone and jacking of the bed joints due to corrosion of the steel frame

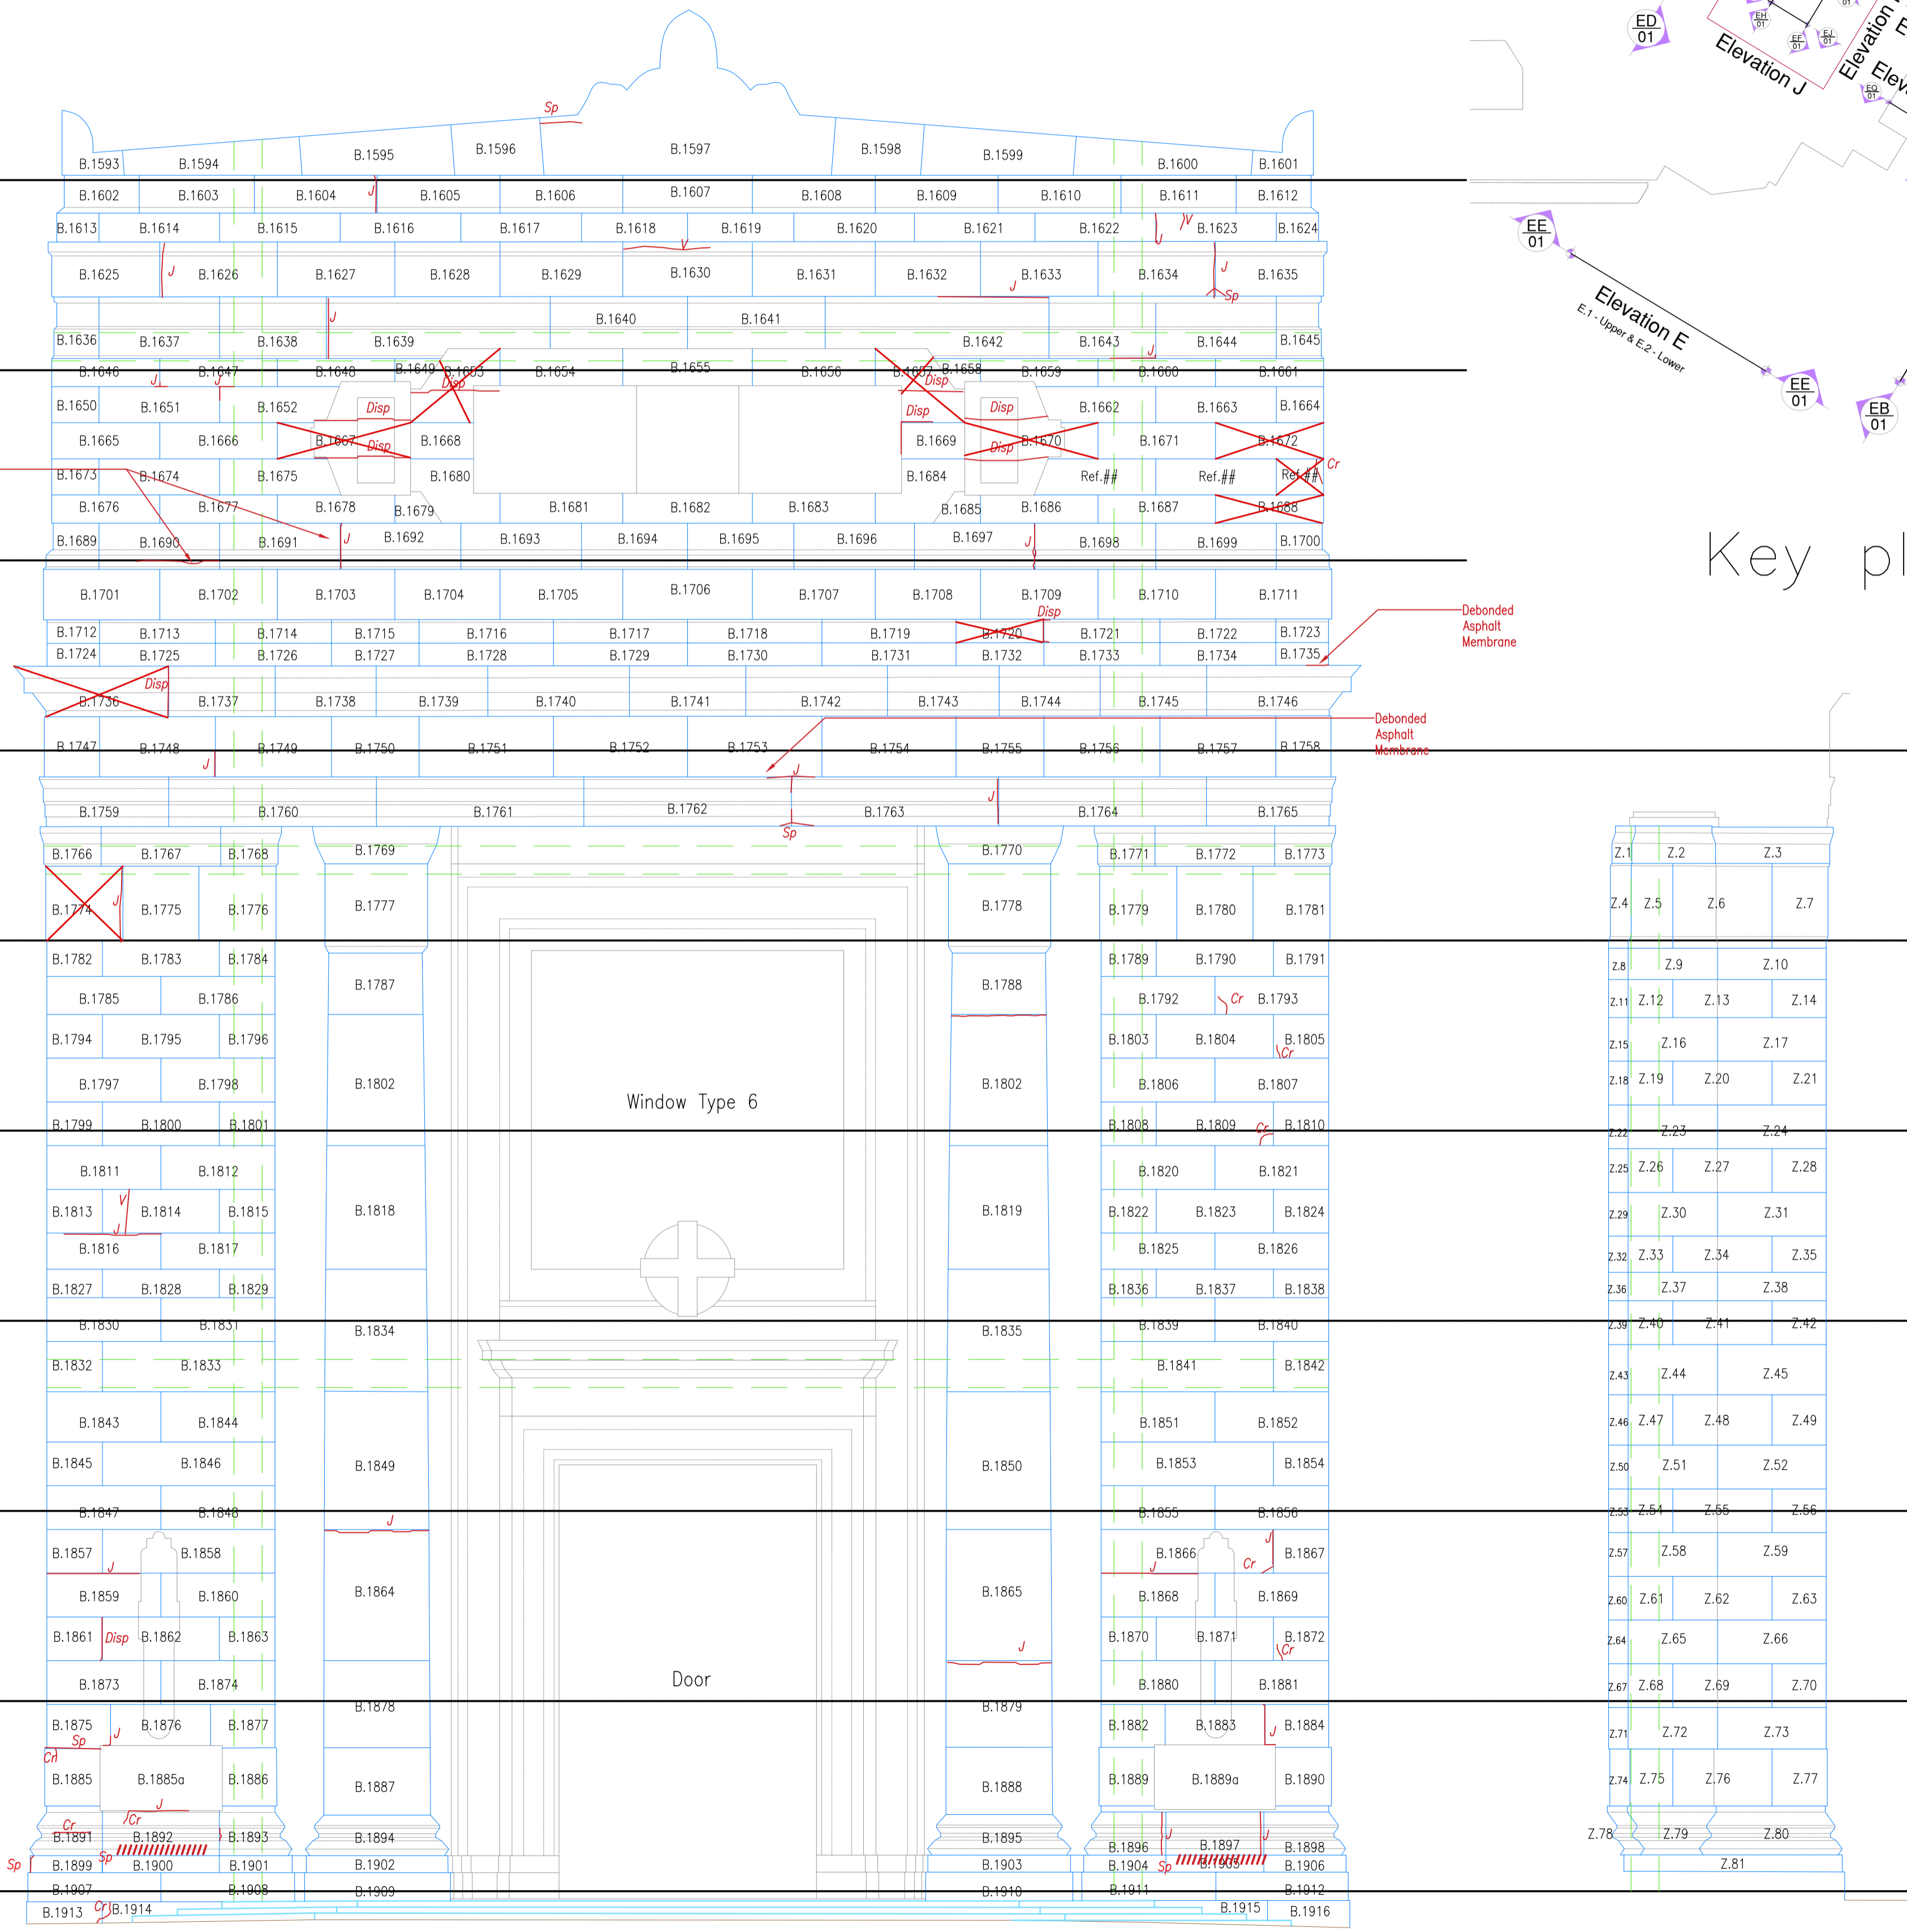
Drawing Title
**DEFECTS:
 ELEVATIONS BA, Q & Z**

Symbol	Description	Proposed action
J	Open stone joint and weathering of the mortar	Rake out existing joint and re-point with the lime mortar
Sp	Spalling and weathering of the stone surface	De-scale the surface and provide mortar/indent repair
H	Ferrous scaffold tie	Remove and undertake mortar repair
V	Vent (natural stone crack)	Seal and stitch pin
Cr	Cracking due to corrosion of ferrous frame/cramp	Use radar scanner or metal detector in order to locate the ferrous frame/cramp. Remove the specified number of stones to clean and treat the steel as necessary before reinstating.
Disp	Displacement of the stone and jacking of the bed joints due to corrosion of the steel frame

Offset 40m From Main Elevation B

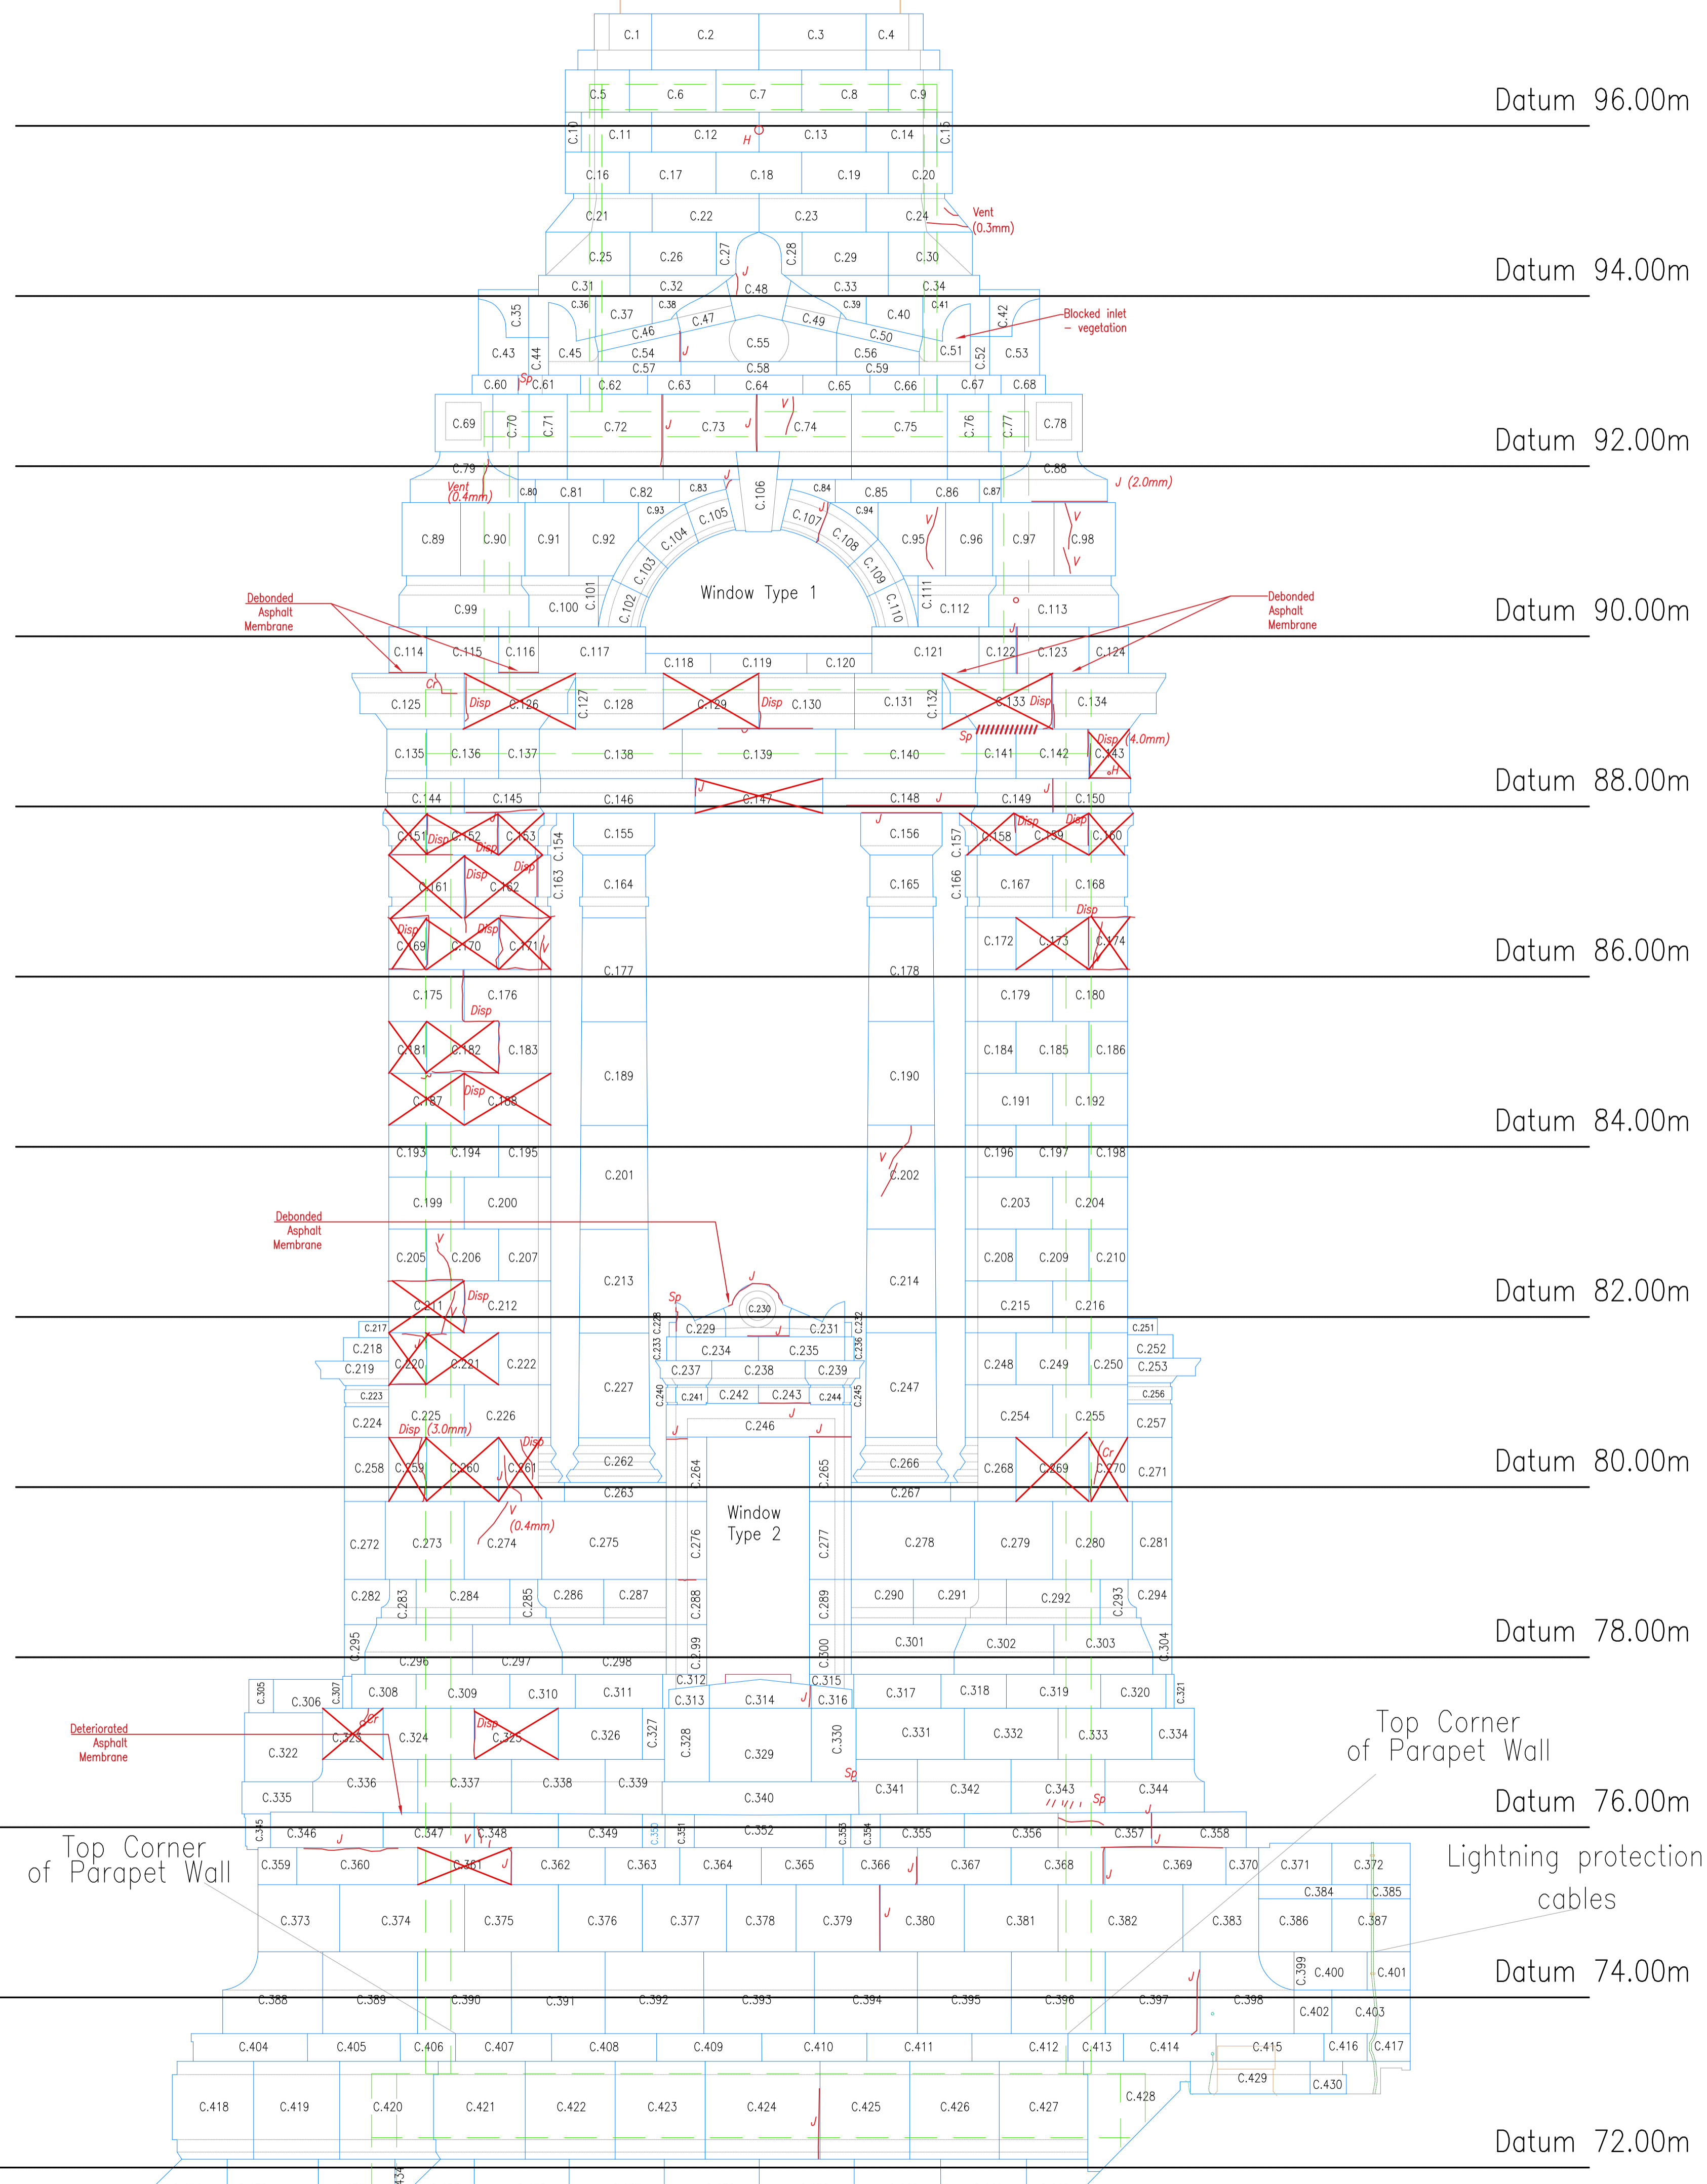
Drawing Title
**DEFECTS:
 ELEVATION C.1**

Symbol	Description	Proposed action
J	Open stone joint and weathering of the mortar	Rake out existing joint and re-point with the lime mortar
Sp	Spalling and weathering of the stone surface	De-scale the surface and provide mortar/indent repair
H	Ferrous scaffold tie	Remove and undertake mortar repair
V	Vent (natural stone crack)	Seal and stitch pin
Cr	Cracking due to corrosion of ferrous frame/cramp	Use radar scanner or metal detector in order to locate the ferrous frame/cramp. Remove the specified number of stones to clean and treat the steel as necessary before reinstating.
Disp	Displacement of the stone and jacking of the bed joints due to corrosion of the steel frame

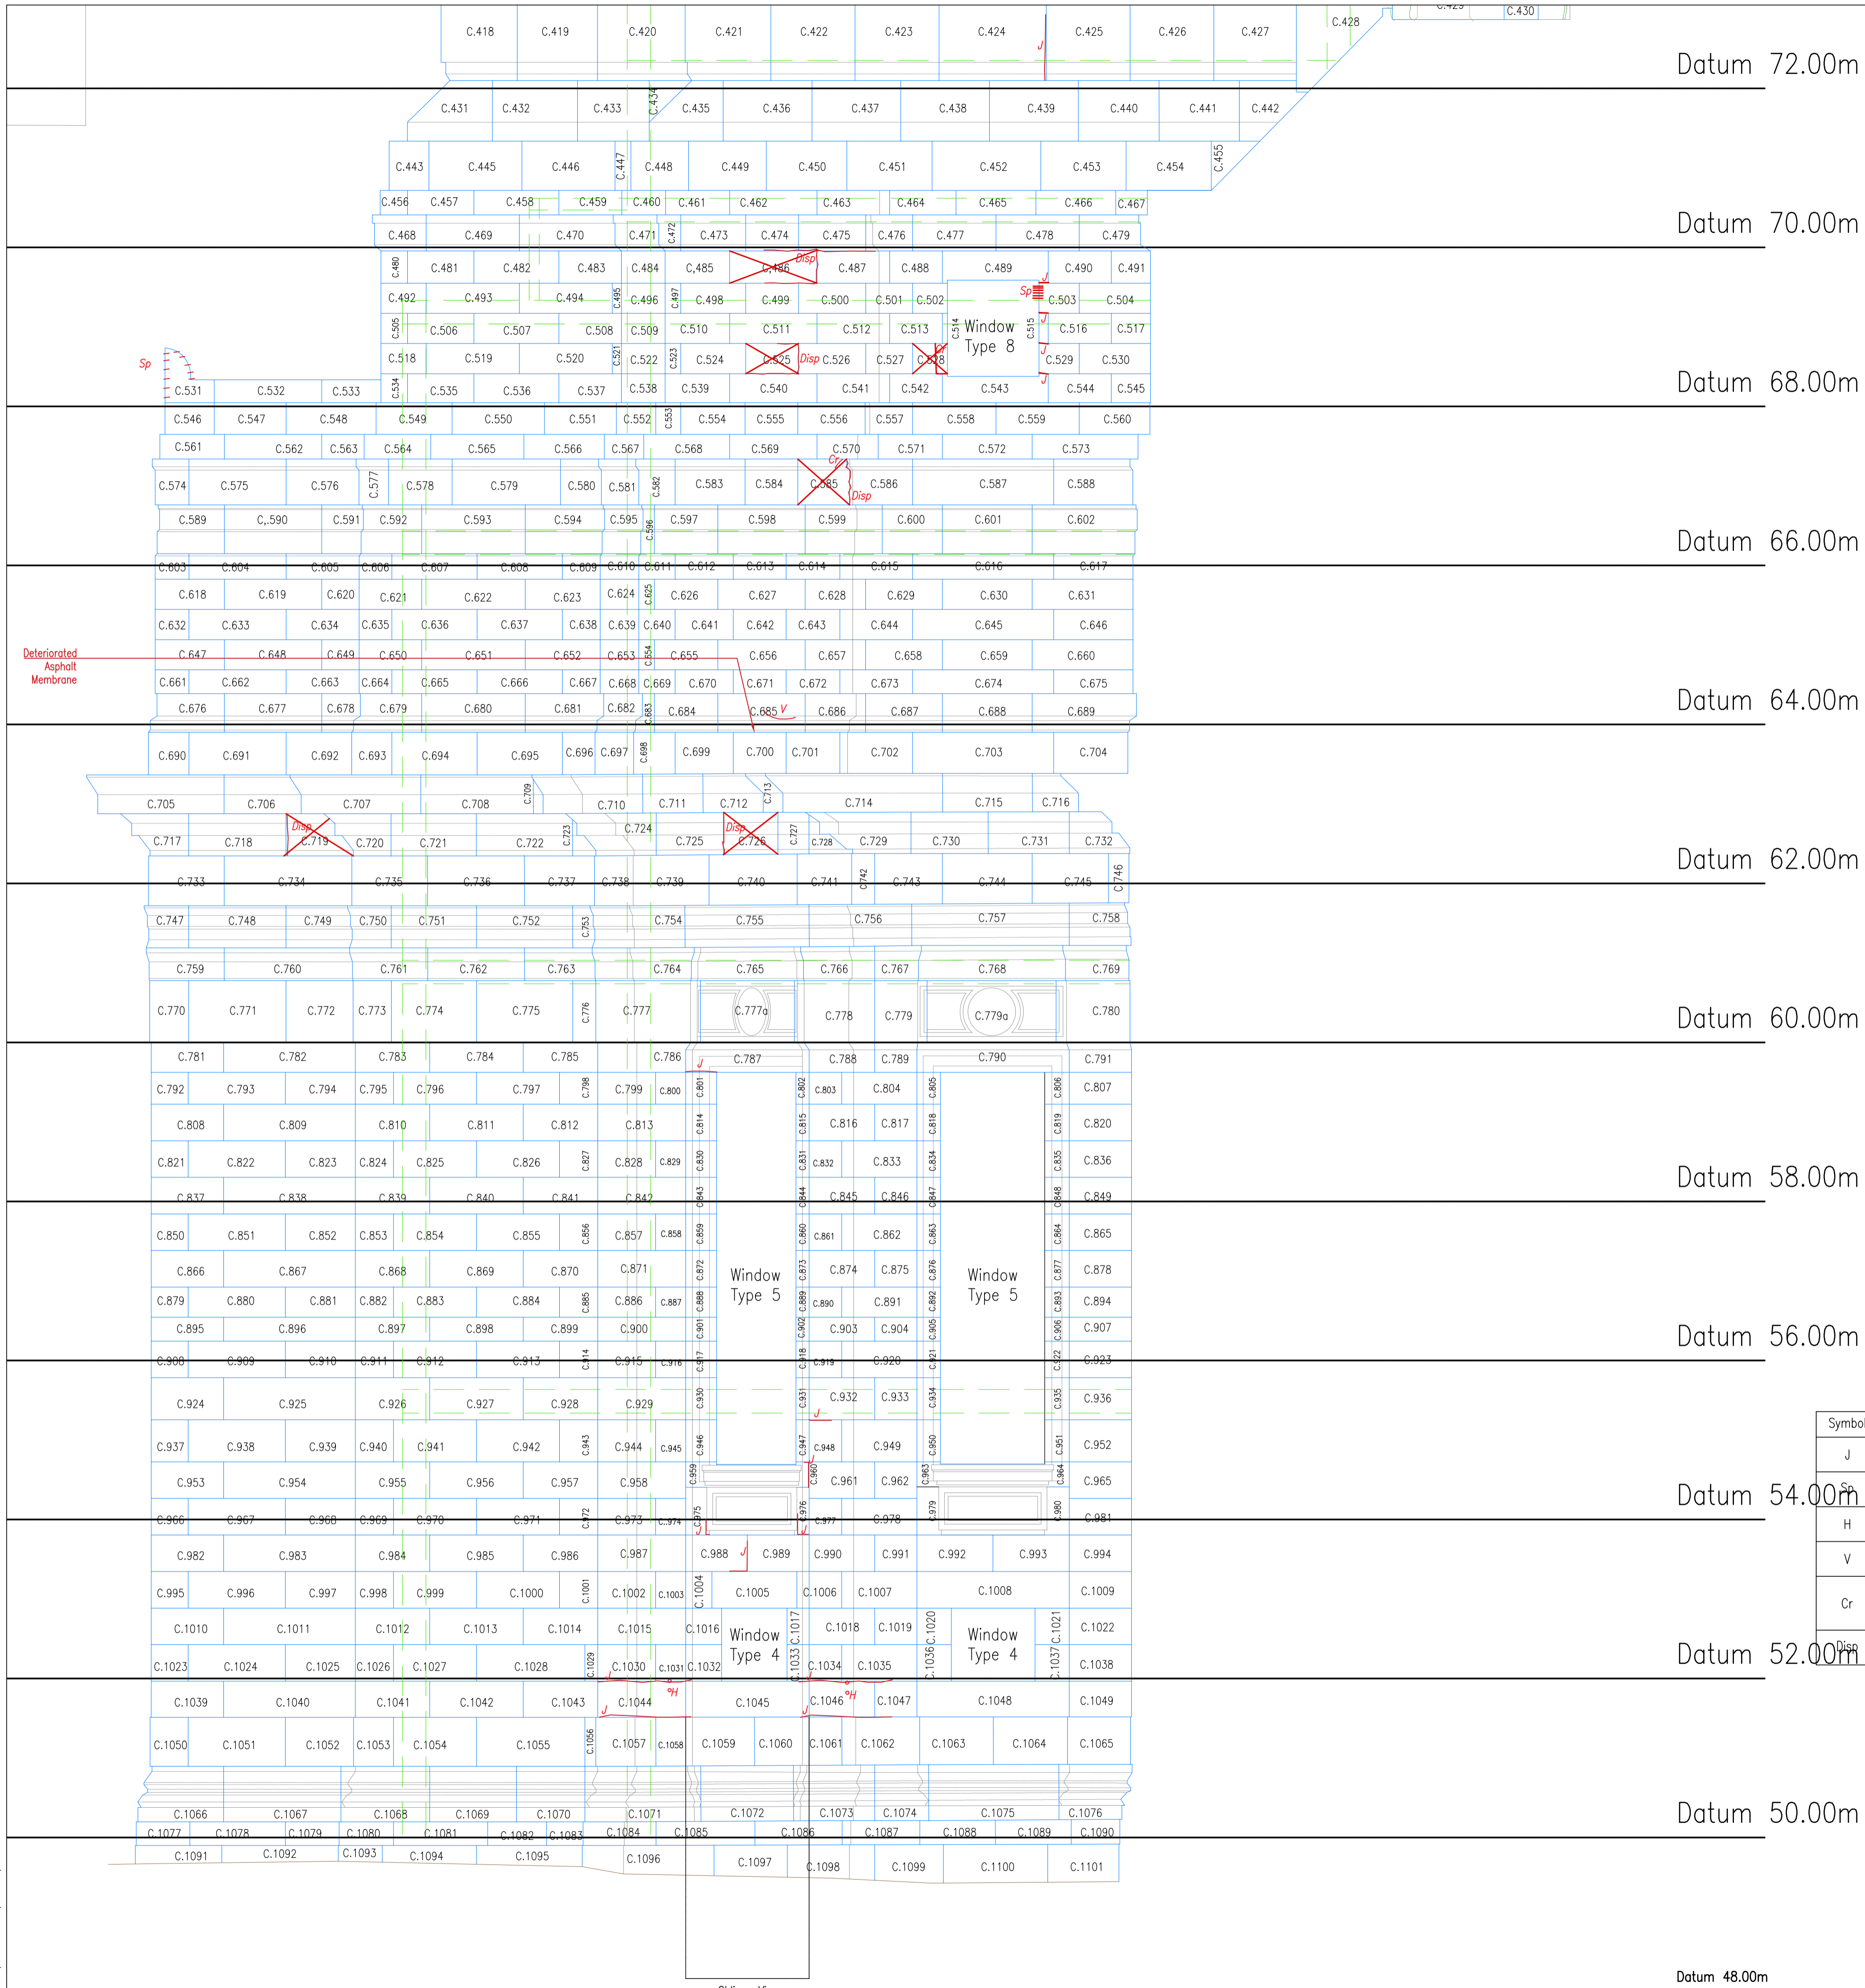
Drawing Title
**DEFECTS:
 ELEVATION C.2**

Symbol	Description	Proposed action
J	Open stone joint and weathering of the mortar	Rake out existing joint and re-point with the lime mortar
Sp	Spalling and weathering of the stone surface	De-scale the surface and provide mortar/indent repair
H	Ferrous scaffold tie	Remove and undertake mortar repair
V	Vent (natural stone crack)	Seal and stitch pin
Cr	Cracking due to corrosion of ferrous frame/cramp	Use radar scanner or metal detector in order to locate the ferrous frame/cramp. Remove the specified number of stones to clean and treat the steel as necessary before reinstating.
Disp	Displacement of the stone and jacking of the bed joints due to corrosion of the steel frame

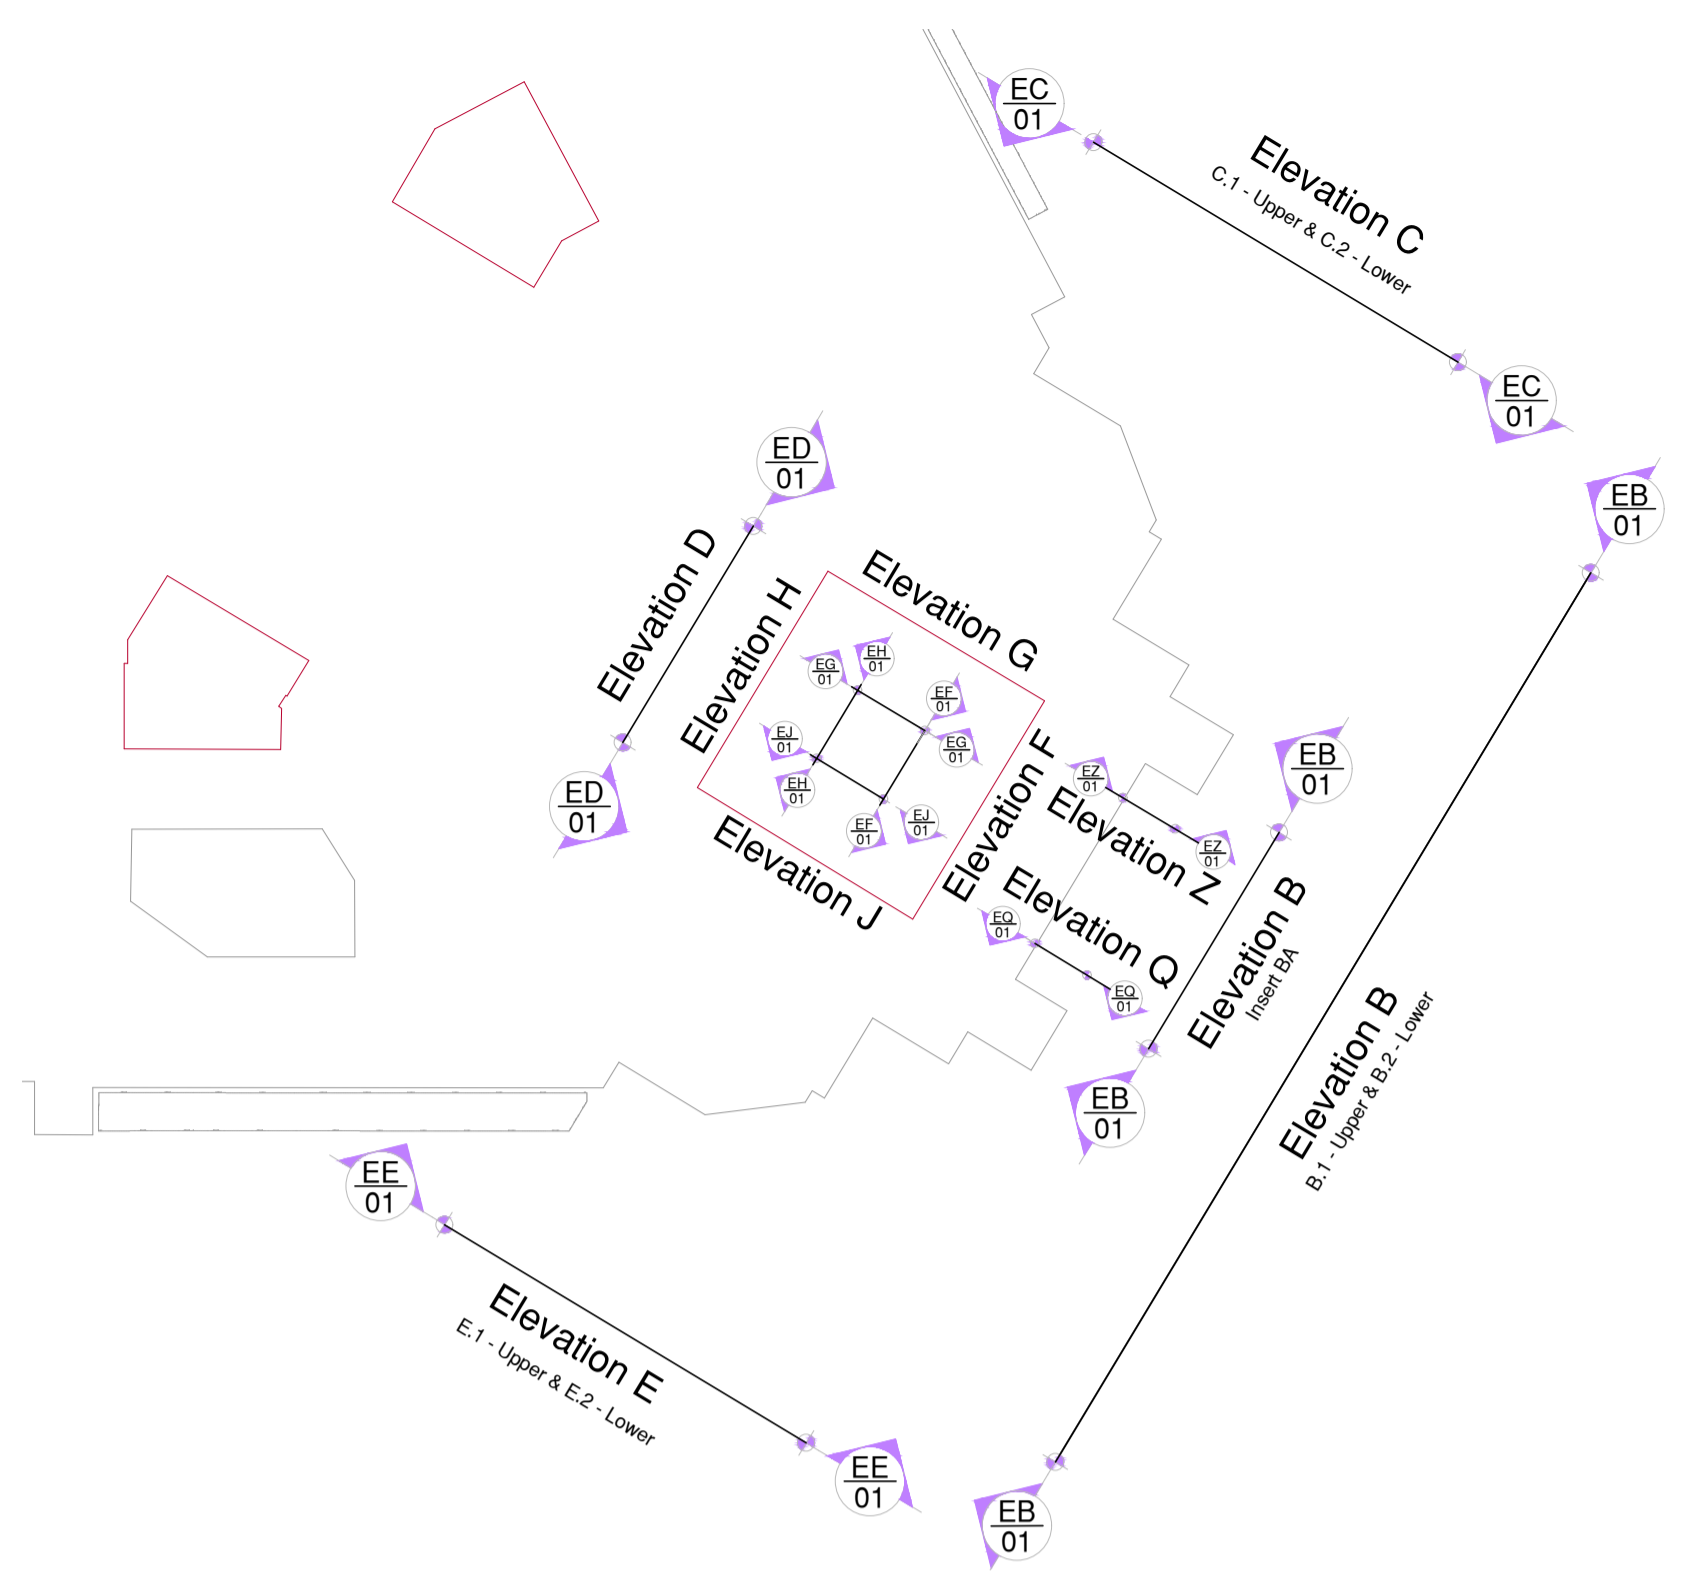
Drawing Title
**DEFECTS:
 ELEVATION E.1**

Symbol	Description	Proposed action
J	Open stone joint and weathering of the mortar	Rake out existing joint and re-point with the lime mortar
Sp	Spalling and weathering of the stone surface	De-scale the surface and provide mortar/indent repair
H	Ferrous scaffold tie	Remove and undertake mortar repair
V	Vent (natural stone crack)	Seal and stitch pin
Cr	Cracking due to corrosion of ferrous frame/cramp	Use radar scanner or metal detector in order to locate the ferrous frame/cramp. Remove the specified number of stones to clean and treat the steel as necessary before reinstating.
Disp	Displacement of the stone and jacking of the bed joints due to corrosion of the steel frame
