Appendix F
Condition Survey Drawings

Client: **UGLE**
 Project: **FREEMASONS HALL GREAT QUEENS STREET LONDON WC2B 5AZ**

Drawing Title: **DEFECTS: ELEVATION B.1**

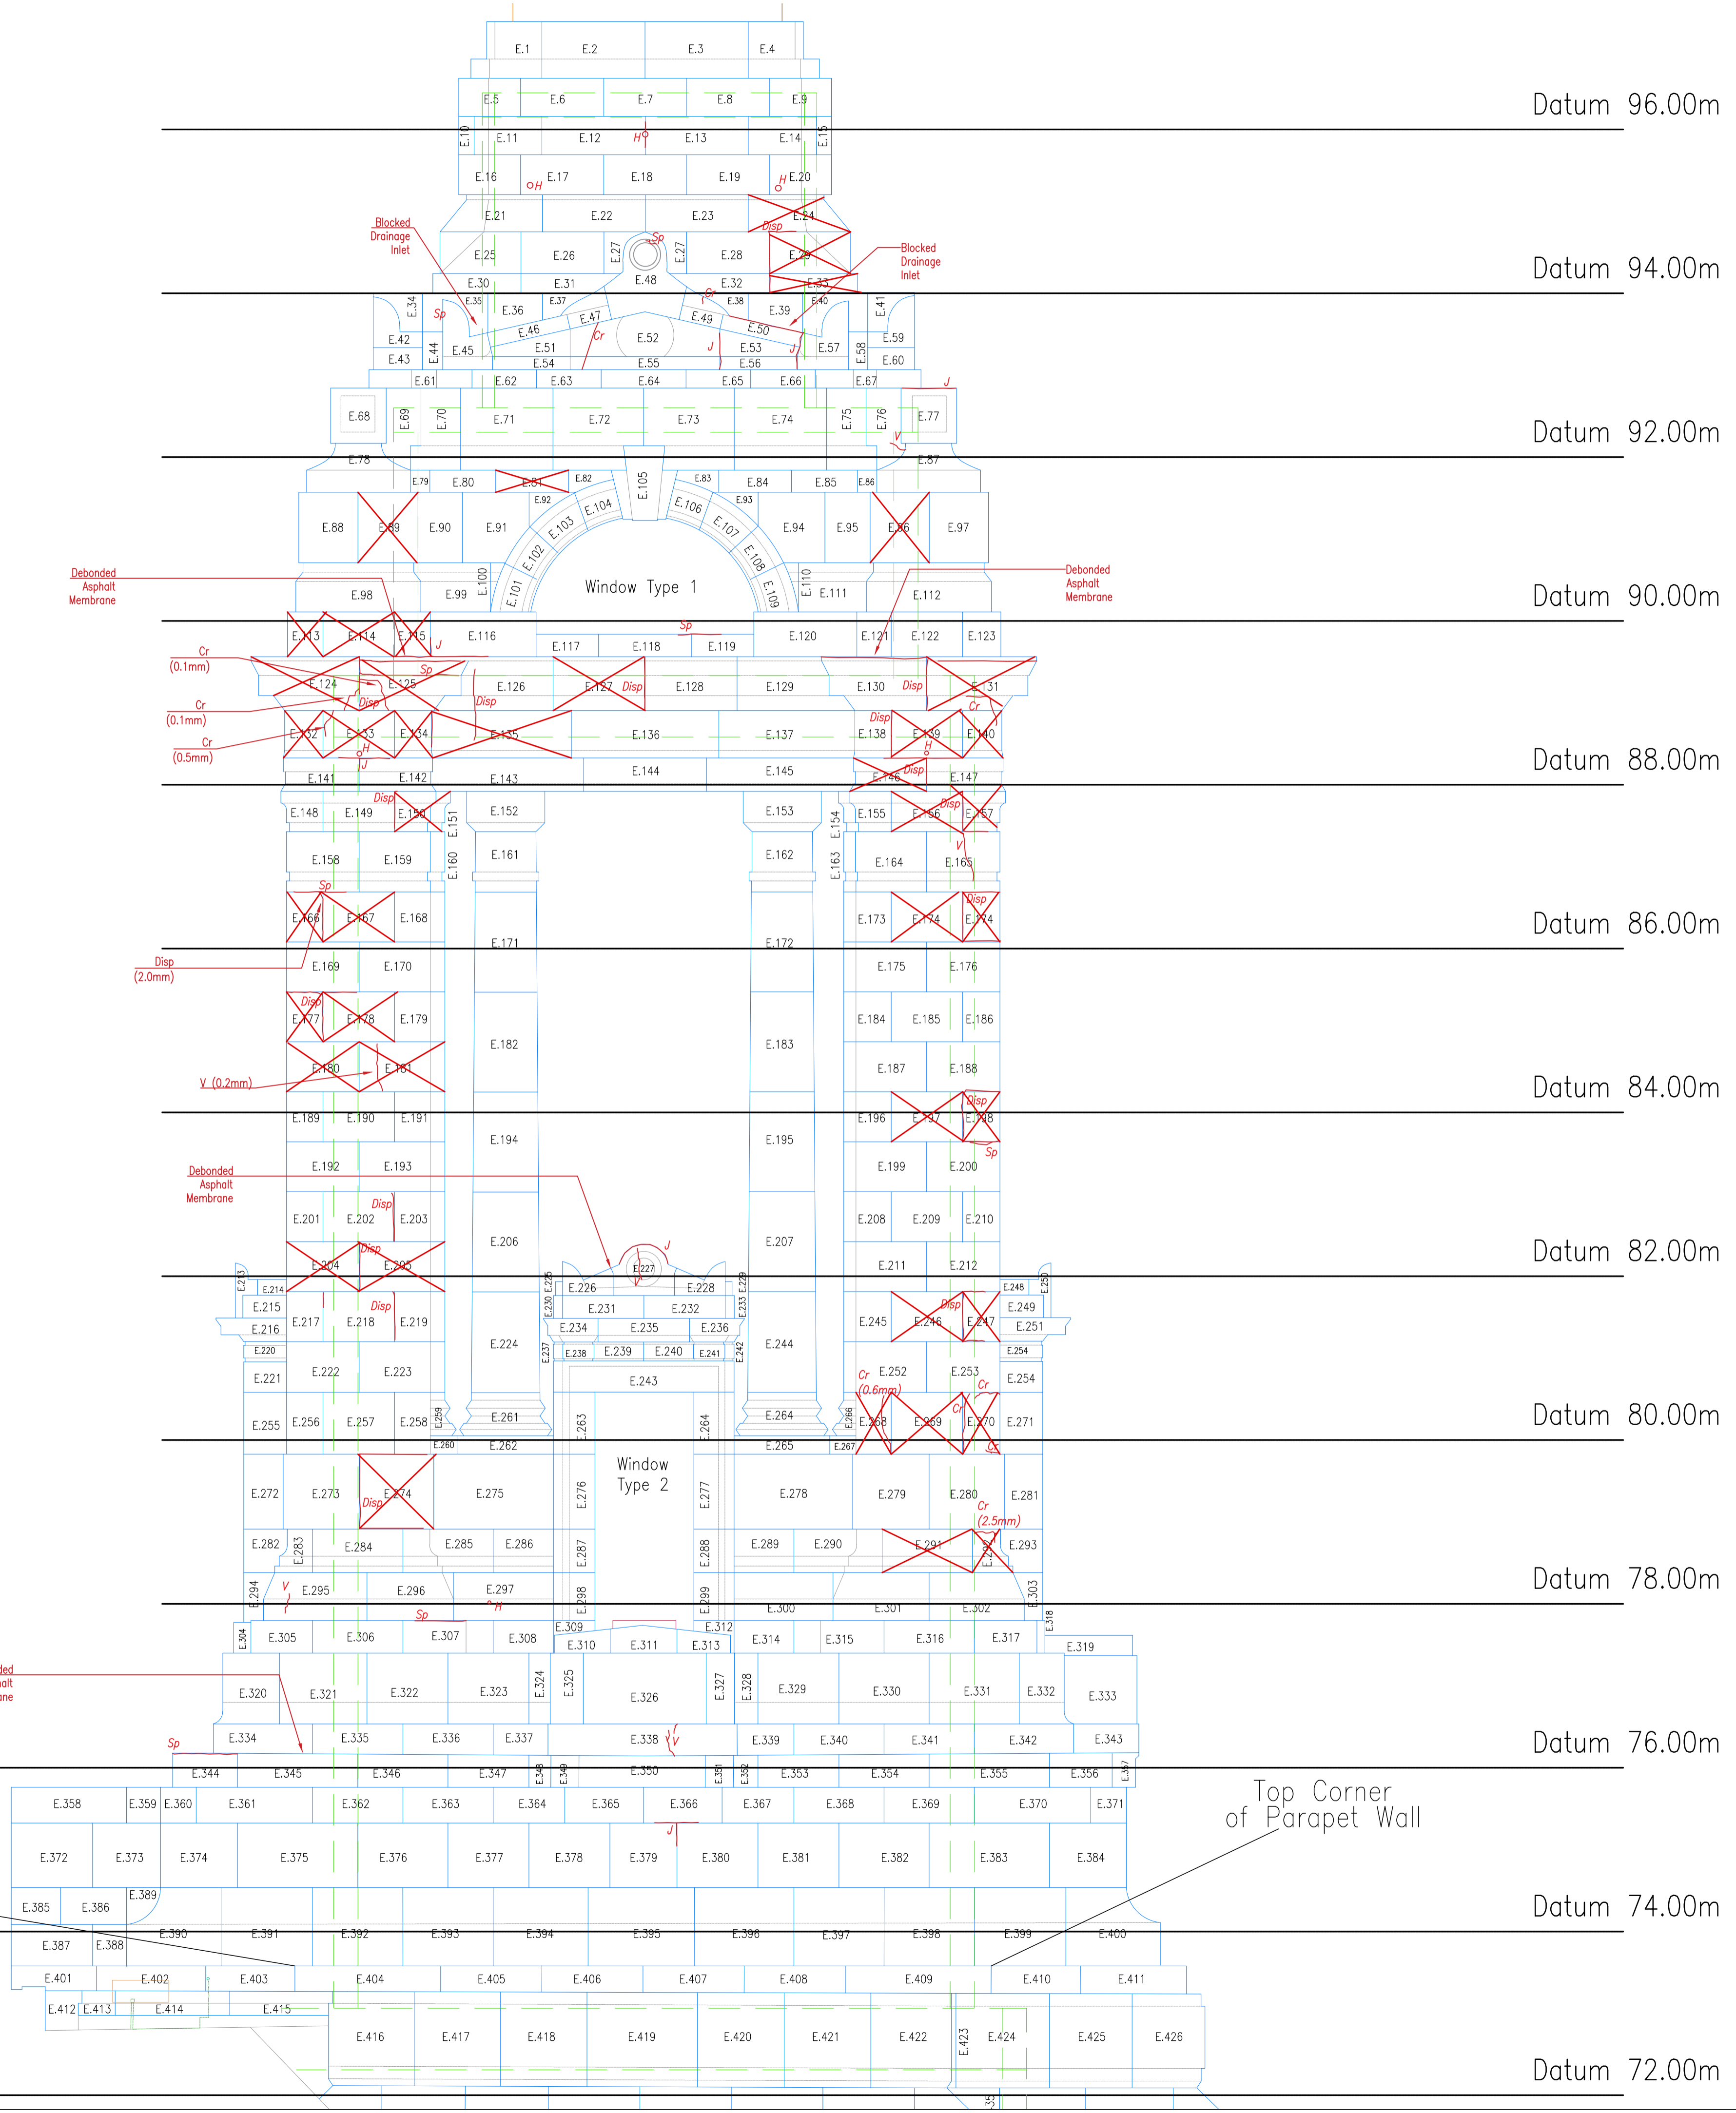
Drawing Title
**DEFECTS:
 ELEVATION E.1**

Symbol	Description	Proposed action
J	Open stone joint and weathering of the mortar	Rake out existing joint and re-point with the lime mortar
Sp	Spalling and weathering of the stone surface	De-scale the surface and provide mortar/indent repair
H	Ferrous scaffold tie	Remove and undertake mortar repair
V	Vent (natural stone crack)	Seal and stitch pin
Cr	Cracking due to corrosion of ferrous frame/cramp	Use radar scanner or metal detector in order to locate the ferrous frame/cramp. Remove the specified number of stones to clean and treat the steel as necessary before reinstating.
Disp	Displacement of the stone and jacking of the bed joints due to corrosion of the steel frame

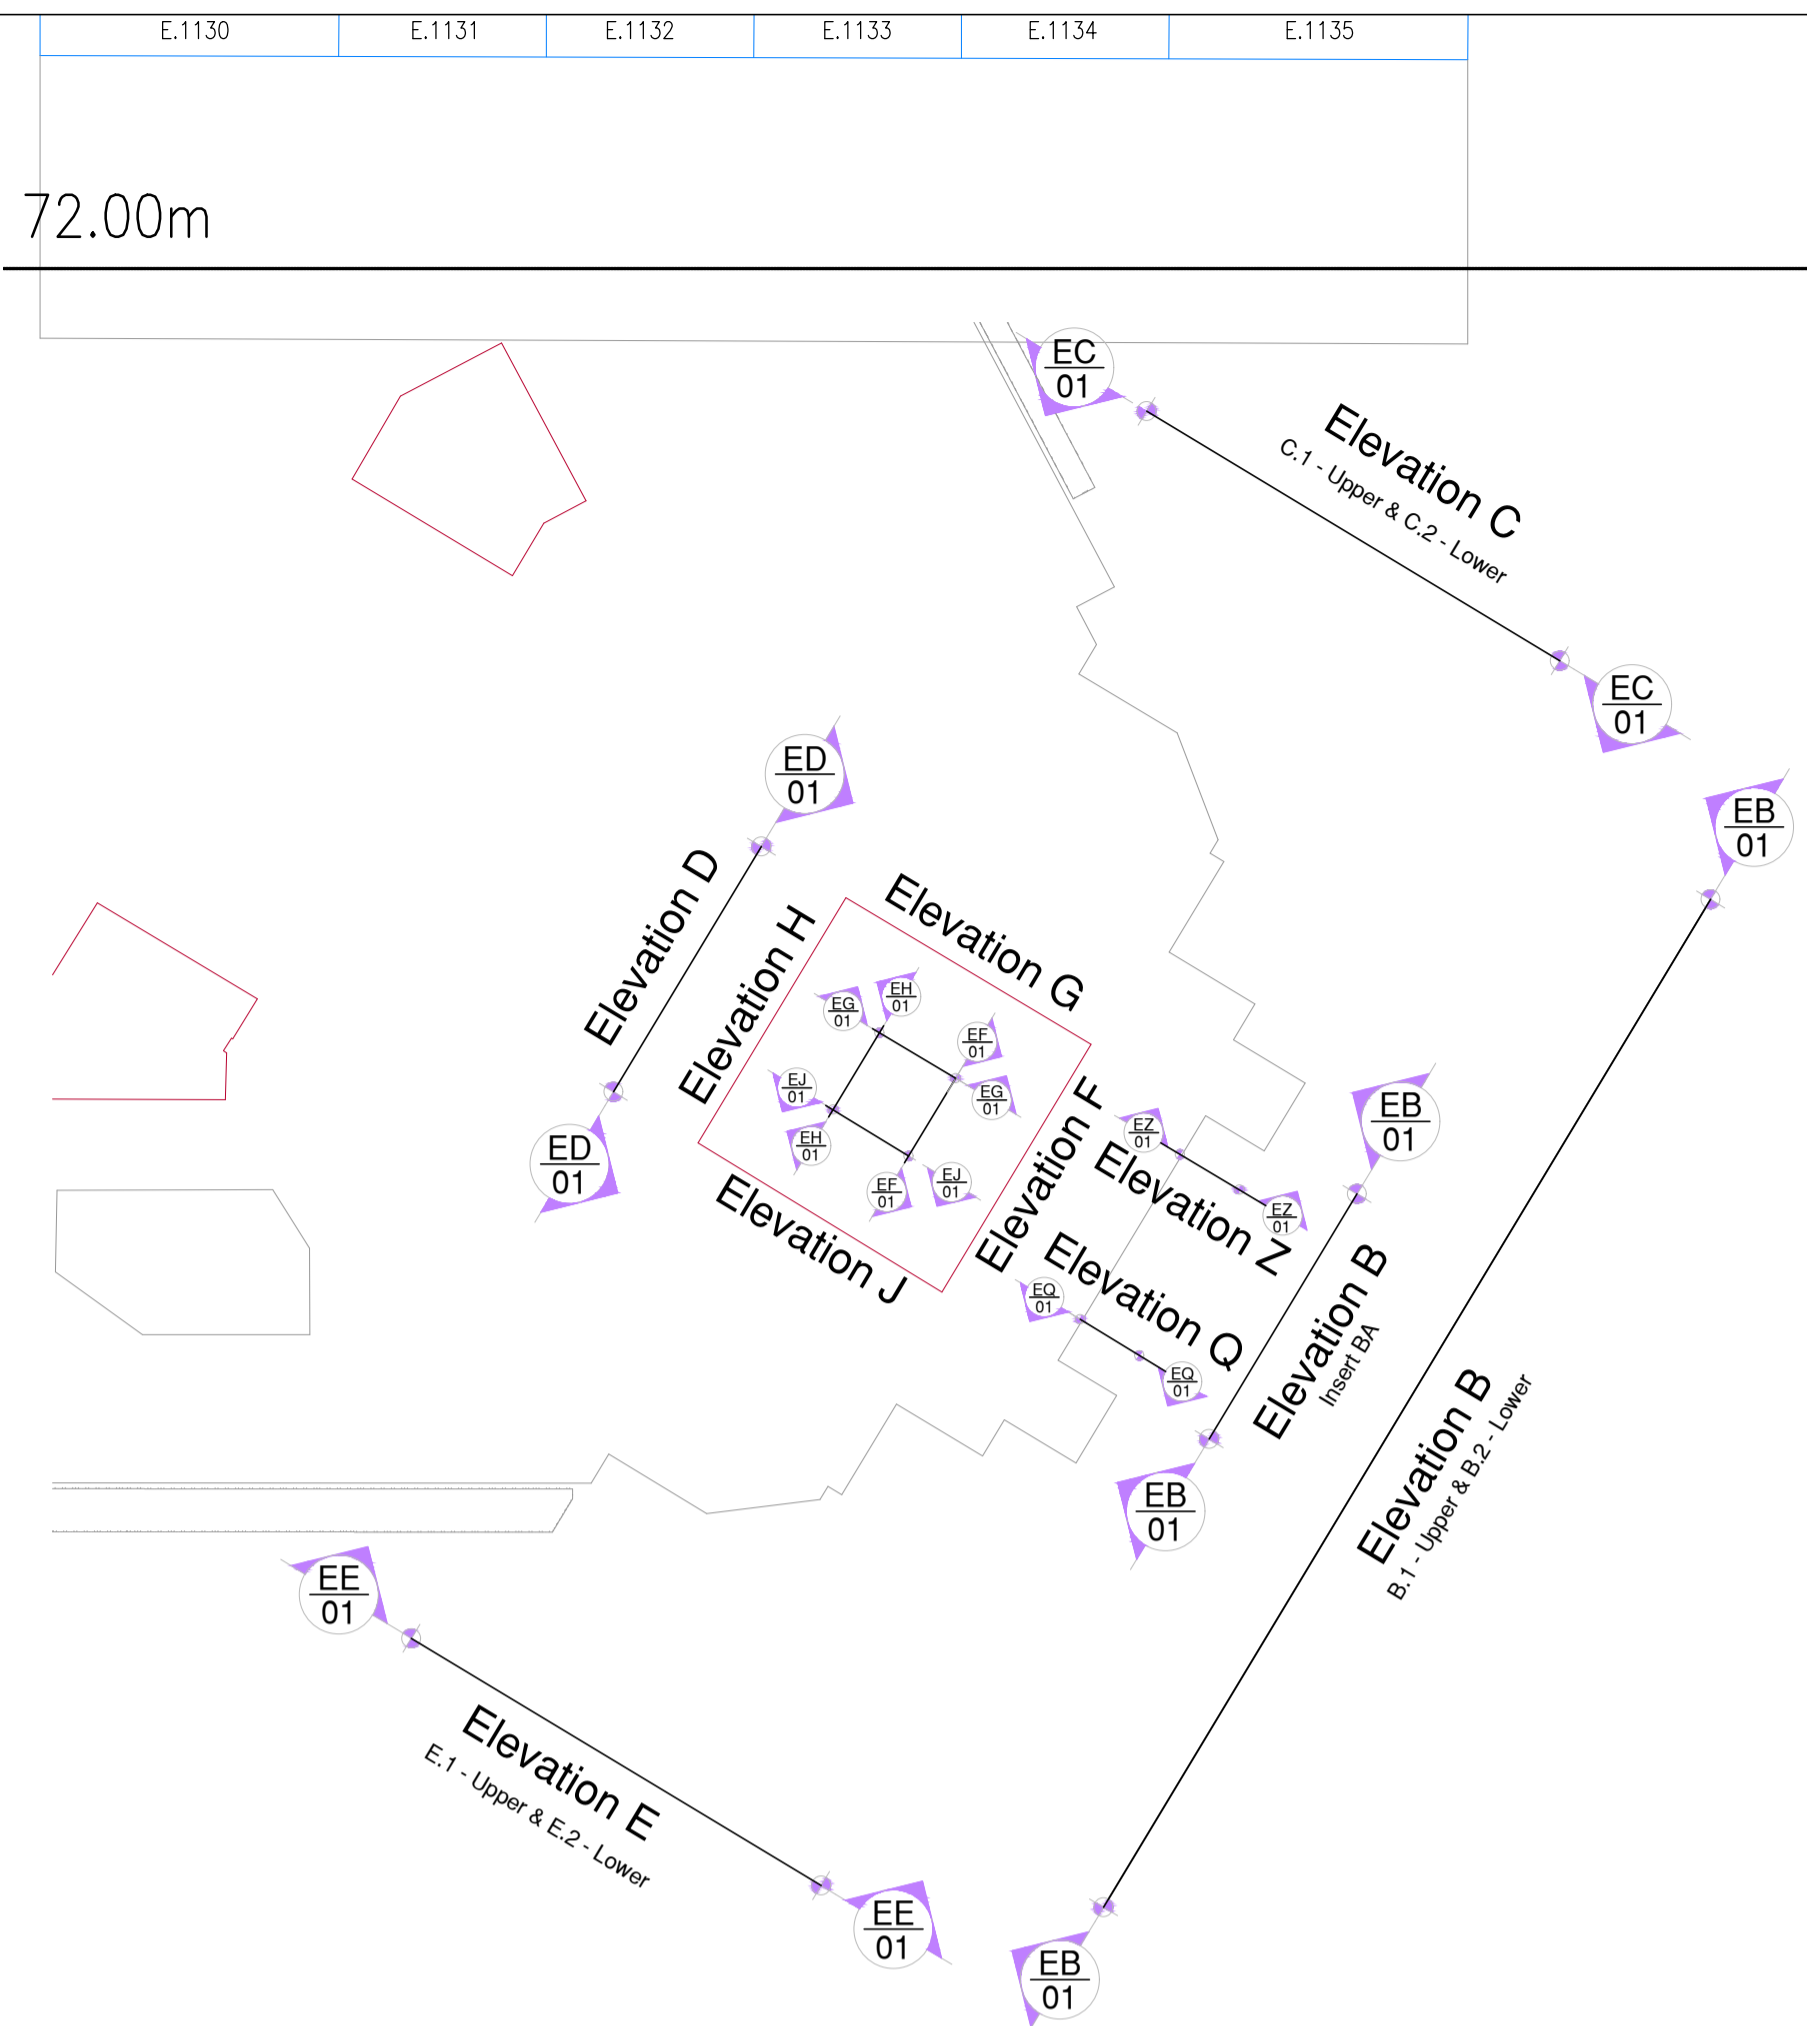
Drawing Title
**DEFECTS:
ELEVATION E.2**

Symbol	Description	Proposed action
J	Open stone joint and weathering of the mortar	Rake out existing joint and re-point with the lime mortar
Sp	Spalling and weathering of the stone surface	De-scale the surface and provide mortar/indent repair
H	Ferrous scaffold tie	Remove and undertake mortar repair
V	Vent (natural stone crack)	Seal and stitch pin
Cr	Cracking due to corrosion of ferrous frame/cramp	Use radar scanner or metal detector in order to locate the ferrous frame/cramp. Remove the specified number of stones to clean and treat the steel as necessary before reinstating.
Disp	Displacement of the stone and jacking of the bed joints due to corrosion of the steel frame

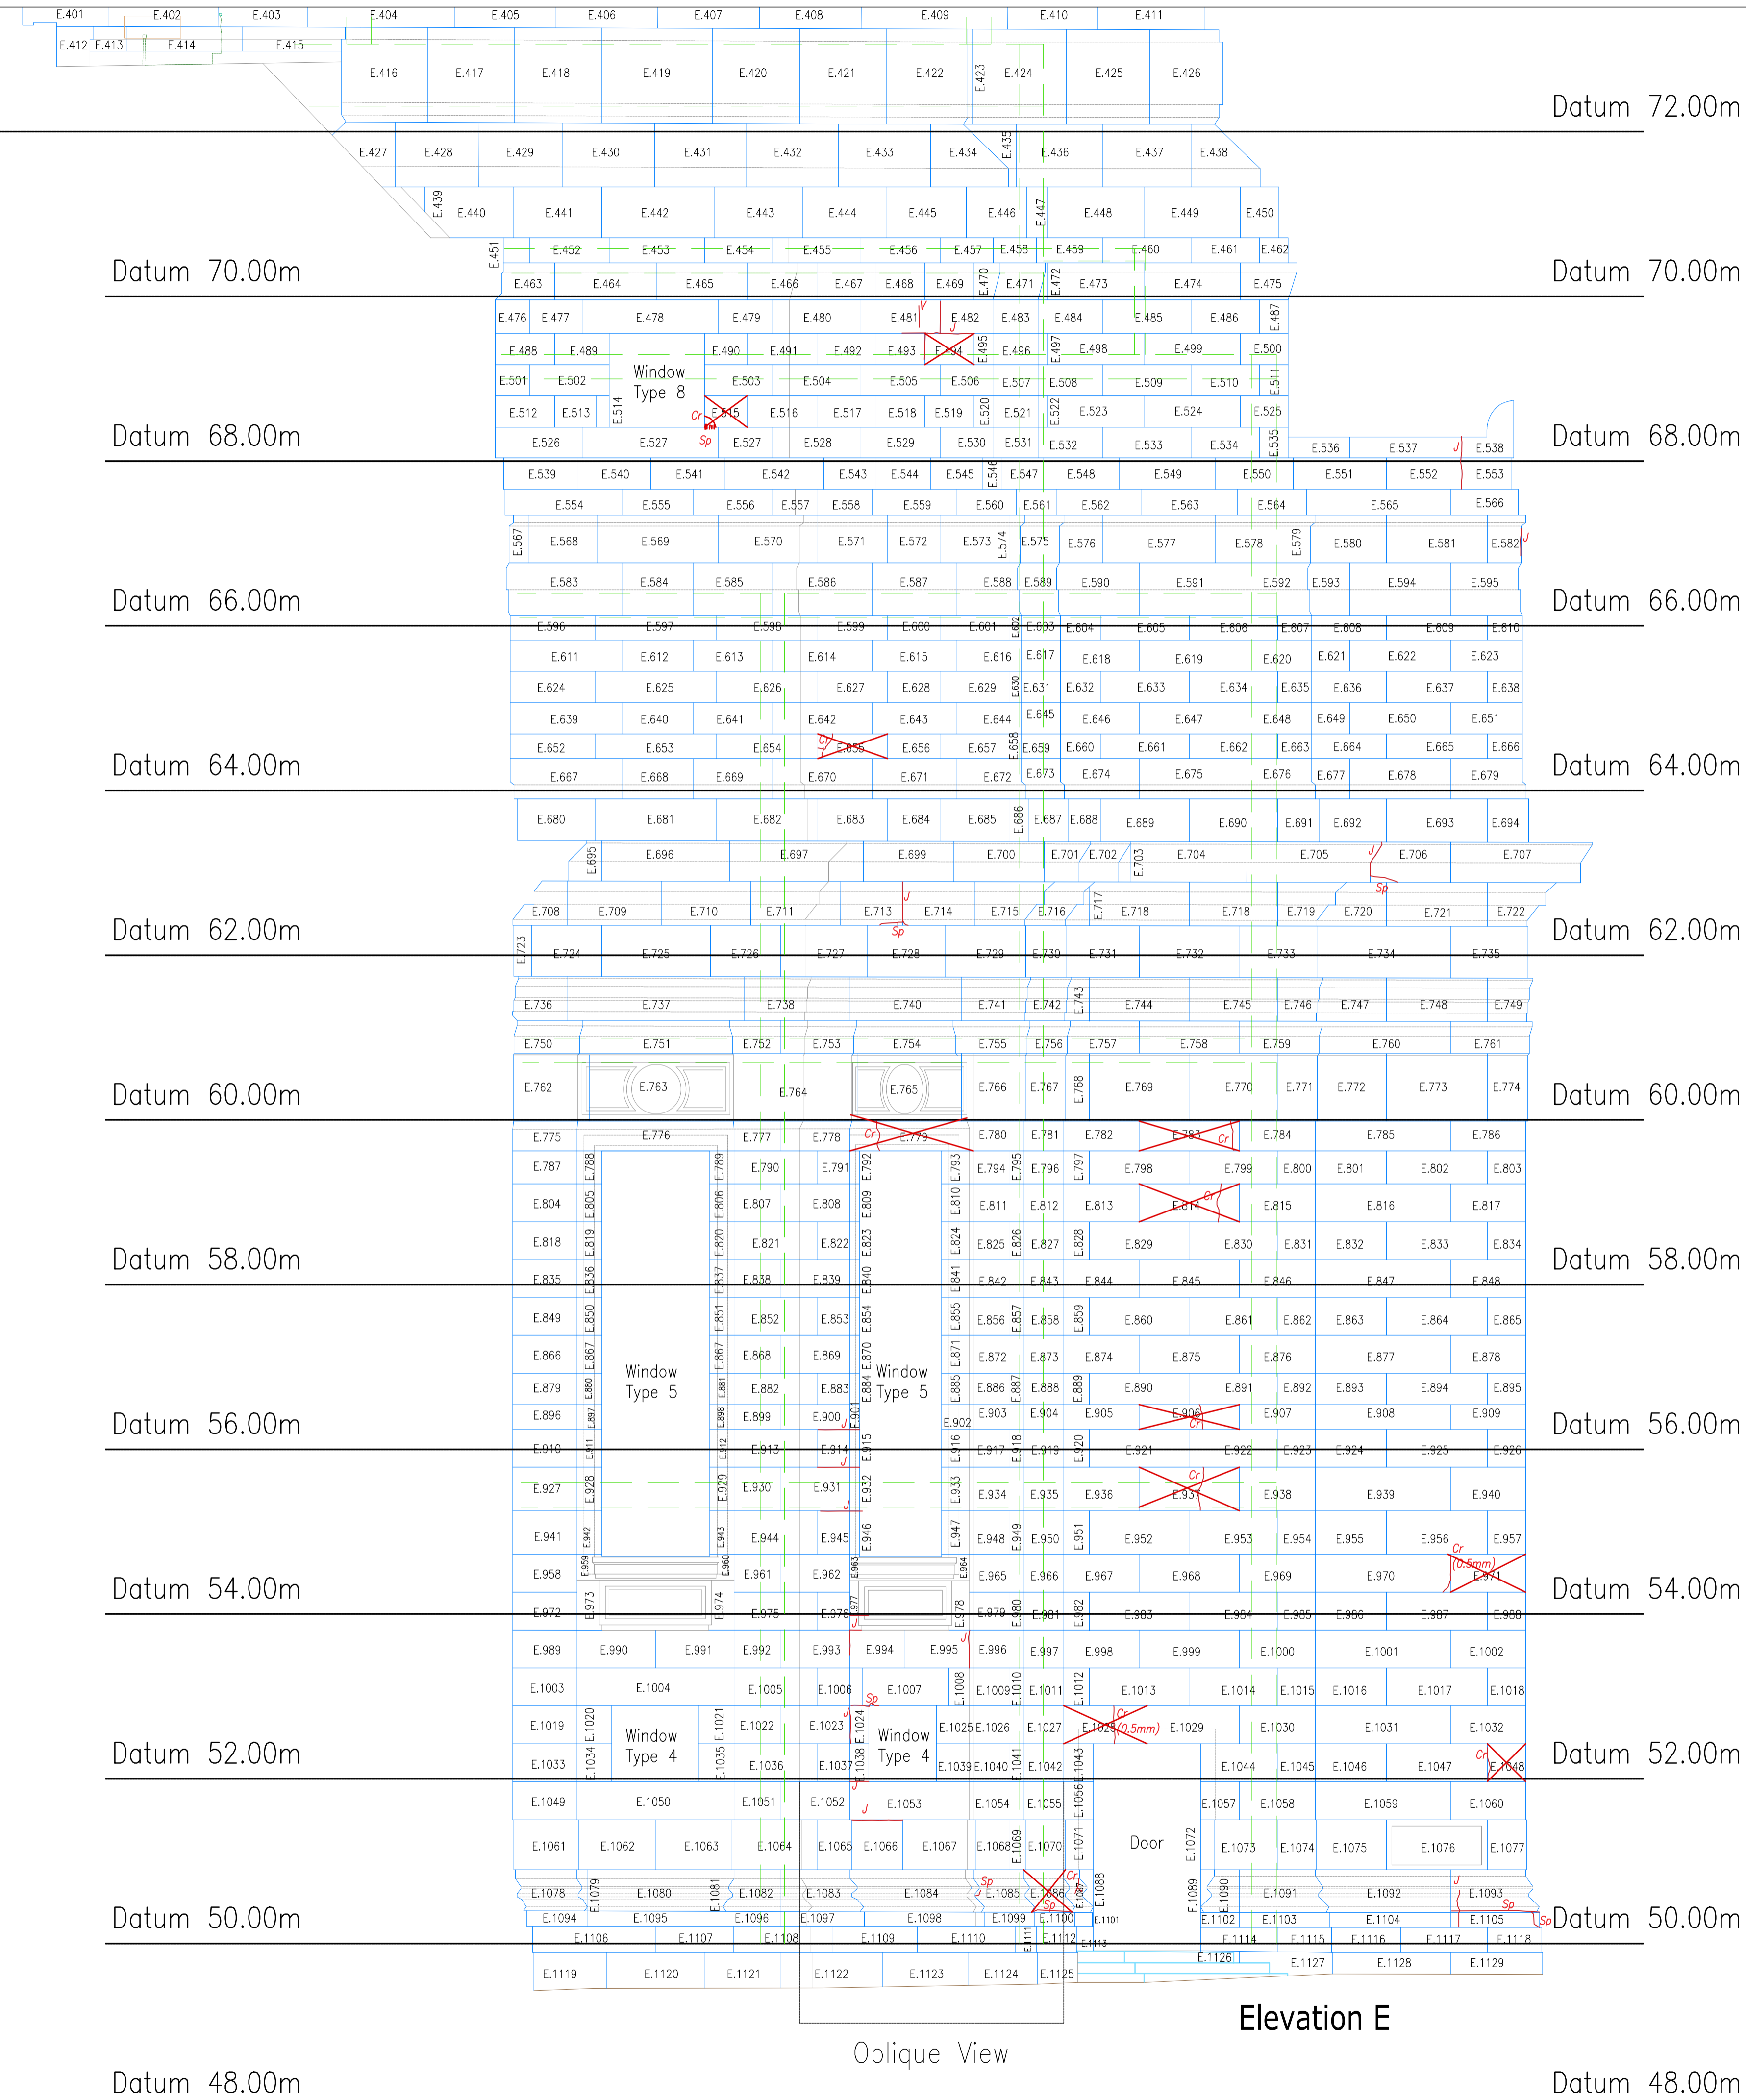
Oblique View

Elevation E

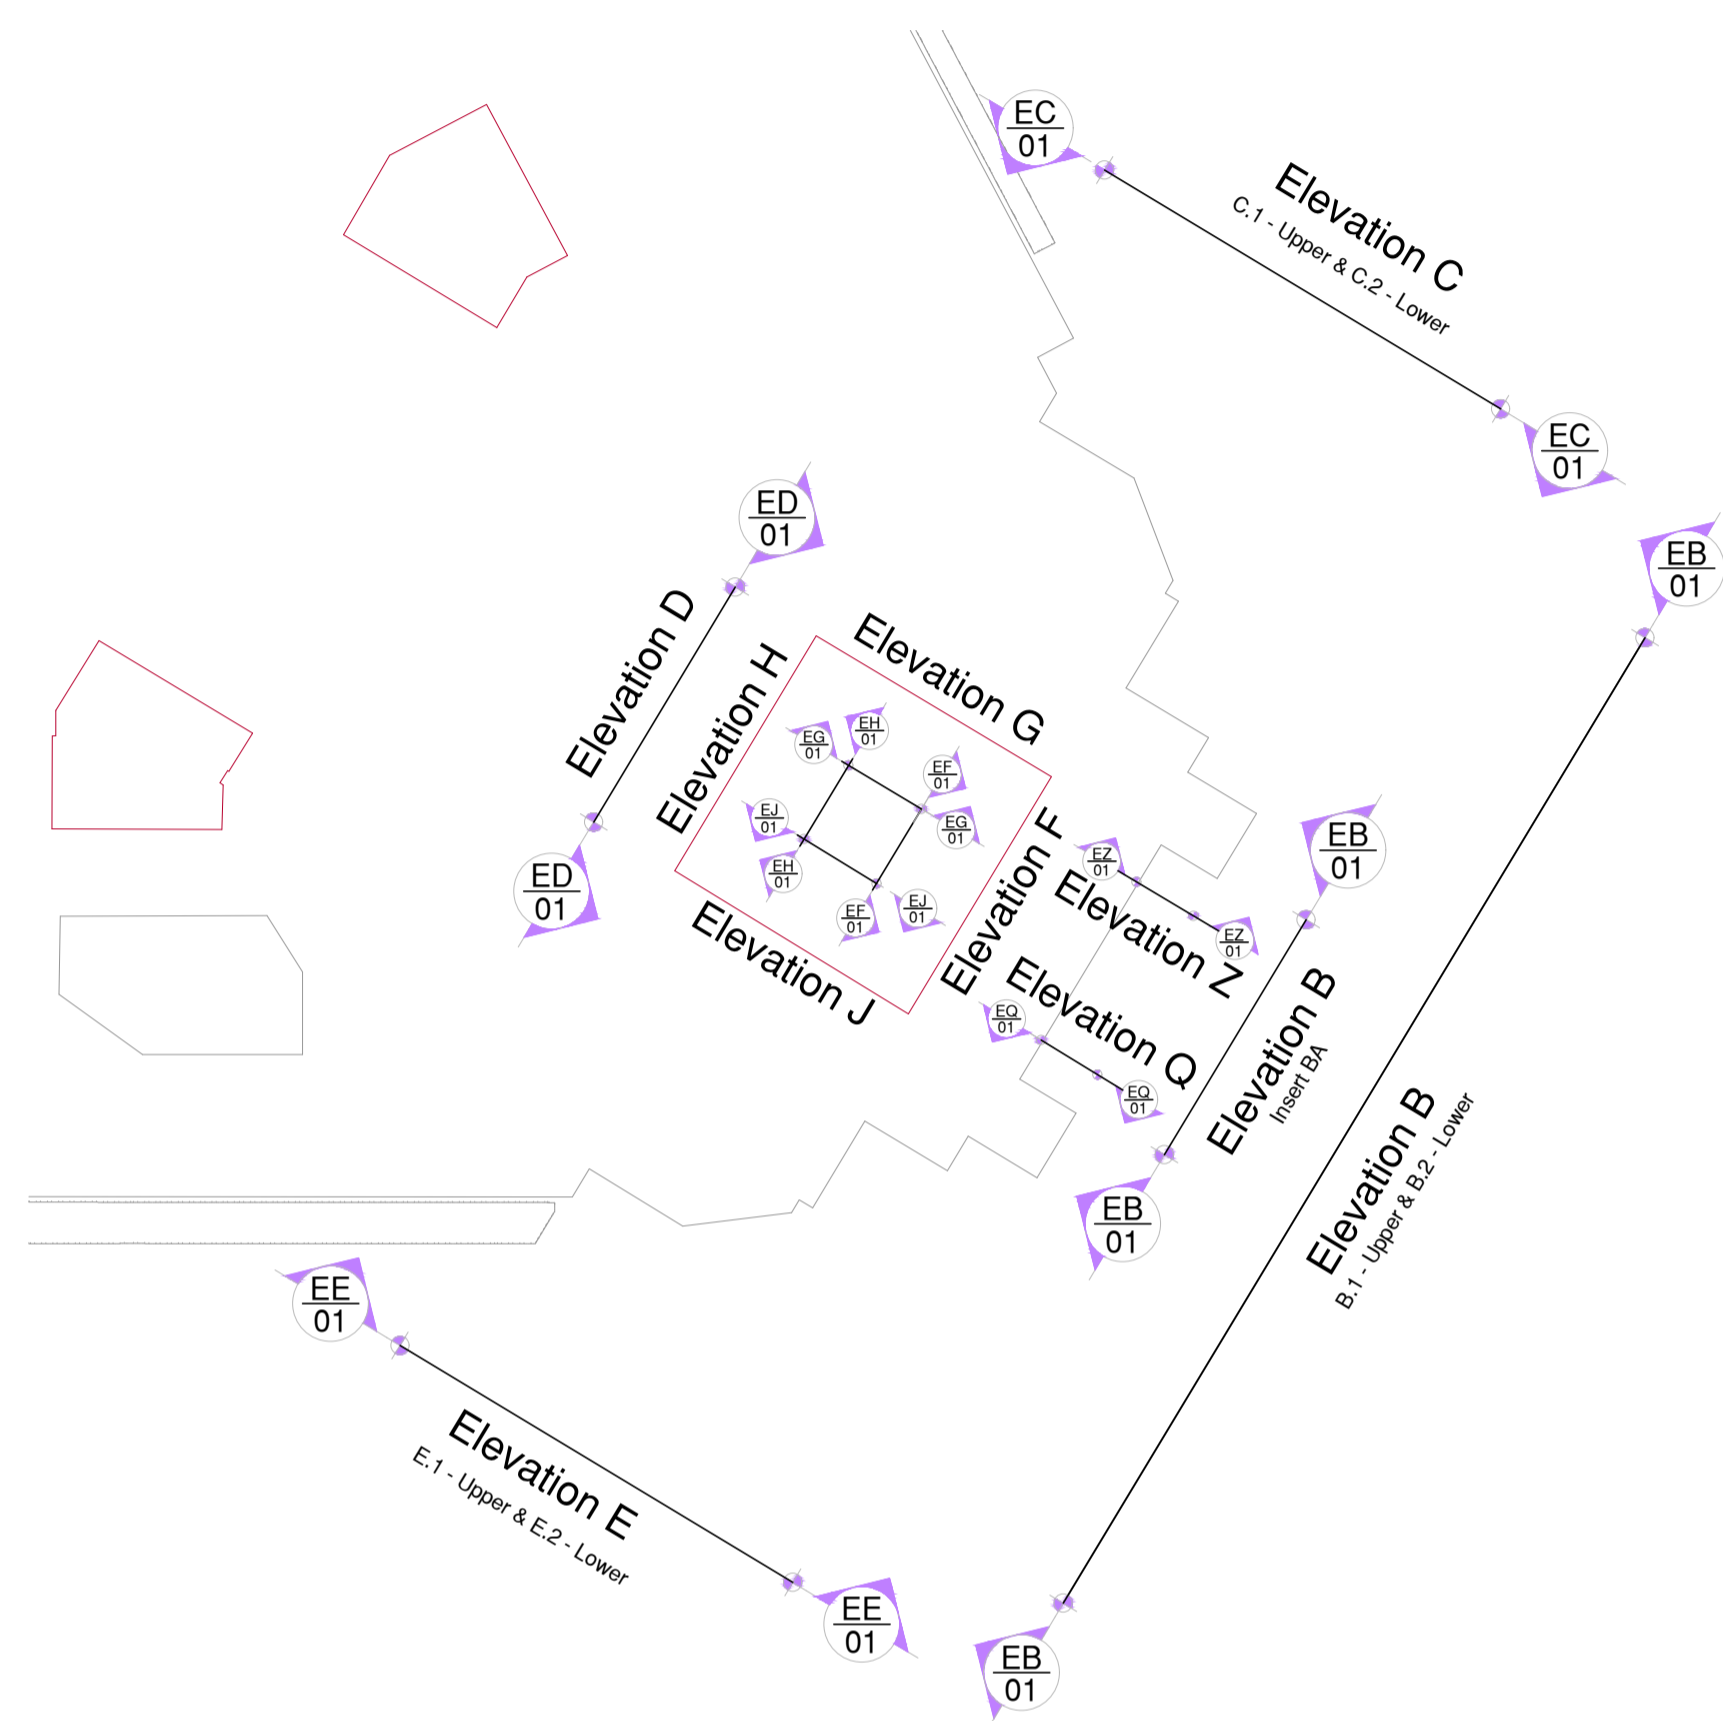
Drawing Title
**DEFECTS:
 ELEVATION D**

Symbol	Description	Proposed action
J	Open stone joint and weathering of the mortar	Rake out existing joint and re-point with the lime mortar
Sp	Spalling and weathering of the stone surface	De-scale the surface and provide mortar/indent repair
H	Ferrous scaffold tie	Remove and undertake mortar repair
V	Vent (natural stone crack)	Seal and stitch pin
Cr	Cracking due to corrosion of ferrous frame/cramp	Use radar scanner or metal detector in order to locate the ferrous frame/cramp. Remove the specified number of stones to clean and treat the steel as necessary before reinstating.
Disp	Displacement of the stone and jacking of the bed joints due to corrosion of the steel frame

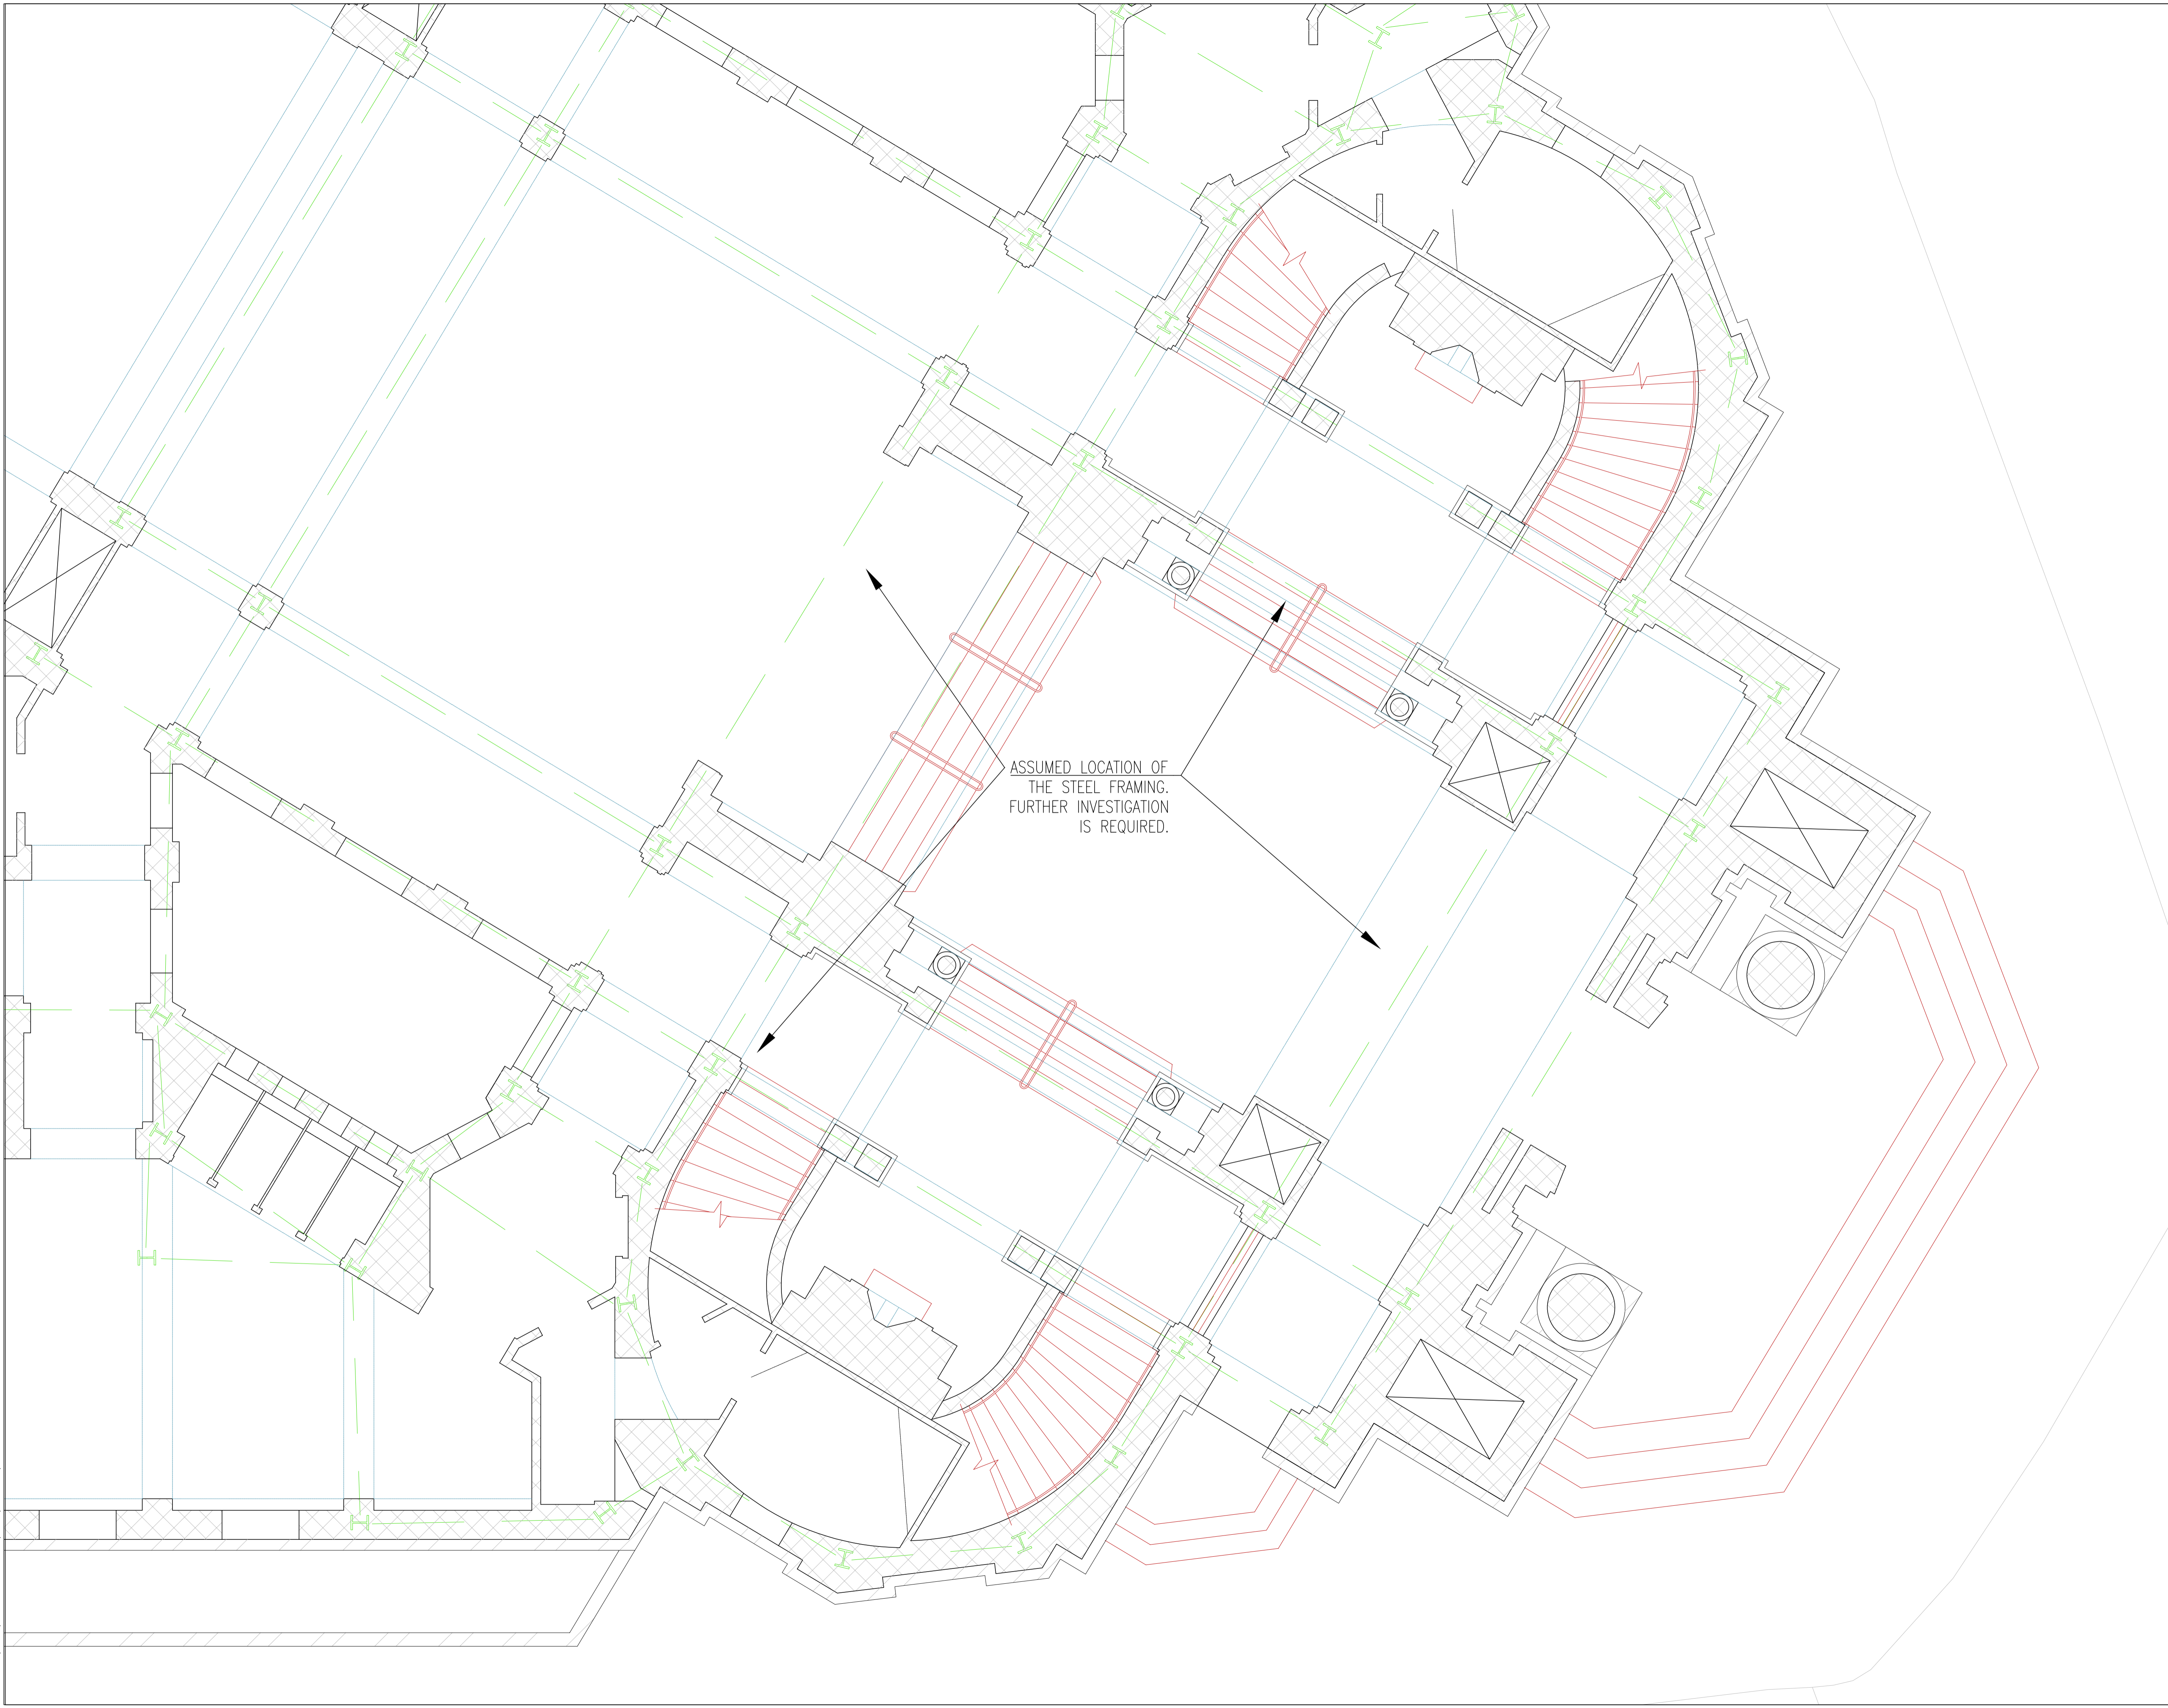
Drawing Title
**PROPOSED FRAMING
 PLAN VIEW:
 GROUND FLOOR**

ASSUMED LOCATION OF THE STEEL FRAMING. FURTHER INVESTIGATION IS REQUIRED.

INDICATES THE PROPOSED LOCATION OF STRUCTURAL STEEL FRAMING

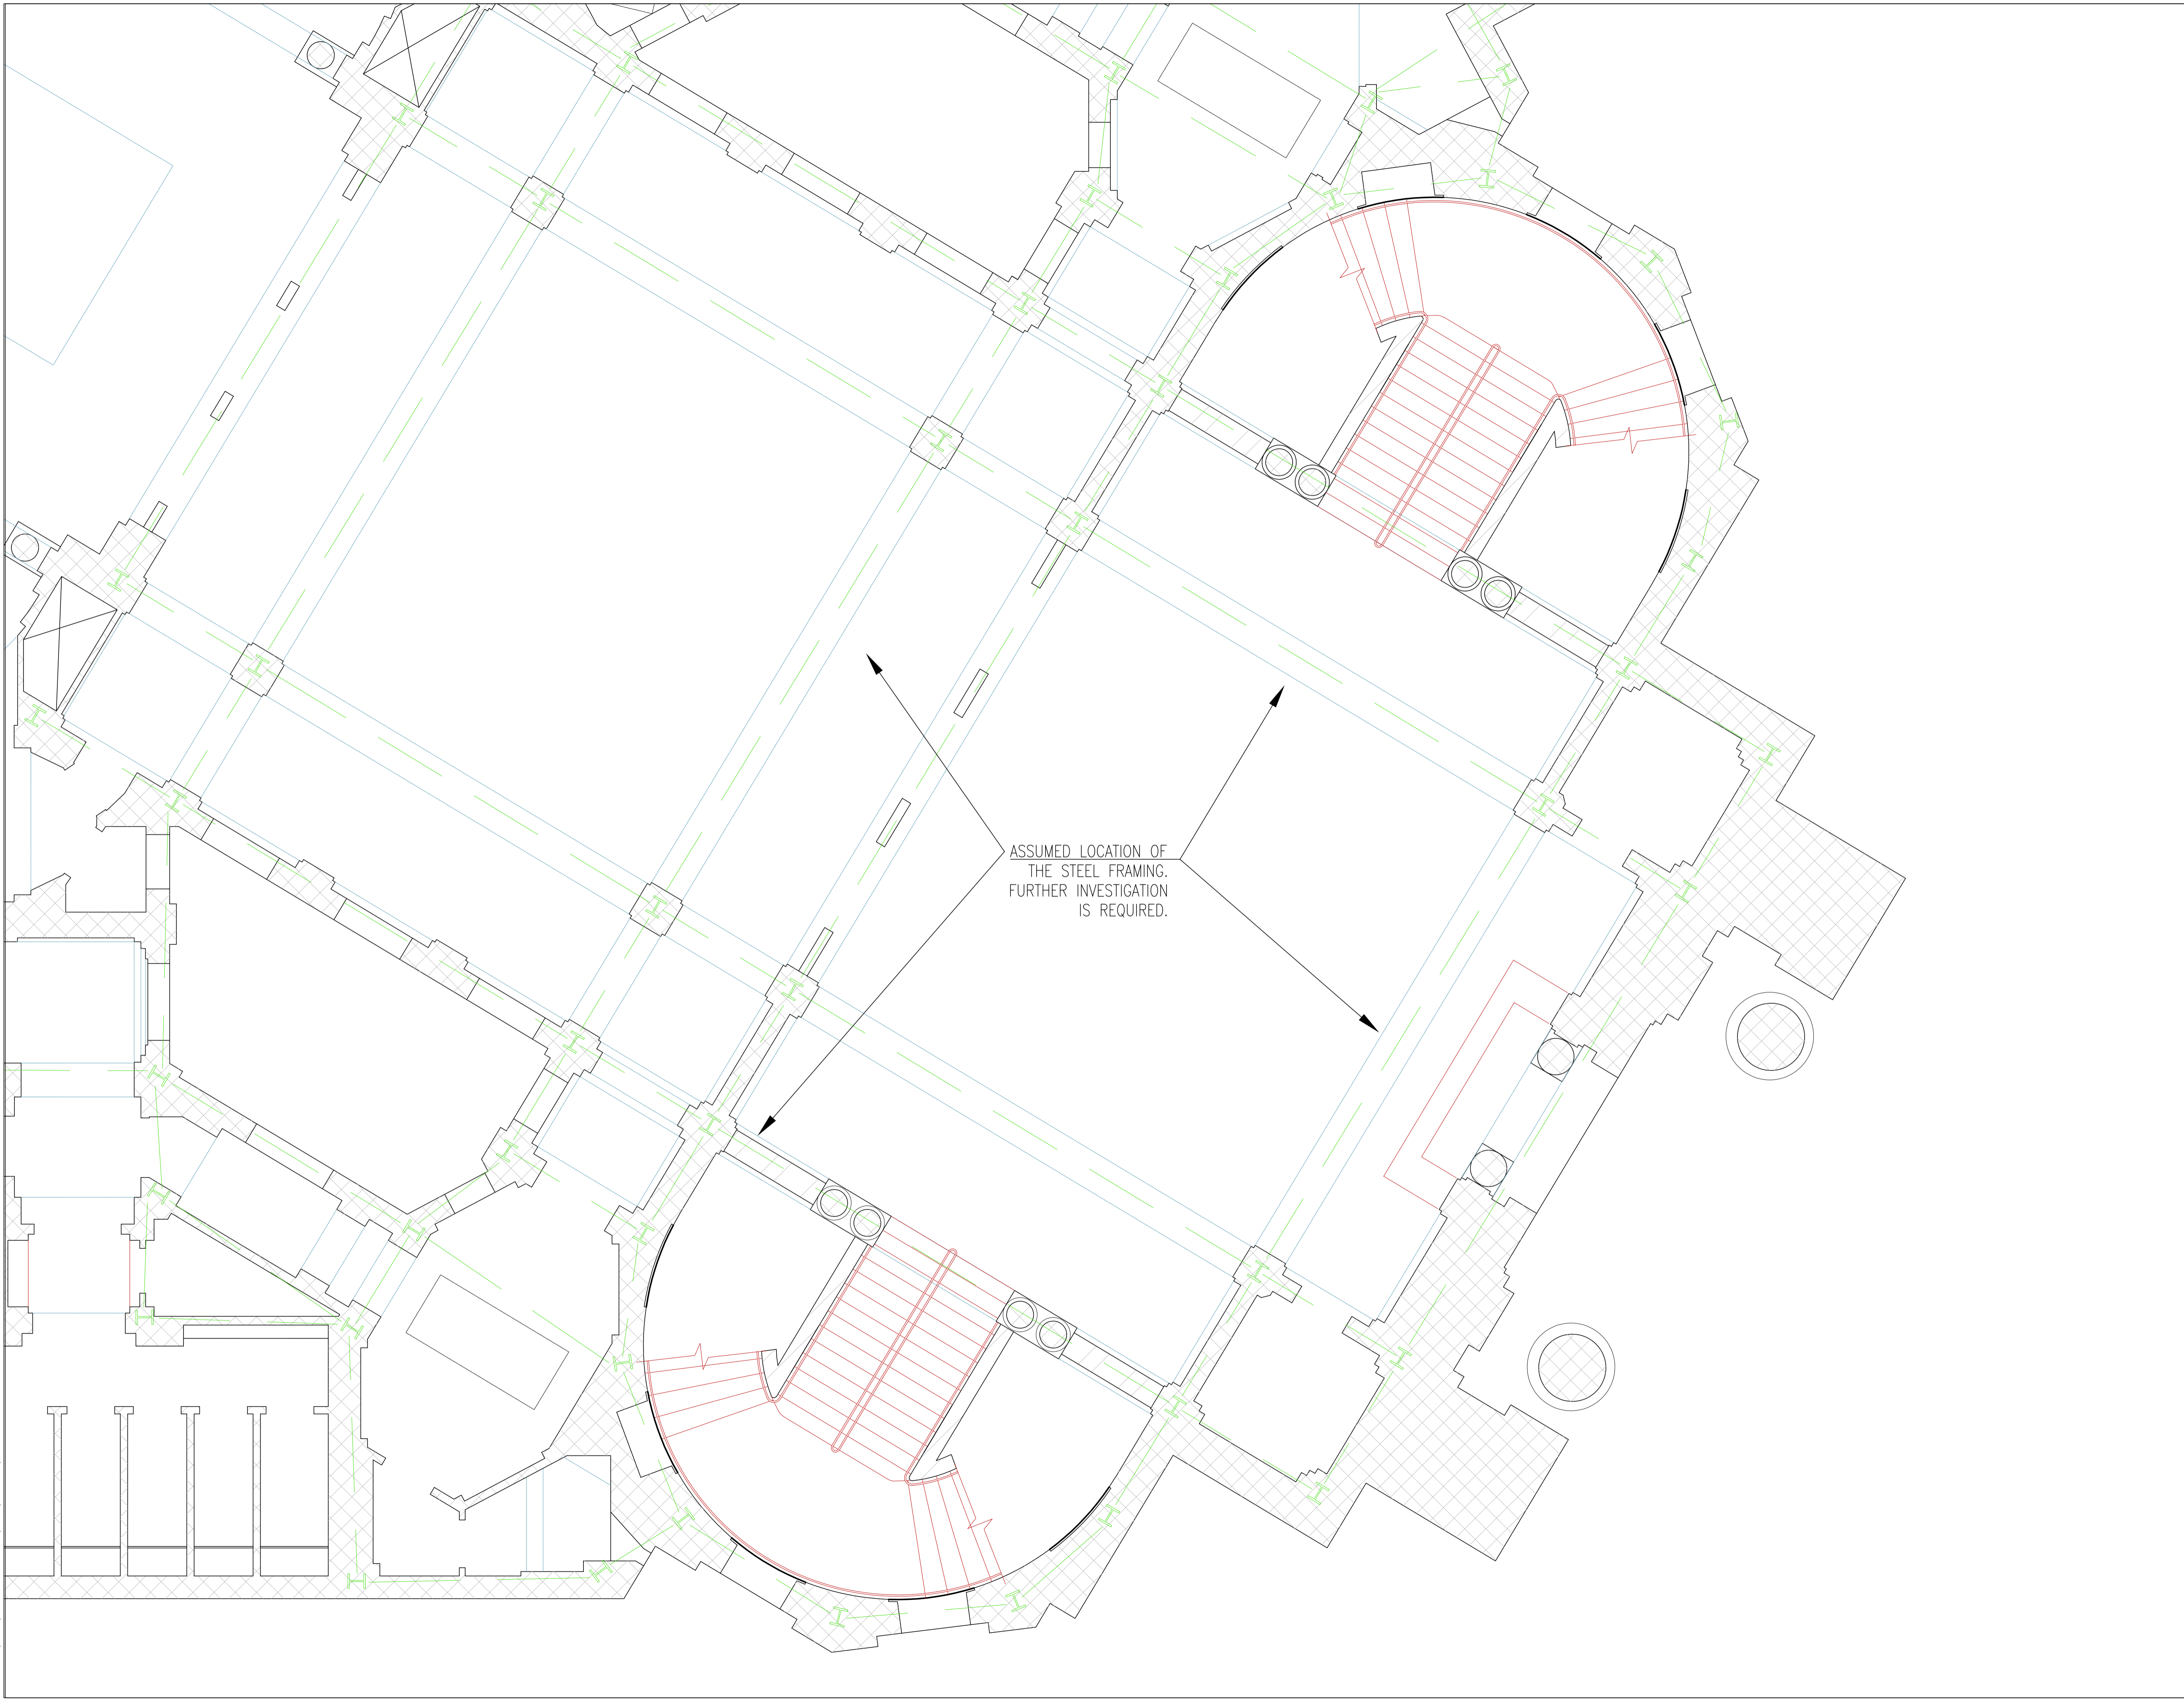
PROPOSED FRAMING
 PLAN VIEW:
 FIRST FLOOR

INDICATES THE PROPOSED LOCATION OF STRUCTURAL STEEL FRAMING
