1. DO NOT SCALE FROM THIS DRAWING. 2. THE STRUCTURAL ARRANGEMENT SHOWN ON THESE DRAWINGS ARE BASED ON PRELIMINARY SITE INVESTIGATIONS CARRIED OUT JANUARY 2018, AND ARCHIVE DRAWINGS OF NEIGHBOURING PROPERTY NO. 42. 21.14 Issued for trider LK BRITISH MUSEUM, 38 RUSSELL SQUARE

EXISTING STRUCTURE ROOF PLAN

C1756/702/506

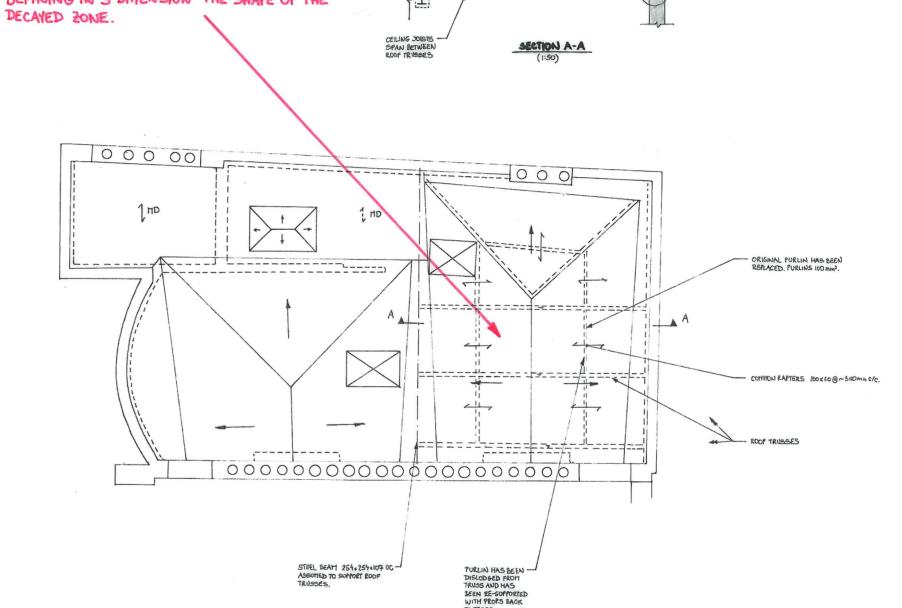
SOG. OI - TIMBER SURVEY

- TIMBER SURVEY TO SE CARRIED OUT IN ROOF

- SURVEY TO COMPRISE

i) VISUAL APPRAISAL OF TIMBERS

ii) THE EXTENT OF ANY DECAY OR DEFECTS

iii) confirmation of timber species

- THE SURVEY SHOULD PROVIDE DRAWINGS IDENTIFYING THE EXTENT OF DECAY WITHIN TIMBERS, DEFINING IN 3 DIMENSION THE SHAPE OF THE

KING POST DETAIL 1-1 TRUSS HEHBERS BOMM DEEPK BOMM WIDE DETAIL 2-2 SECTION A-A

DETAIL 1-1

TIES BETWEEN TOPS OF CONTION RAFTERS.

DETAIL 2-2 (1:10)

DETAIL 3-3 A - TRUSS AT WALL PLATE

DETAIL 3-5 B- COMPON RAFTER AT WALL PLATE
