**22 FROGNAL WAY,
CAMDEN, LONDON**

**STRUCTURAL REPORT ON BOUNDARY WALL
BOUNDARY WITH PERRIN'S WALK**

MARCH 2020

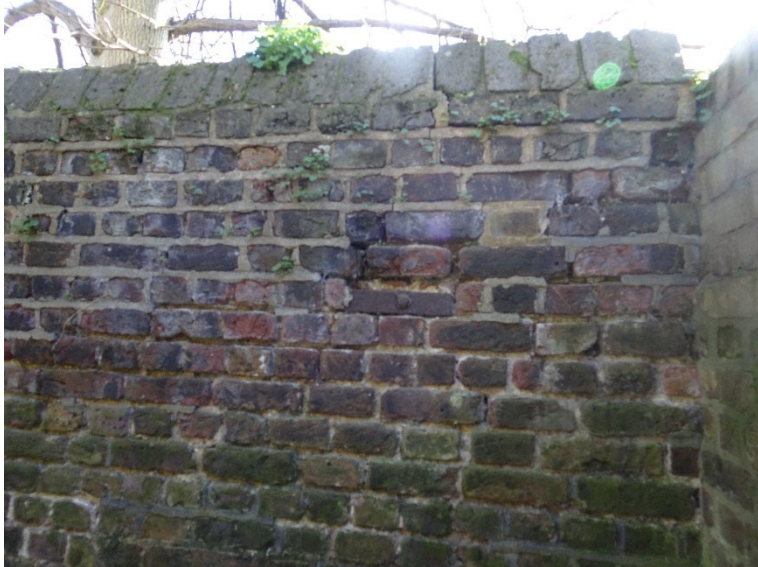
<p>Missing mortar from joints. Diagonal cracking suggests some ground movement. English Garden Wall Bond used in some areas but pattern varies along length of wall.</p>

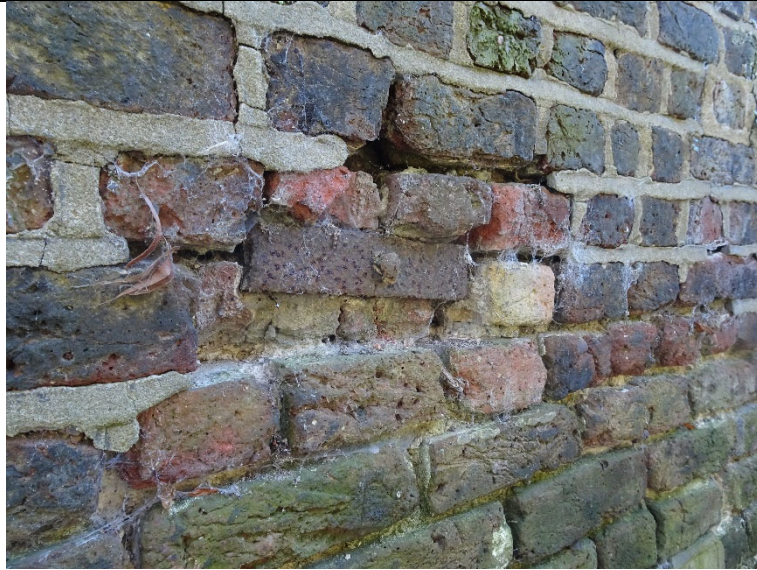
Some bricks appear pitted. Composition of the bricks should be confirmed before repair as this could be a defect that will worsen over time.

- 4.1 Establish the condition of existing brick to quantify amount that can be reused.
- 4.2 Source a similar brick in terms of colour, texture and geometry to replace the defective bricks. New and old bricks should be mixed to create a homogenous finish.
- 4.3 Retaining wall to be formed in reinforced concrete and faced in brick work. This will allow the retaining wall to be formed to comply with current design codes with minimal disruption to the adjoining site.
- 4.4 All of the new wall to be built off new reinforced concrete foundations bearing on suitable stratum.
- 4.5 Root barriers to be installed for trees near the boundary.

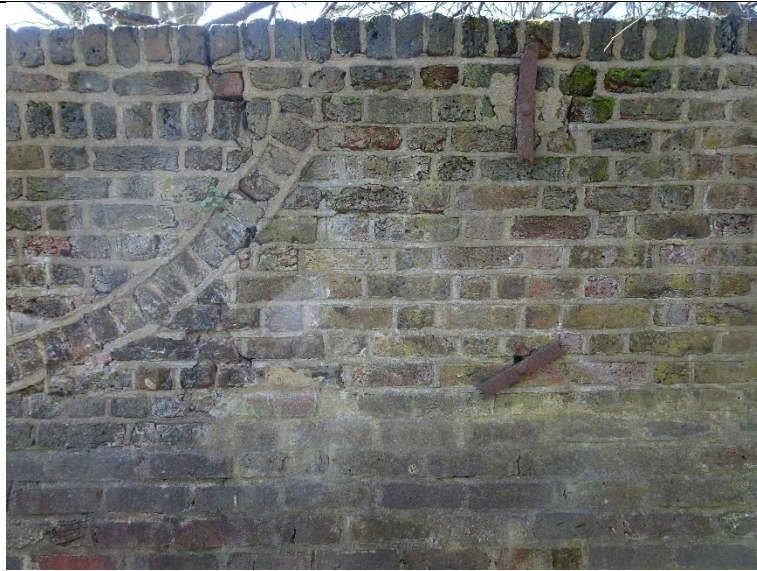
Wall has been extended upwards above the original curved profile. Irregular bond pattern.

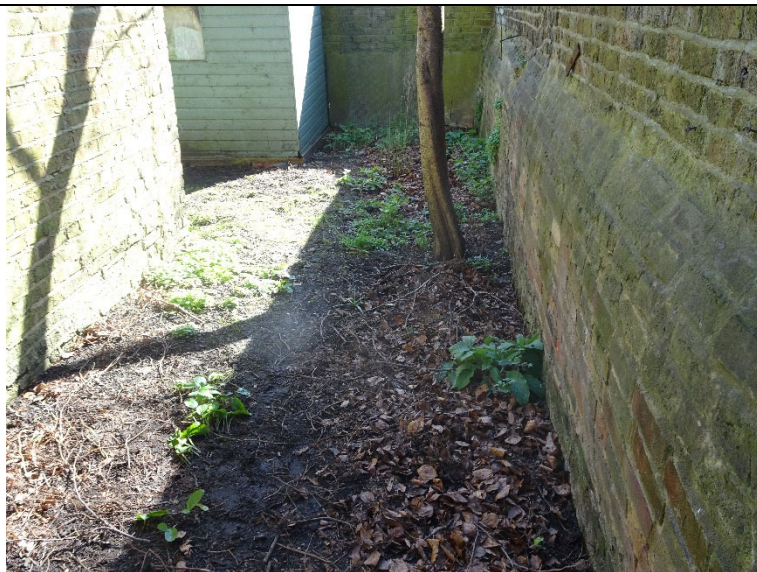
Root damage from tree in future likely.
