PHASE 1 PRELIMINARY RISK ASSESSMENT

**THE DIORAMA,
17-19 PARK SQUARE EAST
LONDON
NW1 4LH**

THE DIORAMA ESTATES LIMITED

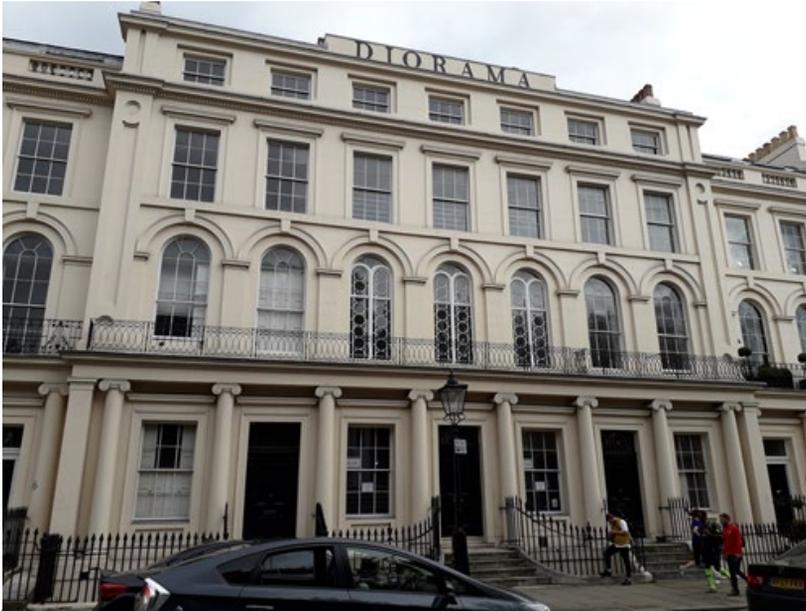
Photograph Plate A – The Diorama, London.

A CET Geotechnical Engineer conducted a site visit on 10th October 2019 during cloudy but dry conditions. The rear of the site was accessed from Albany Terrace and the front of the three properties from Park Square East, Marylebone, London, NW1 4LH (Plate A).

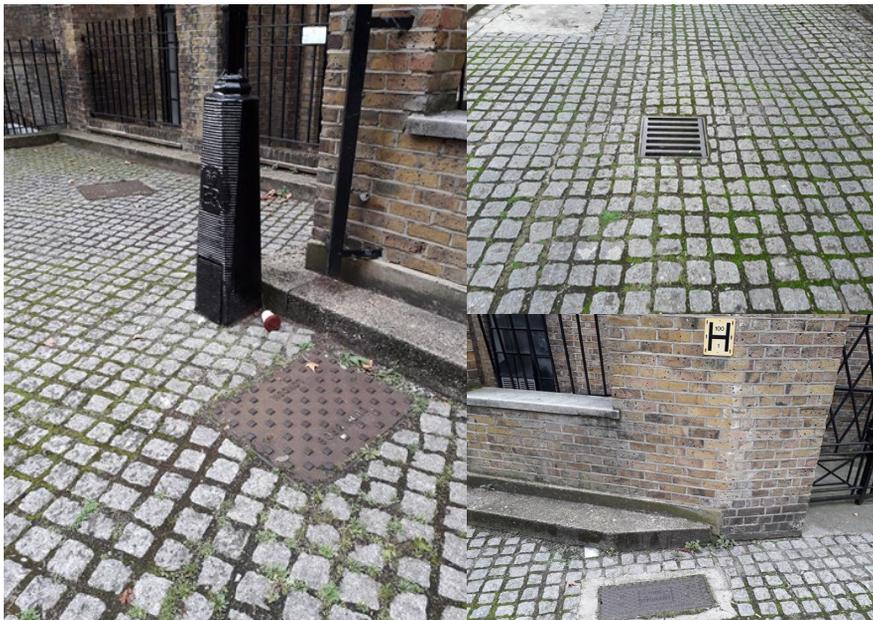
Photograph Plate B – Several manhole covers were recorded around the perimeter of the site, indicating the presence of underground services.

The site is adjacent to Park Square to the west and surrounded on all other sides by residential properties. Several manhole covers were recorded around the perimeter of the site, indicating the presence of underground services (Plate B).

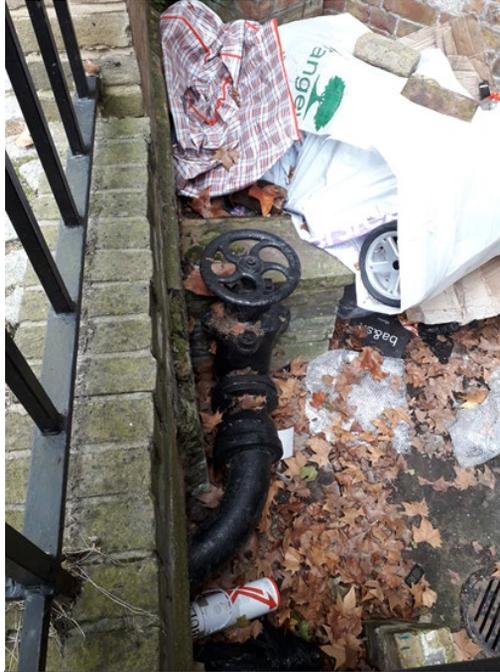
Photograph Plate C - Fly-tipped material.

An area of fly-tipped material (Plate C) was located in the east of the site adjacent to the buildings. This area also contained a large pipe with a wheel-controlled valve, this ran under the adjacent footpath from a brick structure on the site, suggesting a potential historical oven (Plate D).

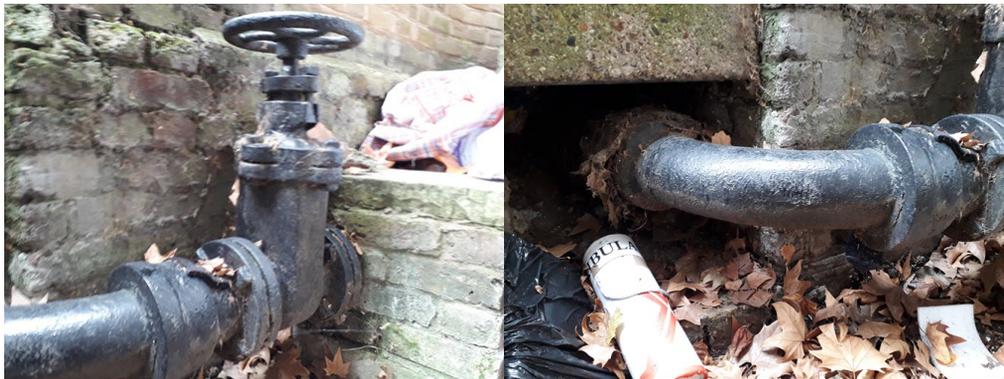
Photograph Plate D - A large pipe with a wheel-controlled valve.

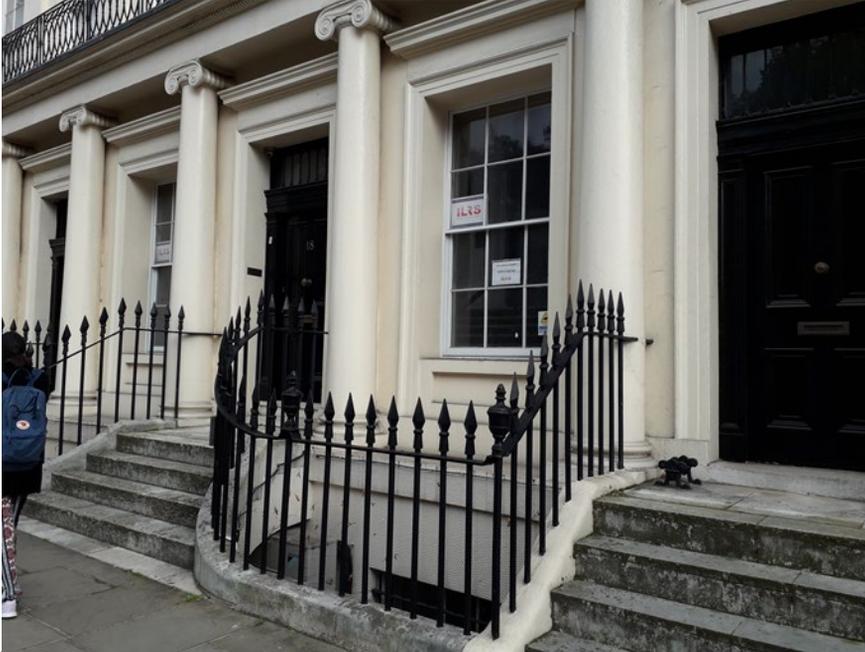
Photograph Plate E - The front of the property light well.

The front of the properties all contained light wells (Plate E), in which, electrical services, pipes and air conditioning units were connected (Plate F).

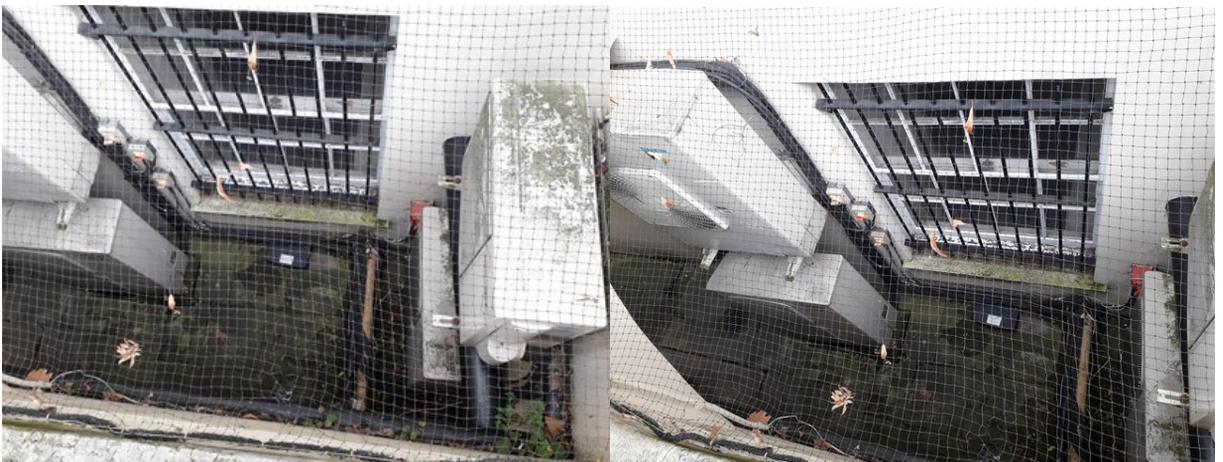
Photograph Plate F - Electrical services, pipes and air conditioning units.
