**FRANCIS GARDNER APARTMENTS,  
89-91 WEST END LANE, LONDON**

**PRELIMINARY BAT ROOST  
ASSESSMENT**

Report No: RT-MME-151827-02

Date: February 2020

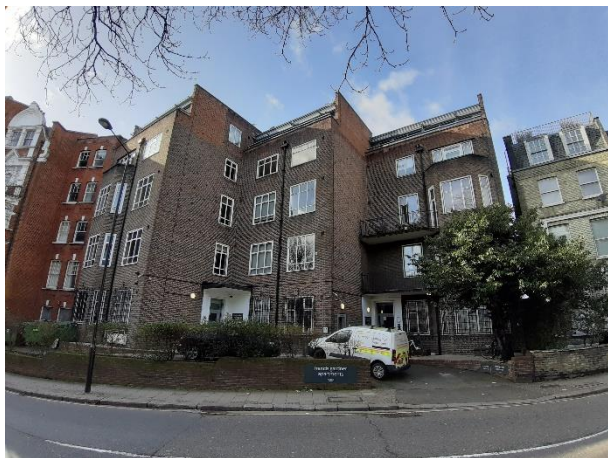
**Plate 4.1: East-facing Aspect**

The site was dominated by a large four-storey block of apartments, which are understood to have been constructed in the 1950s and were generally in a good state of repair (Plate 4.1). The building had a basement which had been converted into a home cinema, and two internal courtyards, the basement floors of which had been converted into glass conservatories (Plate 4.2). A basement-level glass conservatory extension had also been built on the west-facing aspect of the building.

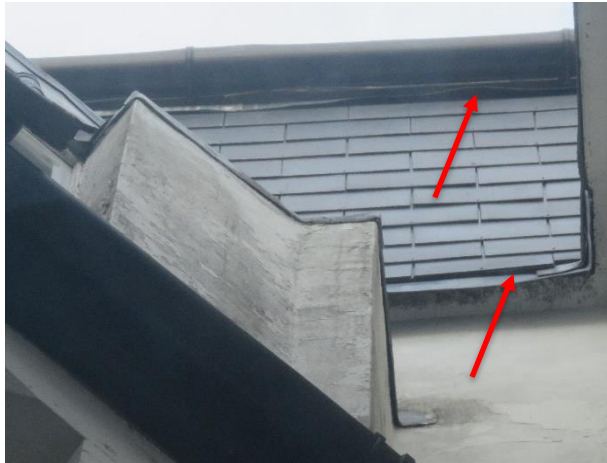
The building had a flat felt roof. Hanging tiles were present in sections of the upper areas of the walls closest to the roof, particularly around the internal courtyard sections. Gaps were recorded beneath some of these lifted tiles (Plate 4.3). Lifted lead flashing was also recorded in sections of the roof near to the hanging tiles, such as where the hanging tiles met the roof. Above many windows on the west-facing aspect of the building, there were gaps between the window frames and the brick lintels (Plate 4.4). It was not possible to fully inspect these gaps but they appeared to lead to crevices and potentially on to cavities within the wall.

**Plate 4.3: Gaps under Hanging Tiles and Lifted Lead Flashing, Viewed from Internal Courtyard**

- Gaps under hanging tiles in the courtyard area of the roof;
- Lifted lead flashing in the courtyard area of the roof;
- Gaps between window frames and brick lintels on the west-facing aspect;
- Gaps in brickwork on the west-facing aspect; and,
- Ventilation bricks on the east-facing aspect.

Francis Gardner Apartments, the large building dominating the site, has been identified as having high potential to support roosting bats. Bat Surveys: Good Practice Guidelines published by the Bat Conservation Trust (Collins, 2016) recommends that for structures with high bat roosting potential at least three dusk emergence and/or dawn re-entry surveys be undertaken during the bat emergence/re-entry survey season to determine the presence/absence of roosting bats within the structure. The bat emergence/re-entry survey season extends from May to September. At least two of the surveys should be undertaken during the peak season for emergence/re-entry surveys between May and August and one of the three surveys should be a dawn re-entry survey. If a roost is discovered during these surveys, a Natural England licence application may be required.

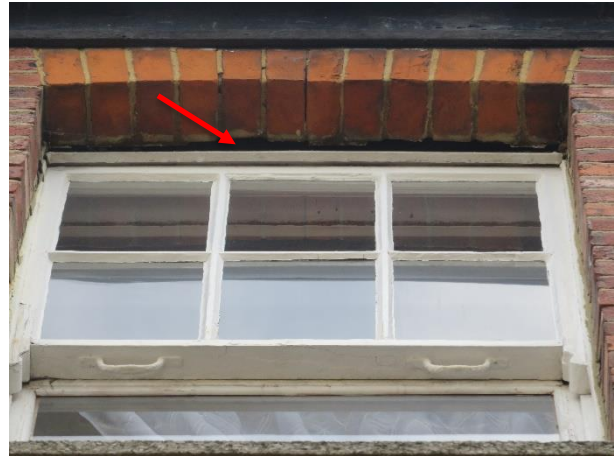
**Plate 4.4: Gap between Window Frame and Brick Lintel**

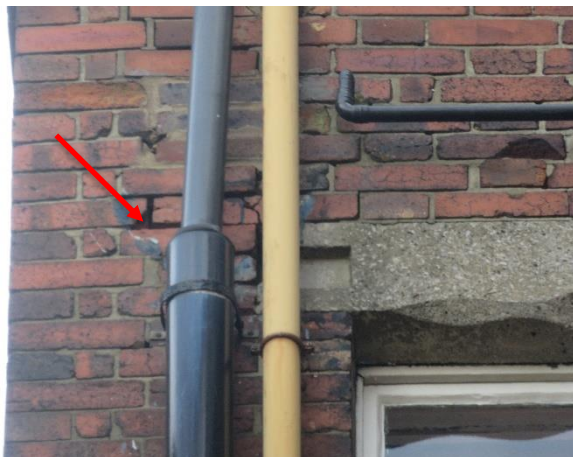
Dormer windows were present throughout the top storeys of the building. These windows appeared to be single glazed and set in wooden frames, with no gaps associated with lead flashing. The building had a mix of brick/concrete soffit and wooden fascia boarding, which appeared flush with no gaps or holes recorded. On the west-facing aspect of the building, brickwork gaps were recorded around pipework (Plate 4.5). The east-facing aspect had multiple ventilation bricks, approximately one for every storey of the building (Plate 4.6). The ground-level ventilation brick was inspected and no evidence of roosting bats was recorded. It was not possible to inspect the other ventilation bricks due to their height.

**Plate 4.5: Gaps in brickwork**

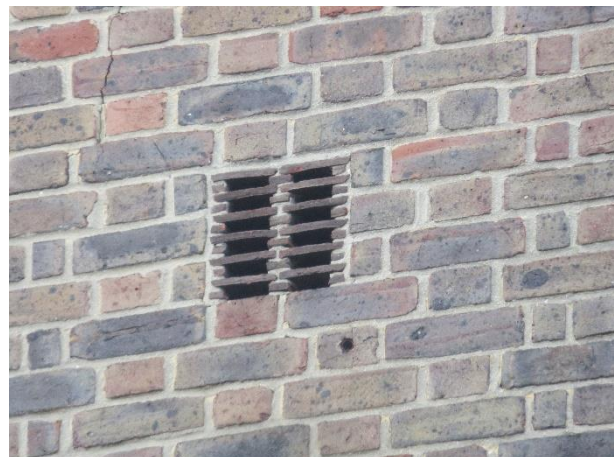
**Plate 4.6: Ventilation brick**

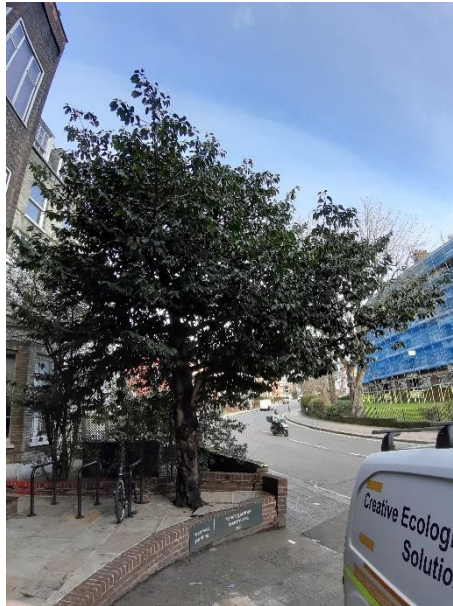
Plate 4.7: Portuguese Laurel

Towards the northeast site boundary was a mature Portuguese laurel *Prunus lusitanica*, approximately 12 m tall. This tree was inspected from ground level, and no potential roosting features such as knotholes and other crevices were recorded.

The mature trees on site were assessed as having negligible potential to support roosting bats due to an absence of features such as knotholes and other such crevices.

The three mature trees on site were considered to have negligible potential for roosting bats. The survey data obtained for the site is valid for 12 months from the survey date. If proposed site works have not commenced within this timeframe it will be essential to update the survey effort to establish if the trees have developed features that could be used by roosting bats in the interim. In the unlikely event that a bat is found during works to the trees all works must immediately cease and a suitably qualified ecologist should be contacted.
