The Heath & Hampstead Society

Planning Ref: 2020/1692/T
Case Officer: Tom Little

Address: 34 Frognal London NW3 6AG
Date: 9th May 2020

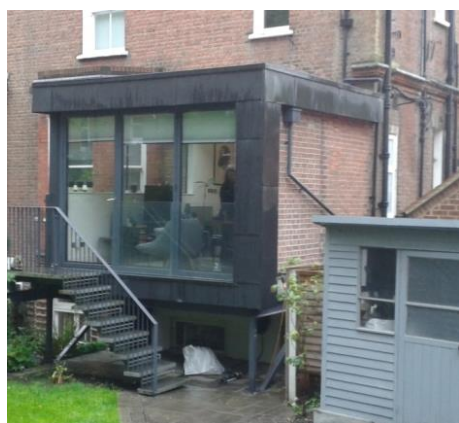
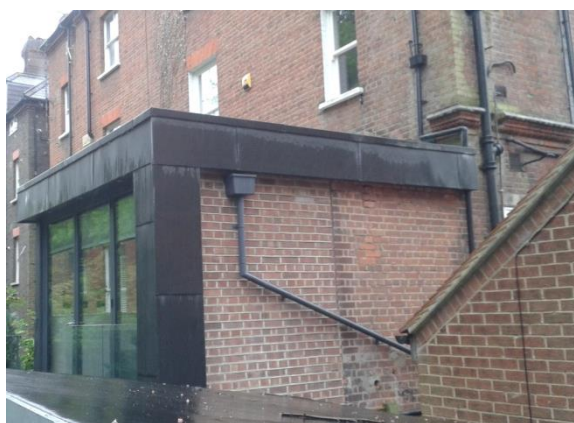
Rear conservatory ~2010
showing movement joint
- not in new add-on

This is a curious case of a rebuilt 'brick conservatory' for an upper ground floor flat supported on stilts (that the new owner was told go 2.5m into the ground) so the lower ground floor flat has light for a window below. It is clear the problems dated from the recent extension re-build, which failed to replace the movement joints while using the same stilts. Thus this conservatory has a very different foundation level and type to that of the main building, yet is now firmly fixed to it. The building shows signs of poor drains and downpipe maintenance, and the drains report indicates a foul water drains leak in the area of movement: a potential cause of movement.

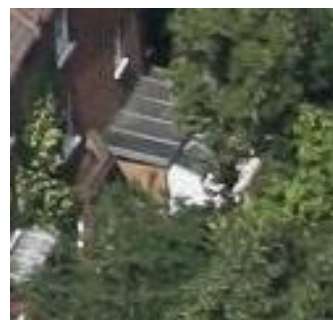
The 2-storey 34A Frognal

The ground is described in the report as level, yet Frognal steeply slopes down to Finchley Road here with deep passageways between each house and major stepping downhill of each of the houses. Have the roots of 34 Frognal limes' gone under the 2-storey 34A Frognal without affecting it, under a deeper passageway and then influenced four stilts? 12 months monitoring of the cracks was supposed to have been done but there is no sign of data regarding crack movement timed to vegetation leaf burst or fall, or to rainfall. The presence of lime tree roots is an indicator of water for the roots to go after e.g. from all the drains reported as damaged and requiring repair and replacement.

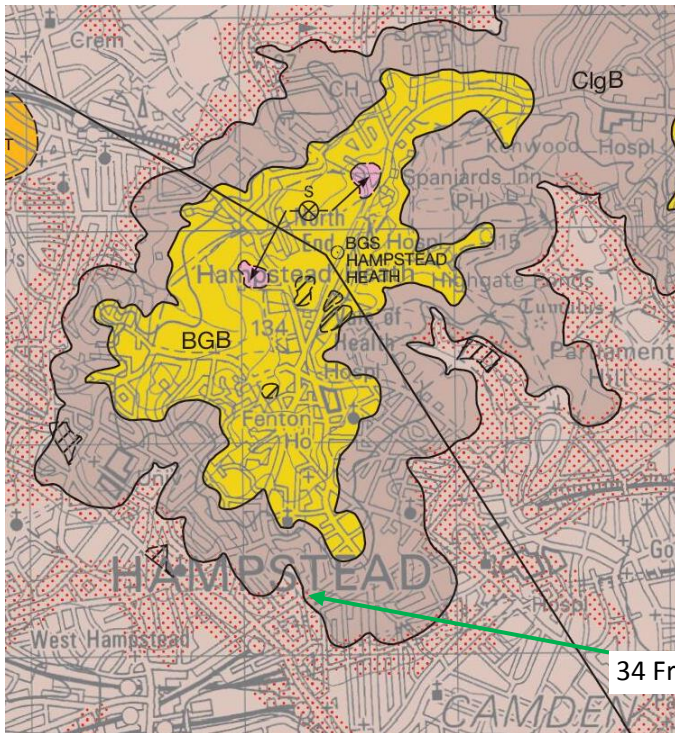
British Geological Survey 1:50 000 series North London Sheet 256 Bedrock and Superficial Deposits

Local geological maps demonstrate 34 Frognal and its conservatory extension re-build are on an area of high to very high potential for slope instability (see below) mainly due to its position immediately below the springline of the geological boundary between Claygate Beds and Unit D of the London Clay Formation, the slope here and the overlying Head solifluction (crimson dots on the geological map) which is a silt-laden unstable water-carrying surface layer. A thick layer of Head has been confirmed here in the boreholes, though it has been labelled 'Made Ground'.

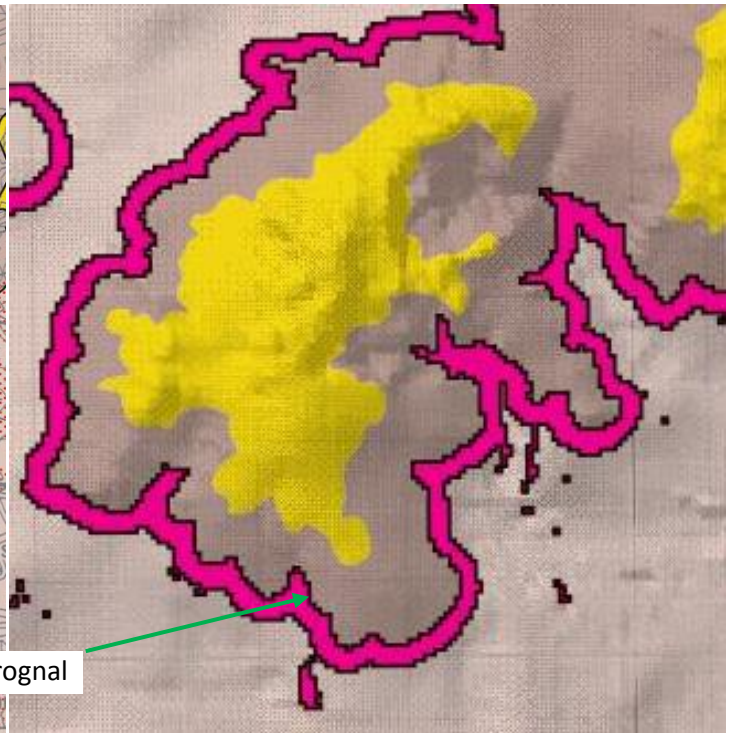
BGS Areas for Greatest Potential for Slope Instability

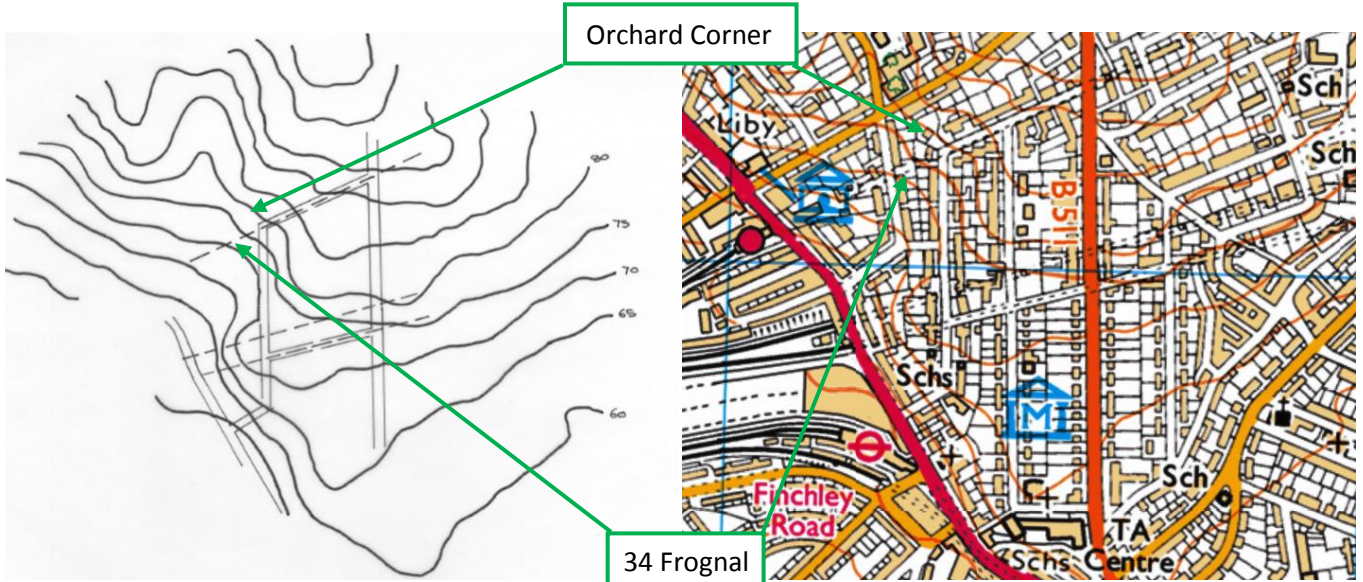
Contour lines show 34 Frognal is near the bottom of a fairly steep south-western running slope, which indicates the likely path of groundwater.

It is in direct line with Orchard Corner (high above on the top turn of Netherhall Gardens) which gained planning permission for an extension and basement garage in 2001 and large basement AND swimming pool (essentially doubling its depth) in 2005/6. This basement will have produced two potential problems:

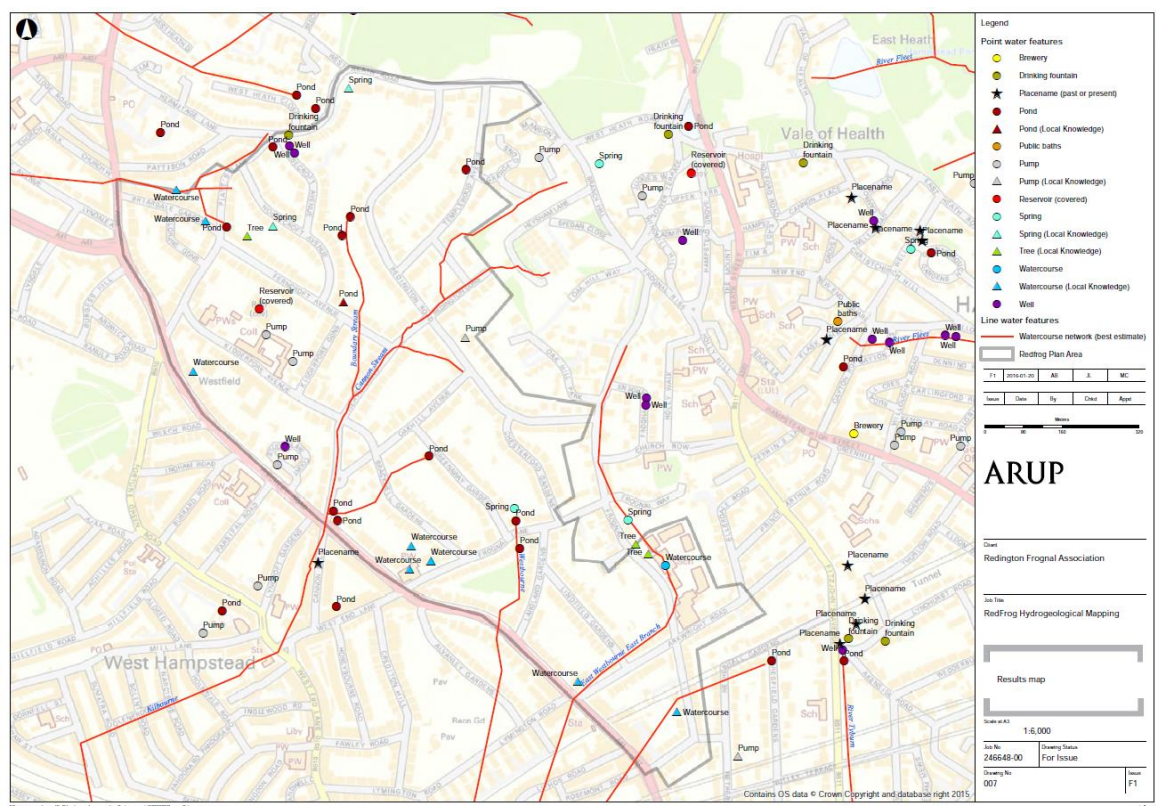
- 1) Vibration and ground pressure changes at dig-out and insertion of sheet piling, causing some landslip at the time - 'kicking the sleeping dog' of this potentially unstable hill - and increasing the likelihood of further problems later.
- 2) Diversion of groundwater running directly towards the most eastern branch of the East Westbourne river that goes under 34 Frognal (see ARUP map below) producing changes to its ability to erode silt from the clay since. There

34 Froggnal is also directly over the North London line rail tunnel near its entrance, so will be sustaining on-going vibration from the trains passing through, particularly the very heavy freight trains.
