PROPOSED REINSTATEMENT OF ORIGINAL **FIREPLACES**

FIREPLACES REINSTATEMENT AS PROPOSED

Rev B : Chimney Piece reproduction

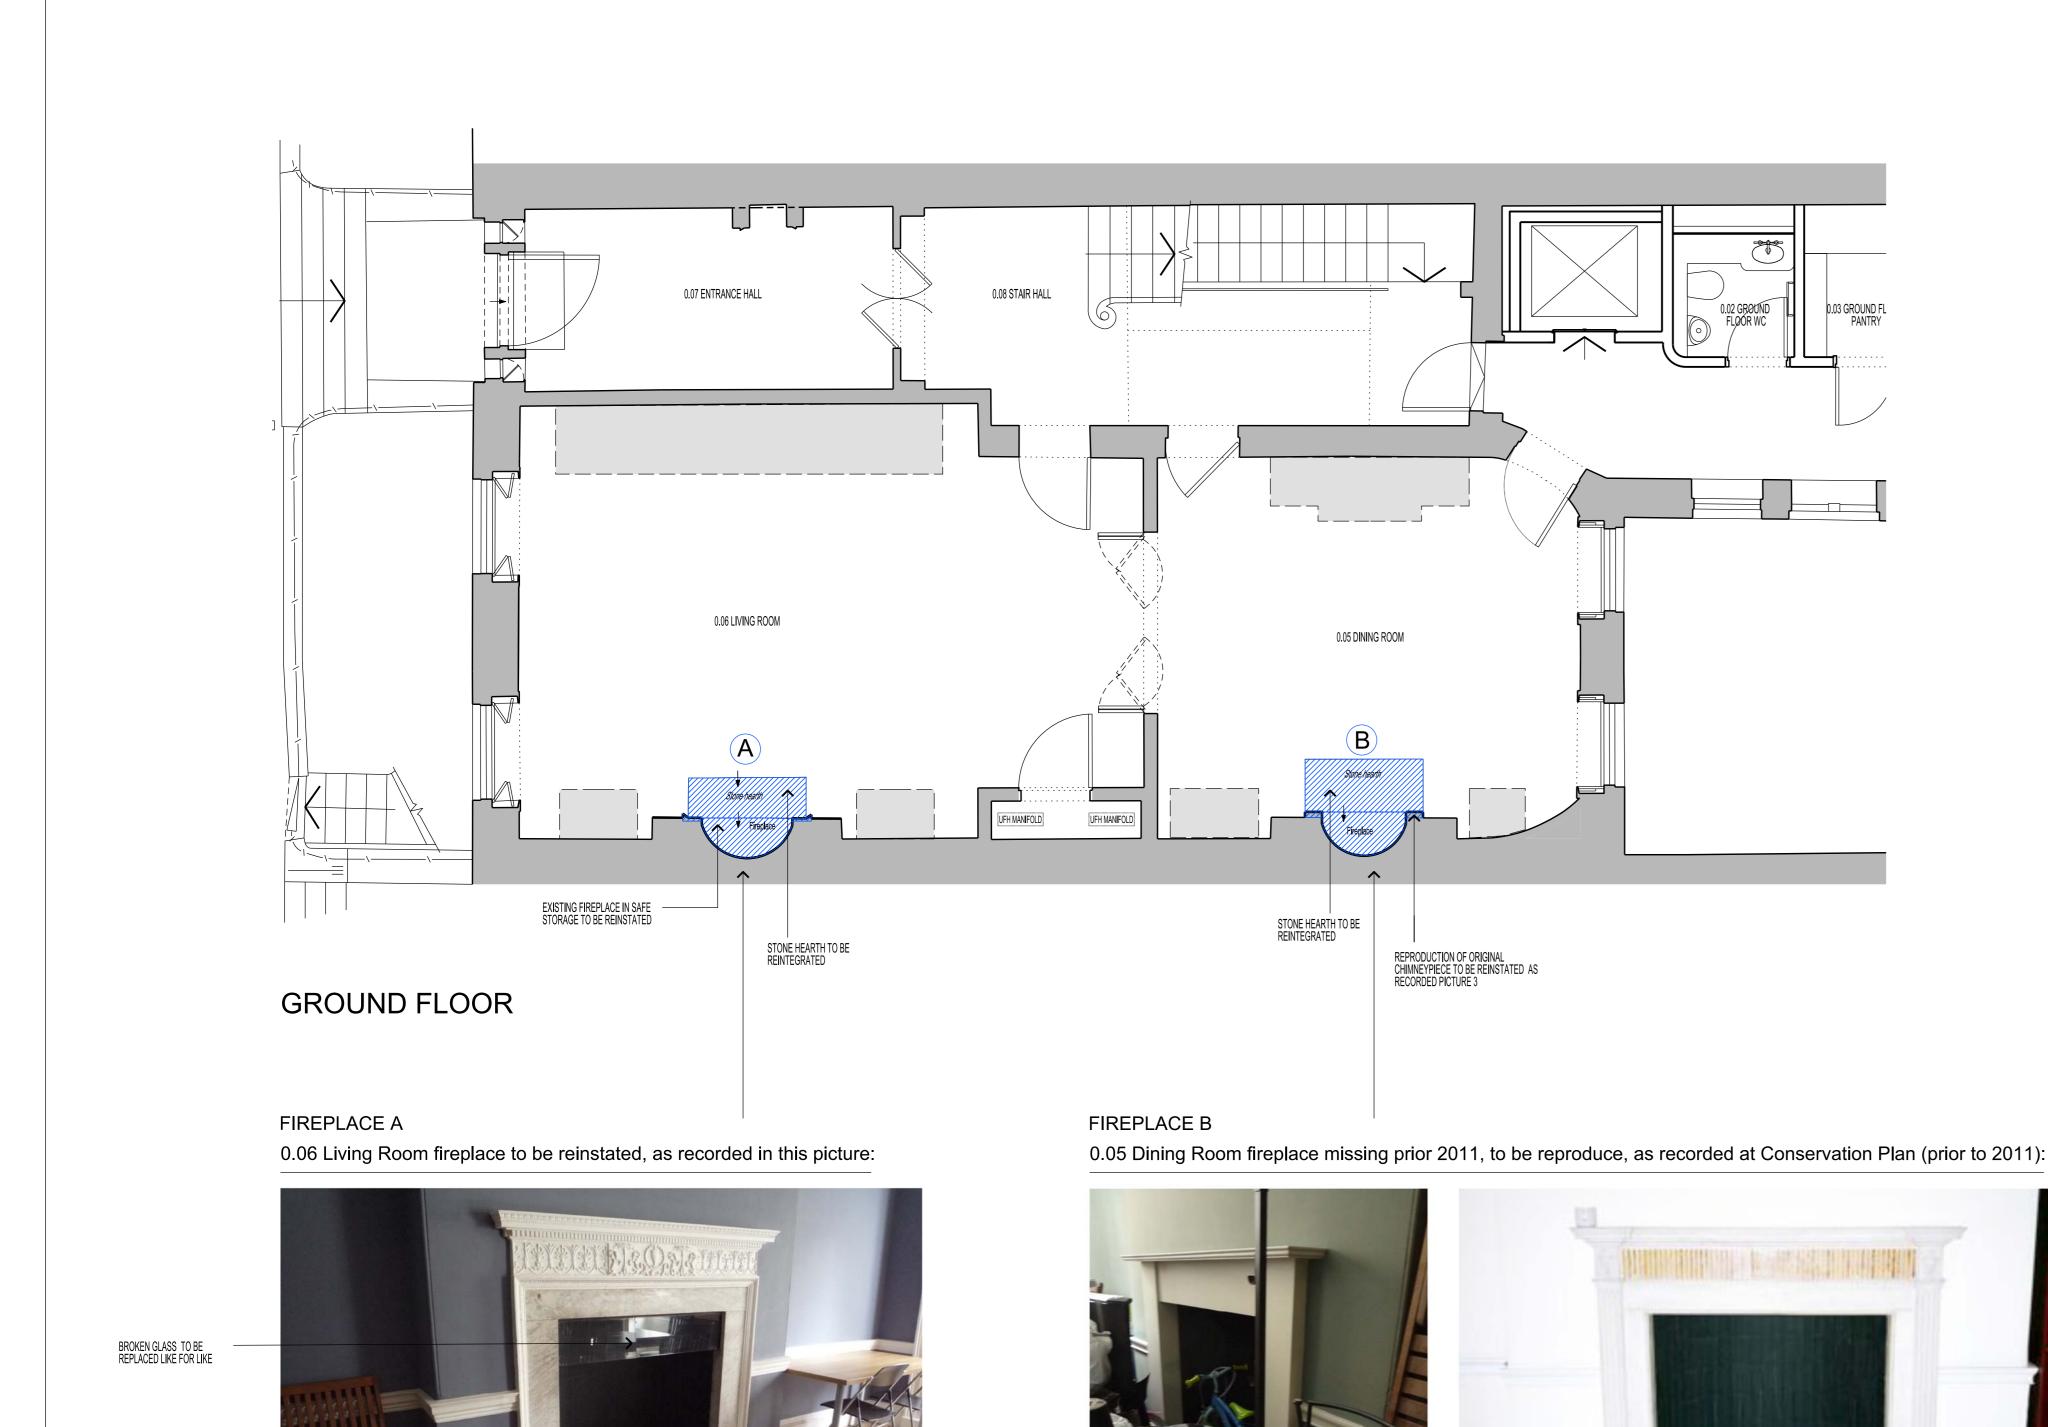
PICTURE 1 taken by BDP (2012)

(A) Existing fireplace in safe storage to be reinstated

FIREBOX TO BE RESTORED

STONE HEARTH TO BE REINTEGRATED

A. LIVING ROOM FIREPLACE

Clean and repair existing firebox and reintegrate original hearth.

Identify original location of storaged parts of as per the attached PICTURE 4. Clean, repair and carefully reinstate original pieces to their original location. And add new pieces, in a like for like basis, when missing or

not able to be repaired.

Redecorate painted elements, using same color and type of pinture, as exisiting.

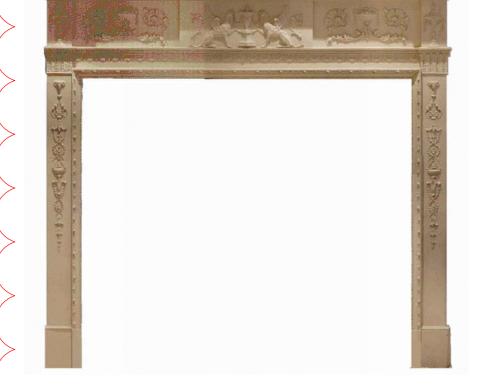
PICTURE 7 18th Century Pine & Plaster chimney piece purchased from Lassco Reclamation in London.

The original chimney piece was lost prior to current owner purchasing the building. Our consent allowed for the reproduction chimney piece however through discussions with the Conservation Officer it was agreed that this reclaimed chimney piece would make an adequate substitute.

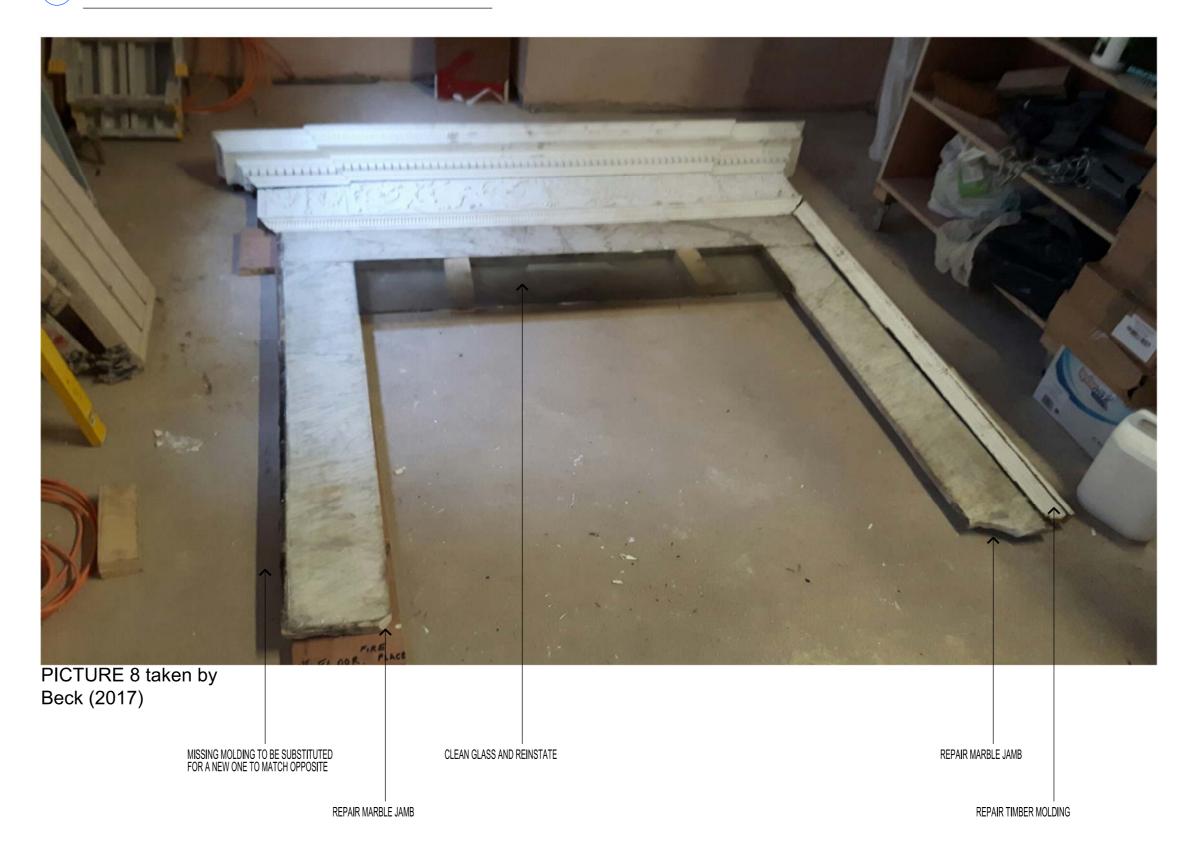
C Existing fireplace in safe storage to be reinstated

Clean and repair existing firebox and reintegrate original hearth. Identify original location of storaged parts of as per the attached PICTURE 8.

Clean, repair and carefully reinstate original pieces to their original location. And add new pieces, in a like for like basis, when missing or not able to be repaired.
