**SPECIFICATION OF WORKS  
FOR**

**INTERNAL ALTERATIONS**

**At  
UNITS 2,4,6 SICILIAN AVENUE  
AND  
27 SOUTHAMPTON ROW, LONDON**

PHOTOGRAPHIC AUDIT  
UNITS 27 SOUTHAMPTON ROW AND UNITS 6, 4, 2 SICILIAN AVENUE  
PHOTOGRAPHS TAKEN ON 16<sup>TH</sup> AUGUST 2005

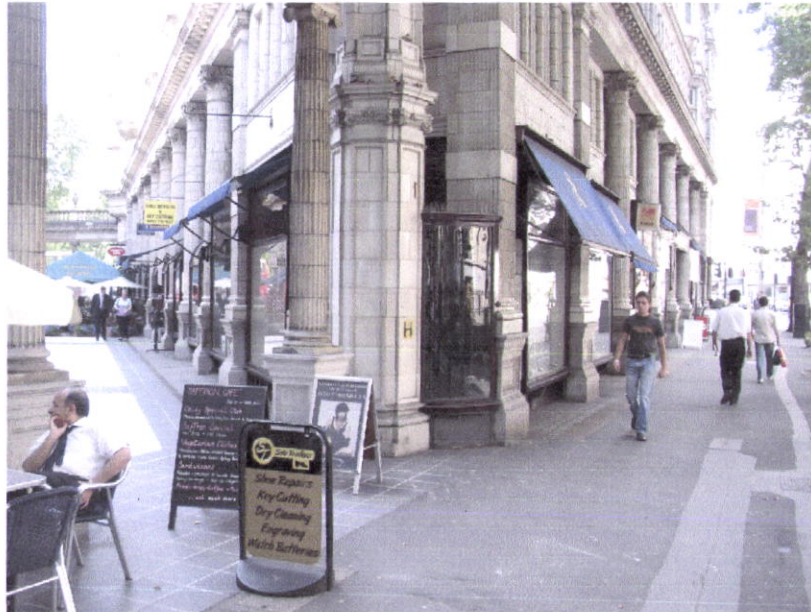
- Photograph No.1 – Showing the corner units 2 and 4 Sicilian Avenue. Unit 6 Sicilian Avenue is the first bay window to the far left. Unit 27 Southampton Row is the unit with the Kodak sign outside.

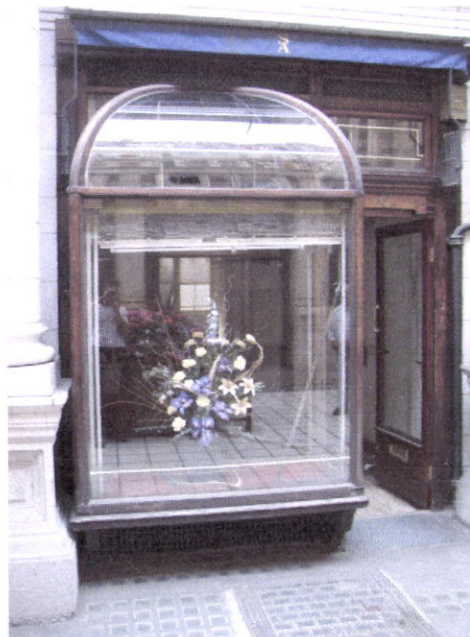
- Photograph No.2 – Unit 6 front shop entrance. The “proposed fire escape”, with door to be rehung opening outwards onto the avenue.

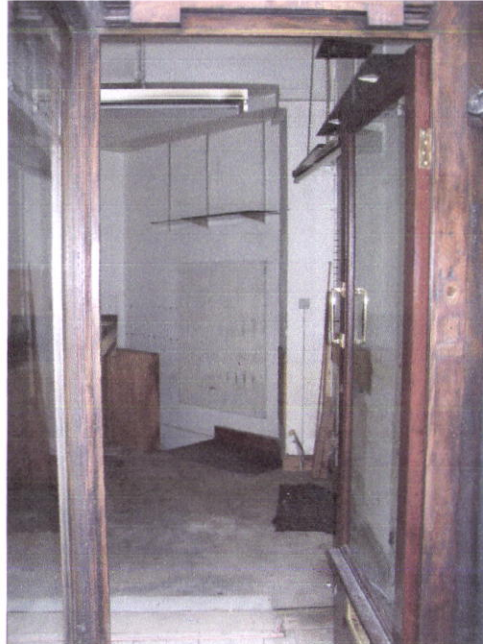
- Photograph No.3 – Looking through the doorway of Unit 6. The right wall is proposed to be removed allowing free access to Units 2 and 4. The wall to the rear with the existing glass shelf will also be demolished for access to Unit 27. The stairs will be removed to allow access through to Unit 27 with the column remaining for support between the two openings.

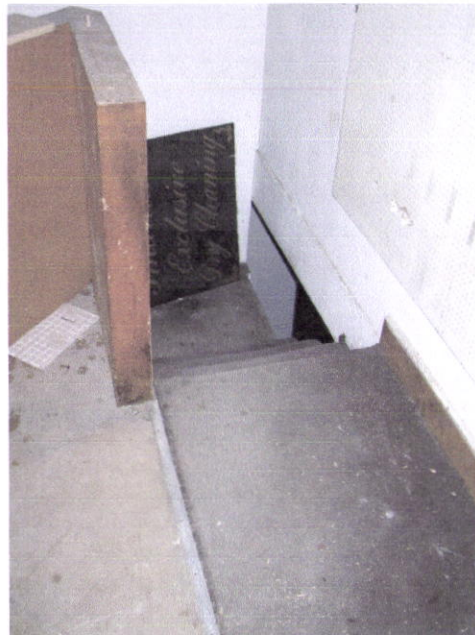
- Photograph No. 4 – Shows the top of the stairs leading down to the basement of Unit 6. The stairs are proposed to be removed and the floor boarded over.

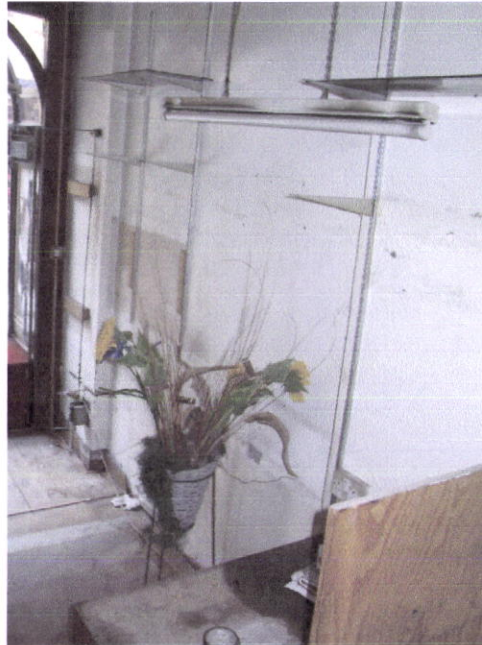
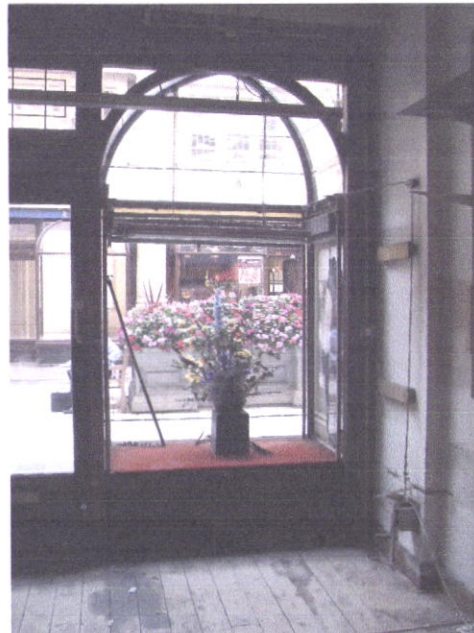
- Photographs No.5 & 6 – Proposed location for a new staircase for access into the basement and the construction of a smoke lobby and fire escape door through to Sicilian Avenue.

- Photograph No.6 – Note above.

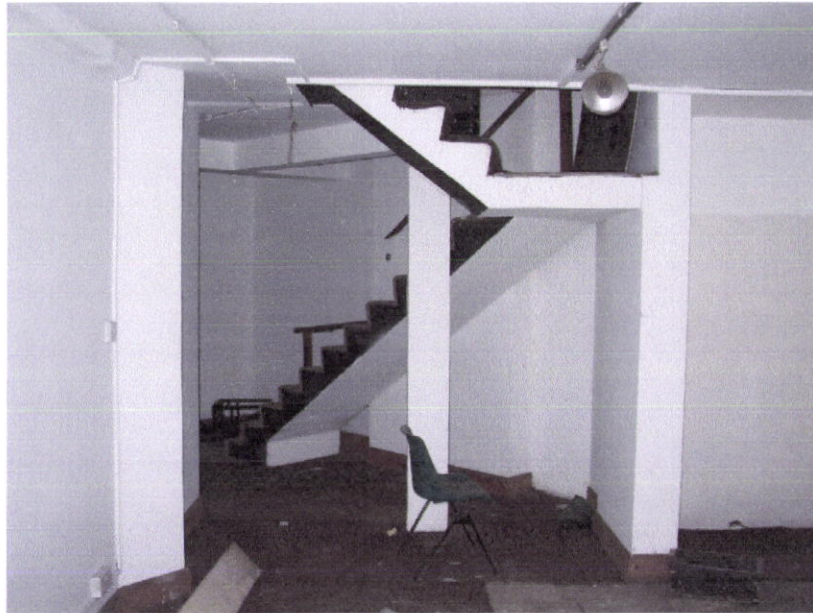
- Photograph No.7 – Showing the stairs construction within Unit 6 basement. The proposed stairs will fall in the opposite direction to the existing stairs.

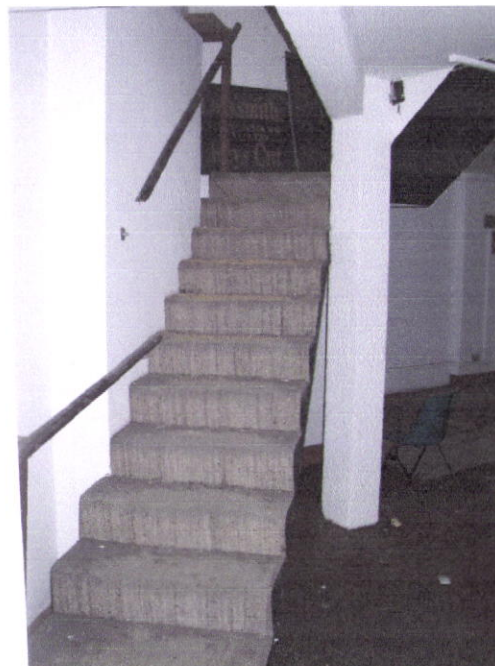
- Photograph No.8 – Showing the stairs construction looking up from the basement to the half landing at ground floor level.

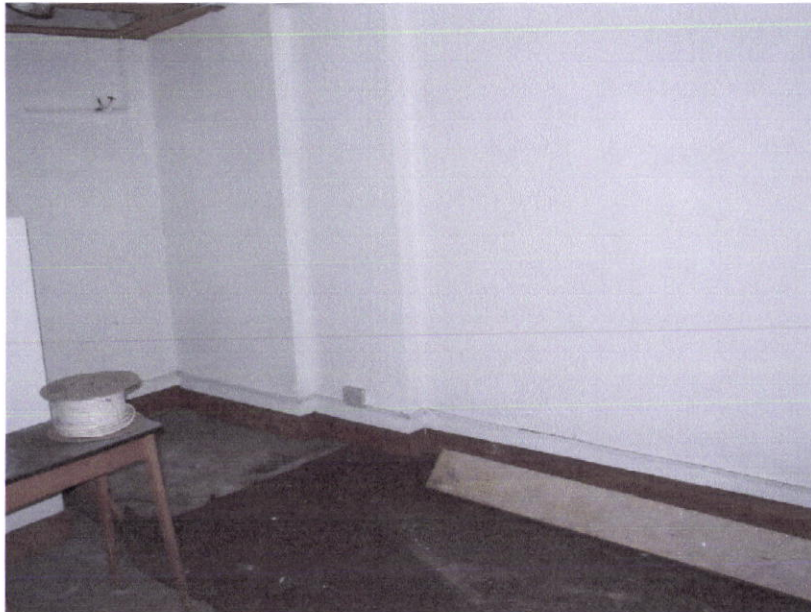
- Photograph No.9 – Within Unit 6's basement below Unit 7, showing the basement wall abutting Unit 29 Southampton Row.

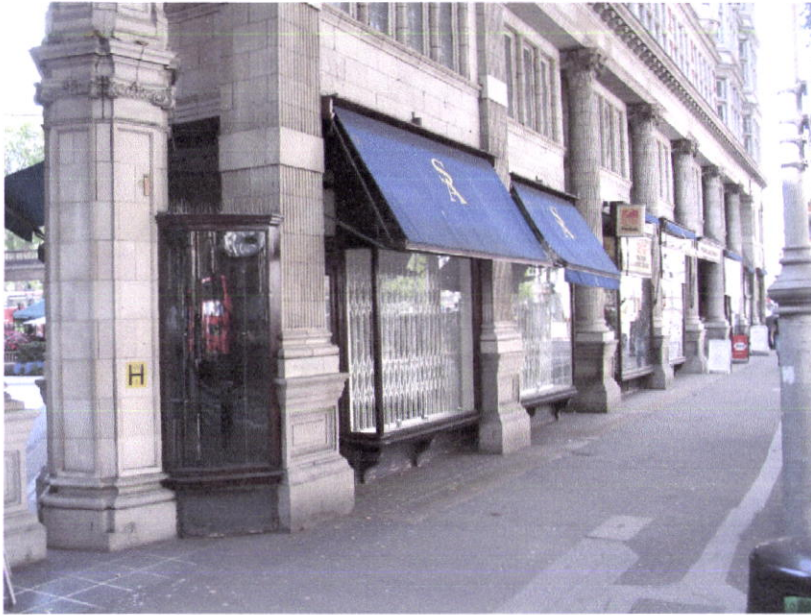
- Photograph No.11 – Showing the Southamptton Row elevation of Units 2 and 4 and the shop frontage of Unit 27 Southamptton Row.

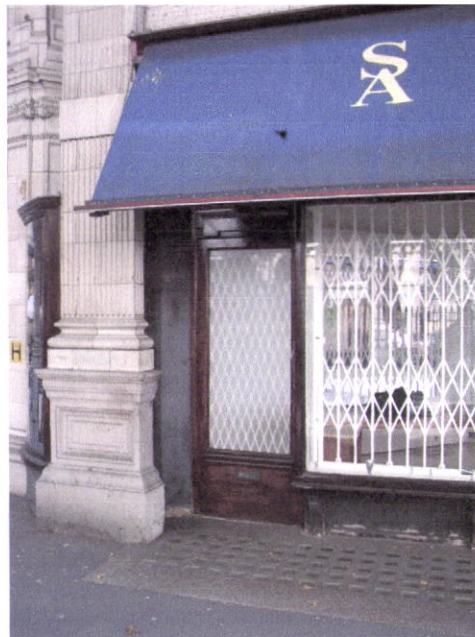
- Photograph No.12 – Existing door to be retained but locked shut at all times as it does not need to be in use.

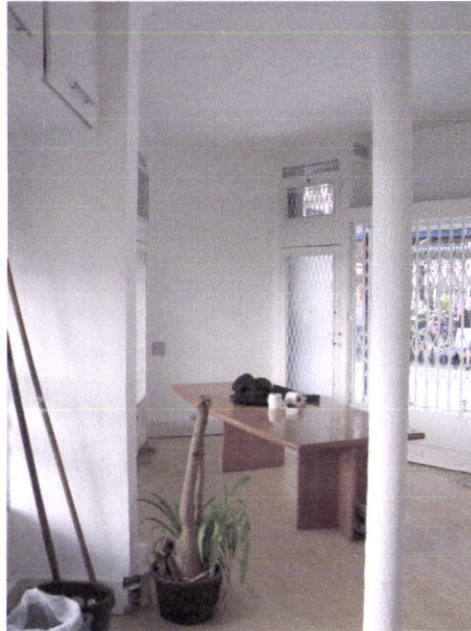
- Photograph No.13 – Looks down Unit 2 Sicilian Avenue showing the door on the left leading onto Southampton Row and the door on the right leading onto Sicilian Avenue.

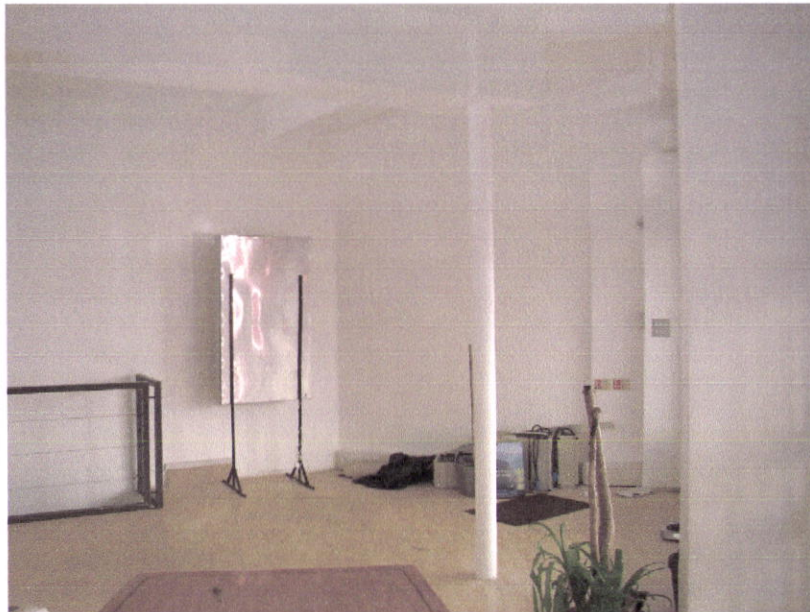
- Photograph No.14 – Showing the two party walls to the adjacent Units that are proposed to be demolished to allow access through. Where both walls abutt a supporting pillar will remain.

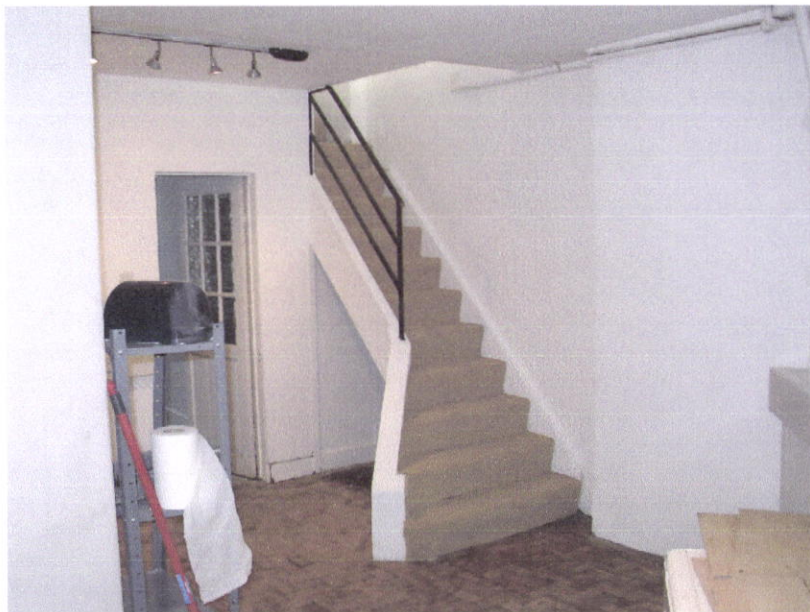
- Photograph No.16 – Shows the stairs leading down from Unit 4 into the basement area. A doorway is to be knocked through at this point through to Unit 6 basement.

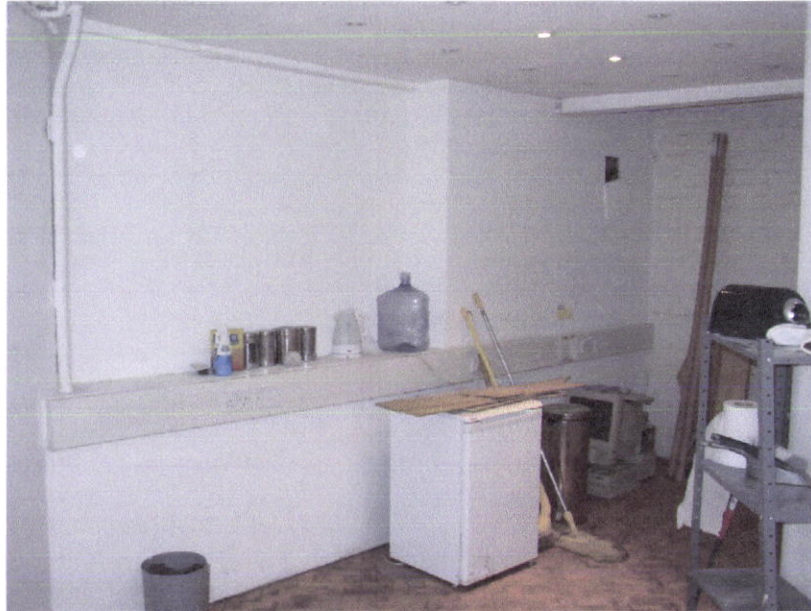
- Photograph No.17 – From the stairs looking at the party wall between Unit 4 and Unit 6 (area of basement below Unit 27) that is to be knocked through to create access through.
