2.1 Site Location

2.2 Existing Building

2.3 Existing Building Photographs

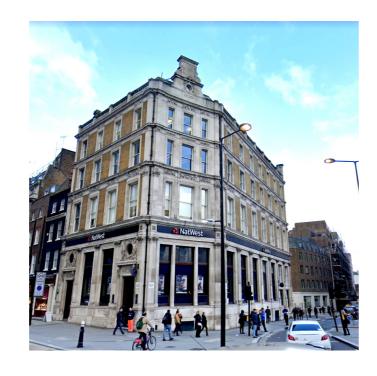
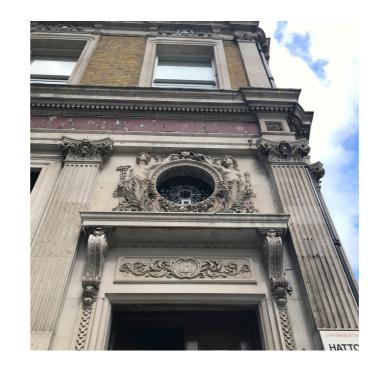
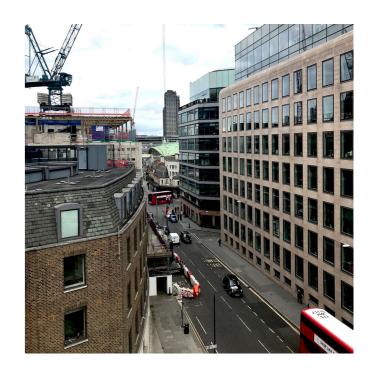
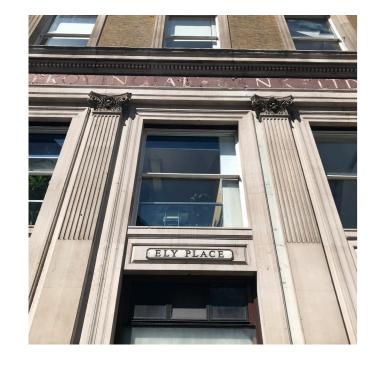
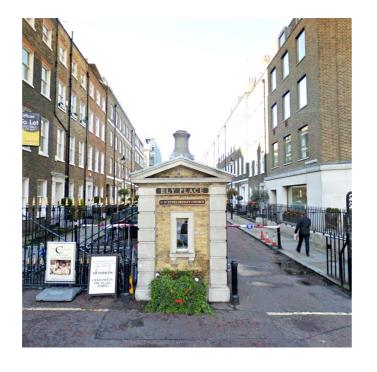
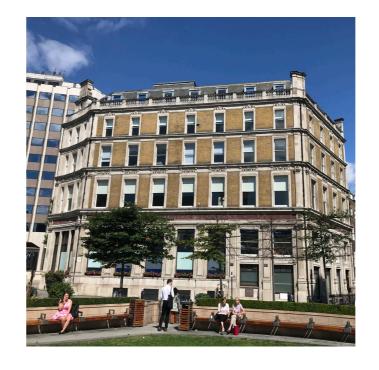
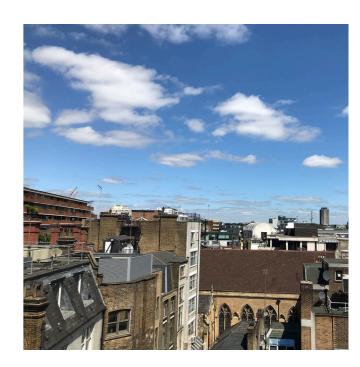
Site photographs of building exterior and surrounding context

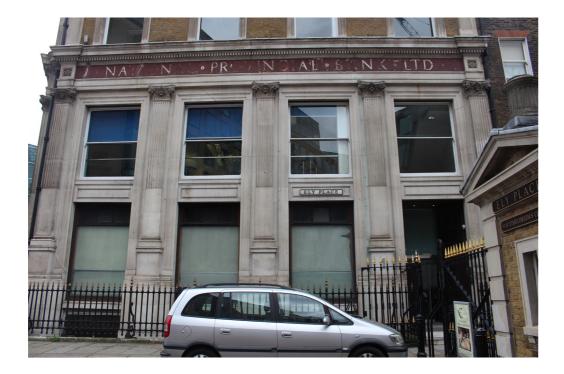
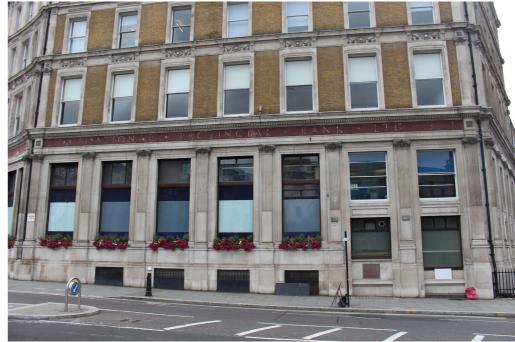
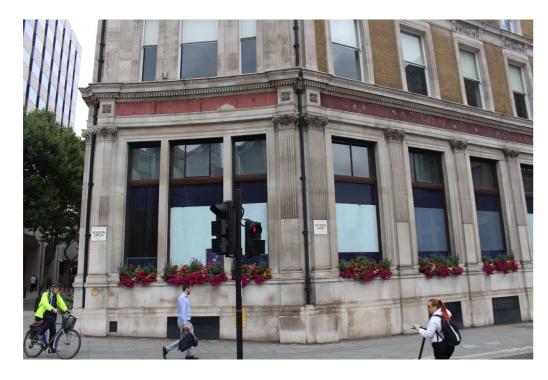
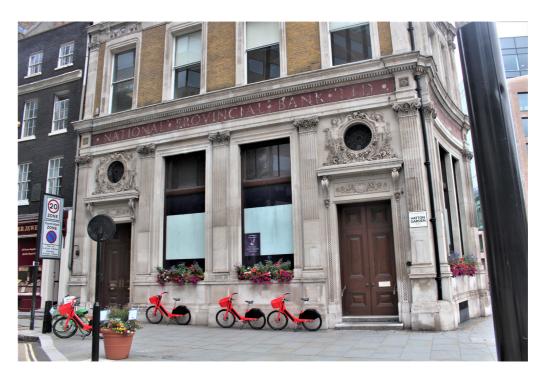
2.3 Existing Building Photographs

Site photographs of existing building signage

The existing signage is a band of hand painted burgundy colour with gold coloured lettering at First Floor level that relates to the former building use, that wraps around the full extent of the street-facing facade.
