01 CHIMNEY PIECE ELEVATION
scale 1:10
Rev B: Revised chimney piece and register grate

PROJECT TITLE	42 BEDFORD SQUARE		
PROJECT NUMBER	P2005698		
DRAWING TITLE	0.05 DINING ROOM CHIMNEY PIECE REPRODUCTION	SCALE @ 1/1	varies
DRAWING NO.	(33)AD001_MH	DATE	03.2019
REVISION	C	REVISION	C

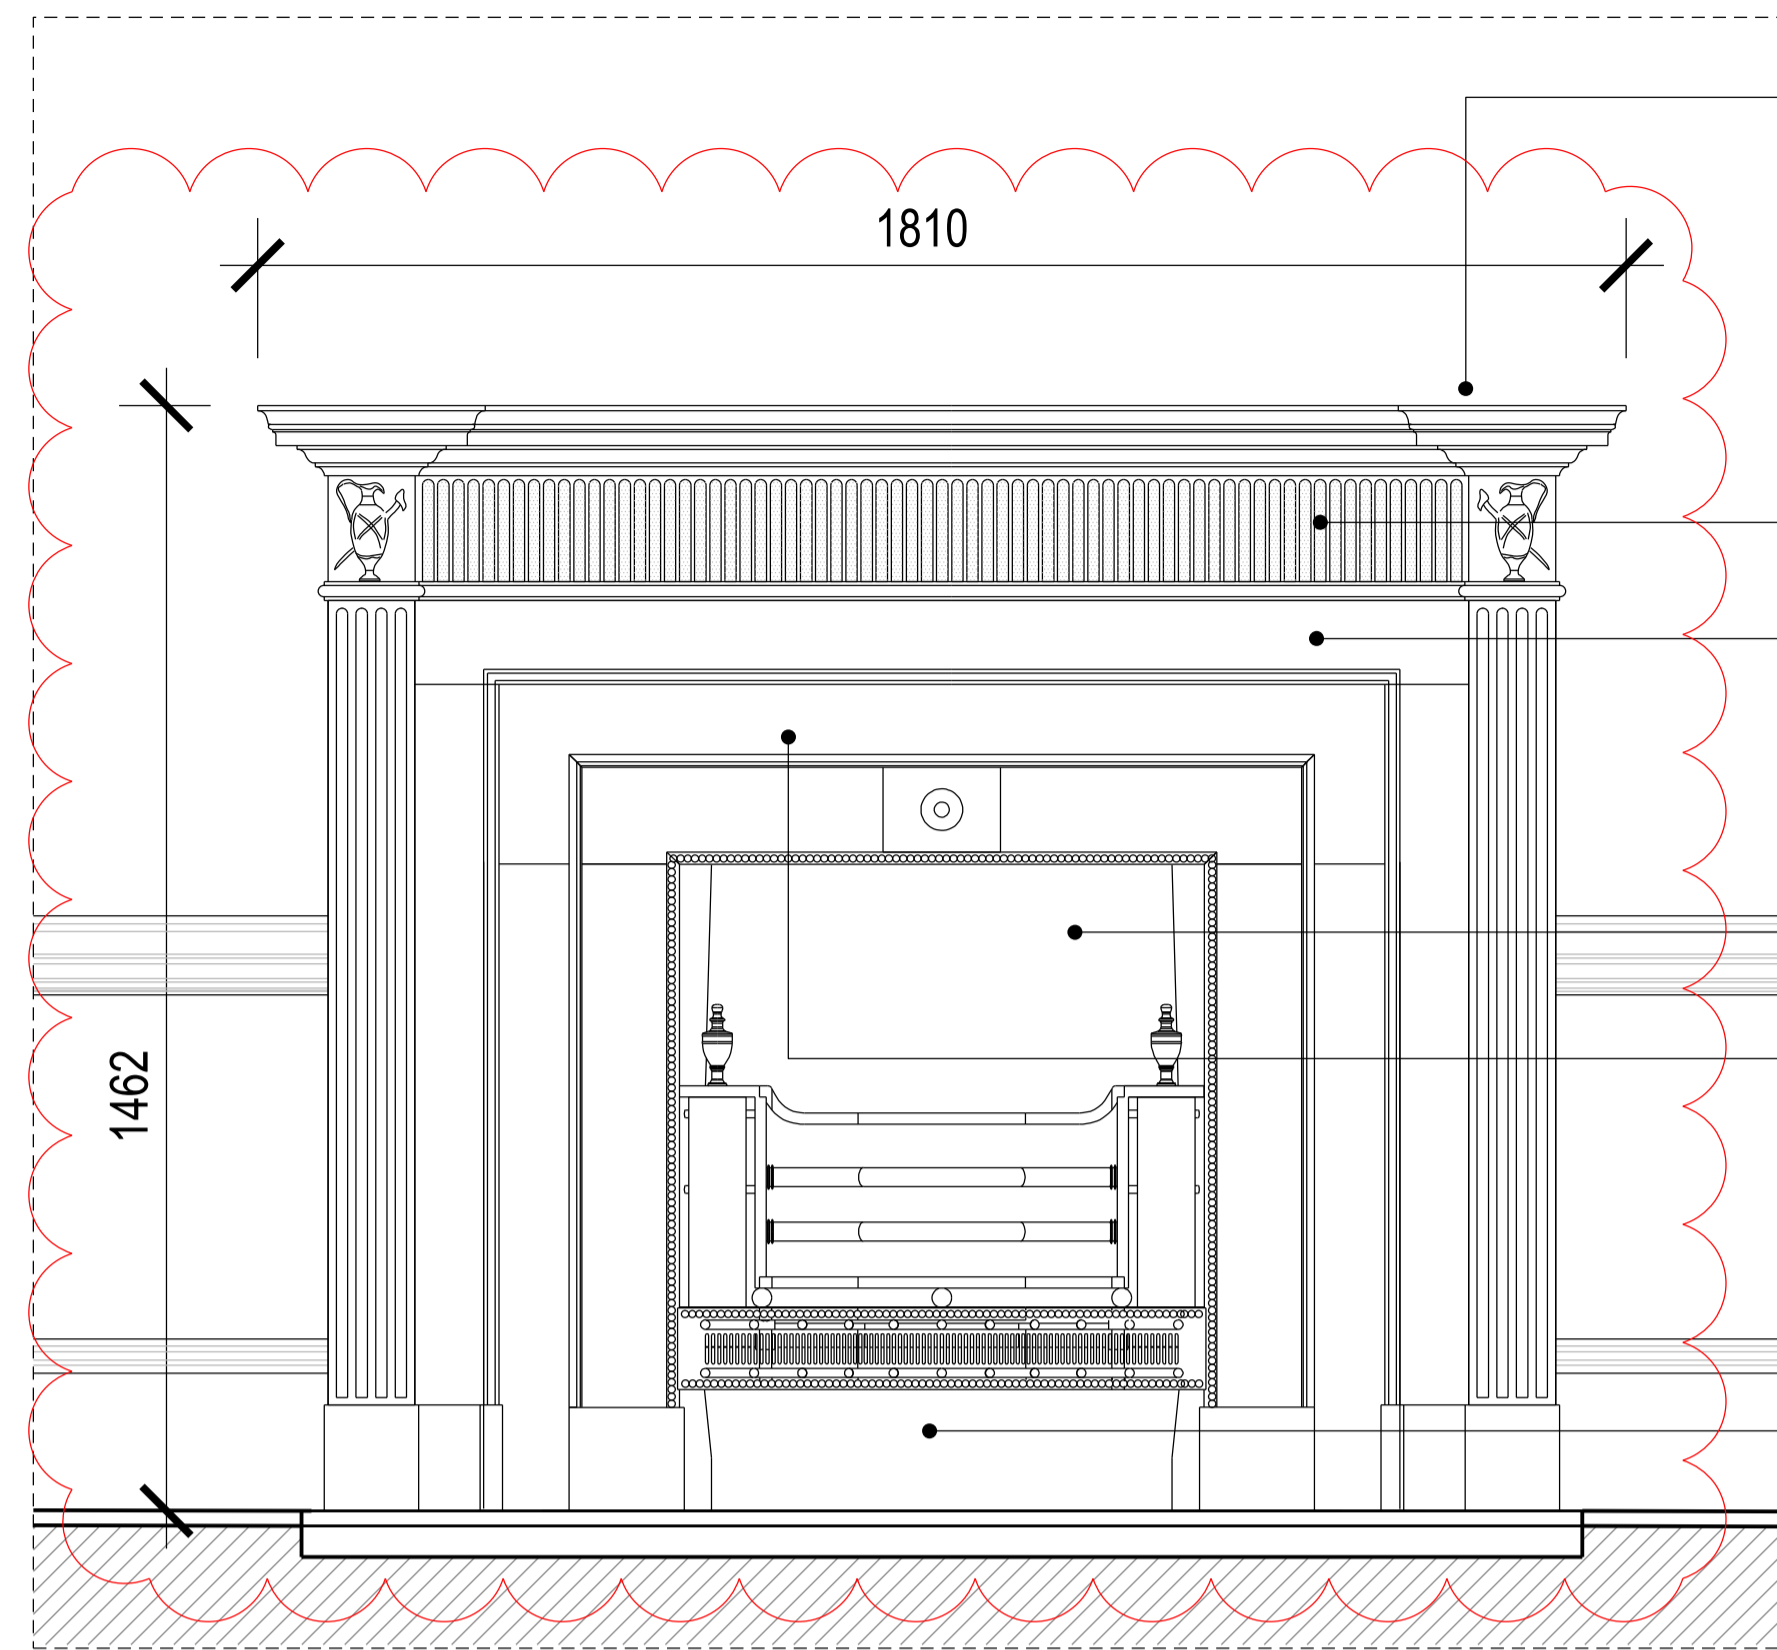
Reproduction of original chimney piece to be reinstated as recorded in image 01, by specialist.

Sienna marble inset

Carrara marble slips required to cover the gap between the register grate and marble front piece. This is to be carefully measured on site and match the hearth stone.

Tile & step insert to be removed.

Metal slips required to cover the gap between the register grate and marble front piece. This is to be carefully measured on site and match the material of the installed grate.

Asthall register grate by Jamb. All dimensions to be checked on site in relation to the reinstated chimney piece, the register grate to be aligned with the back side of front marble pieces.

Method Statement of Repair

Clean, repair and carefully reinstate original pieces to their original location. Add new pieces in a like for like basis, when missing or not able to be repaired.

Clean and repair existing firebox and integrate new marble hearth to match the existing from the photos and the chimney piece as closely as possible.

Tiles to be removed, register grate to be inserted in a 18th century style appropriate to age + style of building. To be discussed with local planning authority prior to submitting to discharge of conditions.

Redecorate painted elements, using same colour and type of paint, as existing.
