2.0 Site Analysis

- prevailing streetscape

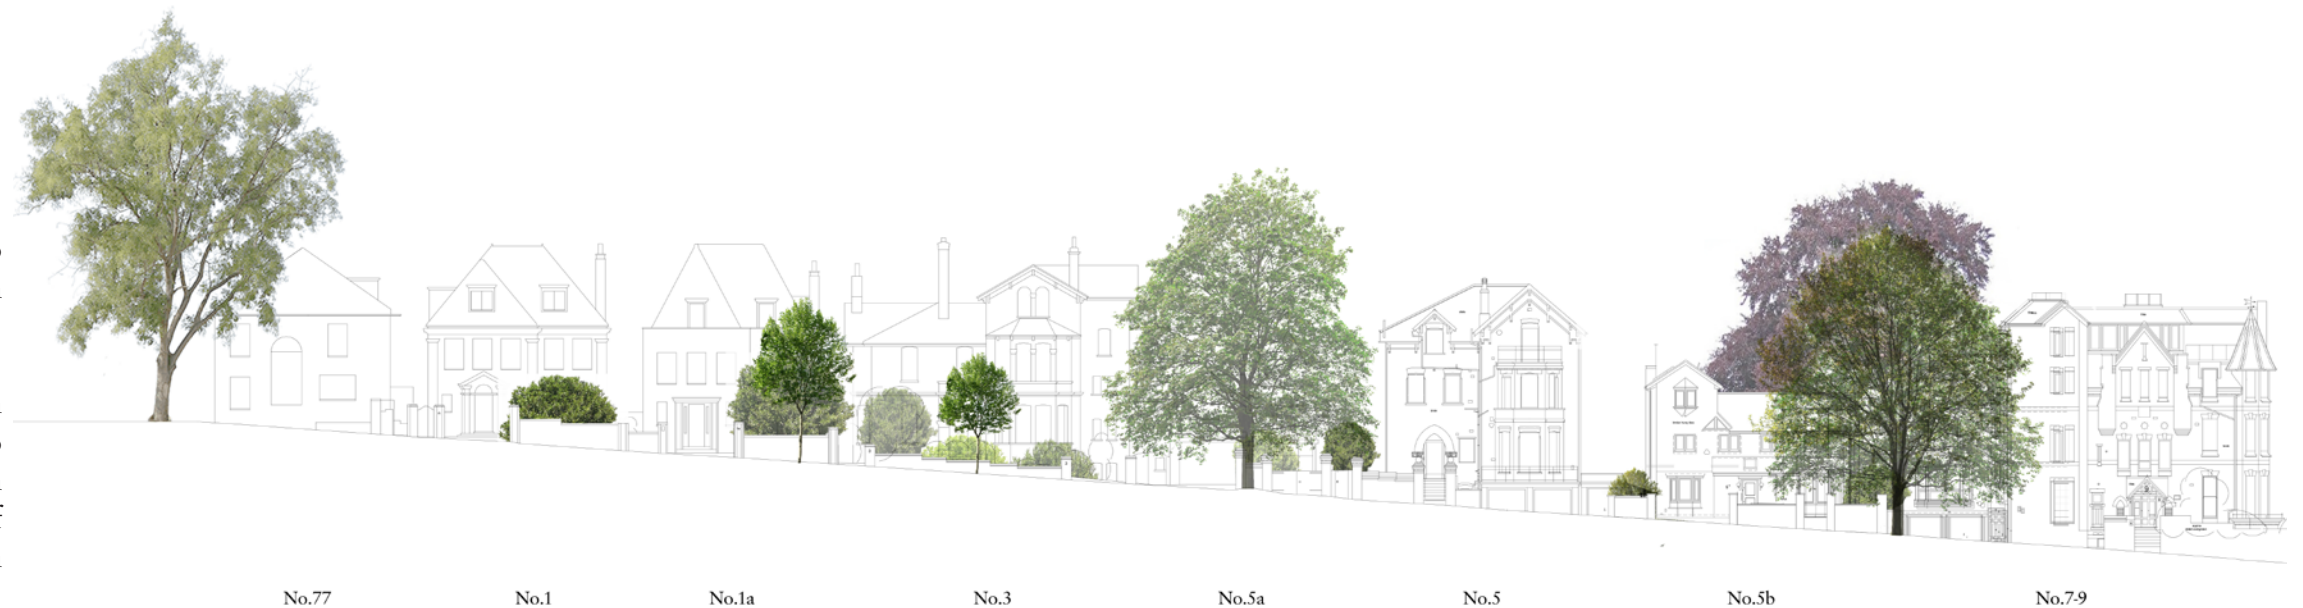
As well as a number of street trees that add character to the street frontage, there is a significant Copper Beech situated at the rear of the site.

An arboricultural survey has been undertaken on the site and early advice was sought in relation to the trees on the site, notably the Copper Beech tree at the rear, which has been a key element of consideration in developing the design ideas from the start.

It also worth noting that there is a significant amount of hard standing in the rear garden, and a network of retaining walls, including a garden house, all with concrete foundations, which are likely to have acted as a root growth barrier for the Copper Beech.

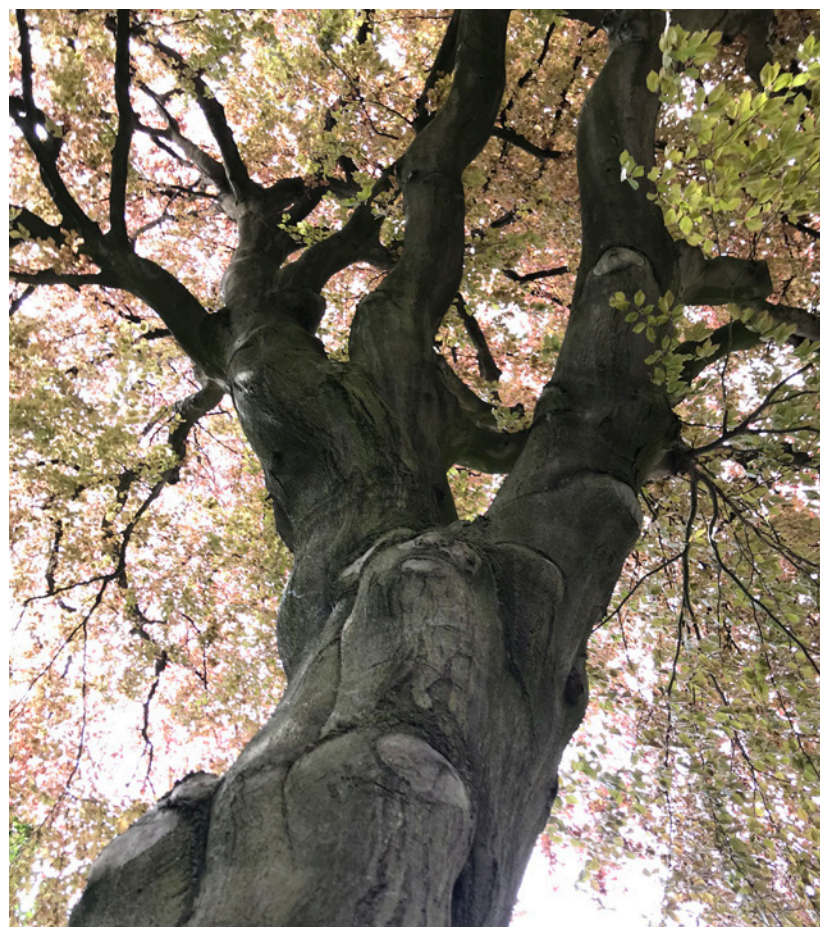
Rear Copper Beech

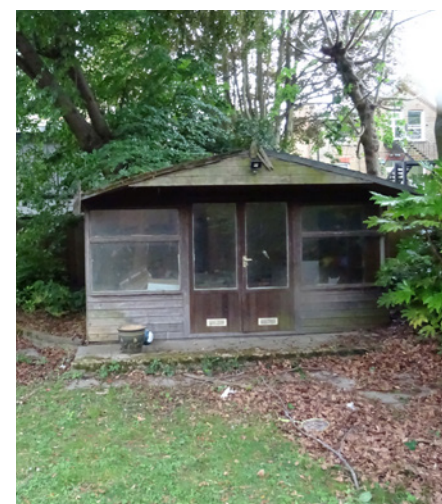
Existing garden house

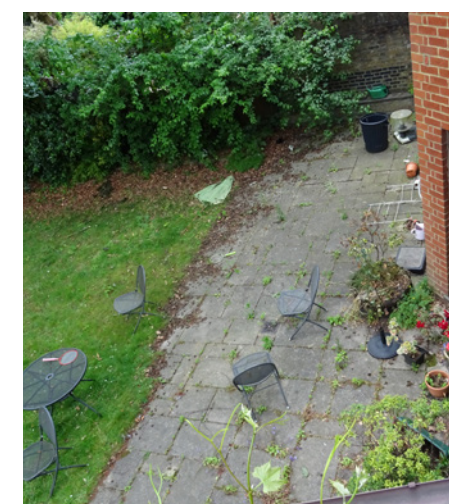
Hard landscaping in rear garden

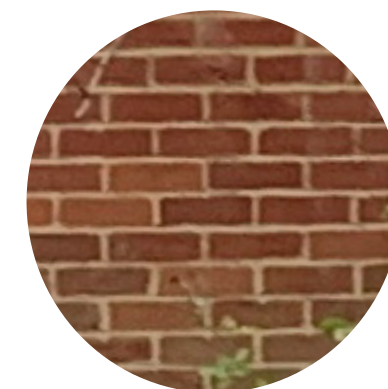
Existing Brick

The existing building stands out, mainly due to its unsightly architectural features and detailing, but the brick is also a bright red which lacks the patina of the brick found on neighbouring buildings.

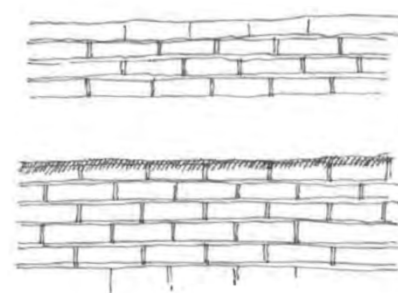
Brick or stone banding to define facade/define openings.

Horizontal brick banding is used to define facades or provide articulation around openings, whilst dog-tooth brickwork is also very common, used in panels on gables or as a more subtle corbelling detail under the eaves.

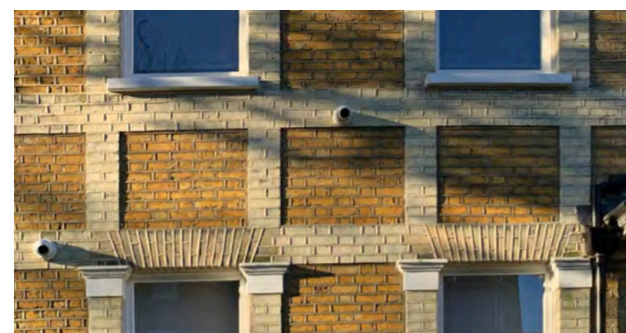
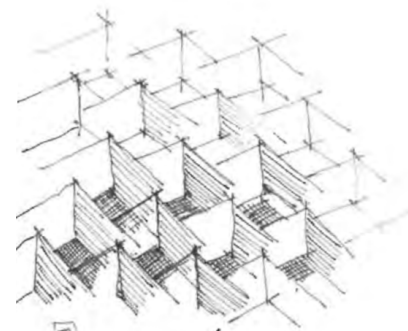
Modern interpretation of traditional brick detailing?

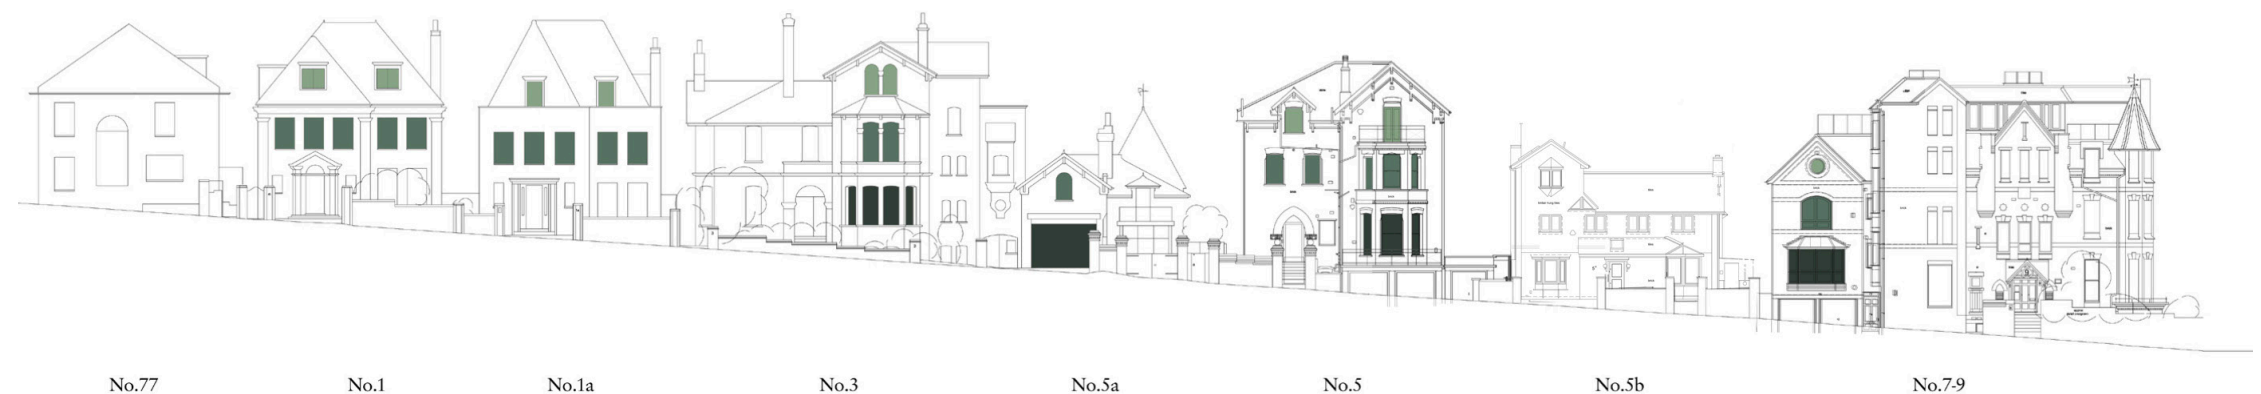
Window hierarchy

Traditional window hierarchies are common across all facades on the street, with key windows and openings situated on the ground floor, occasionally expressed as a bay or oriel window. These gradually 'break up' and reduce in proportion whilst moving up the building.

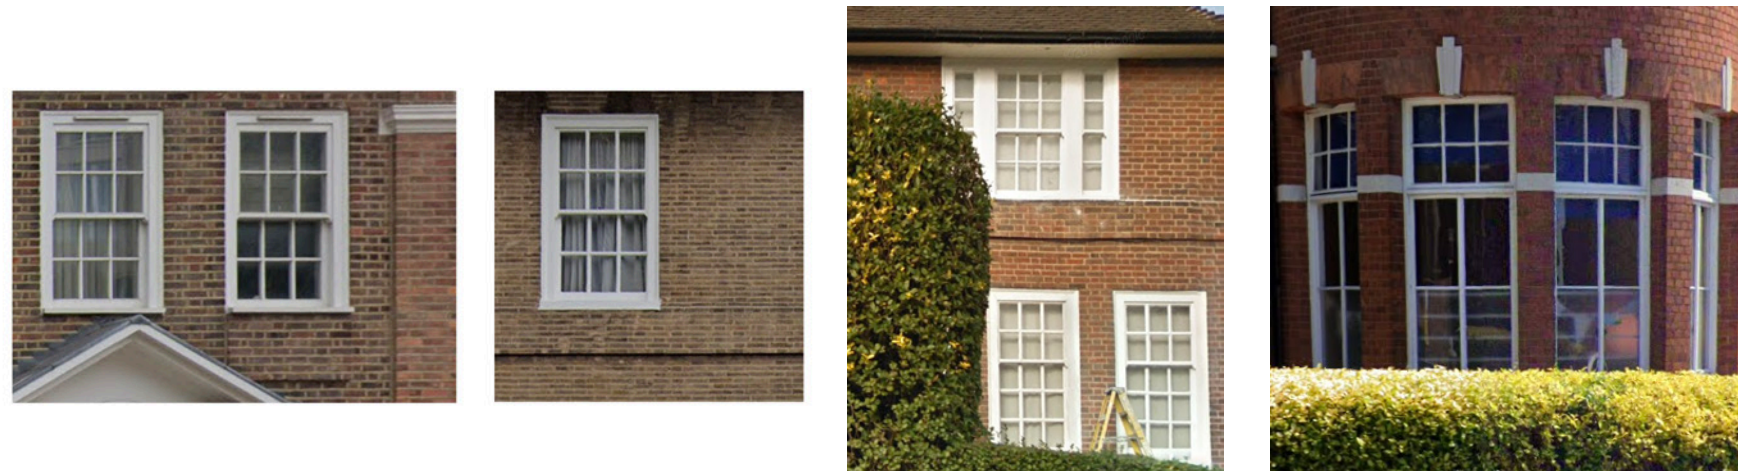
There is also variety in the type and style of windows found across the area. Whilst numbers 1 and 1a Prince Arthur have traditional painted timber sash windows, simpler sashes are found on many others with bay windows including Number 5.

In contrast the windows on some of the 1970s houses directly opposite 5b Prince Arthur are metal sliding/casements. Meanwhile the windows of Arthur West House which has just been built are much more minimal in appearance and appear to be of white PVC.
