5B PRINCE ARTHUR RD, LONDON NW3 6AX

## HYDROGEOLOGICAL IMPACT ASSESSMENT

REV 0

May 2020

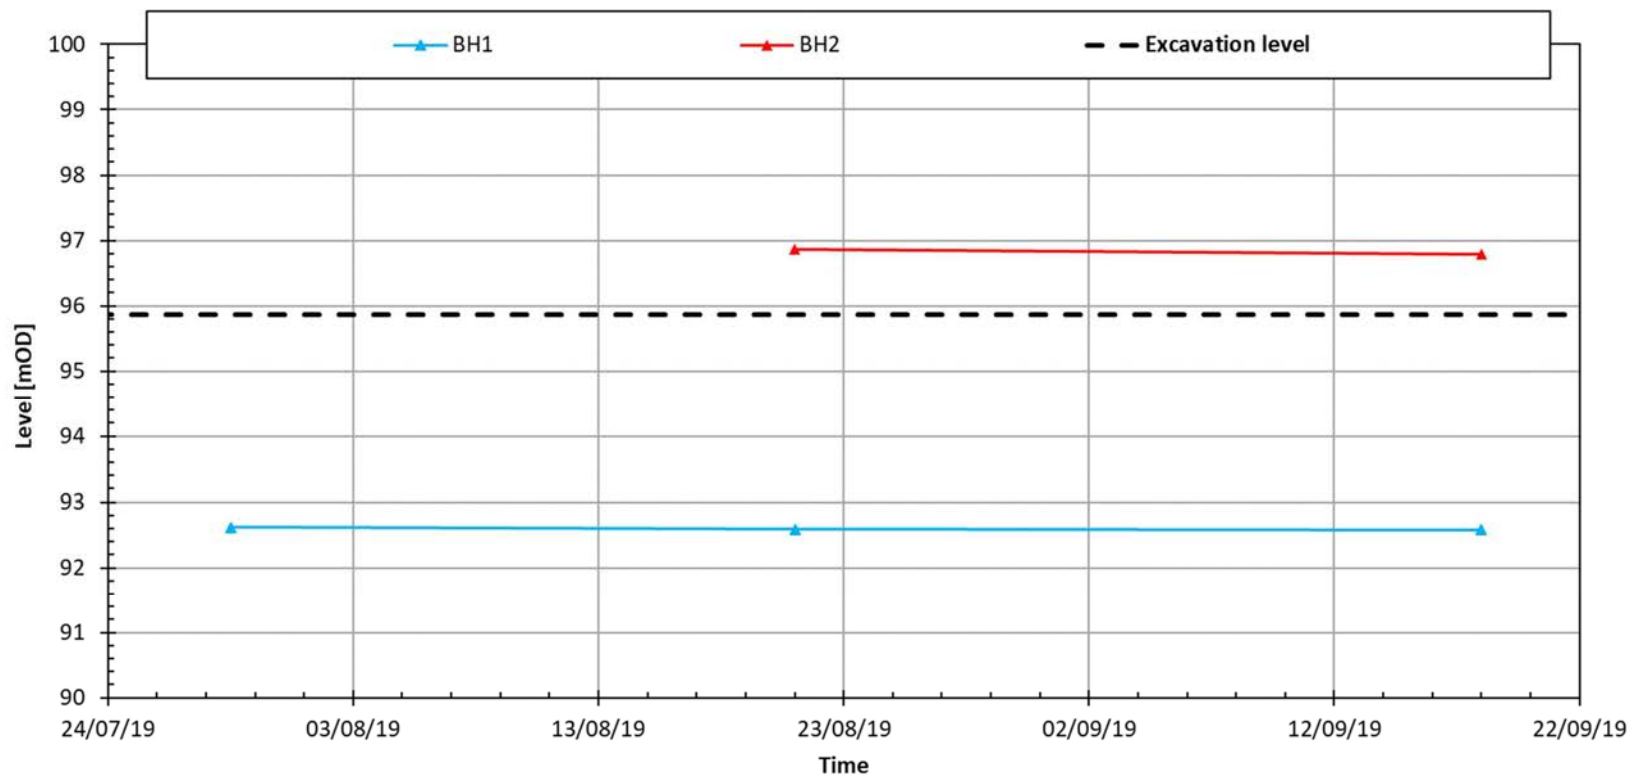
**Figure 10**

**Taylor Whalley Sprya**  
5B Prince Arthur Rd, London NW3 6AX  
**Groundwater levels across the site**

During the investigation groundwater was encountered at 7.6m depth in BH1 and 3.2m in BH2, which, considering the ground levels of these holes, correspond to levels of +92.6mOD and +96.9mOD respectively.

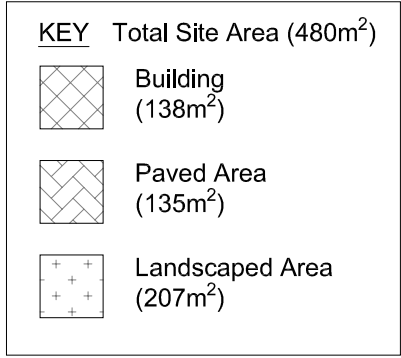
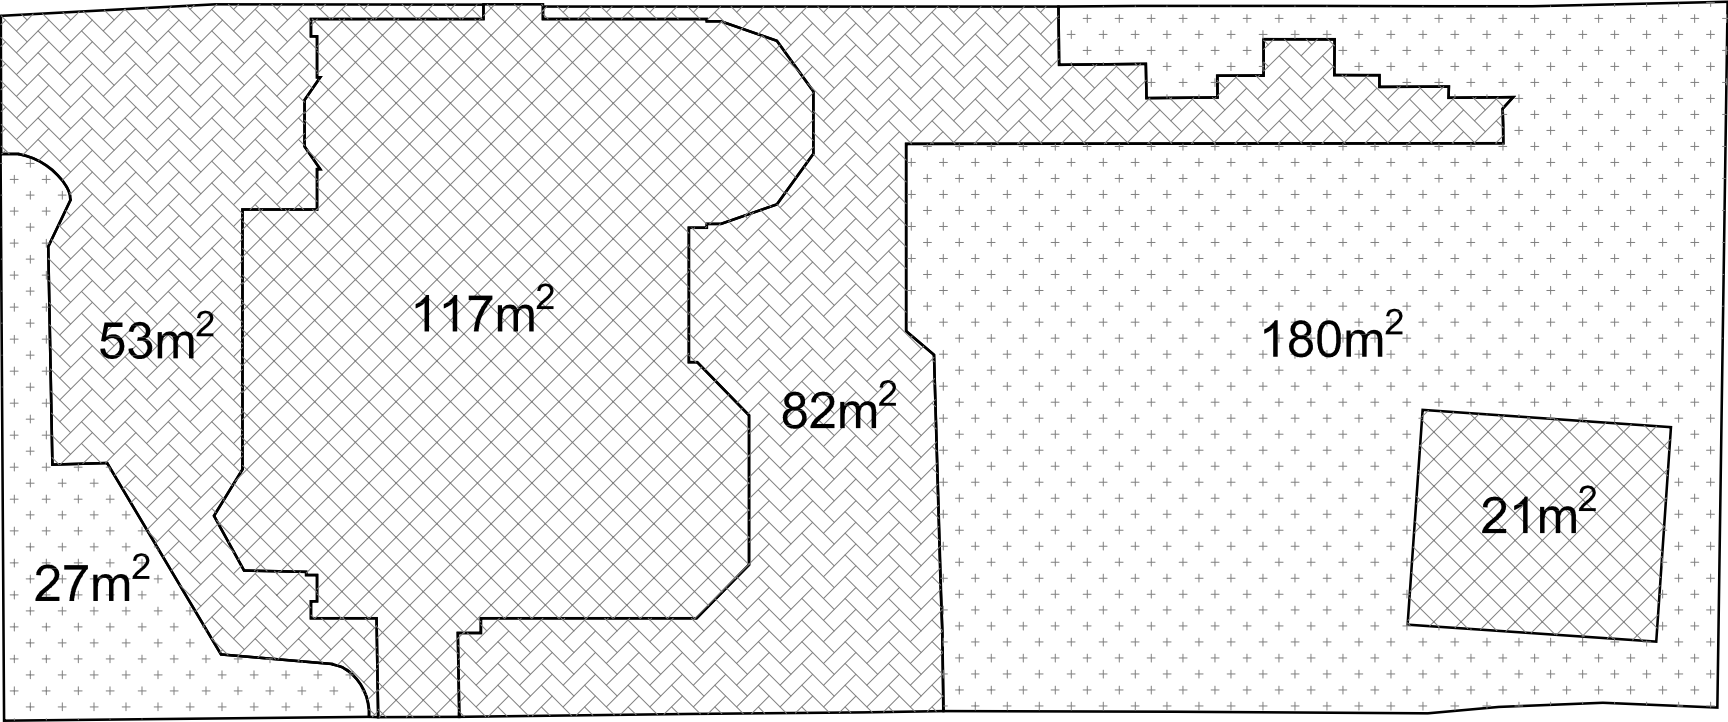
EXISTING SITE HARD AND SOFT LANDSCAPED AREAS  
(SCALE 1:150)

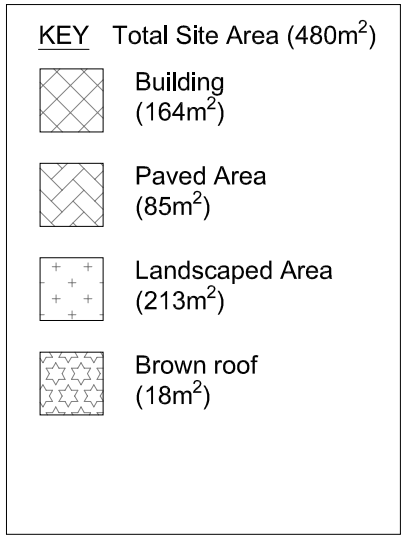
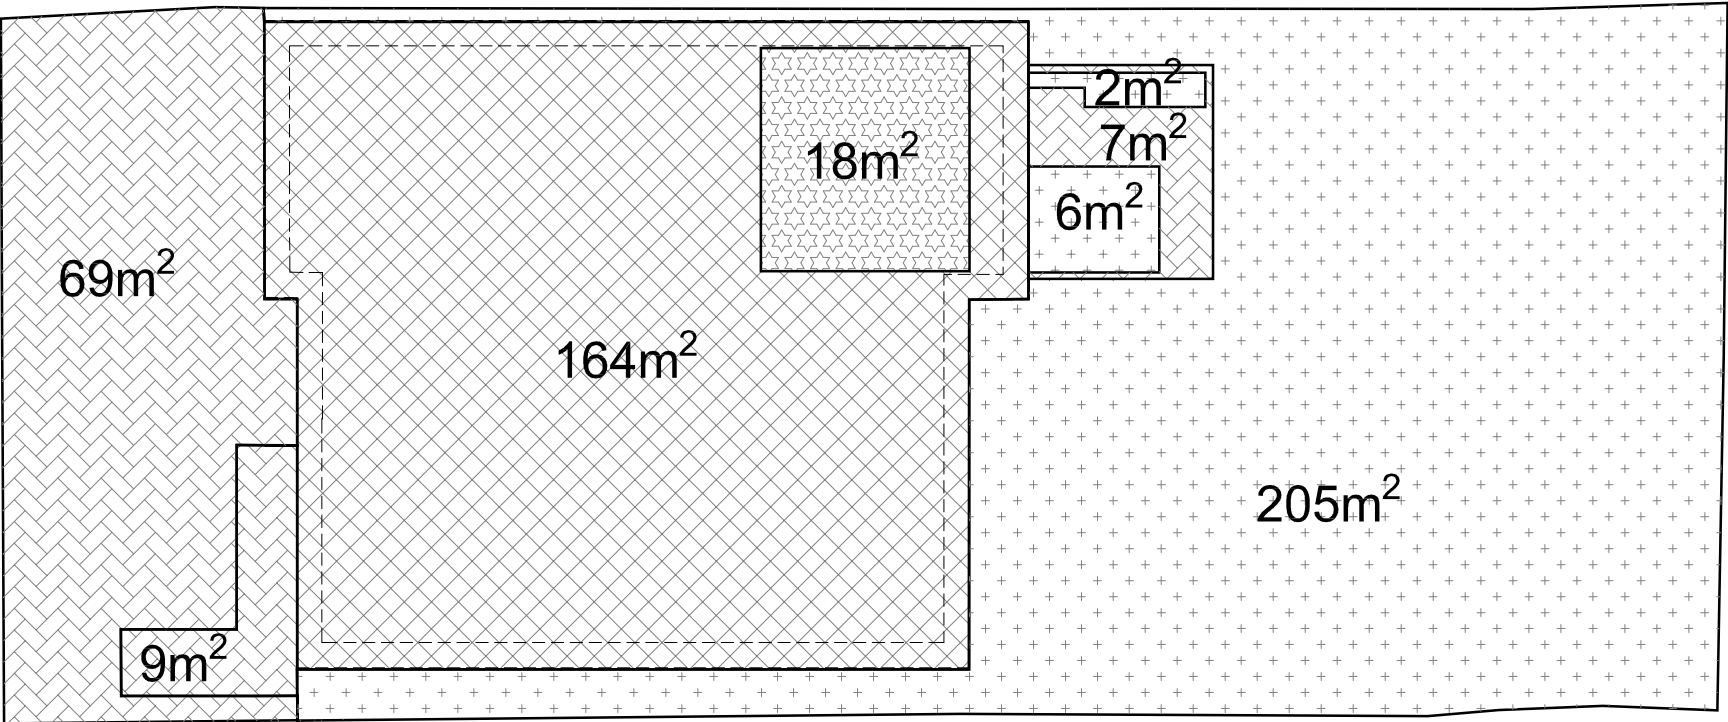
PROPOSED SITE HARD AND SOFT LANDSCAPED AREAS  
(SCALE 1:150)

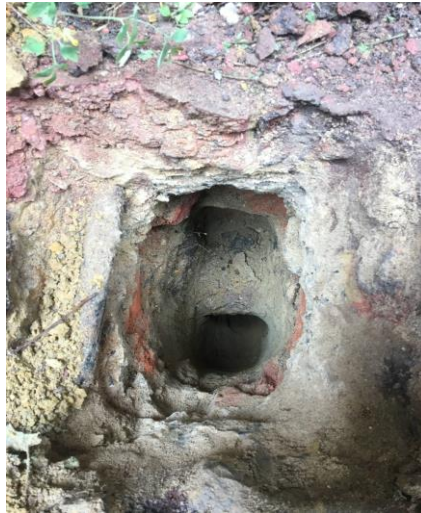
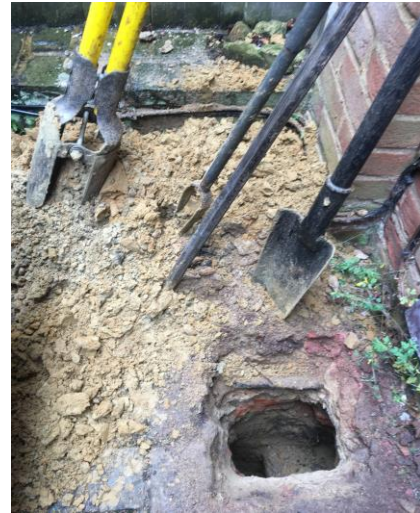
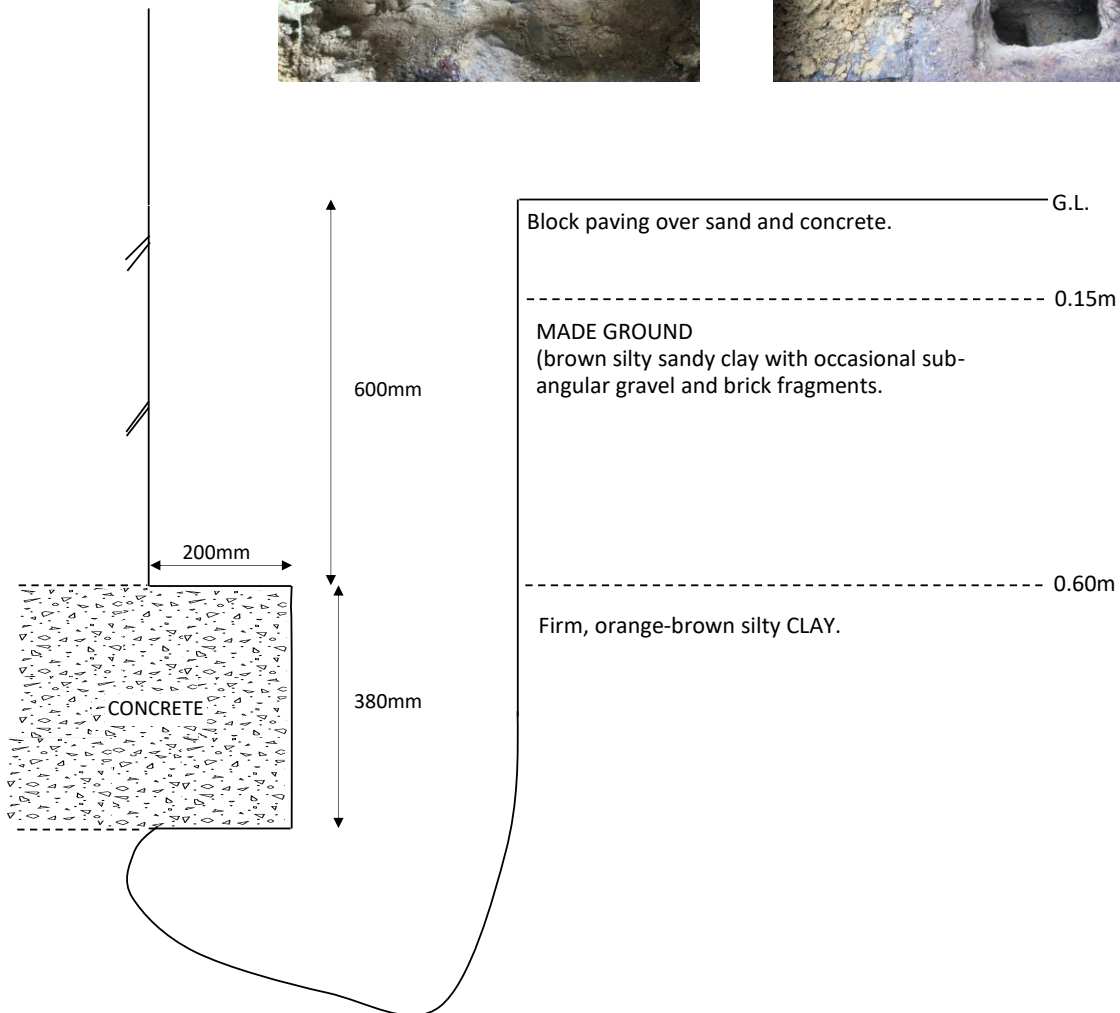
Figure No. **1**

- 2.17 Trial Pit TP1 found that the existing brick wall extended down from ground level some 600mm resting on a concrete footing with a step out of 200mm. The concrete footing was found to extend some 380mm before the underside was founded at approximately 0.98m below existing ground level.
- 2.18 Trial Pit TP2 found that the existing brick wall extended down from ground level some 400mm resting on a concrete footing with a step out of 60mm. The concrete footing was found to extend a further 700mm before the Trial Pit was terminated at 1.10m depth.
- 2.19 Full details of the trial pit sections are given on the appended Figures 1 & 2 and include photographs of the trial pit excavations.

Underside of foundation approximately 0.98m depth

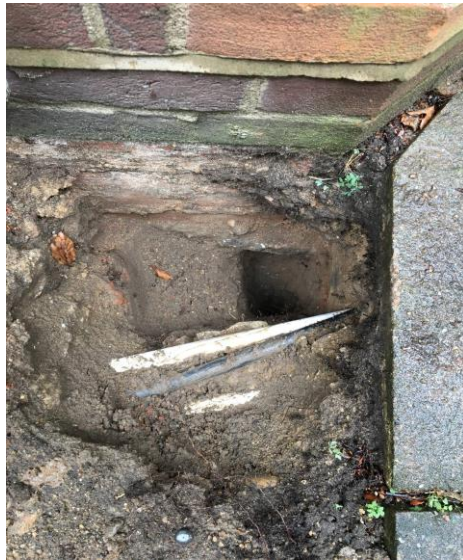
Underside of foundation not determined, > 1.10m depth

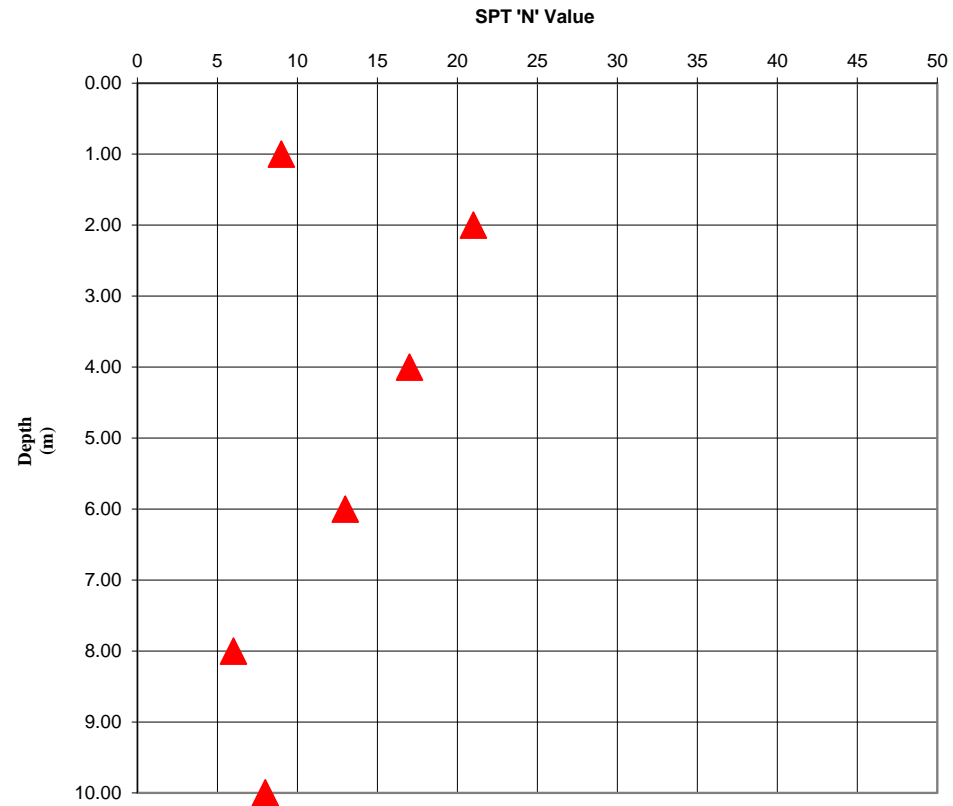
### BH1

Depth (m)	SPT 'N' value
1.00	9
2.00	21
4.00	17
6.00	13
8.00	6
10.00	8
