LEVEL MONITORING - RELATIVE SURVEY READINGS

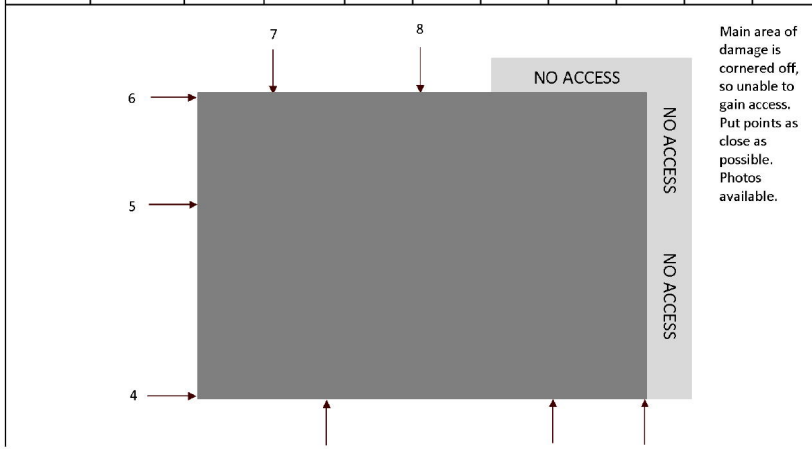
Main area of damage is cornered off, so unable to gain access. Put points as close as possible. Photos available.

- 14/02/2020
 - No new concerns raised at time of
- It was not possible to install all sta within a common brickcourse. The initial readings cannot be interpreted as Distortion Data.
- Readings have been made relative to a manhole in the road. It has an assumed value of 10.0000m. If this is not a true datum please advise if a deep datum is required.
- Further readings to be taken April 2020
