Dr Williams's Library
Library Building

FLOOR PLANS
L01- Essential Repair, Refurb & Maint.

W82-CPM-Z1-01-DR-A-70201 **P01**

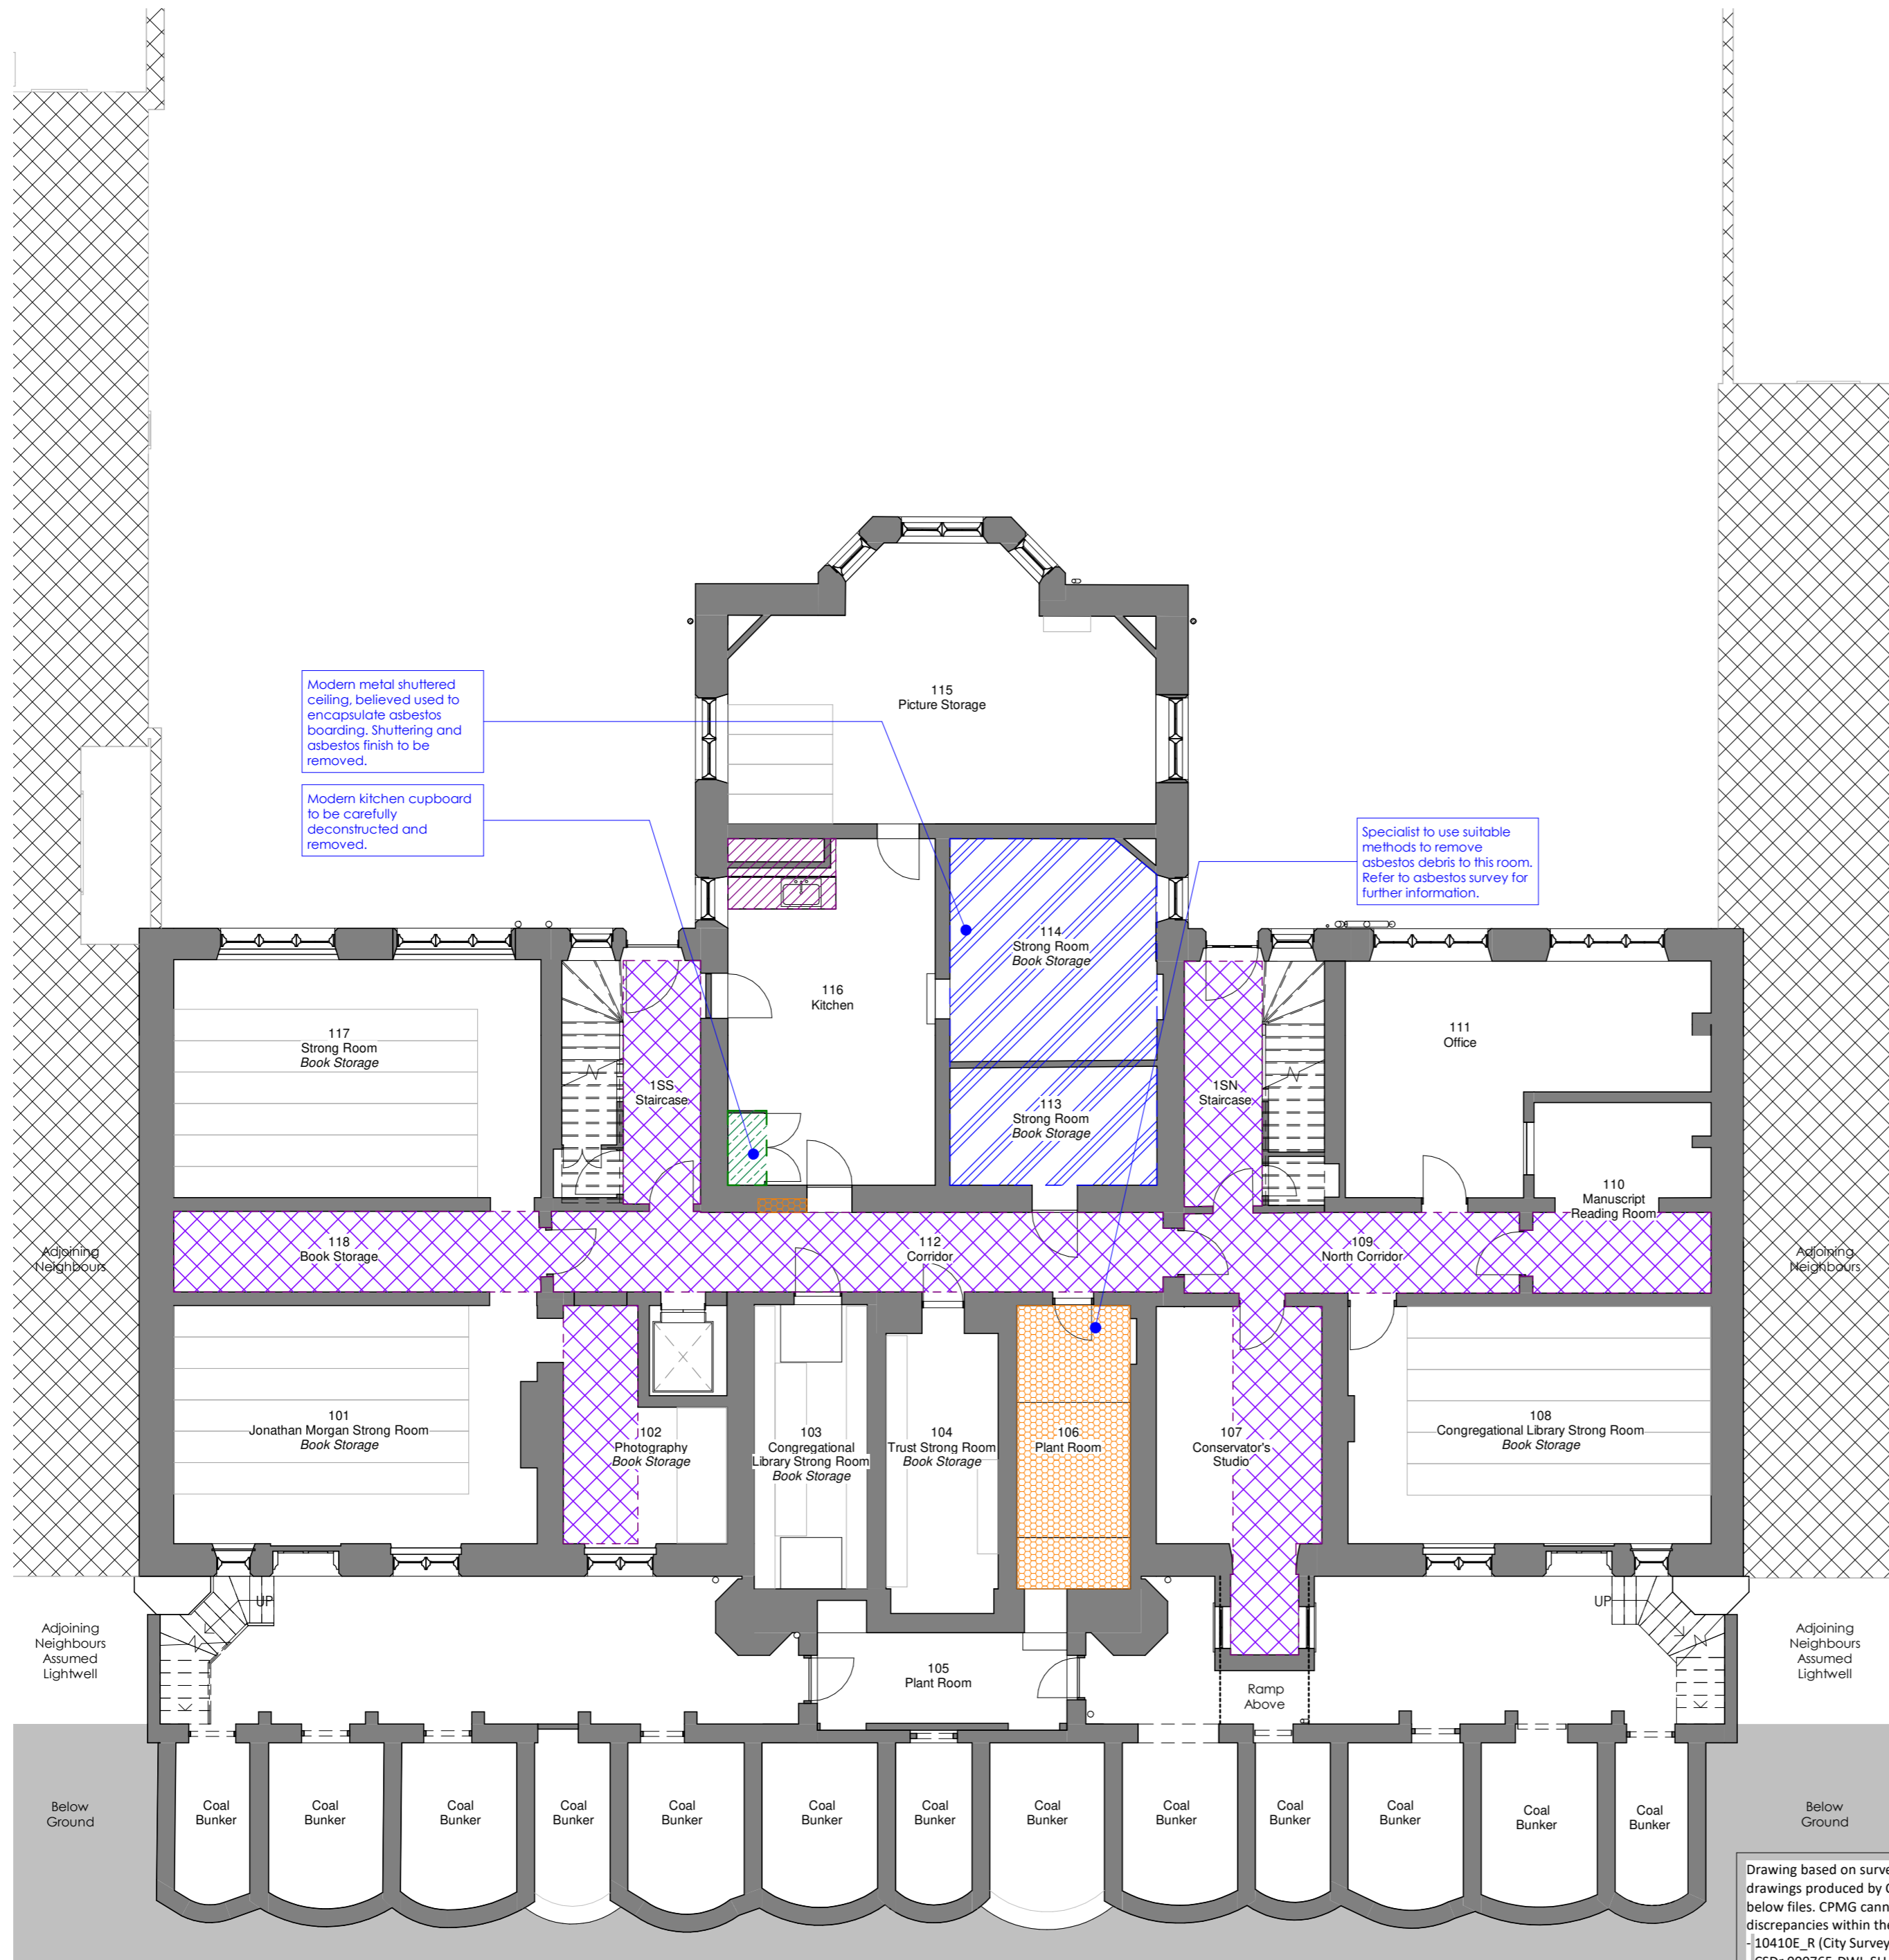
Modern metal shuttered ceiling, believed used to encapsulate asbestos boarding. Shuttering and asbestos finish to be removed.

Modern kitchen cupboard to be carefully deconstructed and removed.

Specialist to use suitable methods to remove asbestos debris to this room. Refer to asbestos survey for further information.

- Lightweight Partitions Demolished- Full Height
All doors and glazed screens within partitions highlighted to be removed. Partition and associated door removal is only indicated to partitions requiring removal due to asbestos issues, or impacts on the repairs of the internal North and South stairs.

- Any profiled skirting, picture rails or door architraves to be carefully removed and retained for later re-use as part of the main works package.
- York Stone Floor
Existing York Stone slabs are to be numbered and photographed prior to carefully lifted during drainage works. Stones to be carefully relaid in original positions following works. Indicated hatched area indicates worst case, opening ups to be limited in scale where possible.

- Ceiling- Asbestos Panelling
Refer to drawing notes for clarification. Works to be carried out by specialist and contaminated material suitably disposed of.

- Floor- Asbestos Covering
Existing floor covering to be lifted by specialist and suitably disposed of.
- Sanitaryware / IPS / Culinary Facilities
Remove and dispose of all associated fittings and pipework, strip back to source. Walls/floors to be made safe from risk of falls/trips. Indicative area highlighted, all items within identified room to be removed.
