Basement Impact Assessment

Vine House, Hampstead NW3 1AB

Hydrogeology, Land Stability and Ground Movement Assessment

MGC-BIA-19-34-V4

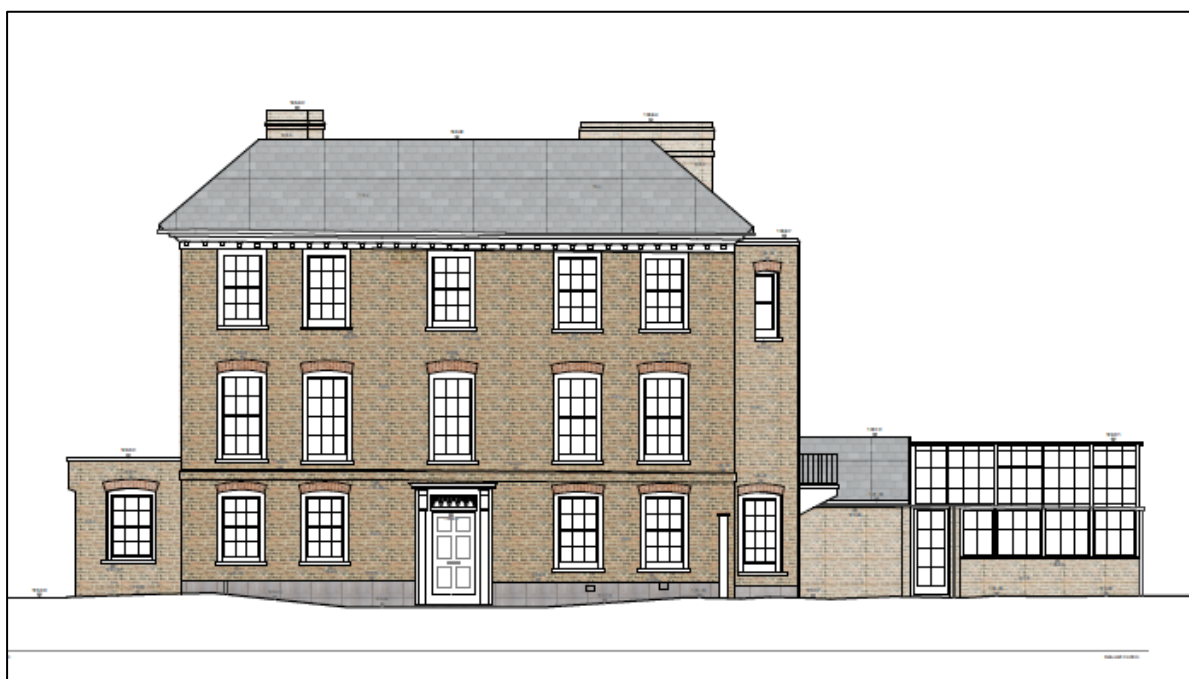
Figure 3.1 South Elevation (From Drawing VH-PP-11 2015)

The existing building comprises a three storey detached house occupying a central location in a garden off Hampstead Square as shown in Figure 3.1.

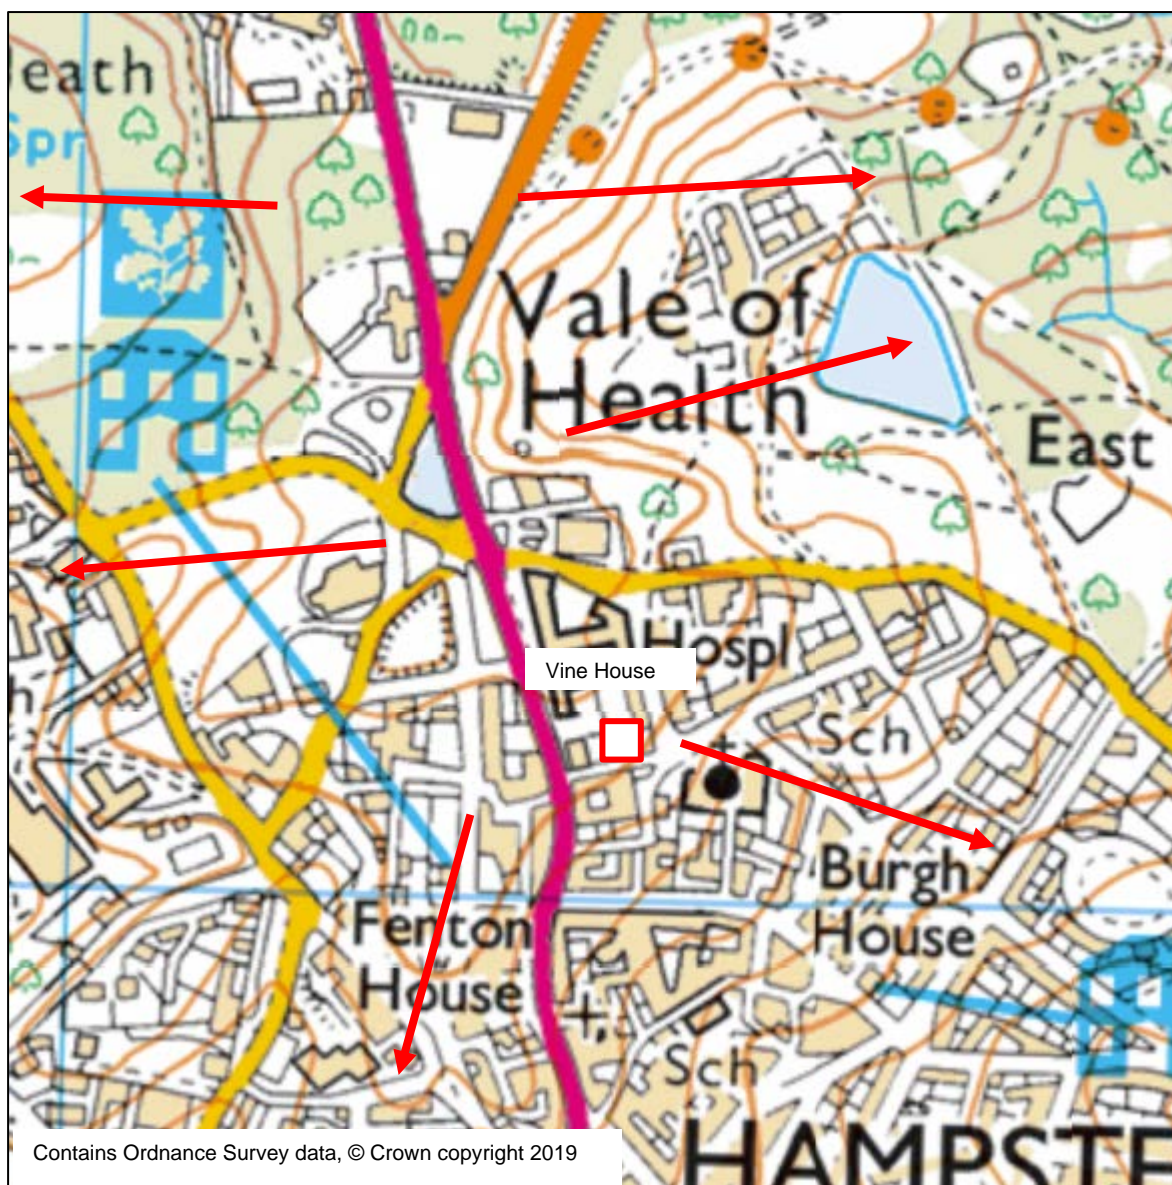
Figure 3.2 Regional topography at Vine House with arrows indicating direction of downwards slopes

The ground level at the site is at approximately 125.30 m AOD. No detailed topographical survey is currently available. The land in the vicinity of the site slopes down to west, south and east from the north, where Hampstead Heath forms an area of high ground at circa 135m AOD as indicated in Figure 3.2, forming a distinctive geomorphological feature.

Whitestone Pond is located about 200m to the north at approximately 129 m AOD and Vale of Health Pond 500m to the north east at approximately 110m AOD. Further Hampstead Ponds lie 1 km to the east of the site. These Ponds are on lower ground on lower ground between approximately 100 and 70m AOD.
