This plan is based on a Tree Survey Plan prepared in 2015 following a site survey in accordance with BS5837:2012

TREE LOCATION PLAN

SITE ADDRESS
10 Nutley Terrace, London, NW3 5SB

DRAWING NO
DS14051501.01-B

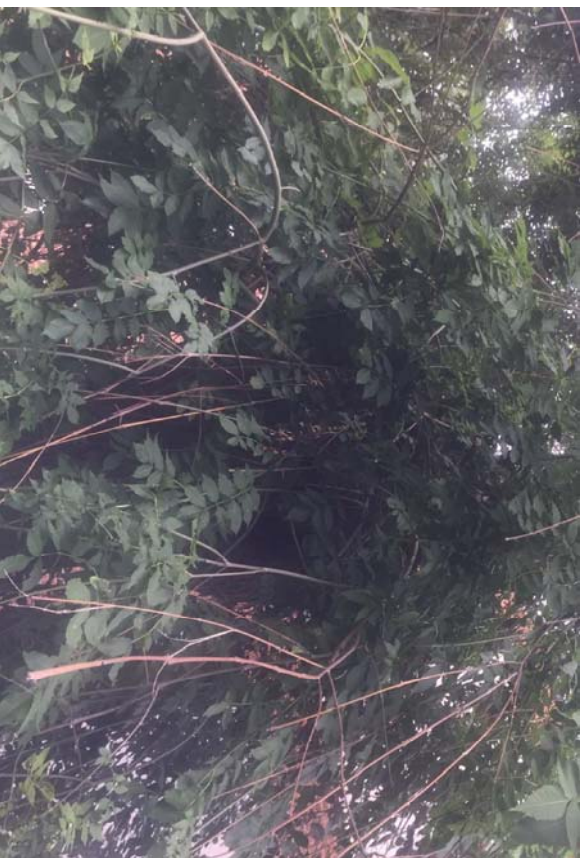
It is apparent from a photograph sent by our client that the condition of Tree 6 has deteriorated since 2015. It now has extensive twig death, almost certainly caused by 'ash dieback' - see photograph adjacent

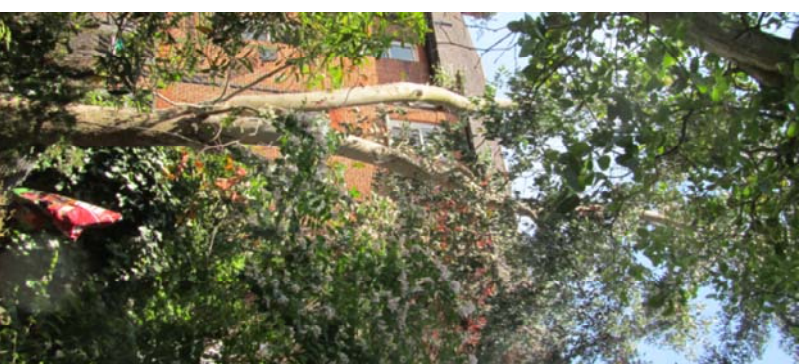
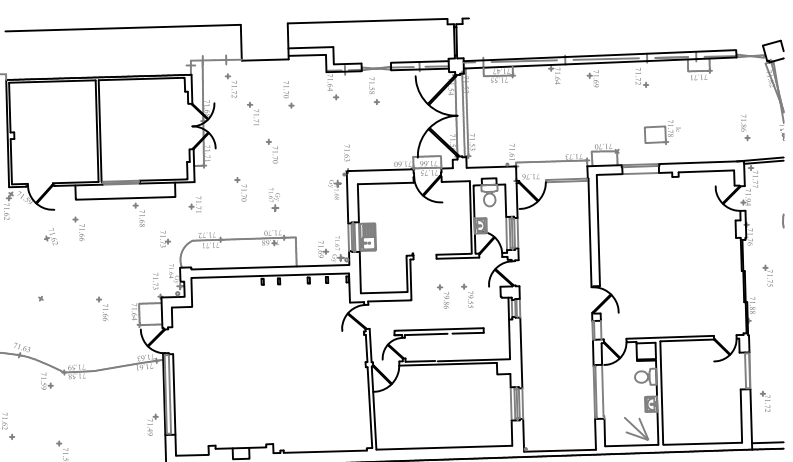
Tree 15 is a poor quality Eucalyptus with slender, leaning stem, and has re-grown from past topping. Tree leans towards school and has short likely retention span
