RESULTS OF A 24-HOUR NOISE LEVEL SURVEY CARRIED OUT ON THE  
ROOF OF THE COMMERCIAL PREMISES KNOWN AS  
MELIA WHITE HOUSE HOTEL, LONDON NW1  
AND A REPORT ON THE NOISE IMPACT OF THE NEW EXTERNAL PLANT

Client : Proffetional Finishing Design S.L.  
Project : Melia White House Hotel, London NW1  
Emtec Ref. : QF9065-PF6759-RP1\_00  
Issue Date : 22nd June 2020

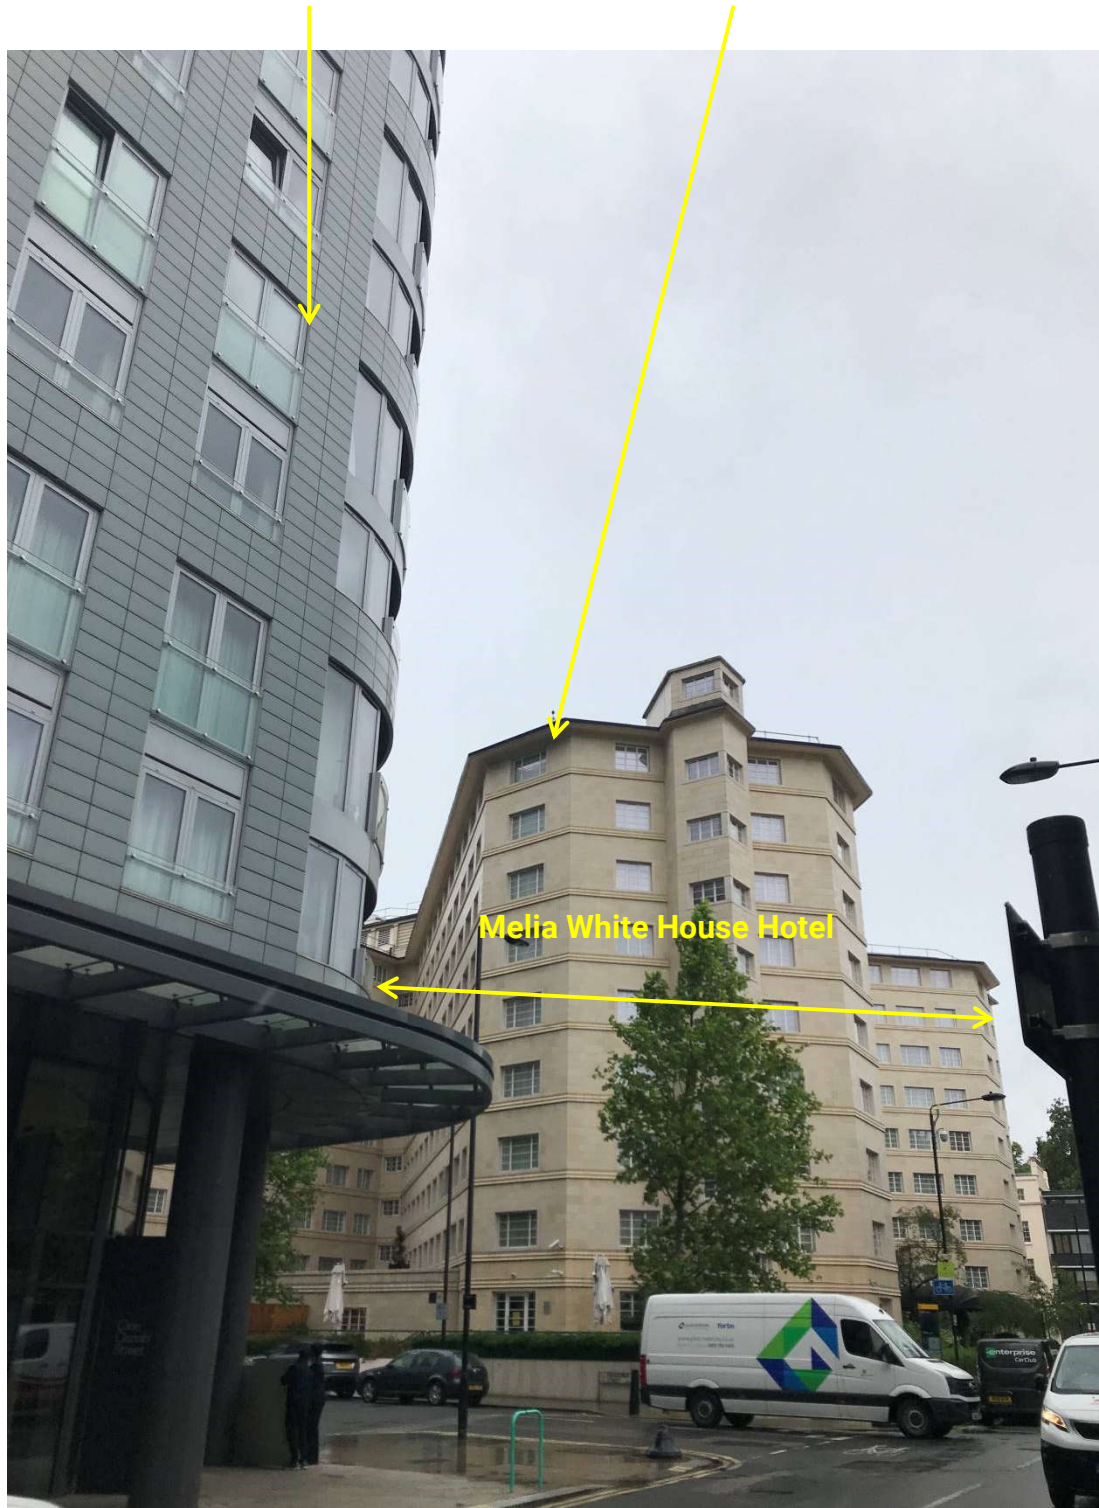
Photo A – View from Longford Street looking towards the Melia  
White House Hotel, London NW1

The façade of the building facing the junction of Longford St. and Osnaburgh St. can be seen on the attached Photo A.

Neighbouring residential  
building

Location of  
microphone

The microphone was mounted on a tripod and positioned towards the north east corner of the roof of the building known as Melia White House Hotel, London NW1. The microphone was oriented vertically and approximately 1.5m above the level of the roof. The location of the microphone can be seen on the attached Photos A, B, C and E.

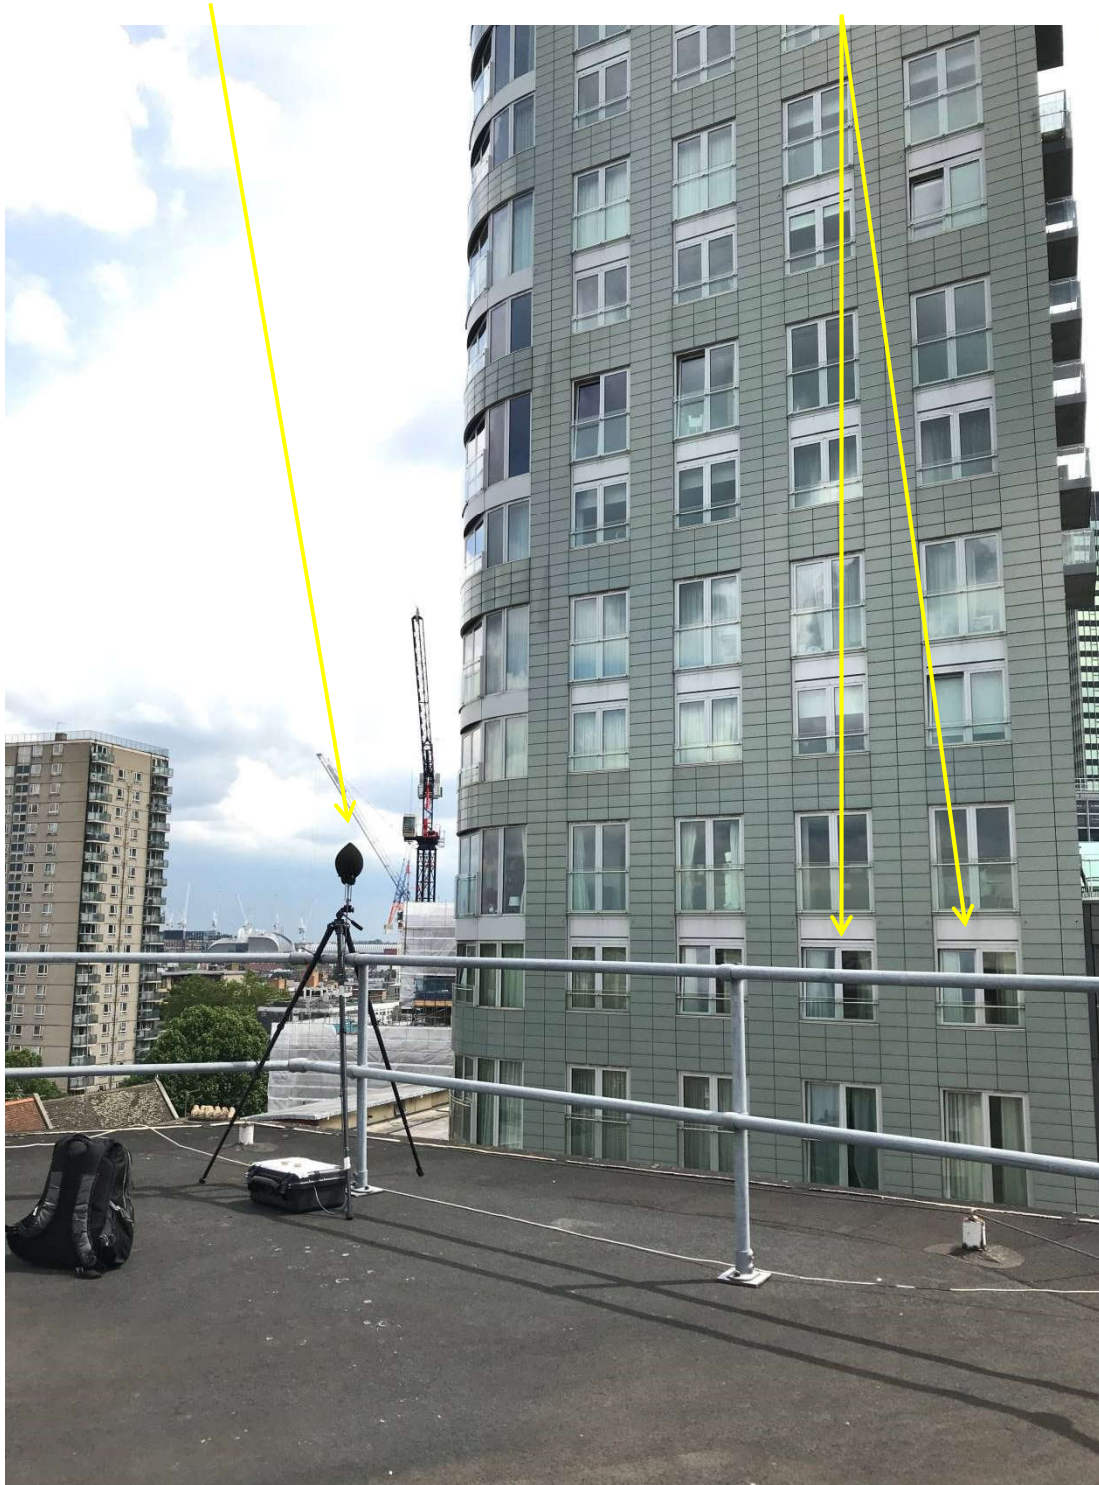
Photo B – View to the north east at roof level from the Melia White House Hotel, London NW1

Location of  
microphone

Neighbouring noise sensitive  
residential windows
