Transformation of the Ugly Brown Building

DTS Raeburn
Preliminary Risk Assessment

CONTRACT NO. E12897/1
PRELIMINARY RISK ASSESSMENT
REPORT FOR UGLY BROWN BUILDING,
2-6 ST PANCRAS WAY
LONDON NW1 0TB

Prepared by
DTS Raeburn Limited

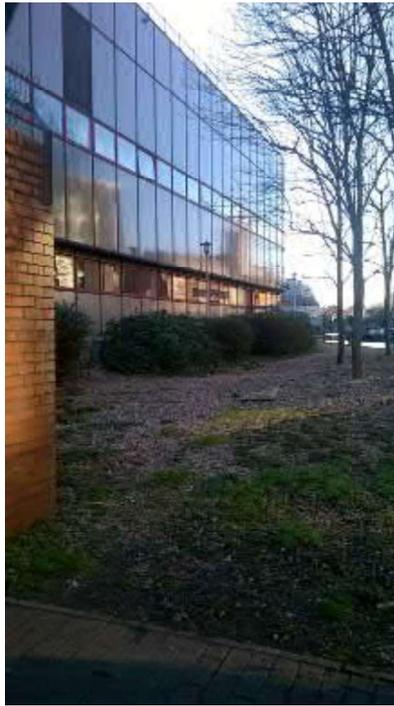
Plate 3: Eastern Boundary with Canal

The nearest surface water is the Grand Union Canal located adjacent the north east boundary of the site. It was indicated in The Structural Engineer paper that the construction of the canal wall was found to be suspect during the intrusive site investigation undertaken prior to construction of the existing building in 1985. Following approval from the canal authority a new permanent sheet steel wall was constructed in the canal over the whole length of the site and sealed back into the existing wall at each end.

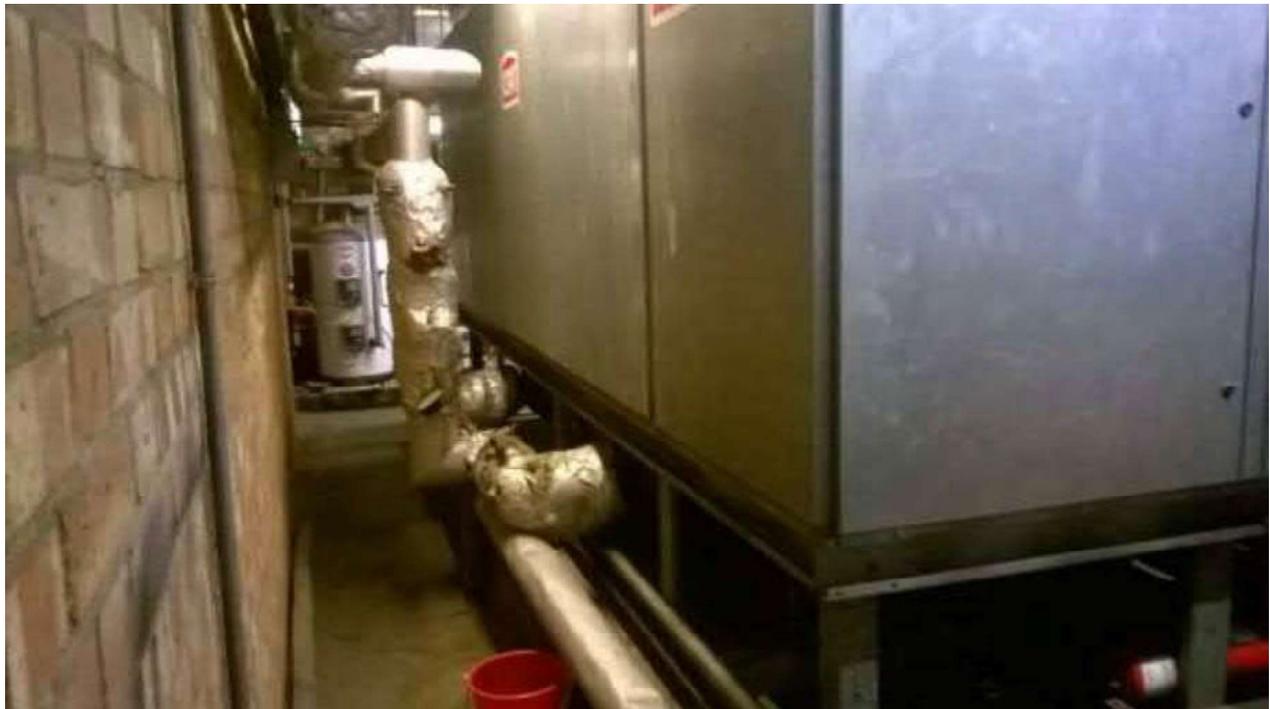
Plate 4: Inside Plant Room

The current site comprises of a five storey portal frame structure with a car parking, a fuel tank and a plant room located on the ground floor. The ground floor has a concrete floor slab and no evidence of spillage or leakage was noted during the site visit.
