# SPT Calibration Report

## Hammer Energy Measurement Report

Project Title  
**UGLY BROWN BUILDING**

Drawing Title  
**BOREHOLE  
DIAGRAM  
(BH01 A-A)**

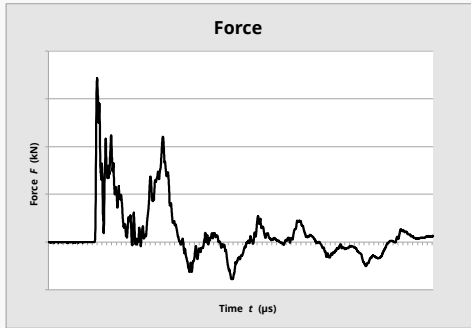
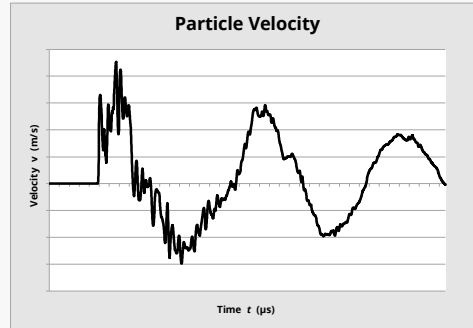
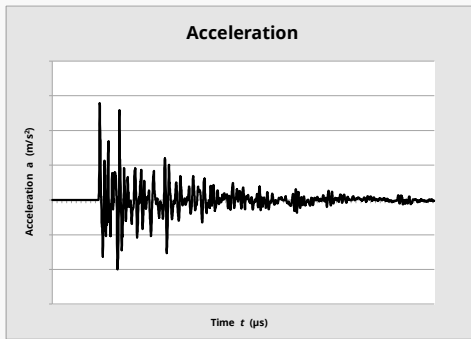
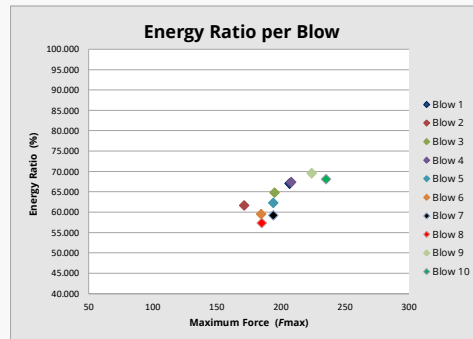
$E_{\text{meas}} = 0.300\text{ kN-m}$   
 $E_{\text{theor}} = 0.473\text{ kN-m}$

Energy Ratio =  $\frac{E_{\text{meas}}}{E_{\text{theor}}}$  **63.47%**  
© Copyright 2018

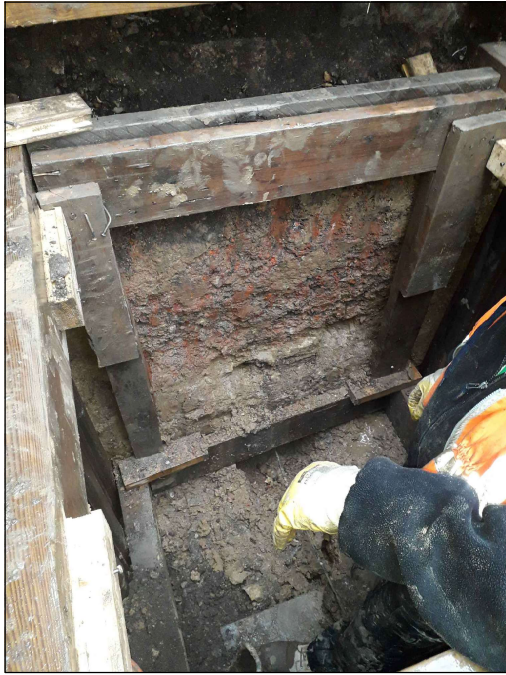
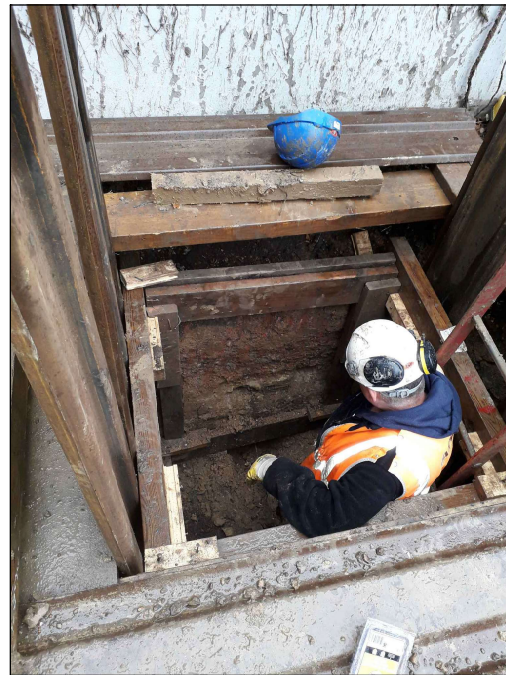
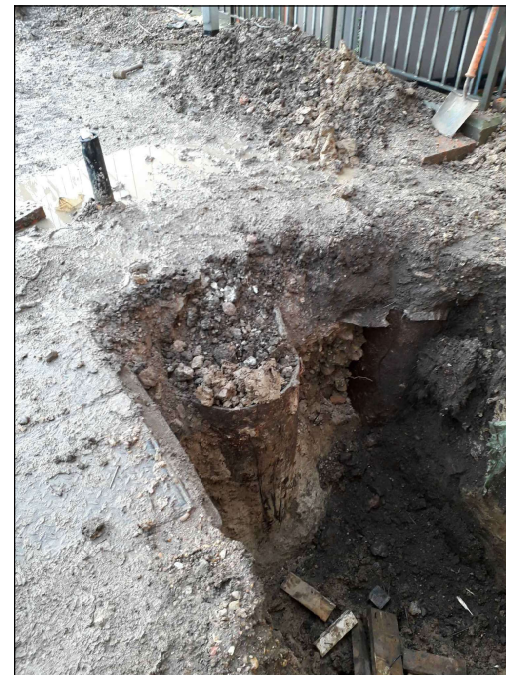
GL - 0.45 Made Ground - Dark brown gravelly sandy clay gravel of fine to coarse sandy brick concrete and flint

0.45 - 1.10 Made Ground - Cemented red brown brick and concrete

1.10 - 1.96 Fine orange brown and brown clay

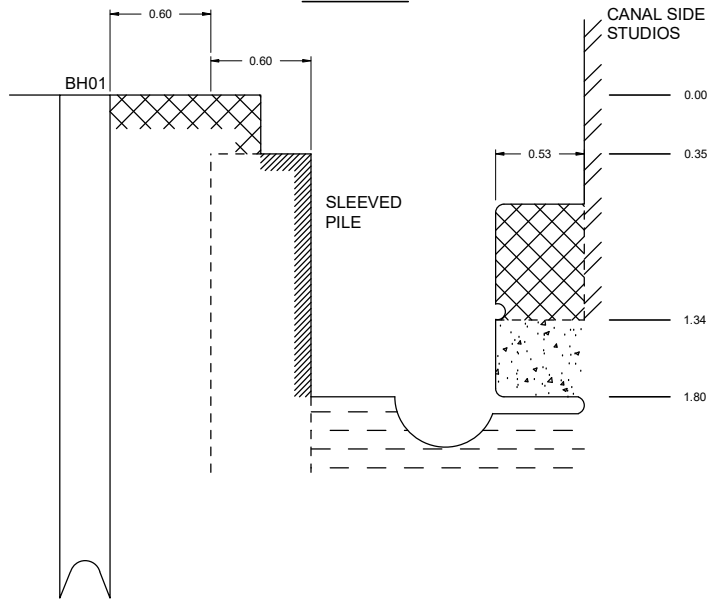
**BH01**  
**SECTION A-A**

Section View:  
(1:30)

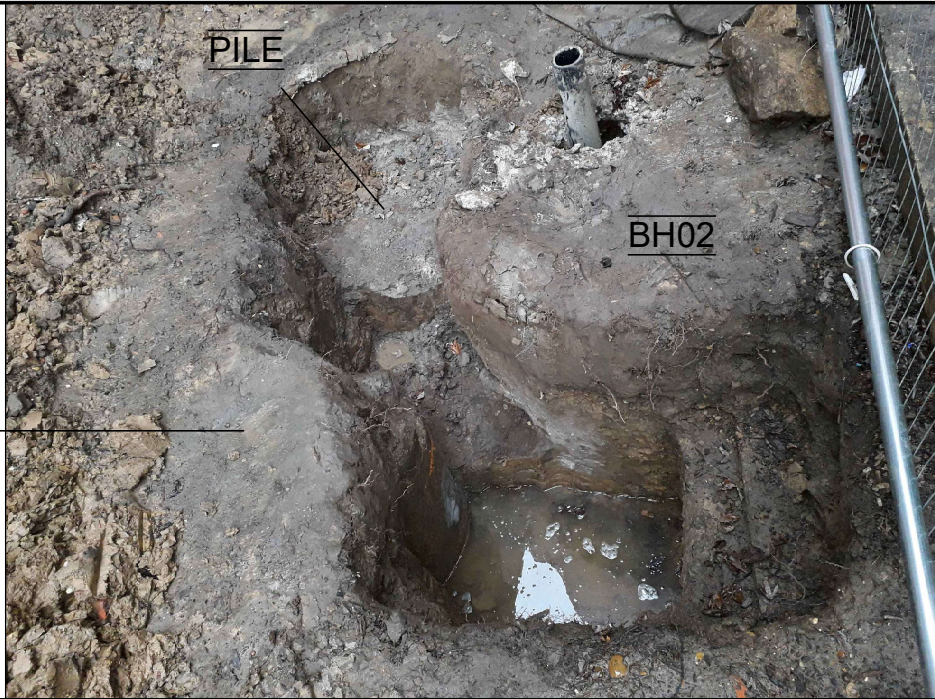
Drawing Title  
**BOREHOLE  
DIAGRAM  
(BH02 A-A)**

Made Ground - Dark brown slightly sandy slightly gravelly CLAY. Sand is fine to medium. gravel is fine to coarse sub angular to sub rounded flint and brick.

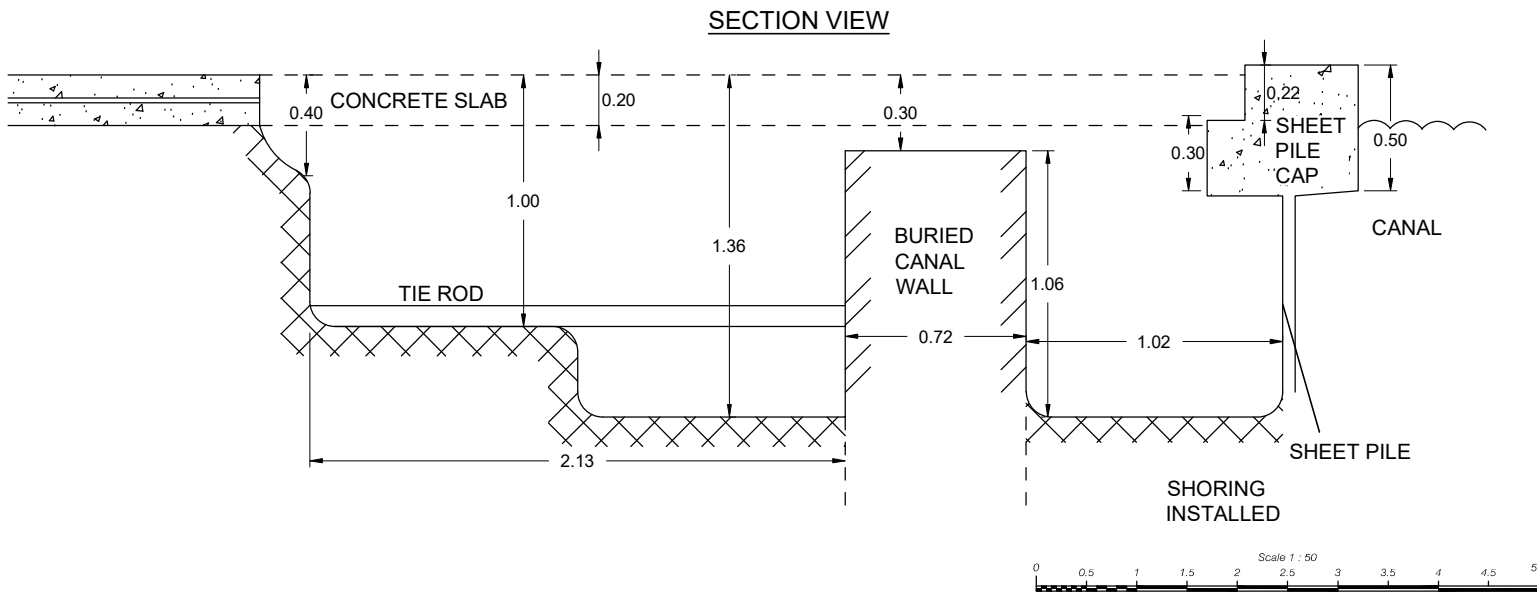
Drawing No.	Rev.
BH04 - TP1	P1

0.20 - 0.37 MADE GROUND: Pale yellow red slightly clayey sandy fine to coarse subangular to sub rounded GRAVEL of flint, brick, concrete and charcoal. Sand is medium to coarse

Section View:  
(1:50)

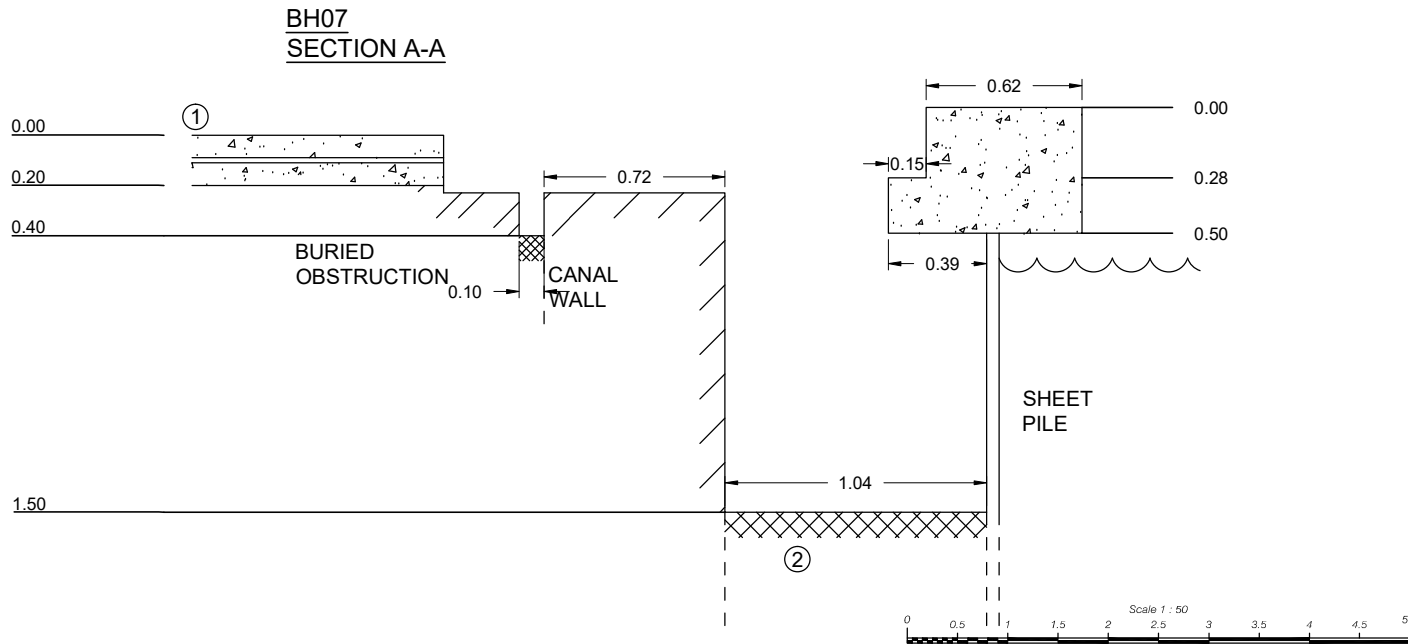
Drawing No.	Rev.
BH07 SECTION A-A	P1

Section View:  
(1:50)

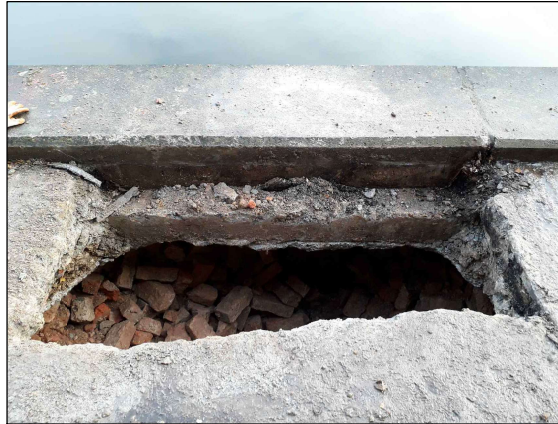
Drawing No.	Rev.
BH10	P1

0.20 - 0.50 Weak Concrete

0.50 - 1.60 Made ground - loose whole and fragmented bricks with localized pockets of orange brown sandy gravel of fine to coarse concrete and brick

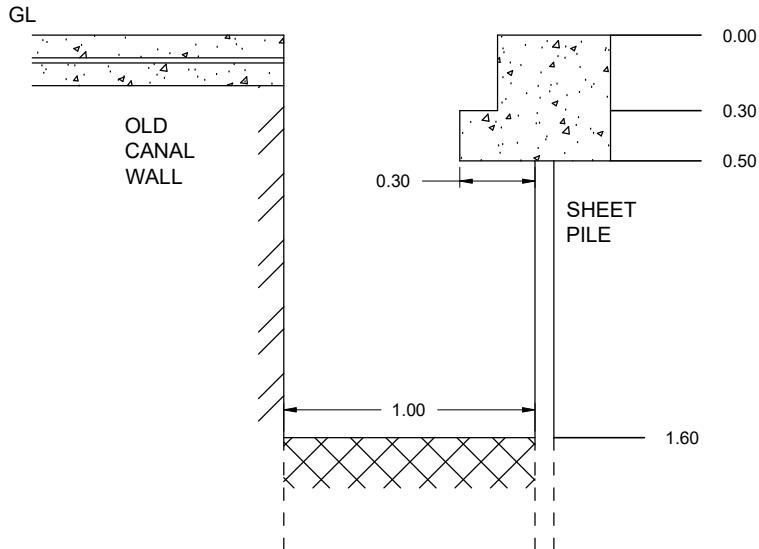
**BH10  
SECTION A-A**

Section View:  
(1:20)

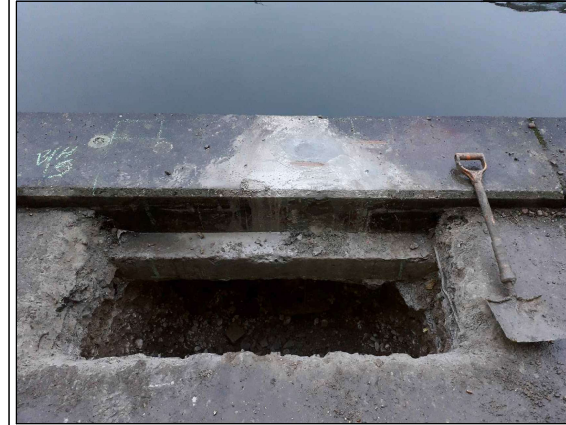
Drawing No.	Rev.
BH15 - TP2	P1

- Section Line
- GL - 0.20 Reinforced Concrete  
- 10mm Rebar at 0.10m
- 0.20 - 0.50 Weak Concrete
- 0.50 - 1.60 Made ground - loose whole and fragmented bricks with localized pockets of orange brown sandy gravel of fine to coarse concrete and brick

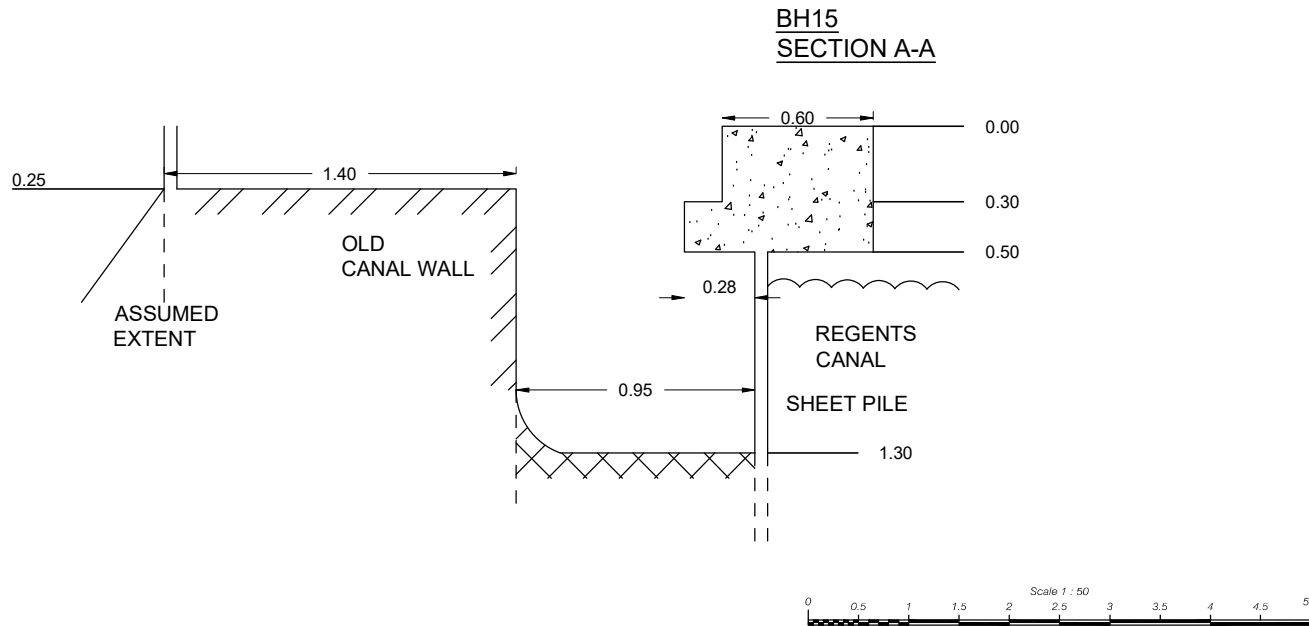
Section View:  
(1:50)

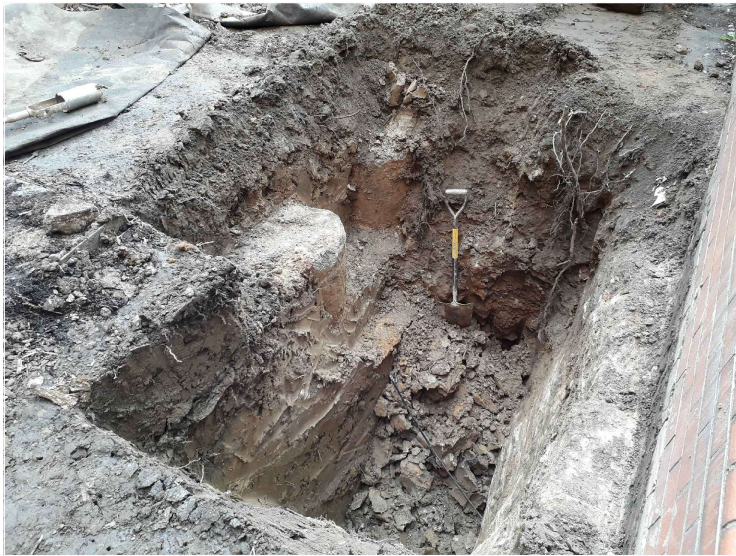
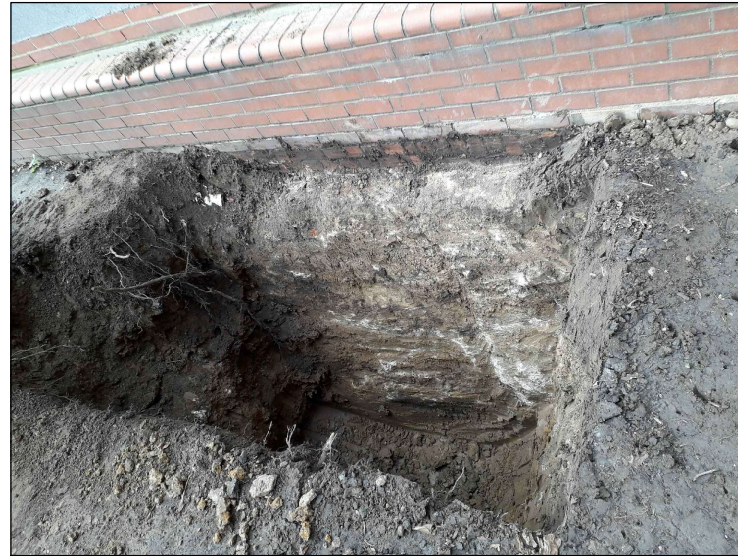
- Section Line
- Wall
- Concrete Pile
- Made Ground: Orange brown gravelly sandy CLAY with occasional pieces of plastic. Gravel is fine to coarse brick and concrete.
- Firm orange brown and brown CLAY with pockets of orange brown silt.

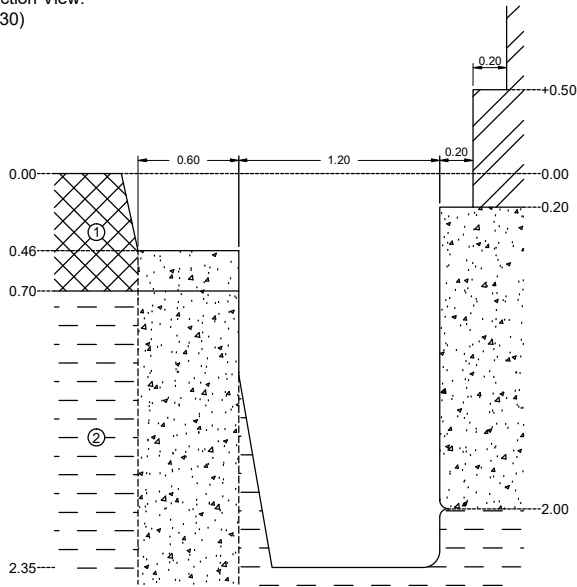
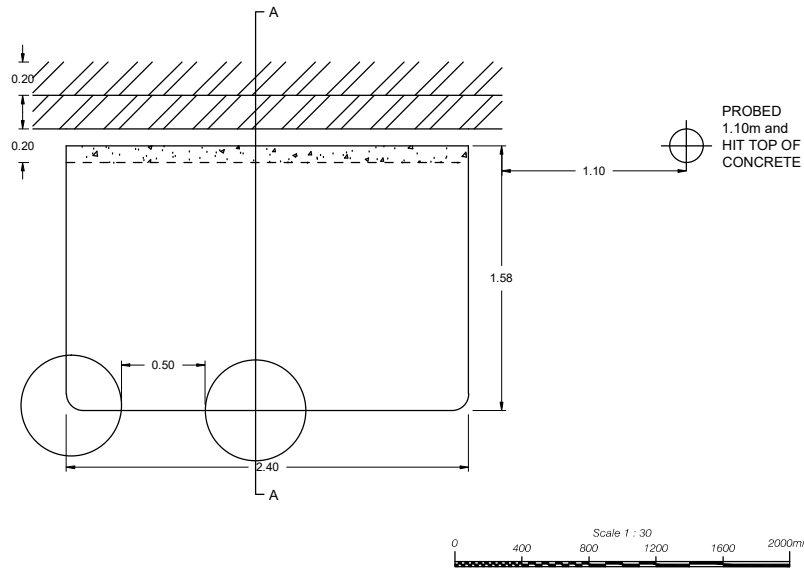
Drawing No. TRIAL PIT 3	Rev. P1
----------------------------	------------

Section View:  
(1:30)
