# Ugly Brown Building

Geophysical Report

Project no. 193152

**Title:** Geophysical Report, Ugly Brown Building

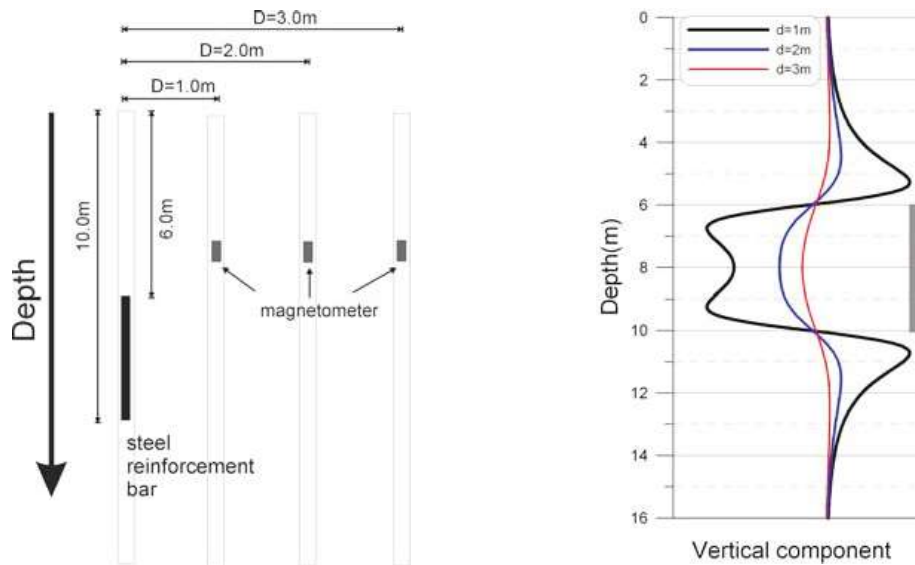
<b>RSK</b>		<b>THE DOWNHOLE MAGNETIC TECHNIQUE</b>	
<b>Client:</b> THE TRUSTEES OF THE ST PANCRAS WAY BLOCK A UNIT TRUST & BIG LOBSTER LTD		Figure: 4	Job: 193152
<b>Site/Project:</b> <b>UGLY BROWN BUILDING</b>		SCALE N/A	DATE March 2019

**B** Example magnetic data for differing offsets (from Jo, Cha and Choi)

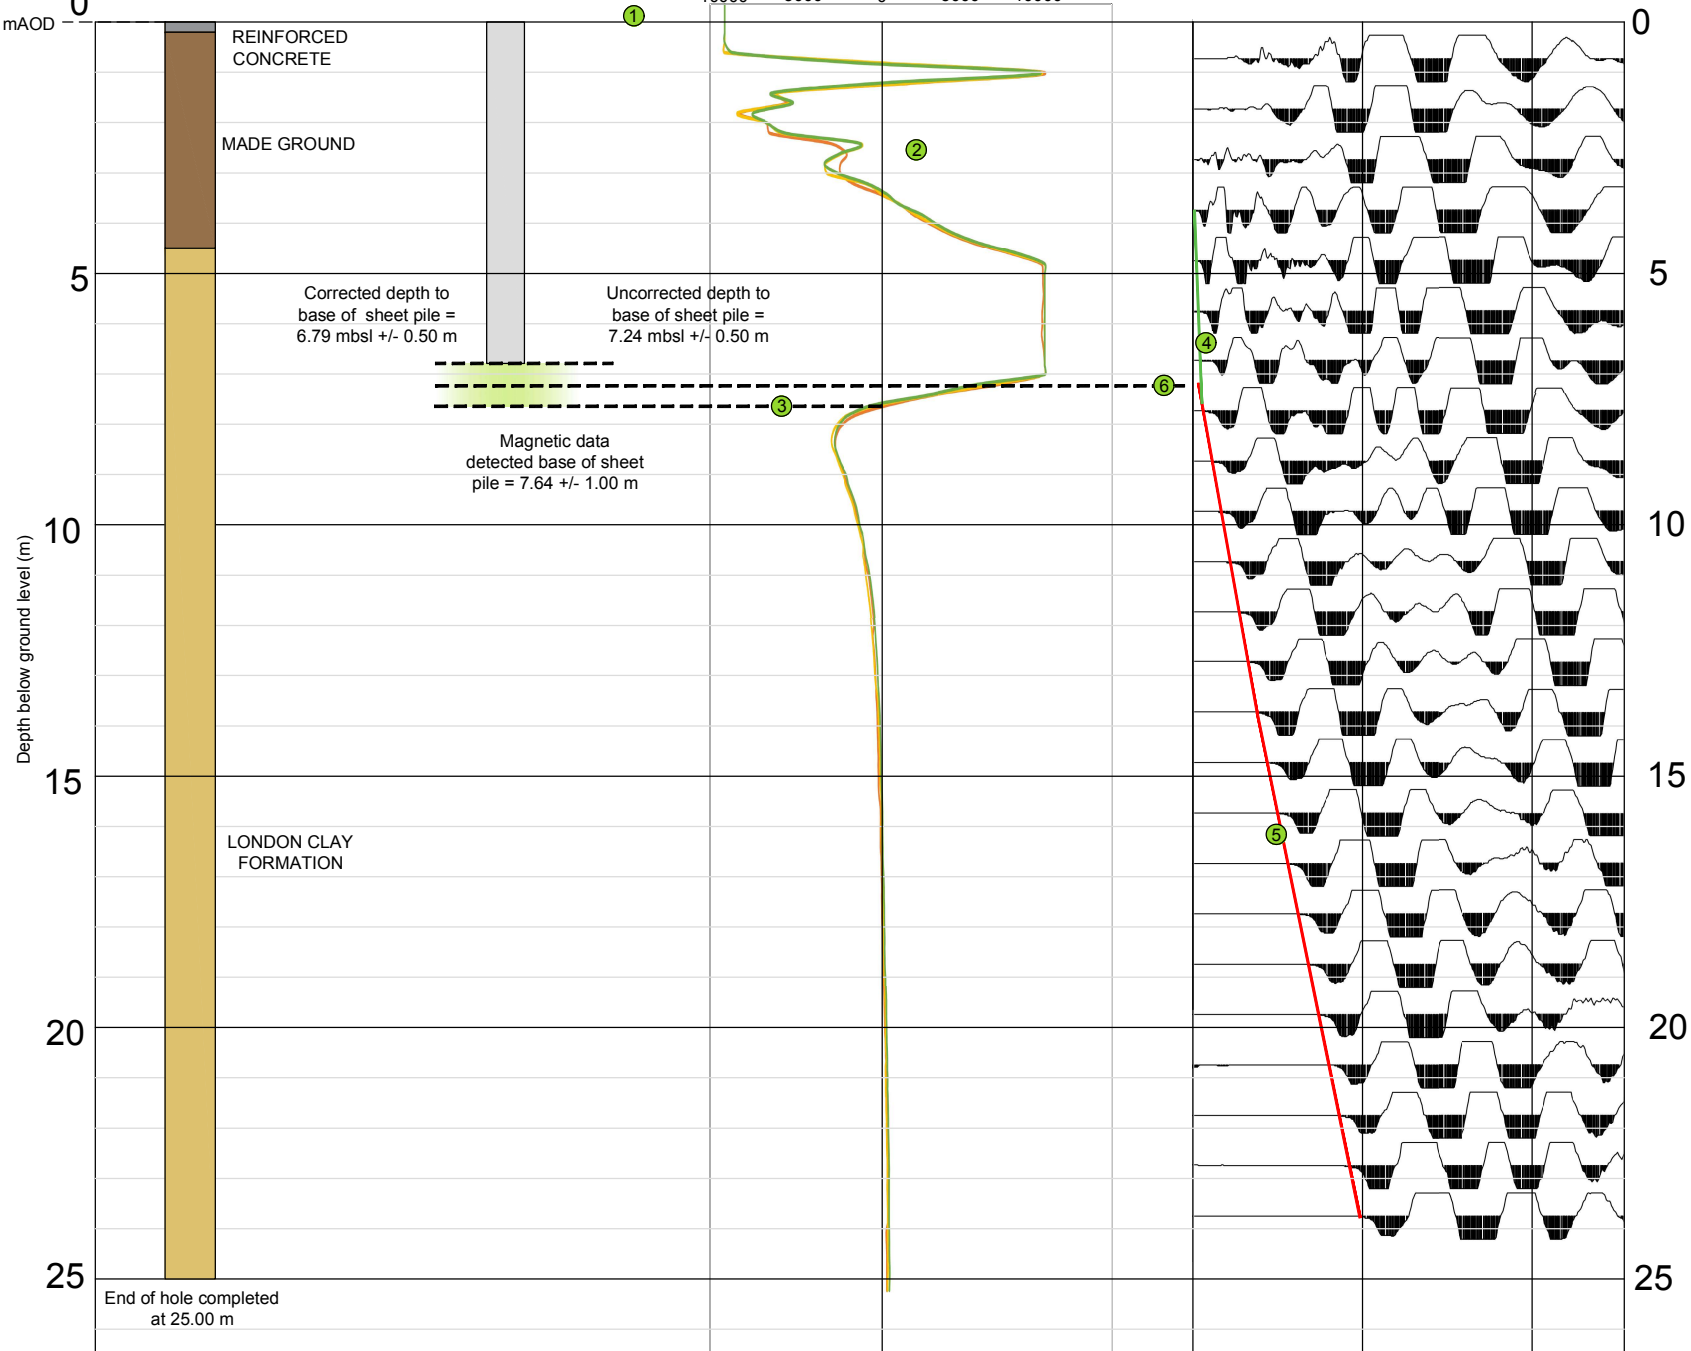
#### SHEET PILE INTERPRETATION

As described in section 3.2, in typical borehole seismic surveys the crossover point from higher velocities (indicative of foundations) to the lower velocity (indicative of London Clay Formation) is used to calculate the depth to the toe of the pile. The corrected depth of the sheet pile takes into account the distance the borehole is from the pile.
