1EW02 Enabling Works – Area South

Heritage Agreement Method Statement

Recording of Pair of Stone Piers with Lamp Standard to East End of Mornington Street Railway Bridge

Document number: 1EW02-CSJ-EV-MST-S003-
000014

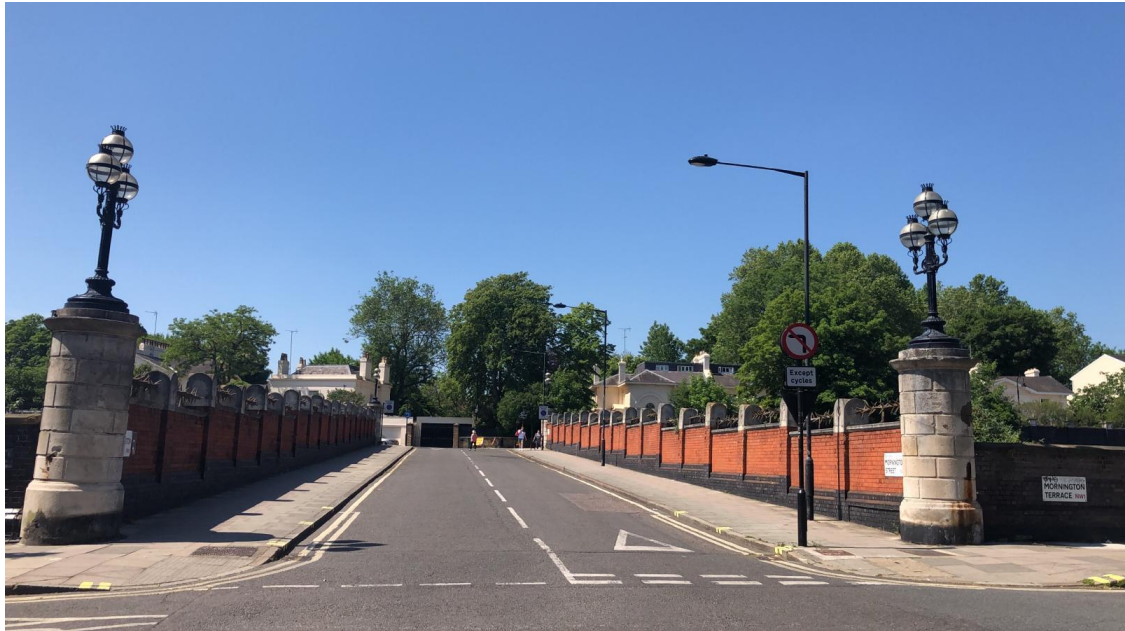
Figure 1 Pair of Stone Piers with Lamp Standard to East End of Mornington Street Railway Bridge, looking west

2.1.1 The pair of stone piers with ornate metal lamp standards are located on the eastern end of the Mornington Street railway bridge at the junction of Mornington Street and Mornington

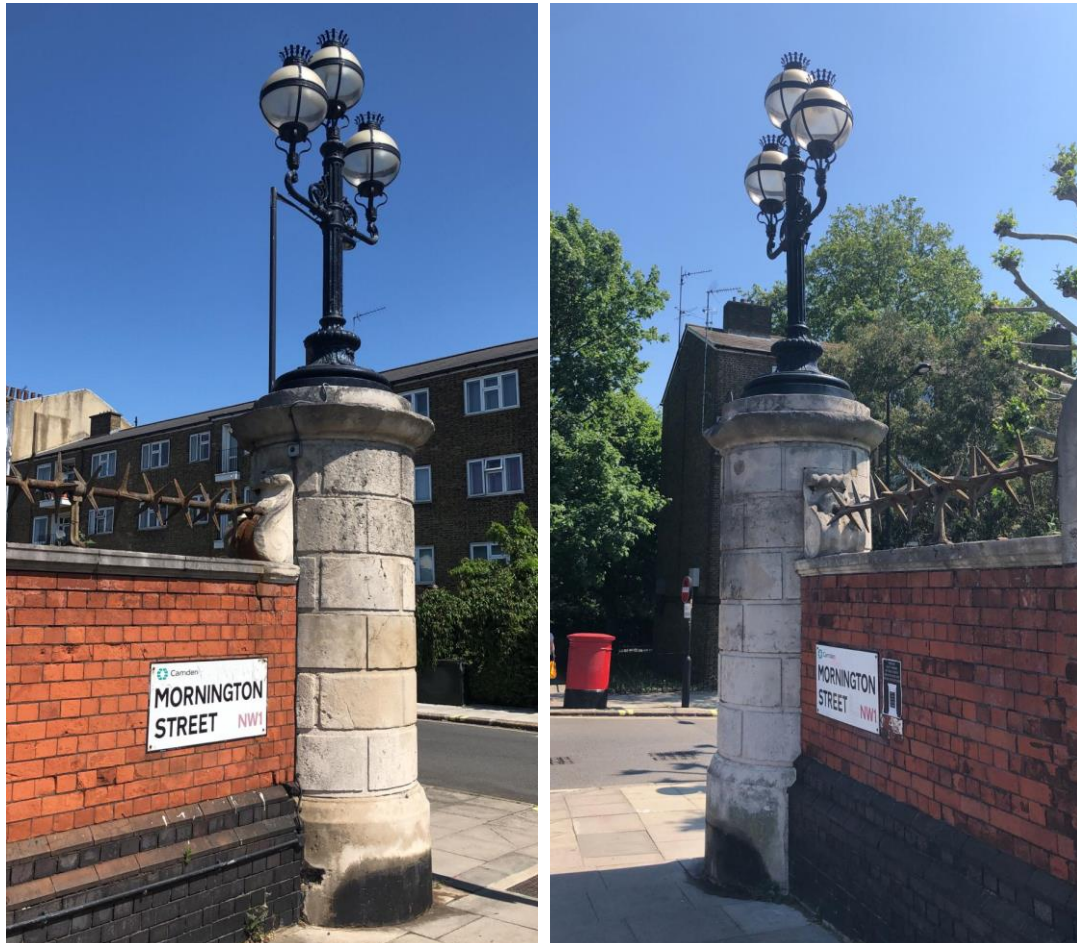
Figure 2 Detail of the northern pier (left) and southern pier (right) of the pair to the east end of Mornington Street Railway Bridge

- 2.1.2 The pair of stone piers with lamps standards are designated as a Grade II listed heritage asset (list entry no. 1409727) and were first designated on 15 September 2004. The National Heritage List for England entry can be found in Appendix B.
- 2.1.3 Historic England lists the asset as 'rusticated Portland stone piers, circular in plan, on deep plinths and with cyma recta cornice' (Historic England, 2004). On top of the stone piers sit ornate metal lamp standards, likely made of cast iron, with 'fluted shafts and a pair of arms to each side' (ibid). The list entry of 2004 states the 'lamp globes have been removed' however works undertaken by Cleghorn Lighting (date unconfirmed but likely 2000s) replicated the originals from 'drawings from the period' (Cleghorn Lighting, 2020). Each standard supports three glass lamp globes with metal detailing including crowns on top.

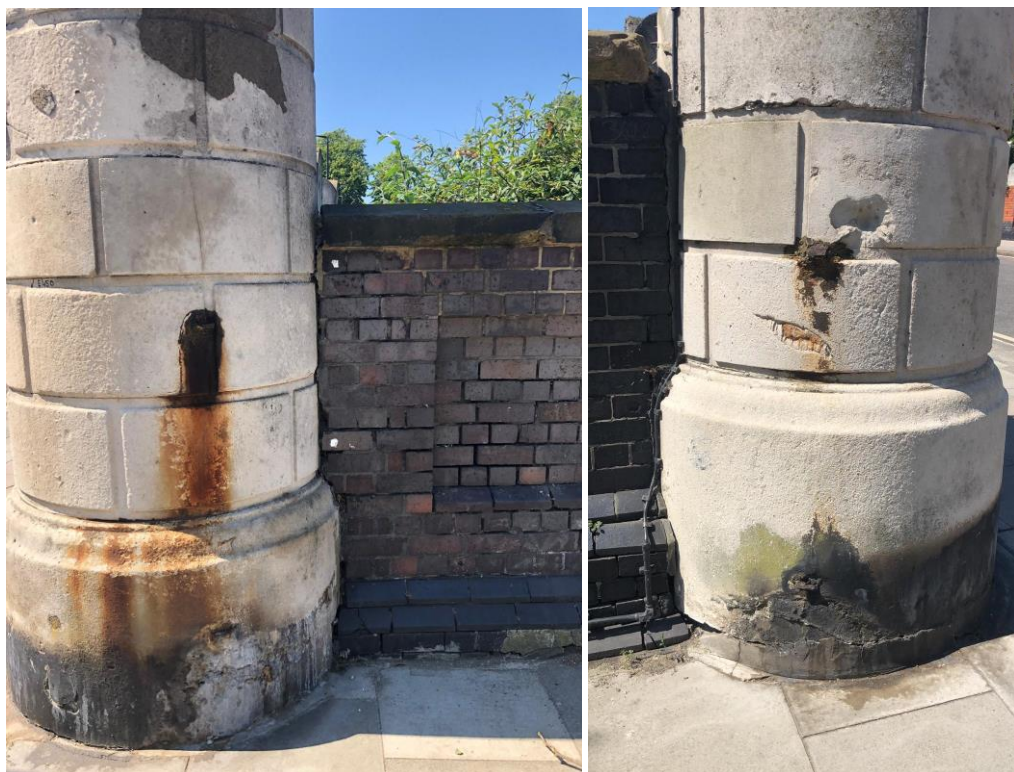
Figure 5 Northern pier (left) and southern pier (right) of the pair to the east end of Mornington Street Railway Bridge, with evidence of former metal work penetrating from the stone piers

- 2.2.10 At the east end, the stone piers at the bridge are abutted up to Mornington Terrace wall, leaving a small gap to allow for movement of the bridge deck. On both stone piers, there is evidence of former metal work penetrating from the stone piers. Small fragments of the metal remain with rust staining the stone pier. These are situated towards the bottom of the stone piers, extend outwards towards Mornington Terrace. This may be remnants of railings extending from the piers, which possibly ran parallel to Mornington Terrace Wall. It is possible that this metal work was removed during World War II, where a significant portion of metal work such as decorative metal railings and gates were requisitioned as part of the war effort (London Park and Gardens Trust, 2015).

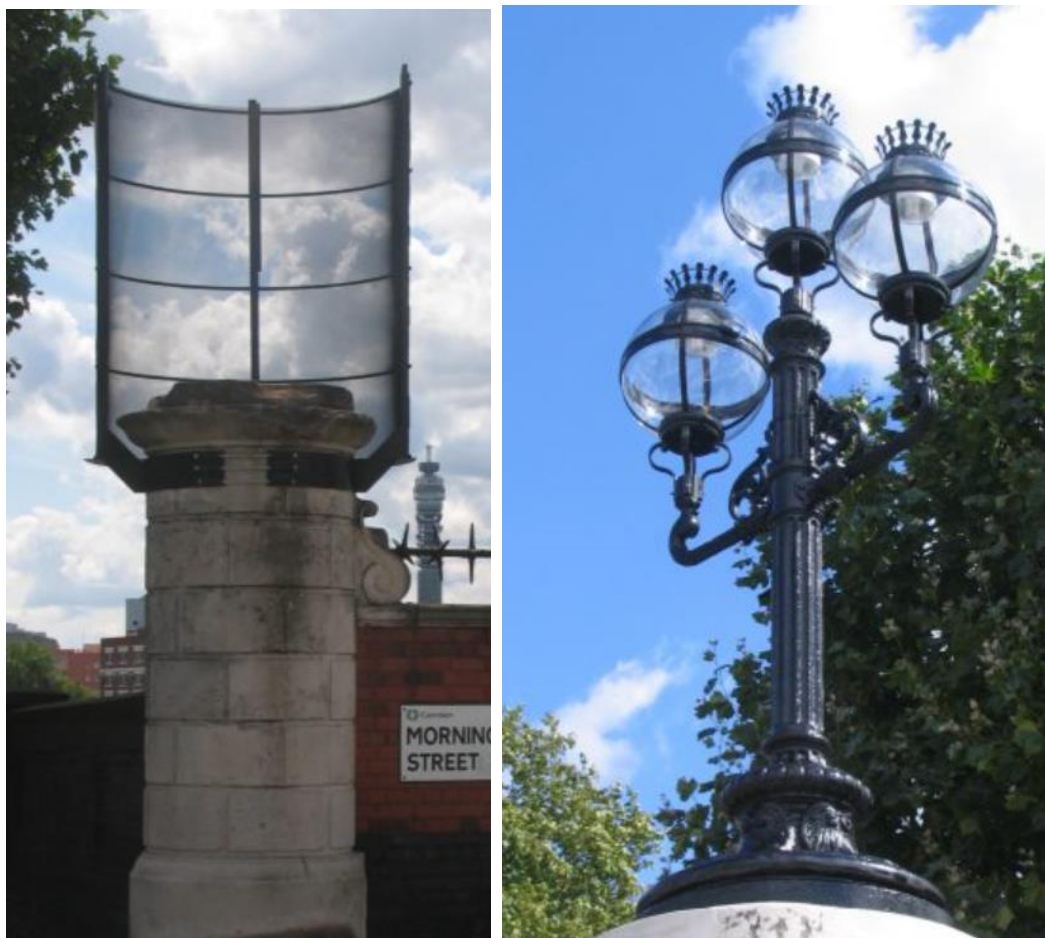
Figure 6 Images taken from the Cleghorn Lighting Ltd. website showing restoration works requiring the removal of the metal standard from the southern pier of the pair to the east of the bridge (left) and the standard and globes following works (right)

- 2.2.11 The lamp standards on top of the stone piers at Mornington Street Railway Bridge were damaged during the World War II bombing (Cleghorn Lighting Ltd., 2020), suggesting that these were not removed, unlike the other metalwork, as part of the war effort. It is likely that the damage occurred during the Blitz as bombs are recorded as having fallen within the surrounding area between 1940 and 1941. Impact damage is evident on the stone piers, particularly to the southern pier (see Figure 5 above), possibly resulting from bomb or shrapnel damage inflicted during the Blitz. The NHLE entry for the pair at the east end of the bridge states 'the lamp globes have been removed' suggesting that up to 2004 at the time of listing, the glass globes had not been replaced (Historic England, 2004). Joint funding raised by the London Borough of Camden and English Heritage allowed for the replication of the lanterns and restoration to the lamp stands (Cleghorn Lighting Ltd., 2020). These works were carried out by Cleghorn Lighting Ltd., who used 'drawings from the period when the bridge was constructed to replicate the original lanterns' (Cleghorn Lighting Ltd., 2020).

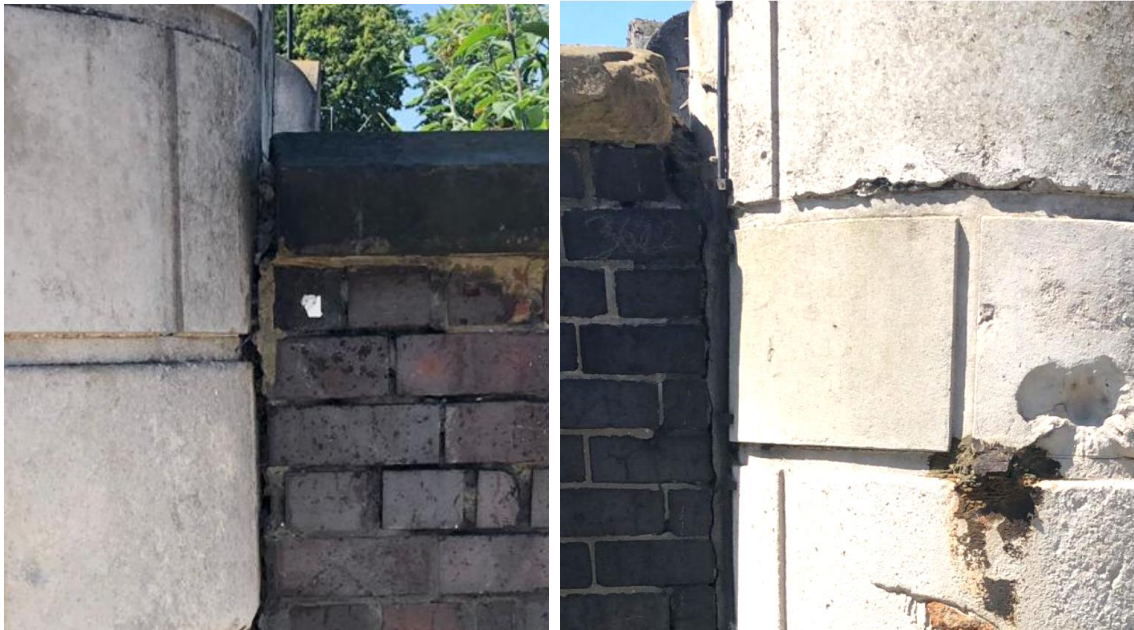
Figure 7 Northern pier (left) and southern pier (right) of the pair to the east end of Mornington Street Railway Bridge, with evidence of mortar packing between the stone piers and Mornington Terrace wall

- 2.3.4 The east pair of stone piers abut up to the Mornington Terrace wall. Mortar packing is visible between the small gap between the wall and piers, likely added for aesthetic purposes when viewed from the Mornington Terrace street front. This mortar packing is failing and falling away, especially to the top of the wall.

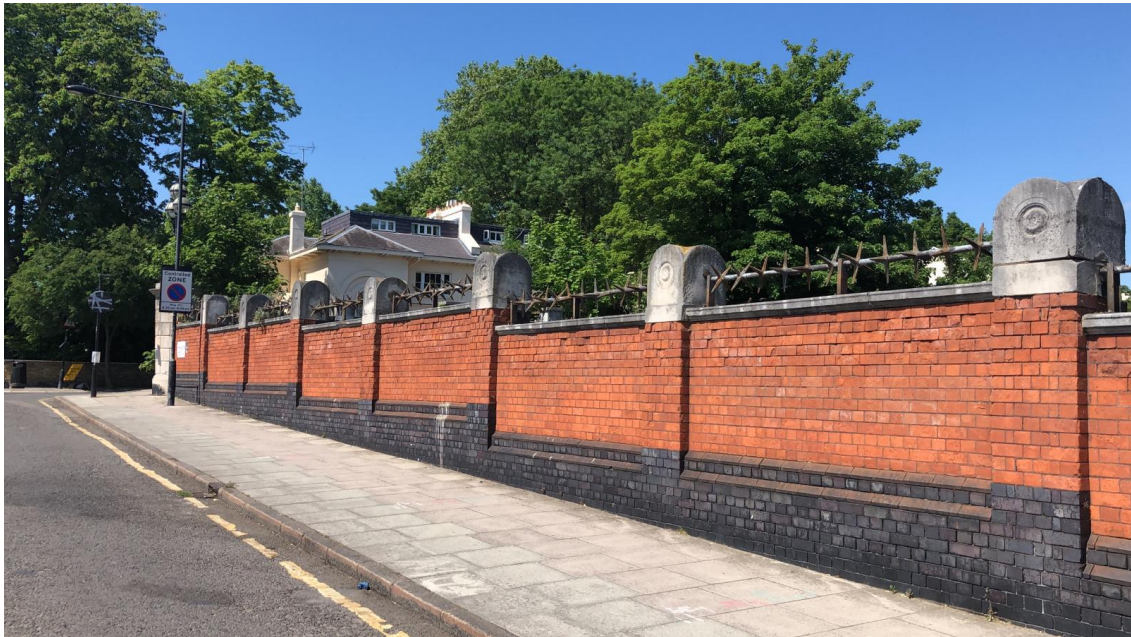
Figure 8 Mornington Street Railway Bridge looking north-west towards the pair of stone piers and lamp standards at the west end of the bridge and Nash property on Park Village East
