# Arboricultural Impact Assessment

***76 Lawn Road, Camden NW3 2XB***

Project Number: P3430.1.2

Date: 23 July 2020

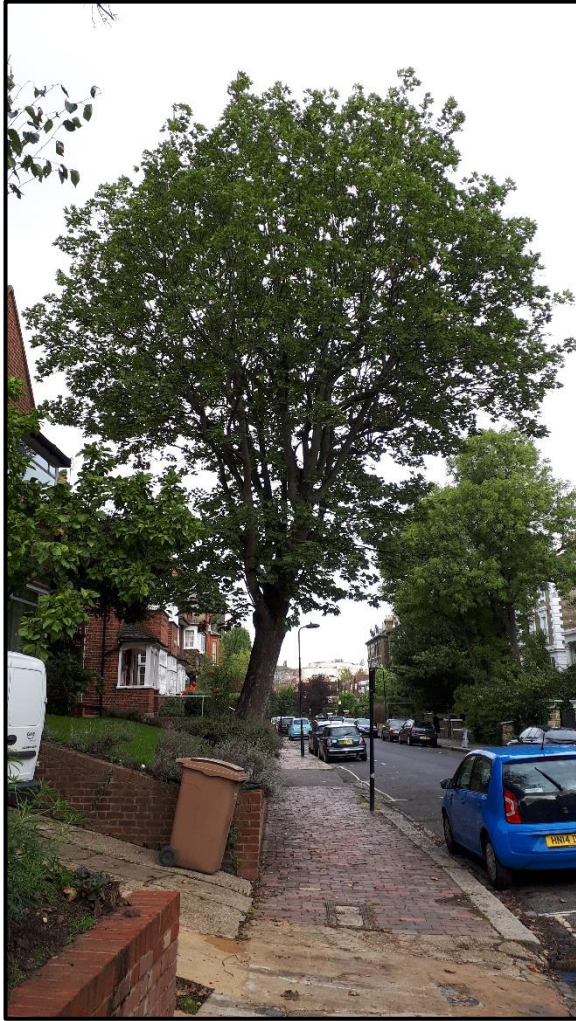
**Photograph 1.** T1, sycamore, located to the west of Lawn Road in raised front garden. Viewed looking towards the north.

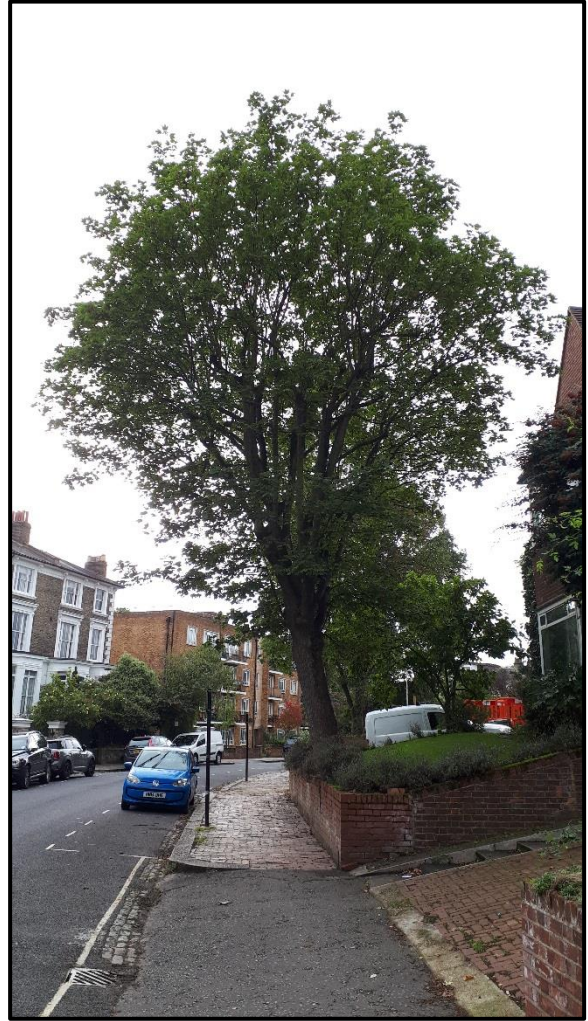
**Photograph 2.** T1, viewed looking towards the south.

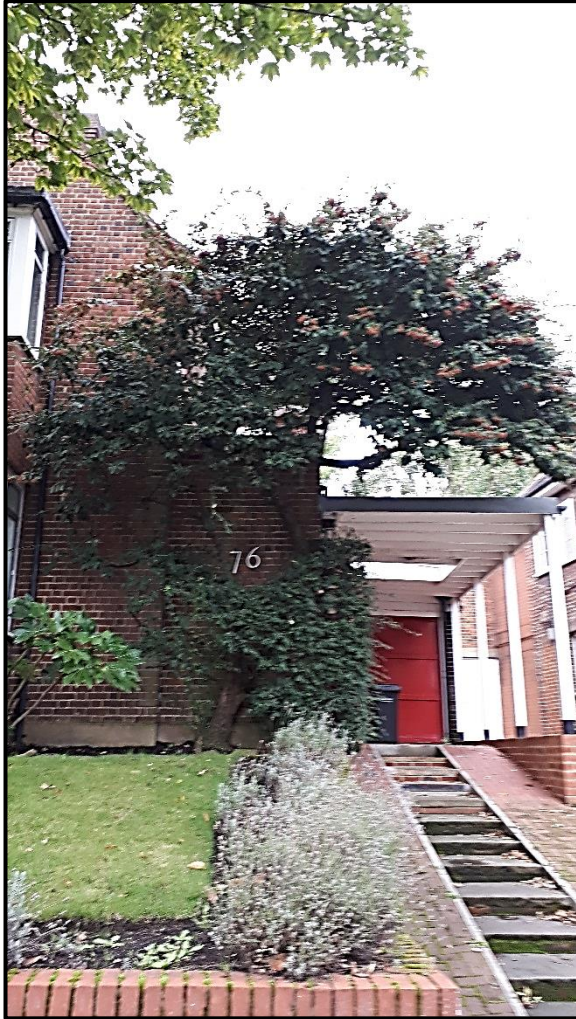
**Photograph 3.** T2, cotoneaster, located close to the property elevation. Viewed looking towards the west.

| Tree No. | Species | Age | Con | Height (m) | Spread (m) | | | | Crown Clear. (m) | DBH (mm) | Comments | PRF | Recommendations | BS 5837 Category | Rem. Cont. (est.) | RPA Radius (m) |
|---|---|---|---|---|---|---|---|---|---|---|---|---|---|---|---|---|
| T2 | Cotoneaster<br><i>Cotoneaster sp.</i> | M | G | 6.0 | 5 | 3 | 3 | 3 | 0 | 160<br>190 | Intermediate overgrown shrub, touching front elevation of property.<br>May cause direct damage to the building in future.<br>Forms two stems at 1m with normally formed union. | N | Remove within one year of survey date. | U | <10 | 3.00 |

- Removal of T2 to prevent property damage; and
- Crown reduction of T4 to prevent obstruction of the garden space.

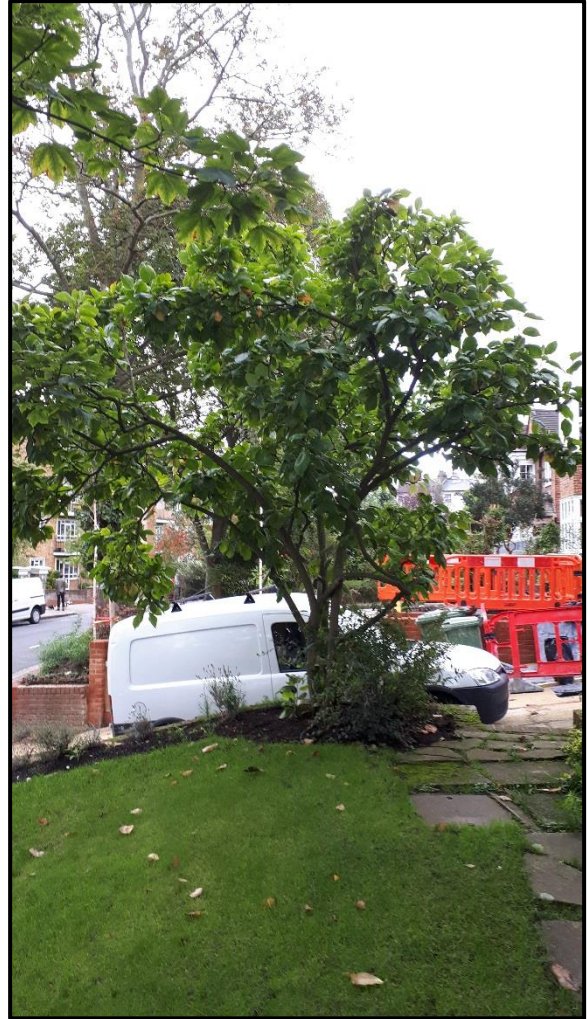
**Photograph 4.** T3, magnolia, located to the south of the front garden. Viewed looking towards the south.

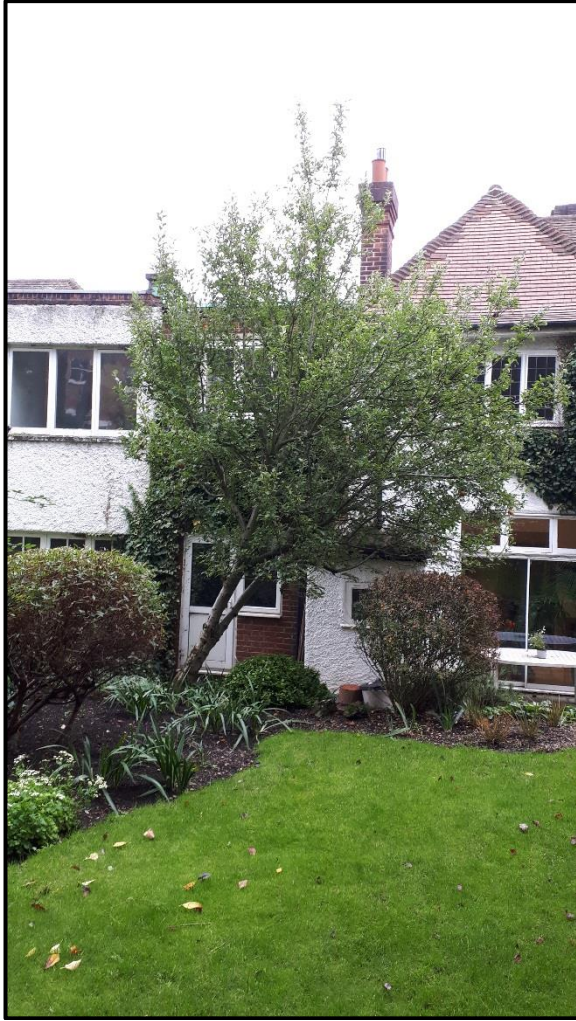
**Photograph 5.** T4, apple. Located in the rear garden. Note lean of main stem. Viewed looking towards the north-east.

| Tree No. | Species | Age | Con | Height (m) | Spread (m) | | | | Crown Clear. (m) | DBH (mm) | Comments | PRF | Recommendations | BS 5837 Category | Rem. Cont. (est.) | RPA Radius (m) |
|---|---|---|---|---|---|---|---|---|---|---|---|---|---|---|---|---|
| T4 | Apple<br><i>Malus sp.</i> | EM | G | 5.0 | 2 | 5 | 3 | 2 | 1.5 | 120<br>80 | Intermediate tree of good extension growth and crown density.<br>Main stem leans at 25 degrees to the south-east.<br>Forms two stems at 0.7m with acute angled V-Shaped union (VSU) and bark inclusion (BI).<br>Longitudinal basal bark damage to the north-west. | N | Reduce crown to south by 2m within one year of survey date. | C1 | 10-20 | 1.68 |

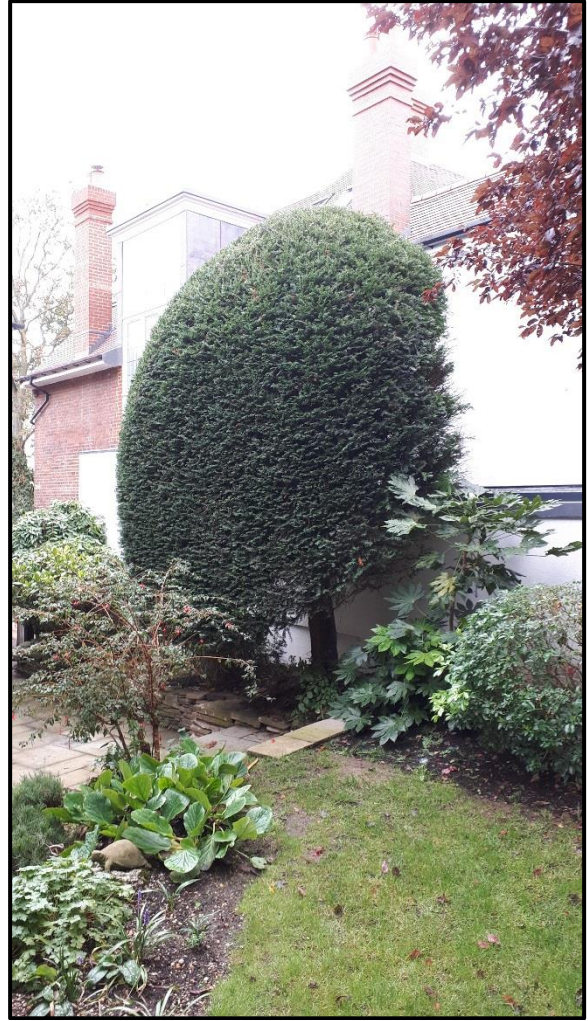
**Photograph 6.** T5, yew. Viewed looking towards the south-east.

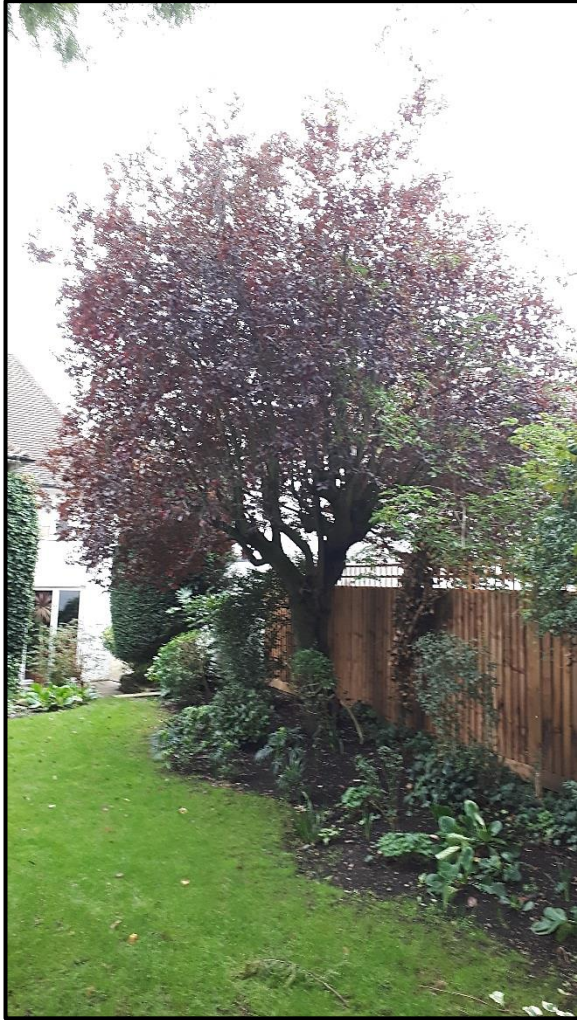
**Photograph 7.** T6, cherry, located centrally in the rear garden along the southern boundary. Viewed looking towards the south-east.

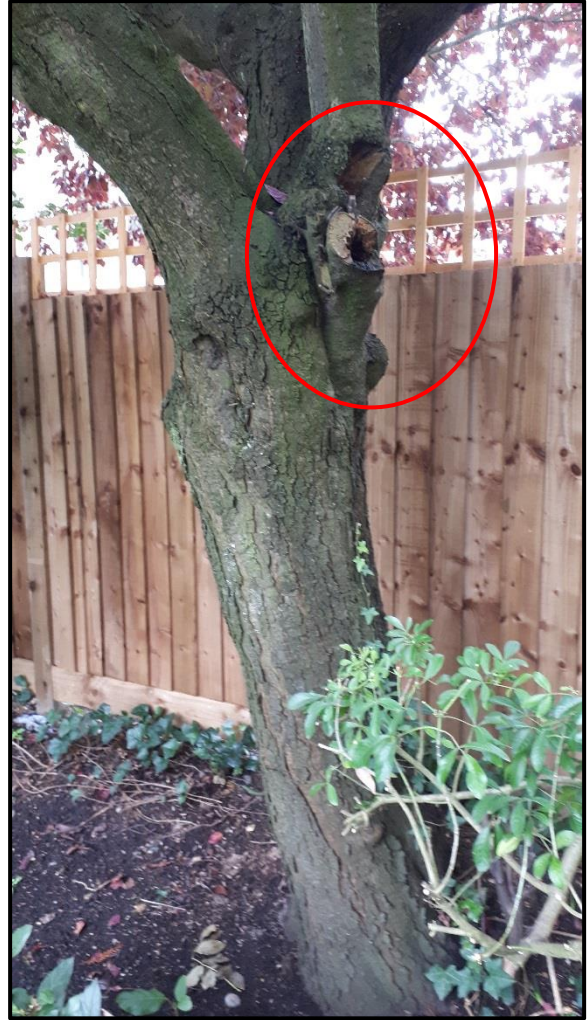
**Photograph 8.** Close-up of T6, showing pruning wound with associated decay and cavity (circled).

| Tree No. | Species | Age | Con | Height (m) | Spread (m) | | | | Crown Clear. (m) | DBH (mm) | Comments | PRF | Recommendations | BS 5837 Category | Rem. Cont. (est.) | RPA Radius (m) |
|---|---|---|---|---|---|---|---|---|---|---|---|---|---|---|---|---|
| T6 | Cherry<br><i>Prunus sp.</i> | M | F | 7.0 | 4 | 4 | 4 | 4 | 2.0 | 410 | Intermediate tree of fair extension growth and crown density.<br>Previously pollarded at 3 to 4m with fair regrowth.<br>130 x 300mm unoccluded wound at 1.4m to the east, with internal decay.<br>100mm diameter wound containing extensive decay at 1.8m to the west. | N | No work recommended | C1 | 10-20 | 4.92 |

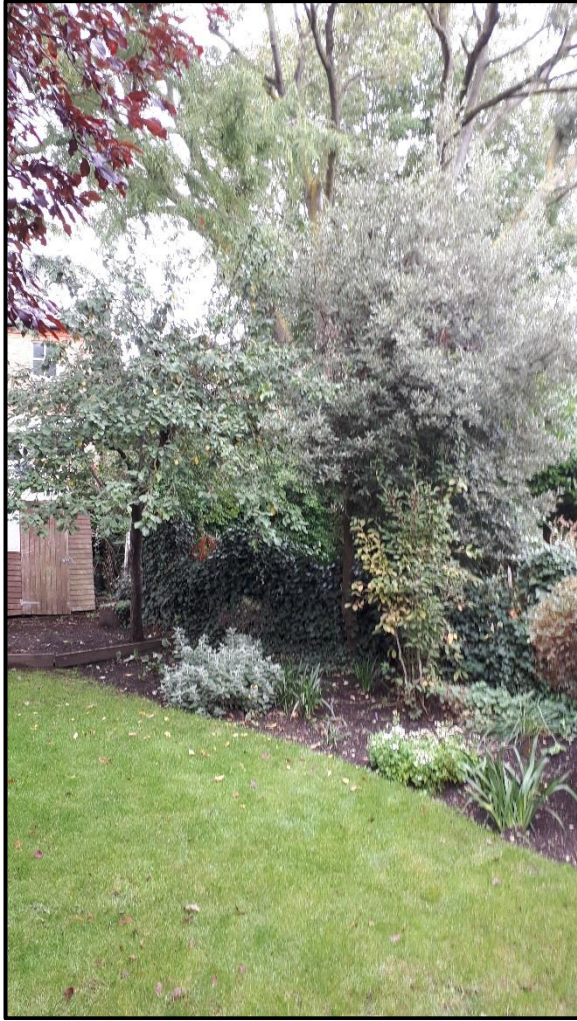
**Photograph 9.** G1, cherry (centre-left) and holm oak (centre-right), with mutual crown formation. Viewed looking towards the north-west.

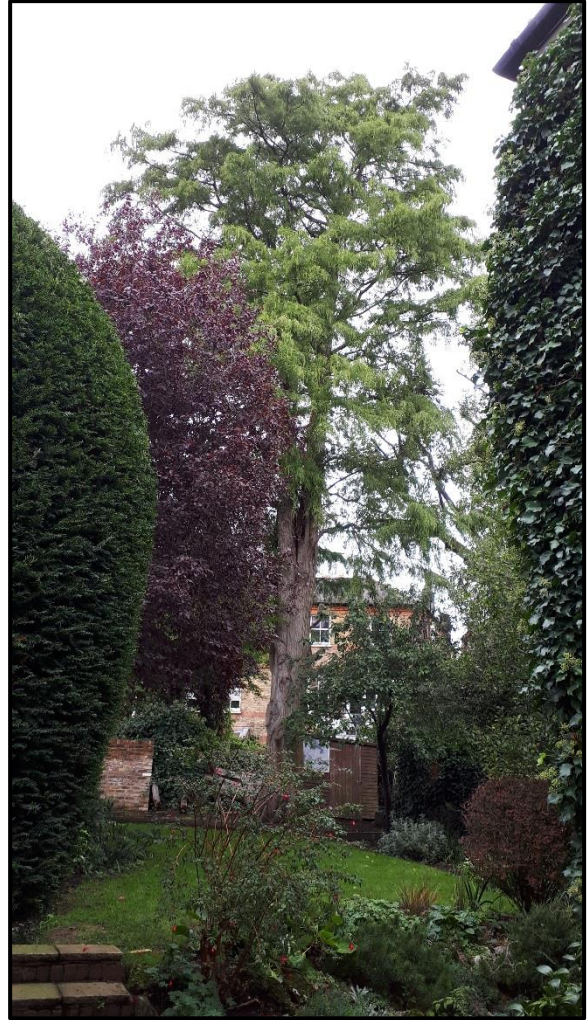
**Photograph 10.** T7, dawn redwood, located to the far west of the rear garden. A high quality and dominant tree in the surrounding environment. Viewed looking towards the north-west.

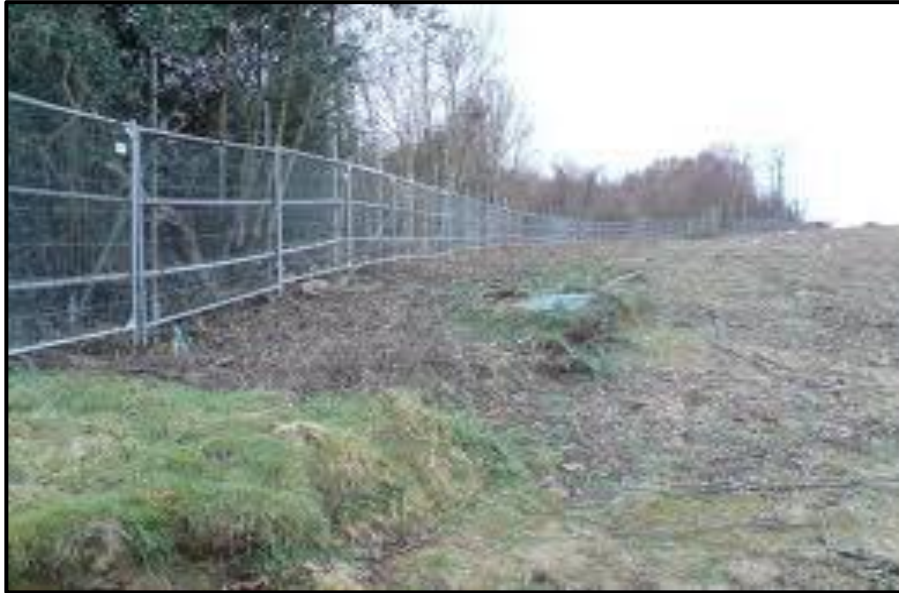
Tree Protective Fencing Panels shall be 2.0m high x 3.5m in length. (see image below).

**Tree protective fencing example.**
