BRITISH MUSEUM SOUTH COLONNADE ESSENTIAL
INFRASTRUCTURE WORKS – CROSS VENTILATION OF NEW
COPPER ROOF OVER GALLERY 48

DESIGN, ACCESS AND HERITAGE STATEMENT

GALLERY 48 ROOFING WORKS AS PART OF THE SOUTH COLONNADE ESSENTIAL INFRASTRUCTURE WORKS

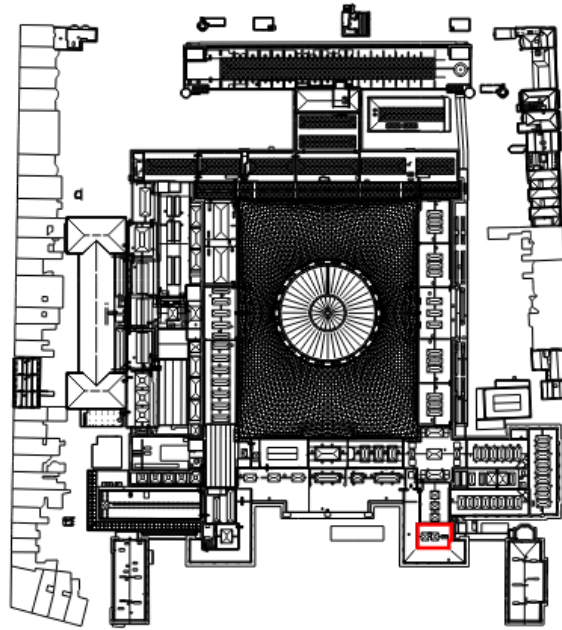
Figure 2: British Museum site plan with Gallery 48 identified by red outline

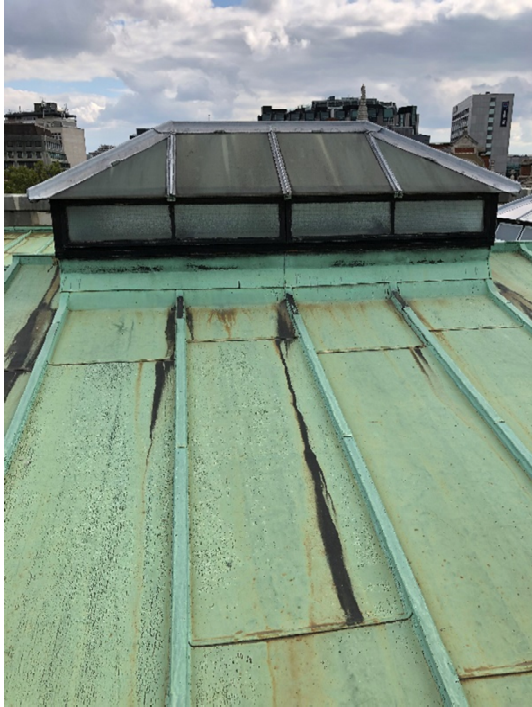
Figure 3 – Eastern advancing wing roof lantern and copper roof

Like the main Eastern Advancing Wing roof, it would appear that the Gallery 48 roof was redressed after the Second World War, possibly as late as the 1950's. It is showing considerable signs of distress as can be seen in the photos contained in the appendix and consent for its replacement was granted 27 December 2019.

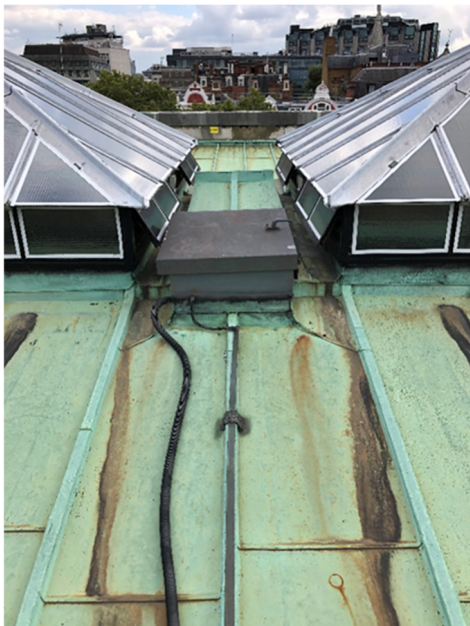
Figure 4: roof lanterns and access hatch over Gallery 48 , Eastern Advancing Wing

The works proposed in this retrospective application affect the Eastern Advancing Wing of the South Colonnade and in particular the area of roof over Gallery 48. The roof over contains three roof lights, two square of similar construction and the most easterly is of a different profile. It has a ridge running east – west which is punctuated by the roof lanterns.

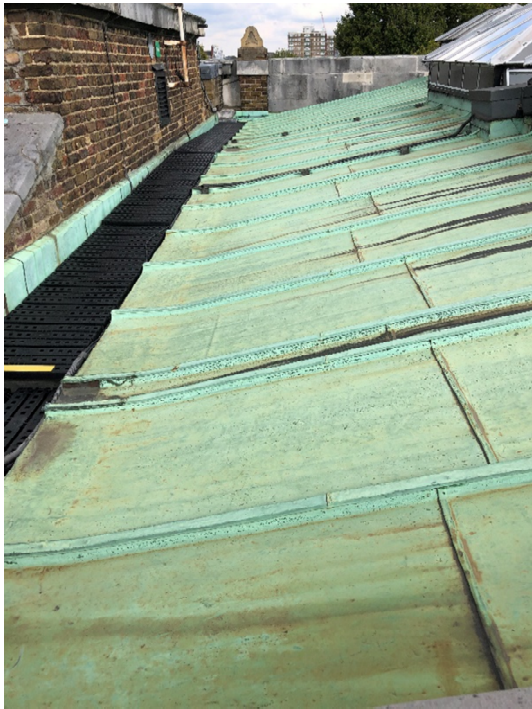
Figure 5: - area of deflected copper roofing

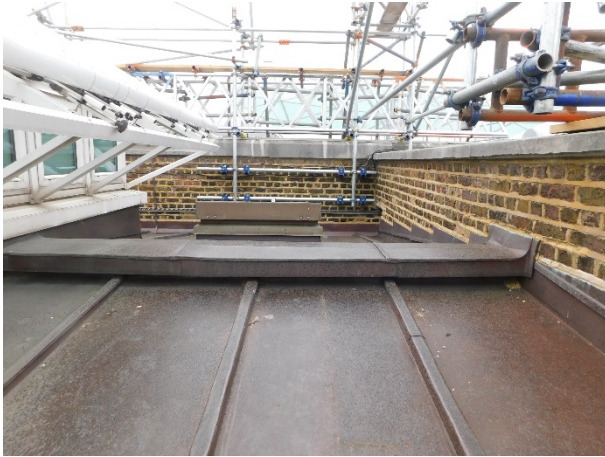
Figure 7: – 2008 ridge detail over G36-37 to be adopted

The detailing that will be adopted is based on the British Museum Gallery 36-37 works that were completed in 2008. These details introduced an amended ridge profile and a new wall plate beam inserted under the roof lanterns. The latter is to allow a new copper flashing to be dressed up and provide an effective seal against the elements. This will result in the lantern ridge being raised approximately 120mm. Where the lower slopes of the copper sheet meet the existing gutter the upstand is raised by 75-100mm. Refer to appendix B in this Design and Access statement to see photographs of the Gallery 36-37 as built conditions to allow you to assess the visual impacts this retrospective change will have.

The detailing required to cross-ventilate has been successfully used on the adjacent copper roof over galleries 36-37 which was completed in 2008.

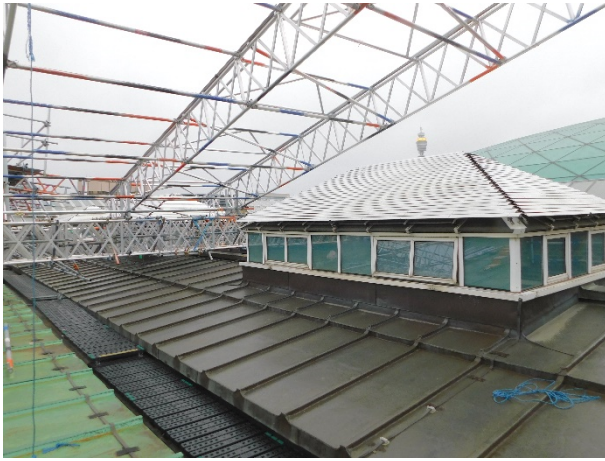
Figure 8:: detail at gutter showing visual impact of raising roof for cross ventilation

One of the mitigation measures is to cross ventilate the roof to allow any dampness to properly dry out. As the existing copper roof is being replaced as part of the approved scheme the Museum are looking to introduce over-boarding the existing sarking boards with treated timber battens and then apply a 25 mm plywood. This new deck receives a vapour permeable roofing membrane and then the copper roof is applied. Because of the over-boarding the height of the roof raises nearly 100mm.
