3 Fitzroy Square

LKB09_552

FIREPLACE GFR-R(NW)

STATUS: PLANNING

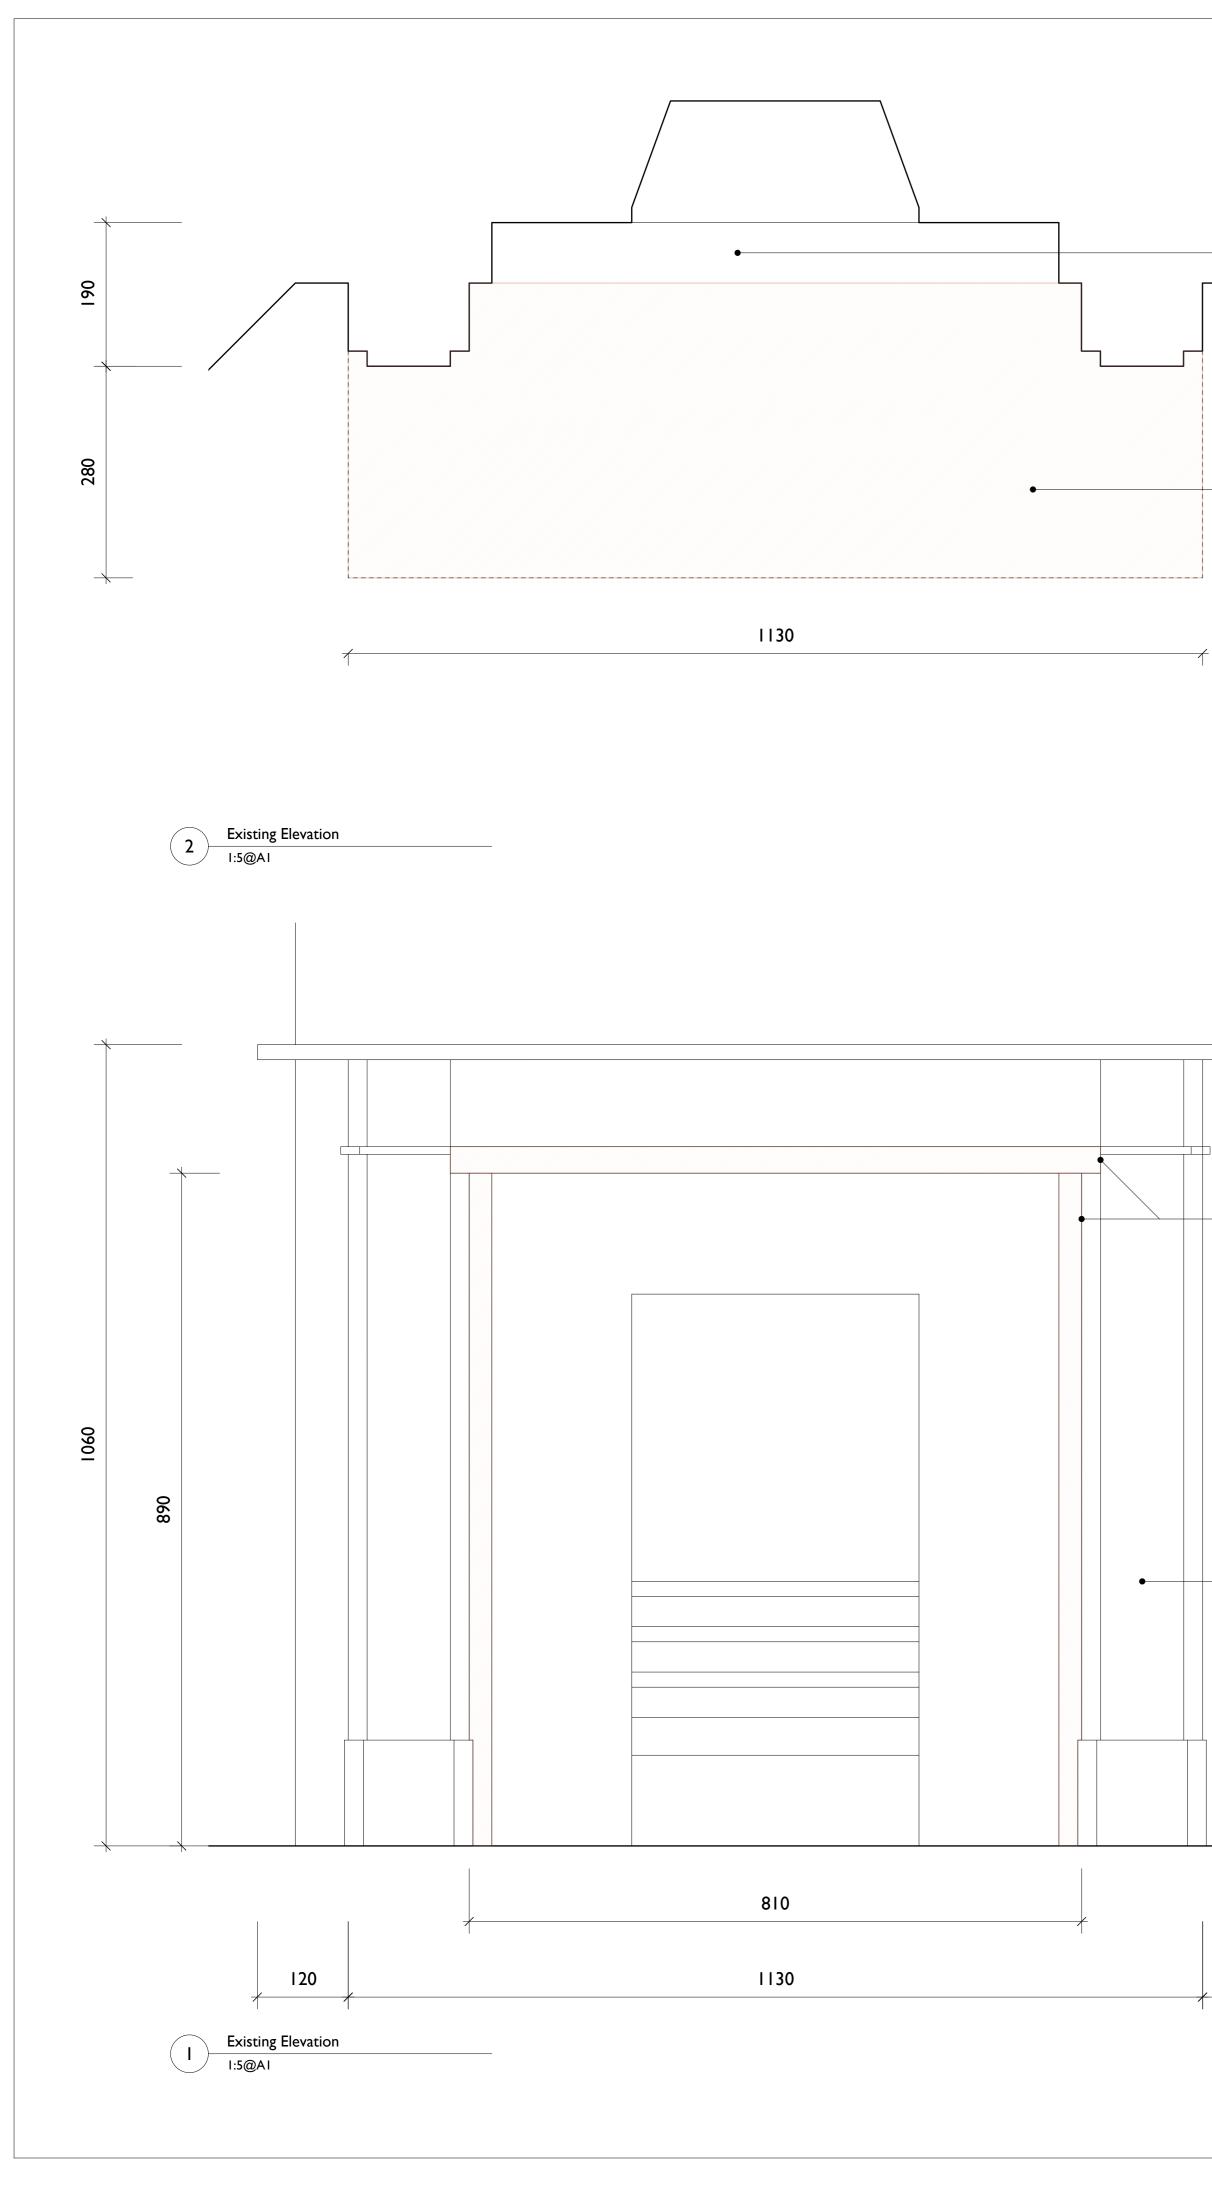
Existing chamber base in glazed ceramic tiles.

Existing rouge marble soffit and slips are incongruous later additions To be replaced with new section to match existing

Existing stone chimneypiece painted, possible veined Carrara marble. To be retained, w/dry removal of paint, cleaning and wax.

To be retained and cleaned

Existing hearth screeded and glued over, in very poor condition. To be removed and replaced with new carrara marble hearth slab (see JF18_5913).

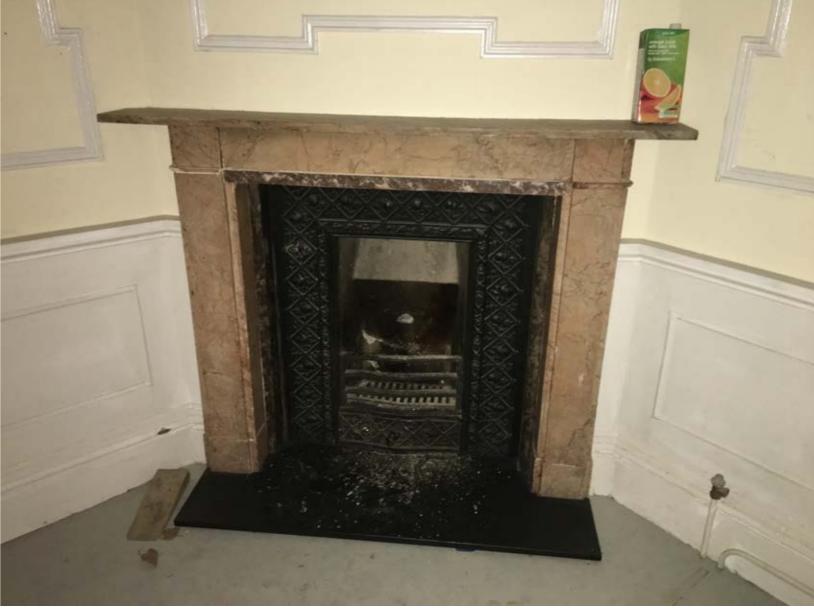
Photograph of existing (original hearth slab covered)
