Ground Conditions Assessment Report

Francis Gardner House, West Hampstead

PREPARED BY: Jubb Consulting Engineers Ltd. FOR: Empiric Properties DATE: January 2020 reference: 19366-GCA-1

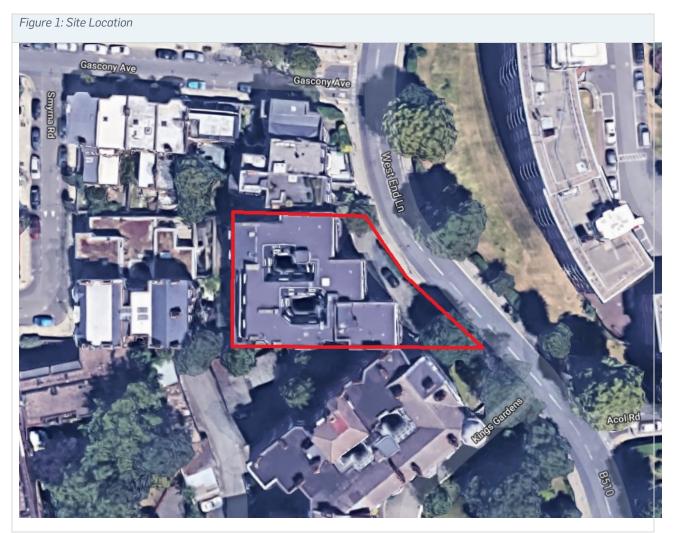
Figure 1: Site Location9

The site is located at the existing Francis Gardner Apartments, situated along West End Lane in West Hampstead. The outline of the site is depicted in Figure 1 below.

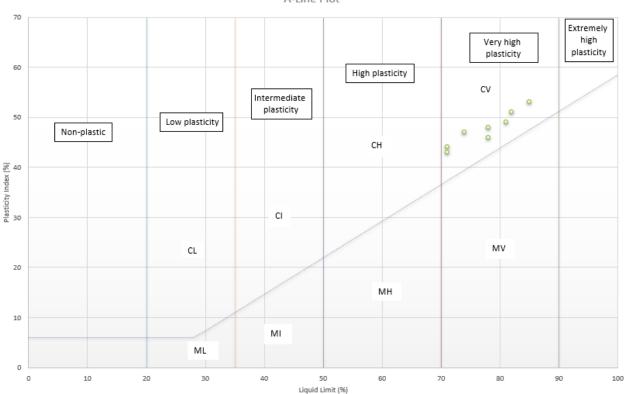
Table 11: Plasticity Chart

The results show that the clay from the London Clay Formation has a very high plasticity and a high volume change potential with changes in moisture content.

Minimum	Maximum	Average
Natural Moisture Content	25	35	30
Liquid Limit	71	85	78
Plastic Limit	27	32	30
Plasticity Index	43	53	48

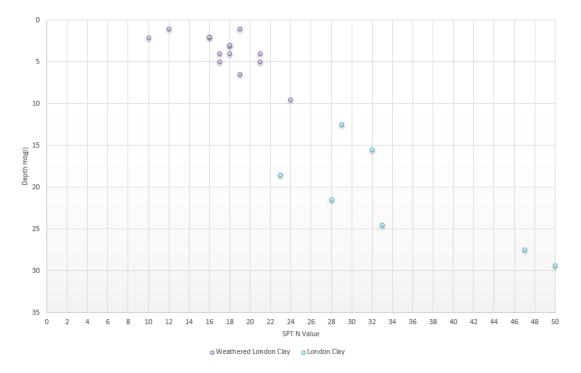
Table 12 SPT v Depth Plot

SPT tests were carried out throughout the London Clay profile, with the results shown in the below depth v SPT N value plot. As can be seen the SPT results show a marked increase in strength with depth.

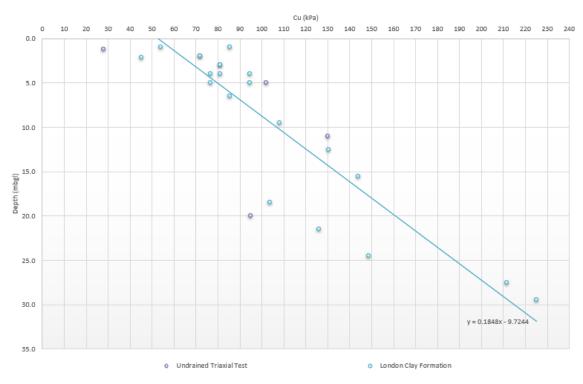
Table 13: Undrained Shear Strength v Depth

Using Stroud and Butlers (1975) correlation, the SPT N value can be correlated to an undrained shear strength value using the formula Cu = SP N value * 4.5.

The correlated values together with the laboratory undrained shear strength test results are shown on the below plot.
