# Construction/ Demolition Management Plan

14-19 Tottenham Mews

Derwent London

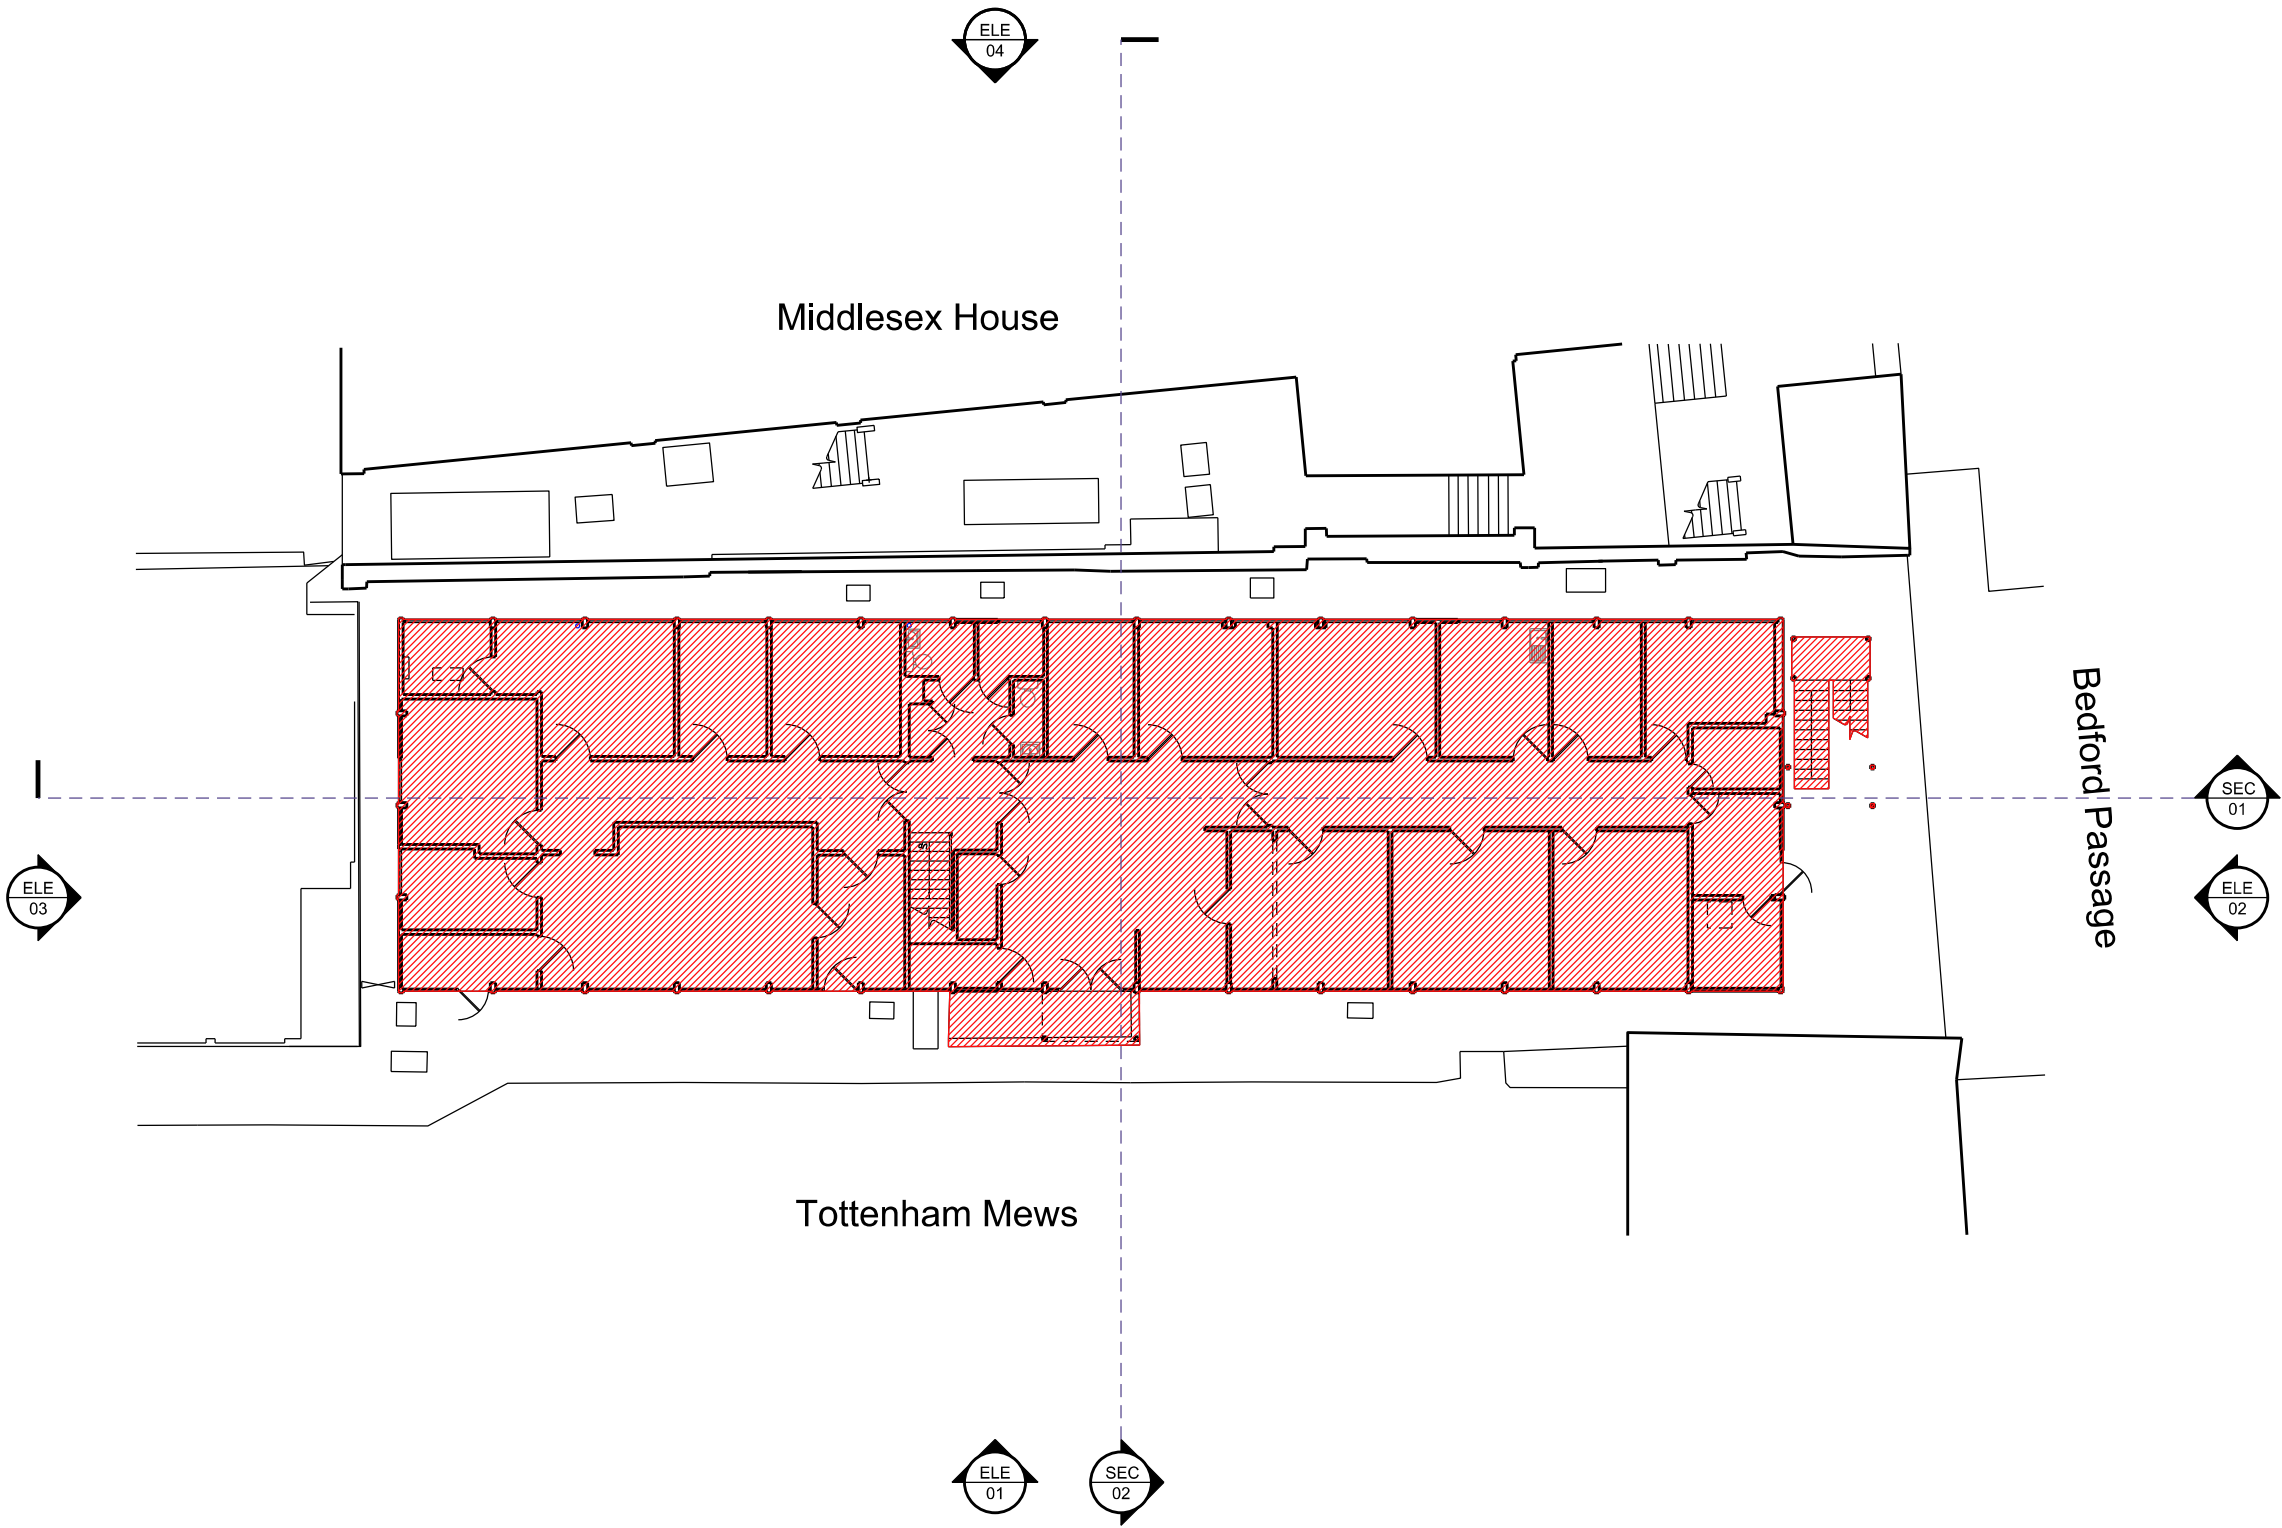
Area to be demolished

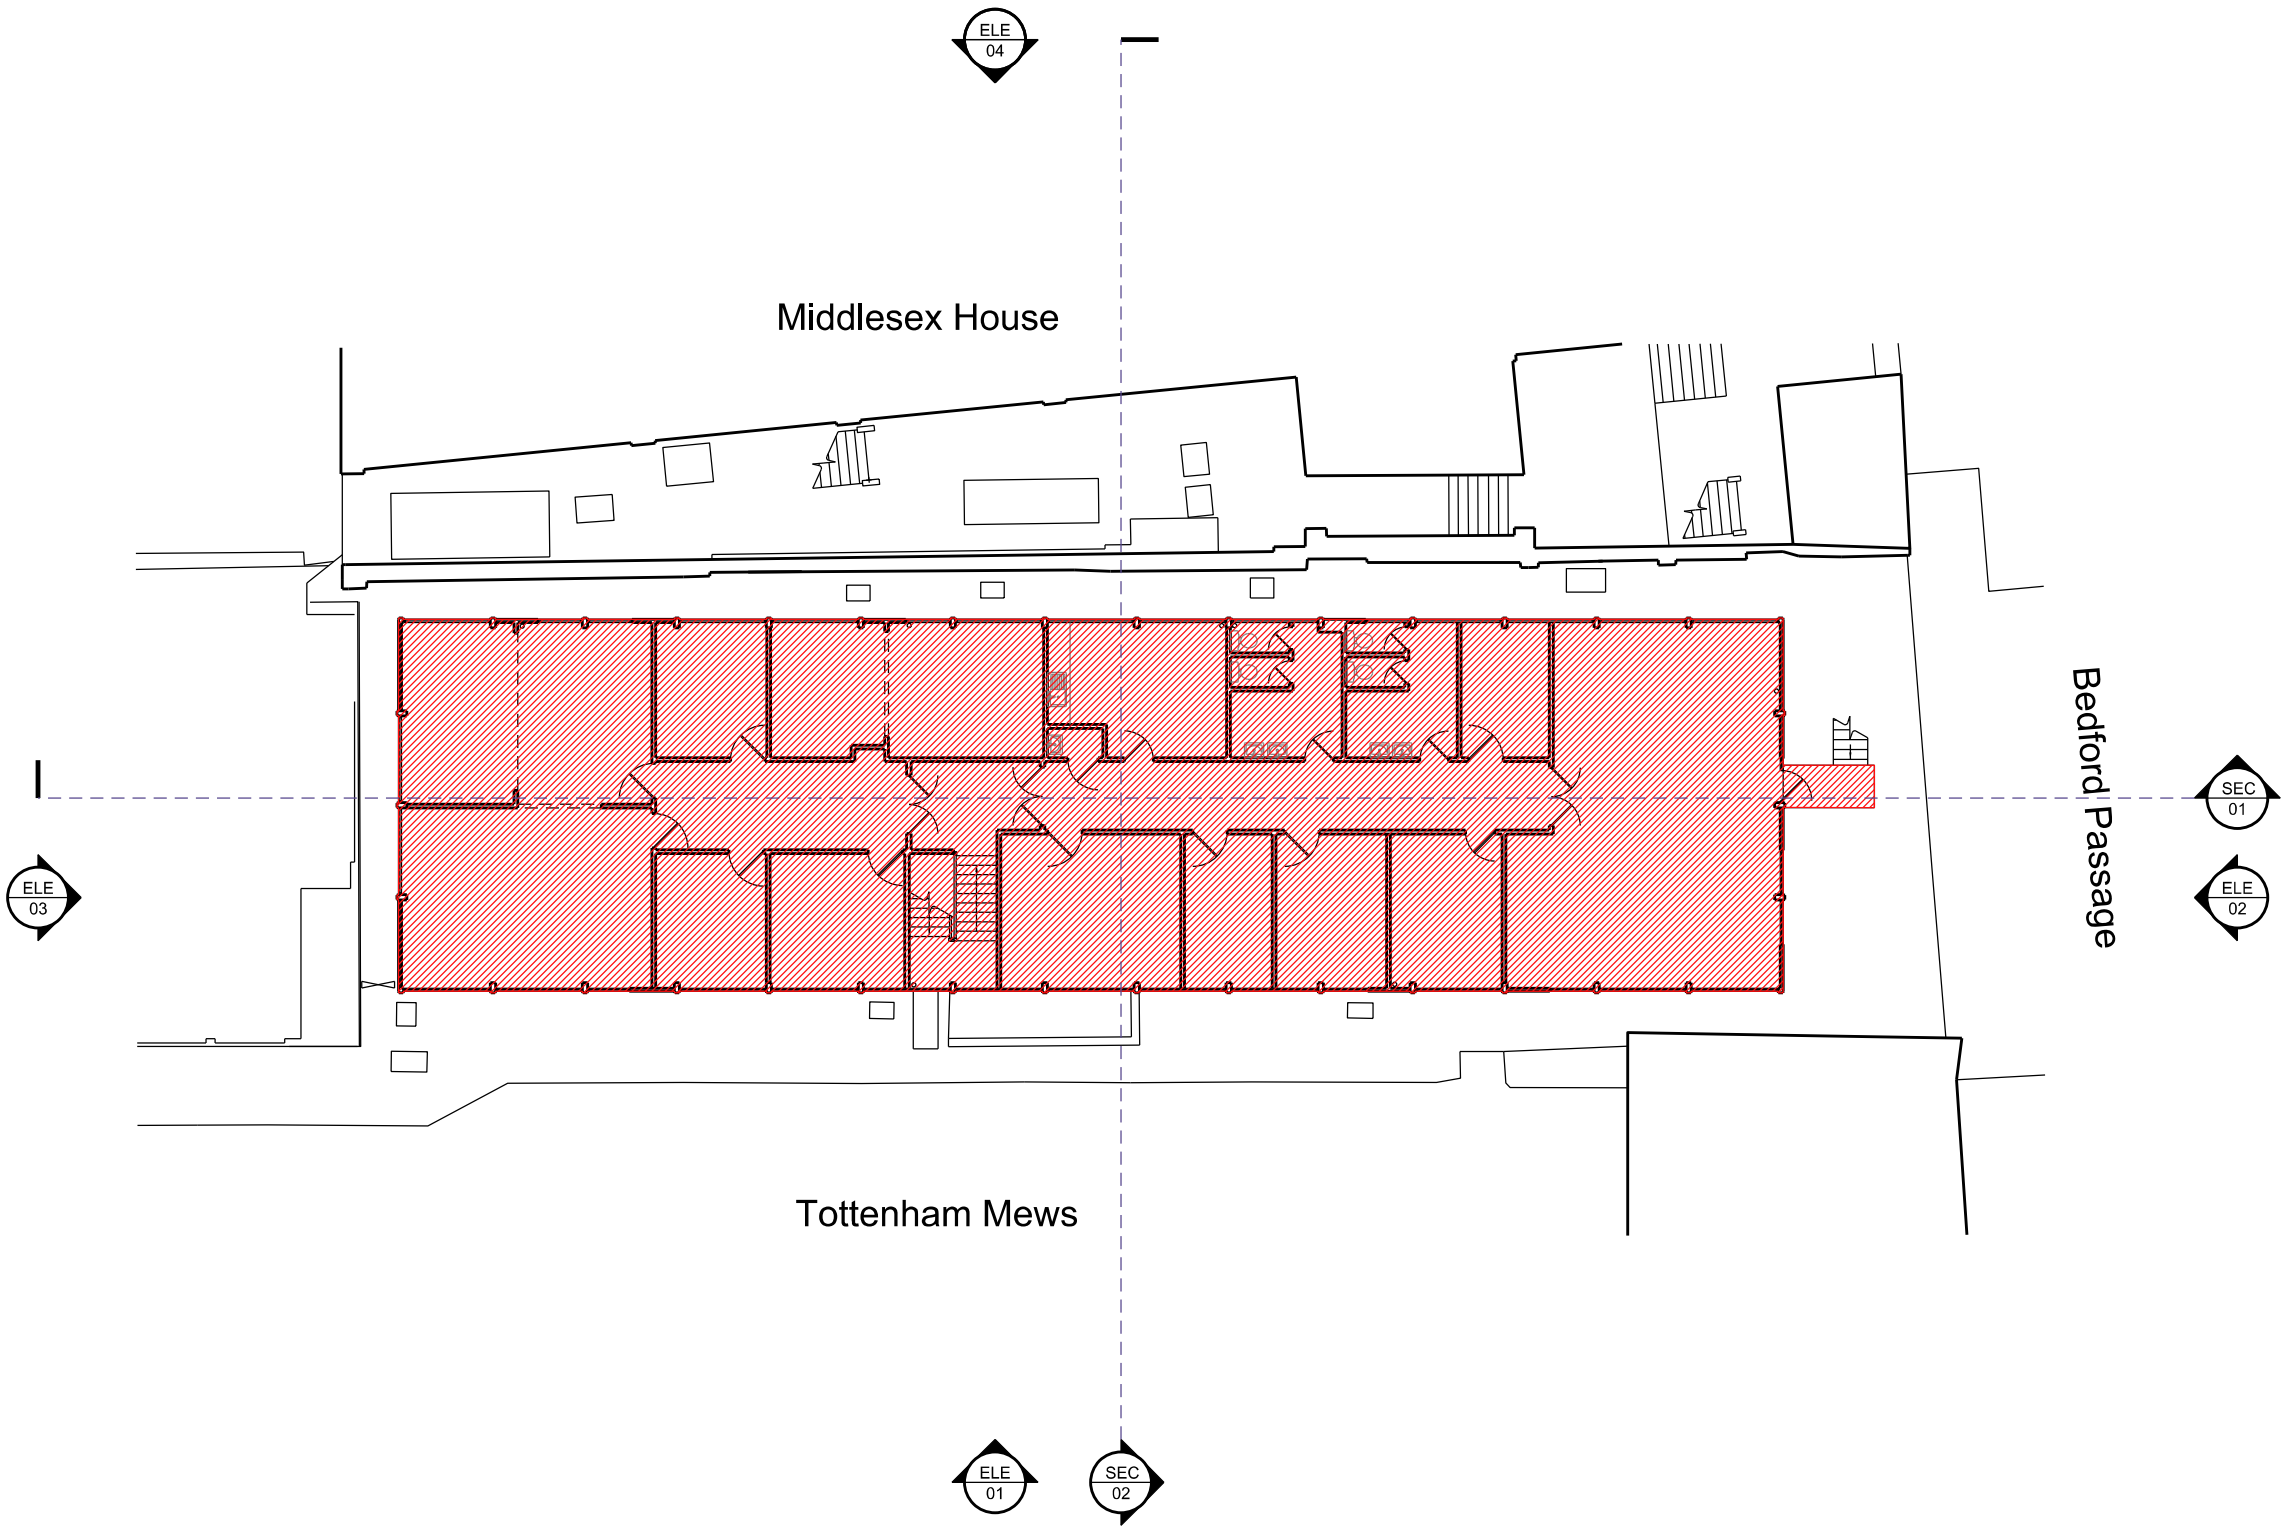
Area to be demolished

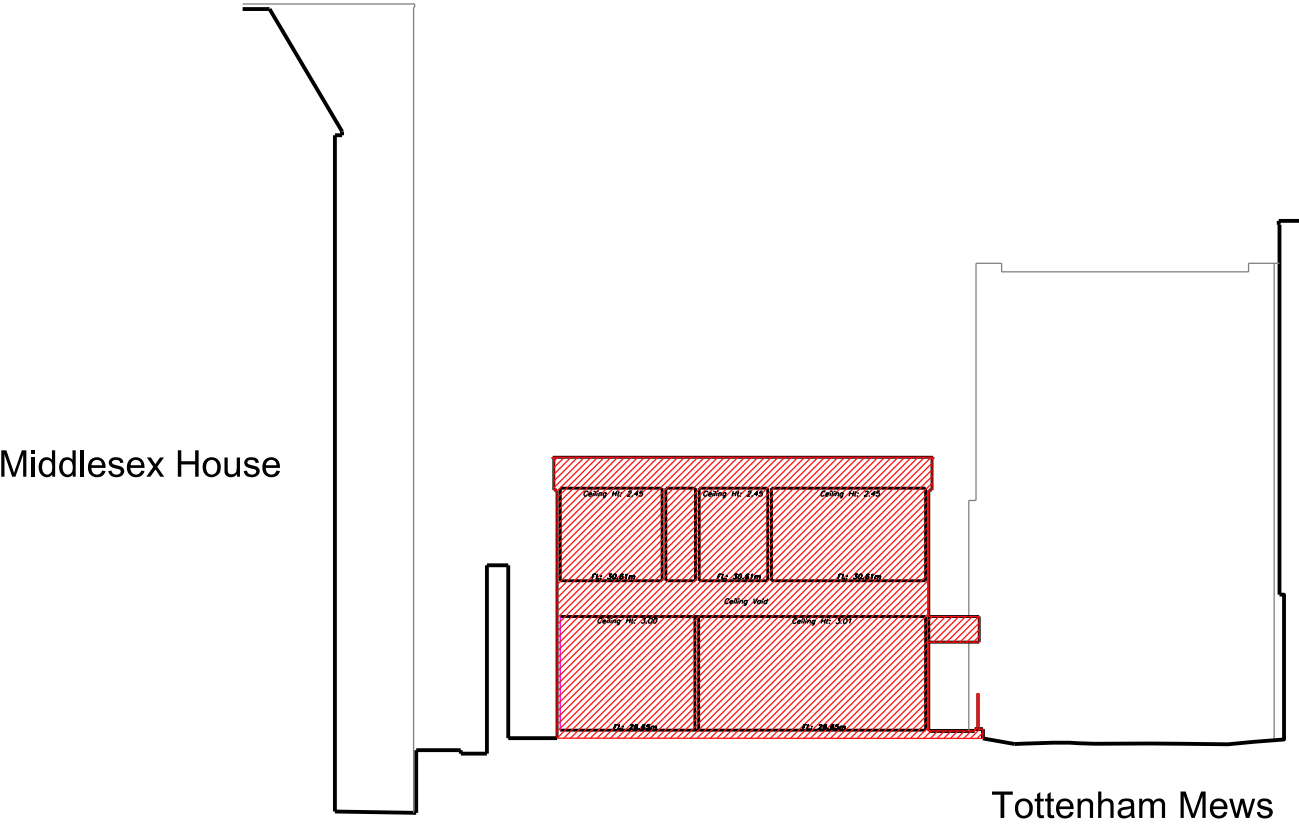
Section 02

Area to be demolished

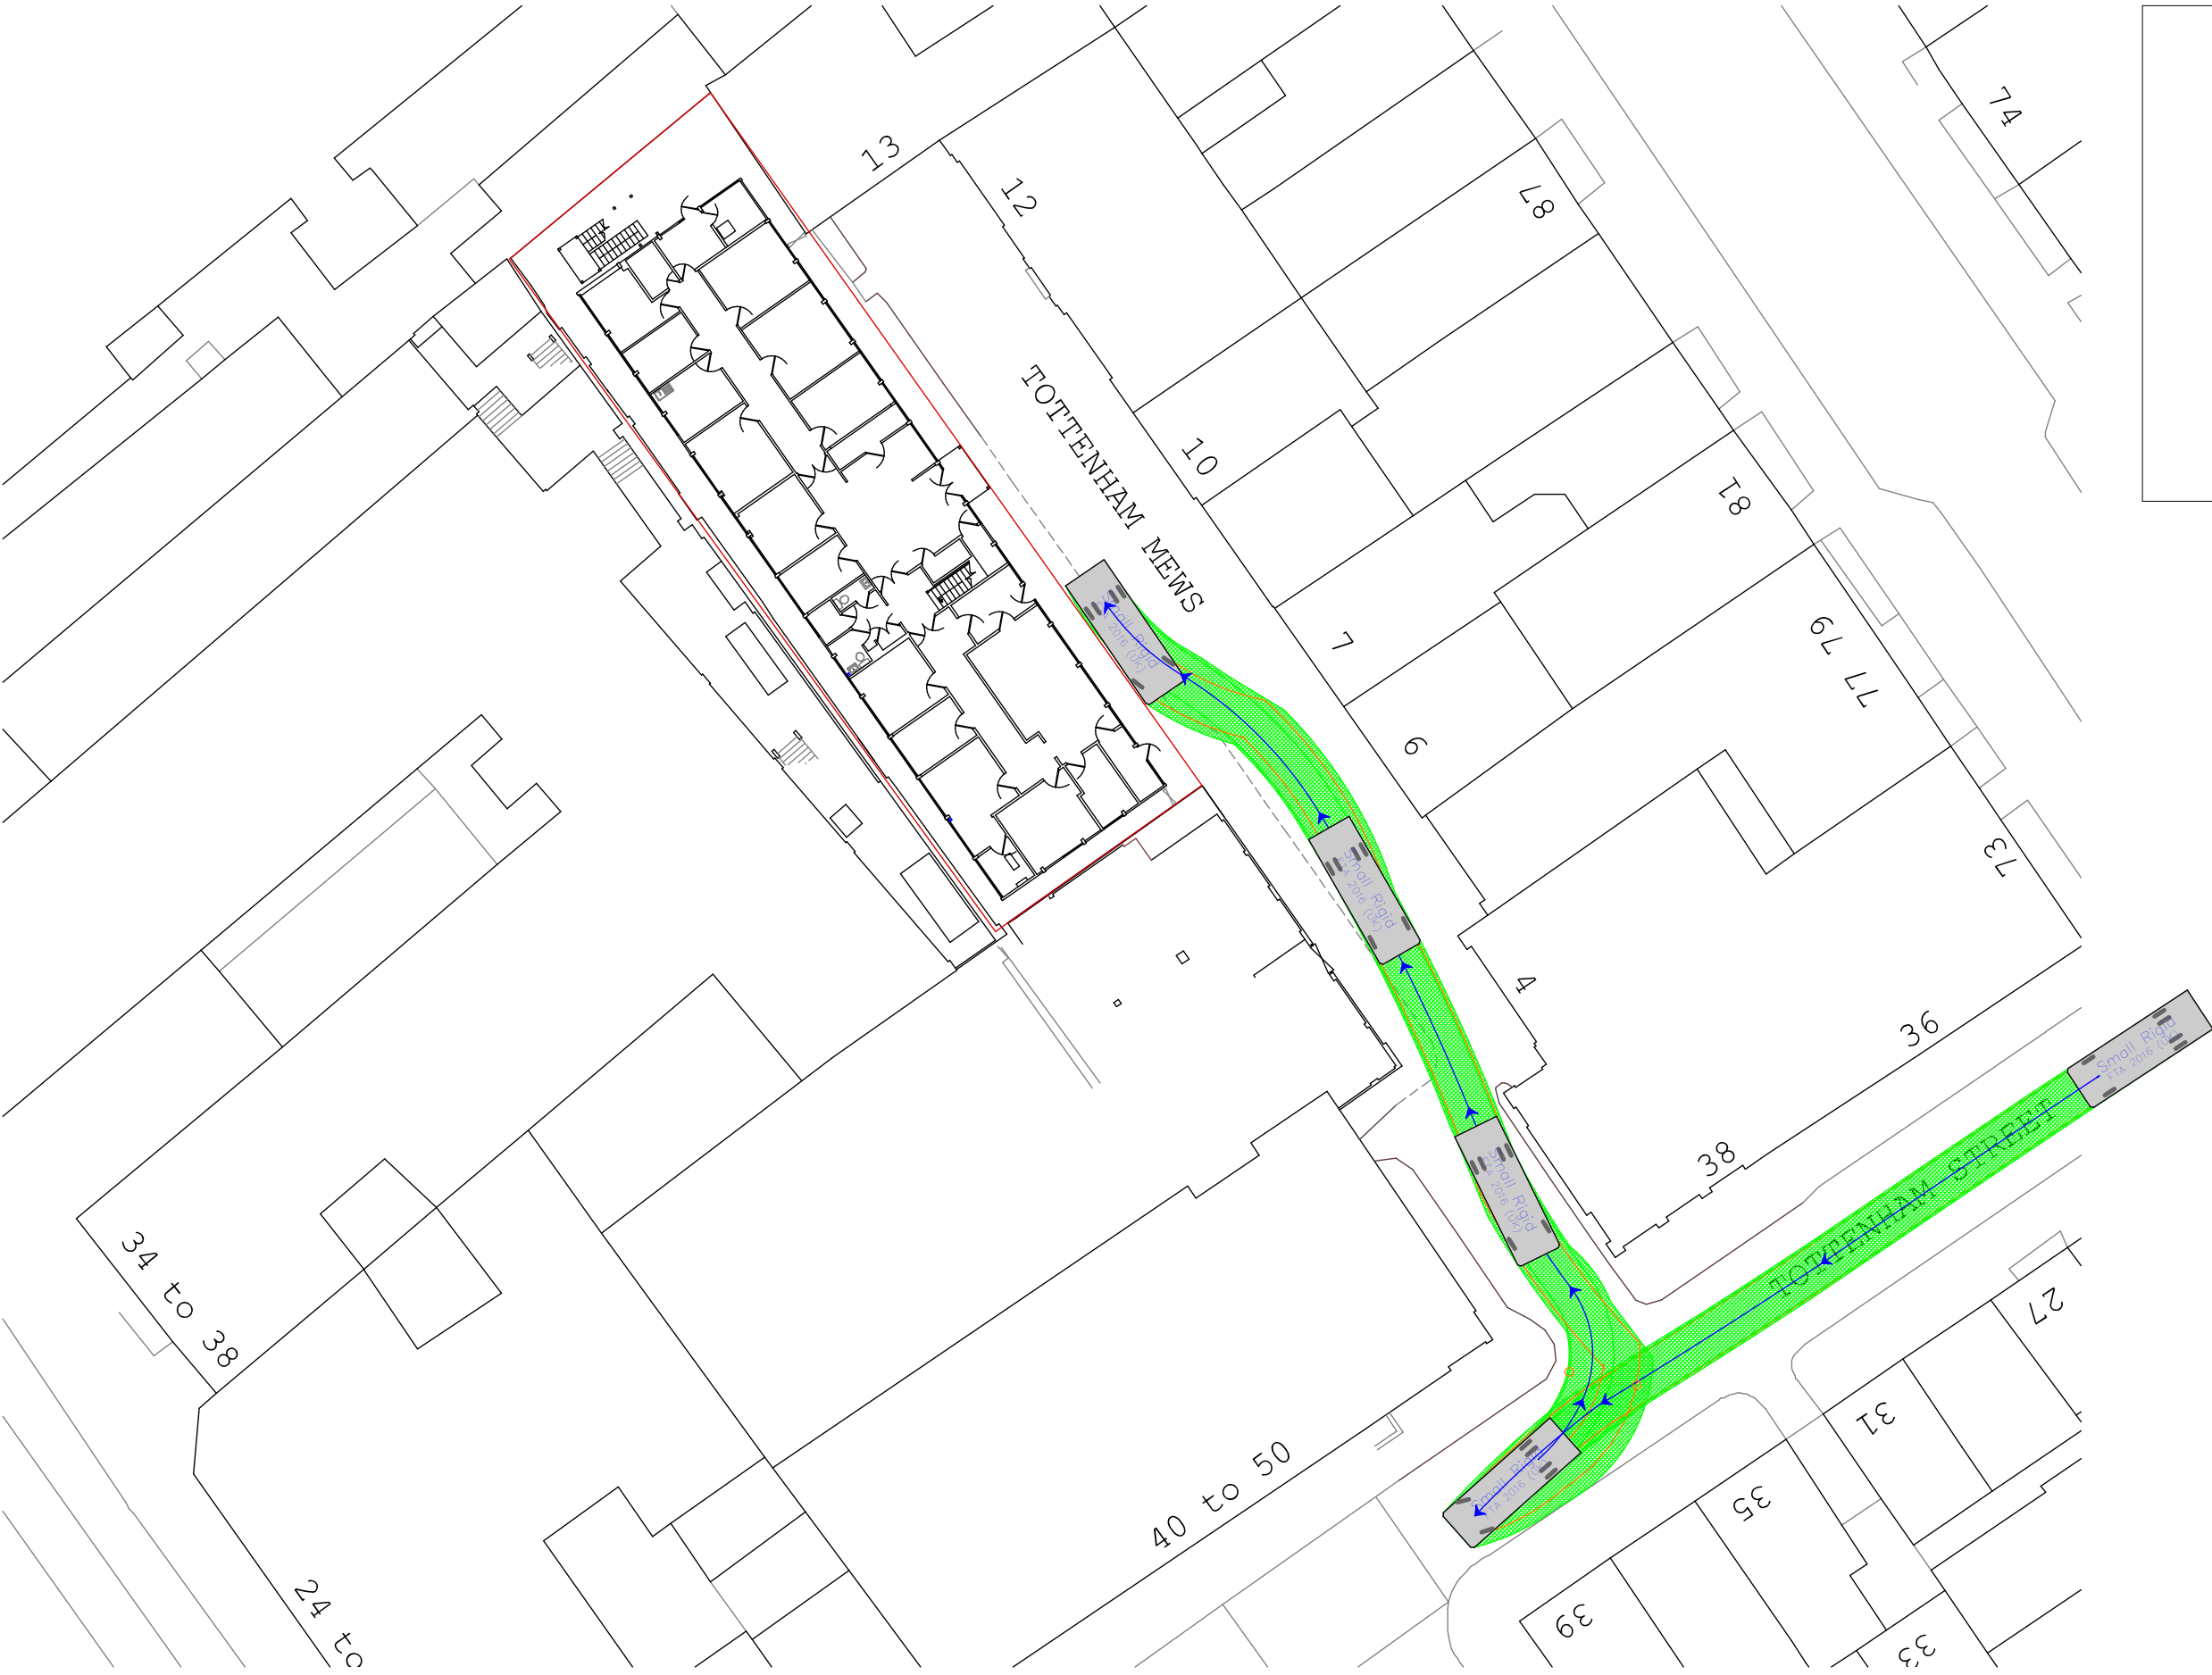
Swept path Small Truck - IN

Small Rigid

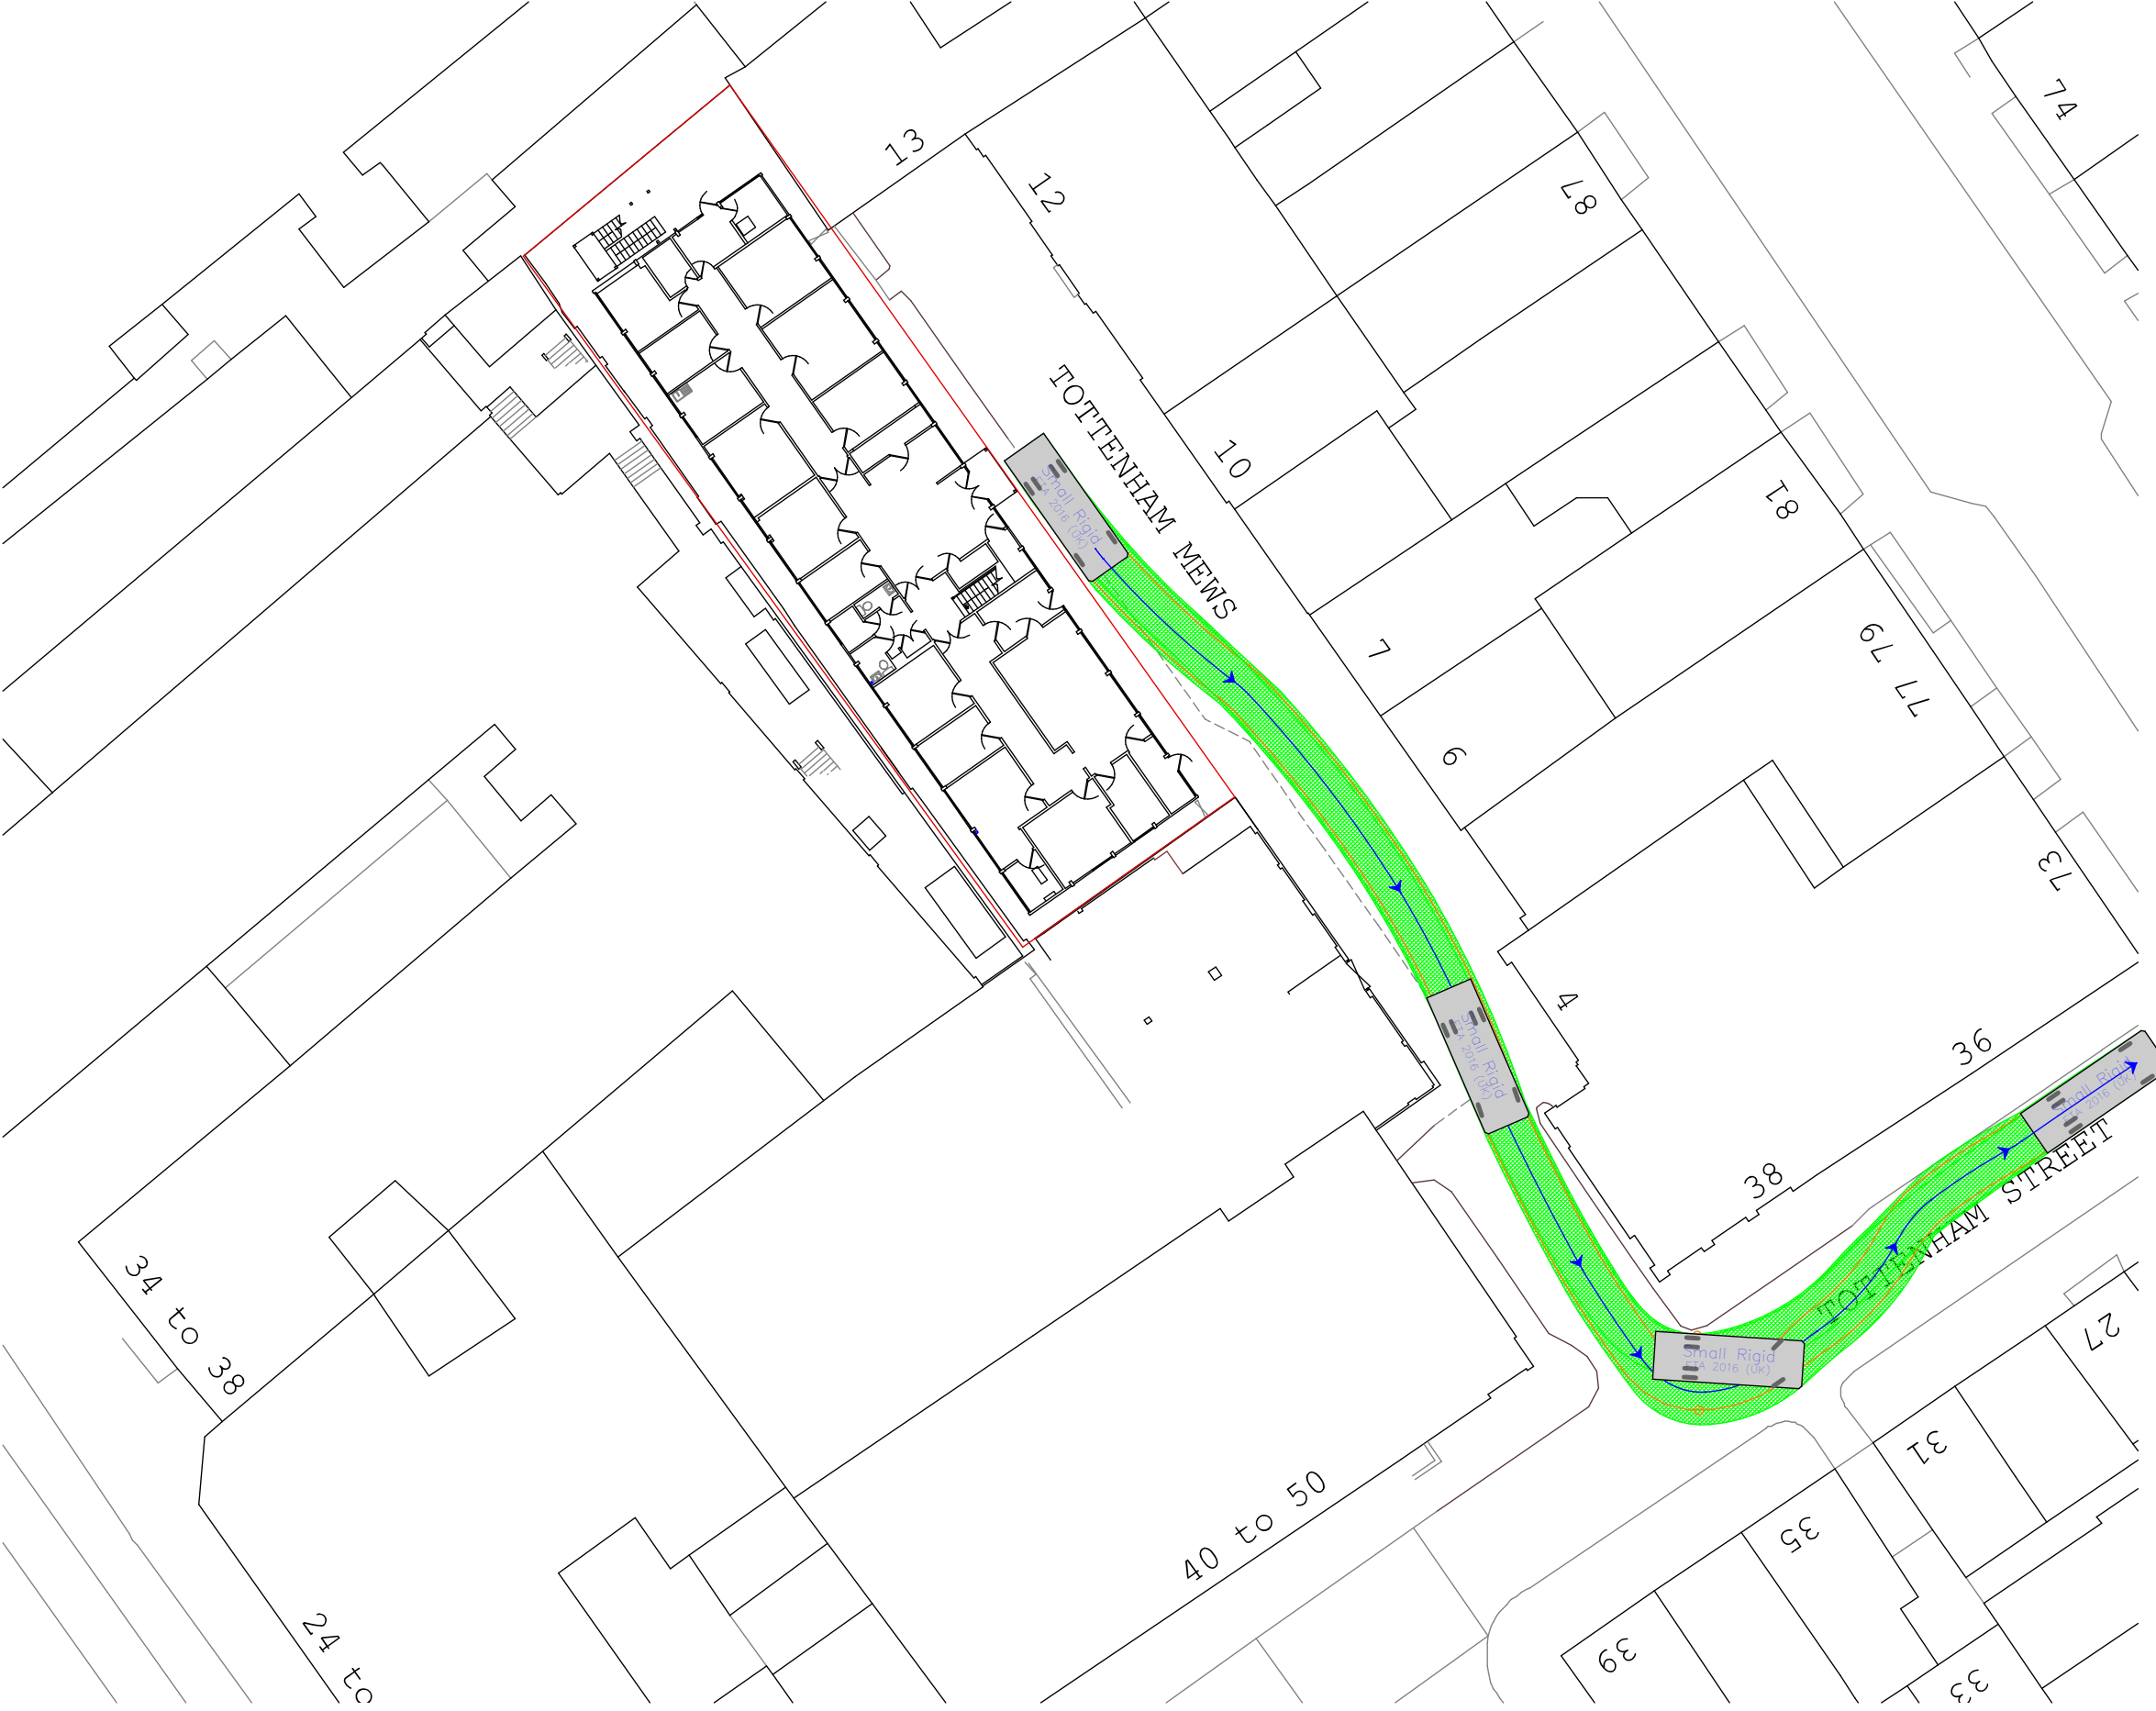
# Swept path Small Truck - OUT

Small Rigid

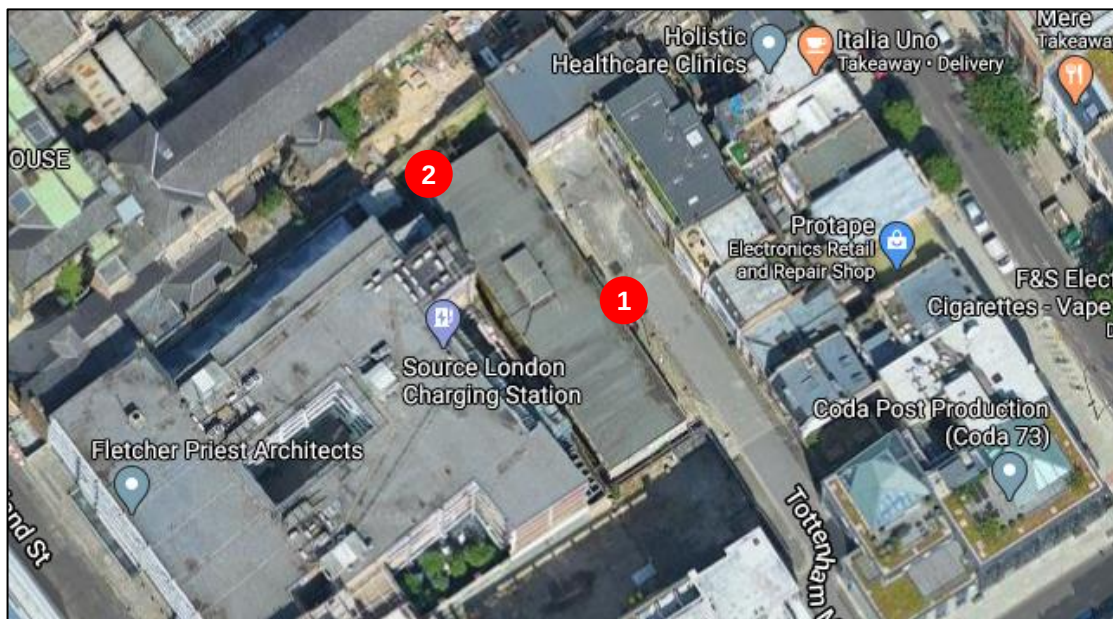
The positions are shown on the plan below.

Plan Showing Unmanned Measurement Positions (Imagery ©2020 Bluesky, CNES / Airbus, Getmapping plc, Infoterra Ltd & Bluesky, Maxar Technologies, The GeoInformation Group, Map data ©2020)

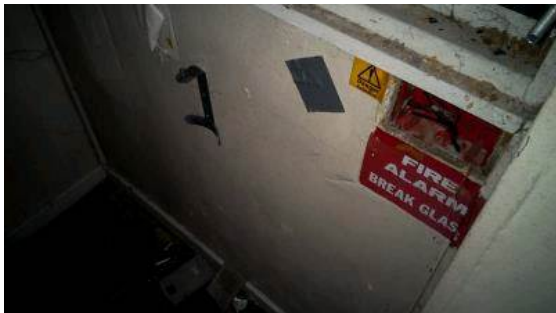
| | | Item Reference | J263902 #1 |

| | | Condition / damage | (1) Low Damage |
| | | Risk code | Risk code B |

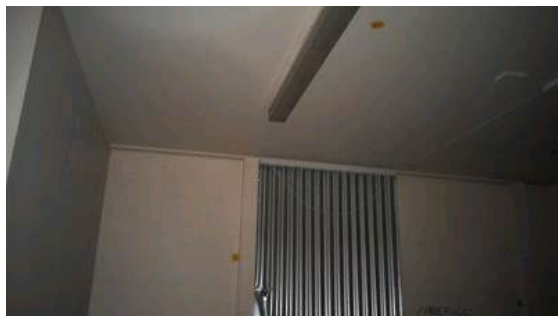
| Risk code | Risk code B |

**Recommended Action** Remove

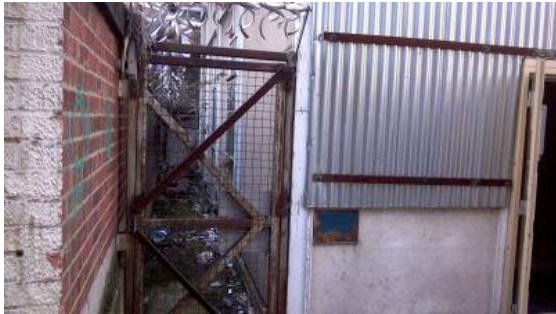
**Recommended Action****Comments:** doors welded

| Risk code | Risk code F |
