CAMDEN TOWN HALL

LBC Condition 5 (ref: 2020/0214/L)

Further information provided following meeting presentation 29/07/20

1.0 FURTHER IMAGES OF SELECTED PORTLAND STONE SAMPLE – BROADCROFT WHITBED

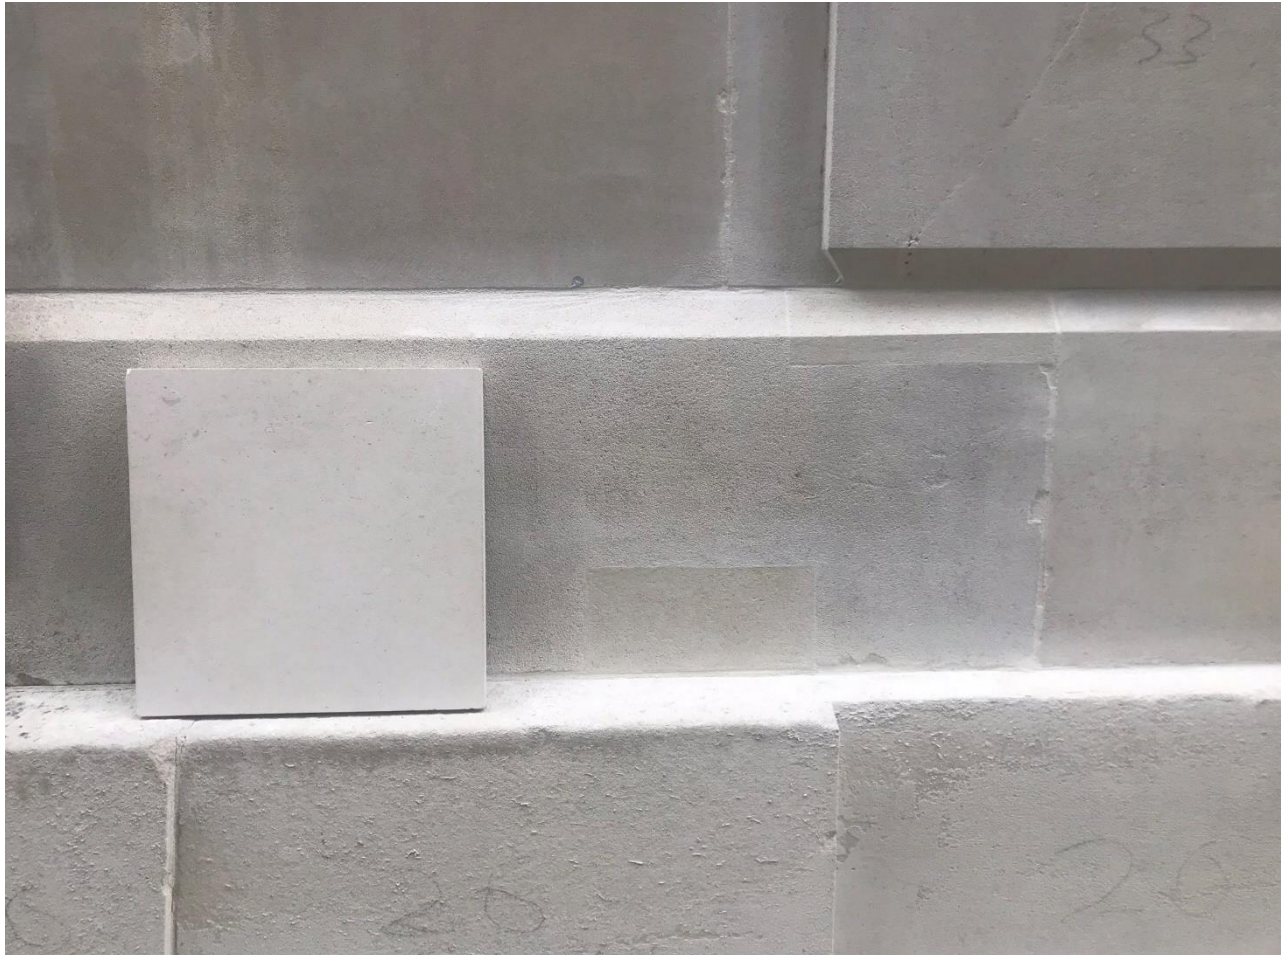
CH comment: The sample looks smooth in comparison to the existing façade.

The above image shows the proposed sample against an area of existing cleaned Portland stone, which demonstrates a visible variation of texture in the existing façade – some smoother areas, some slightly rougher. Specialist stone contractor has also confirmed that the new stone will weather over time resulting in a slightly rougher finish.

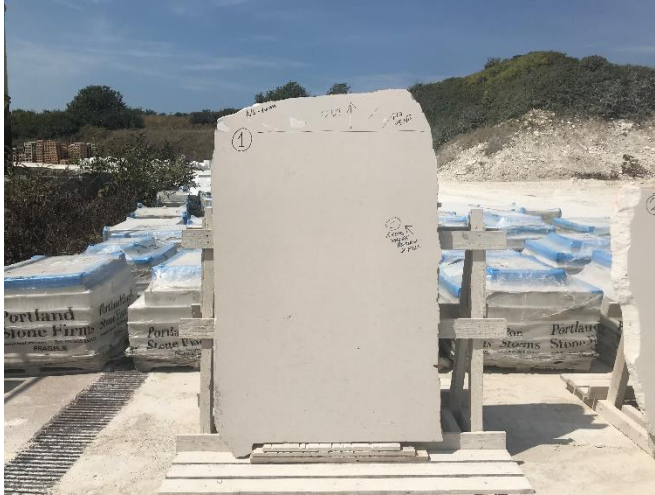
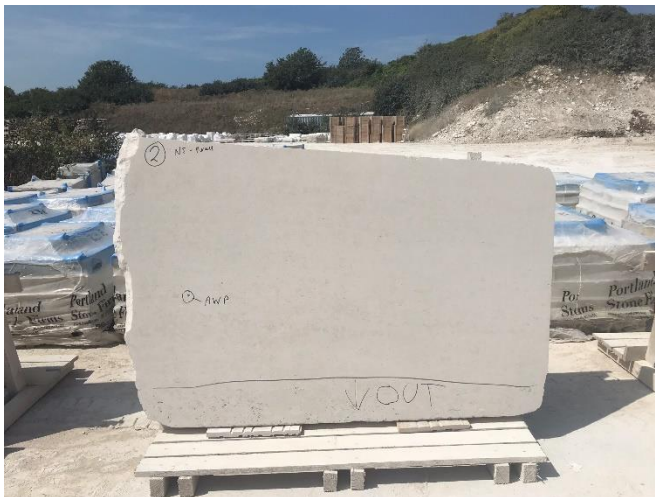
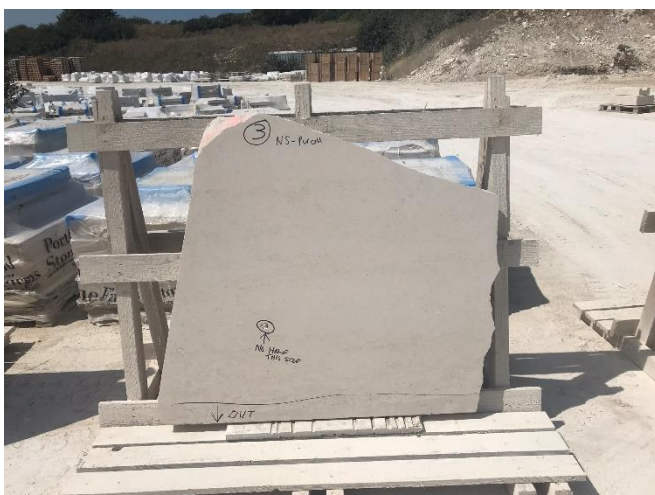
Larger format samples of the selected Portland Broadcroft Whitbed – reviewed during quarry visit

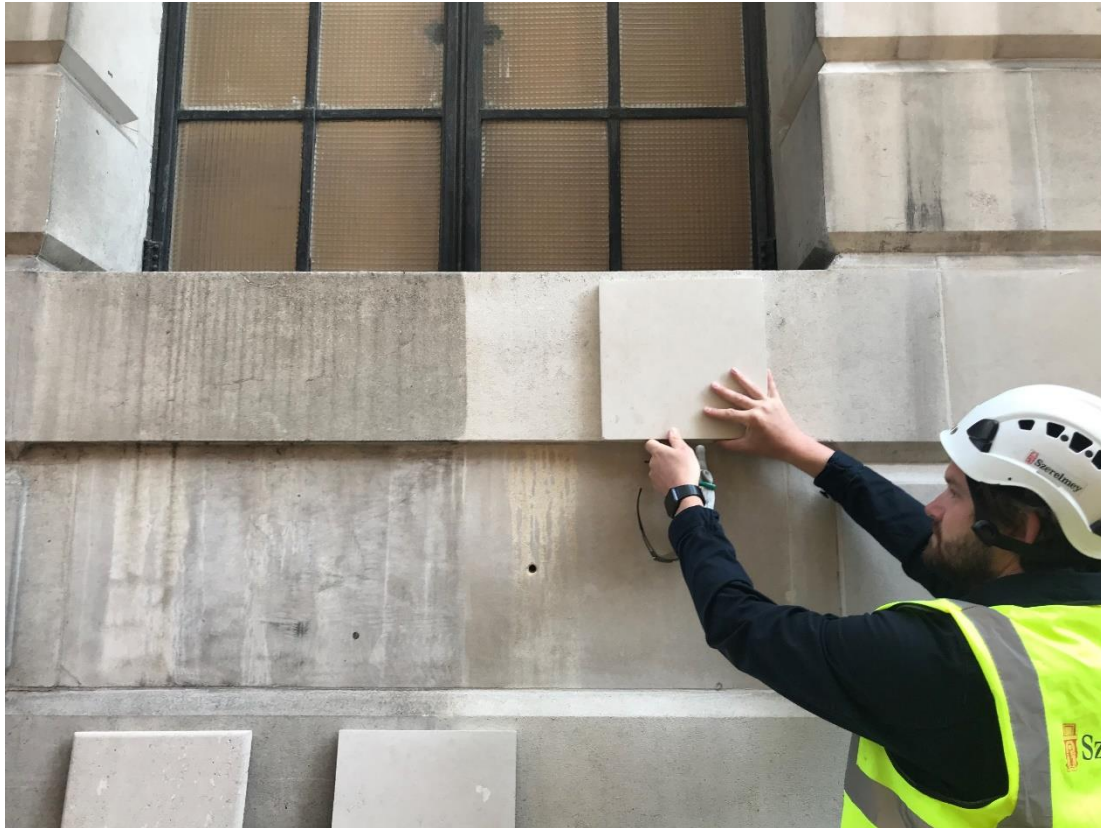
The initial image shows the preferred sample being held against the clean section of façade and the rejected samples below. It was deemed that the selected sample had the best match in terms of colour, grain, and texture.

CH requested to see the other Portland Stone samples reviewed to support to rationale of selected Portland Stone.

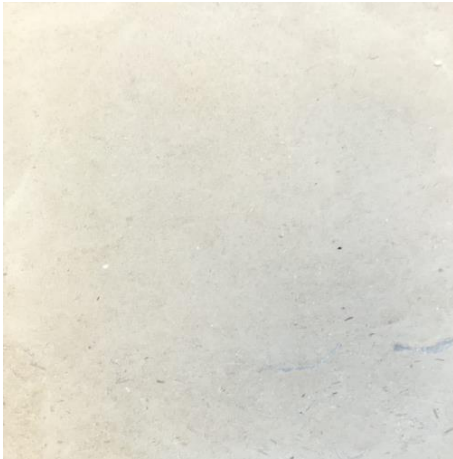
Portland Coombefield Whitbed Natural Stone - rejected

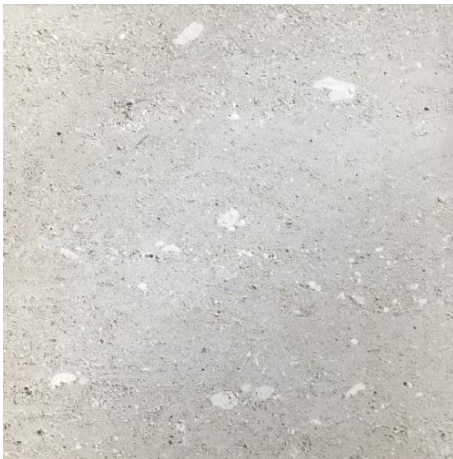
Portland Jordans Whitbed Natural Stone – rejected

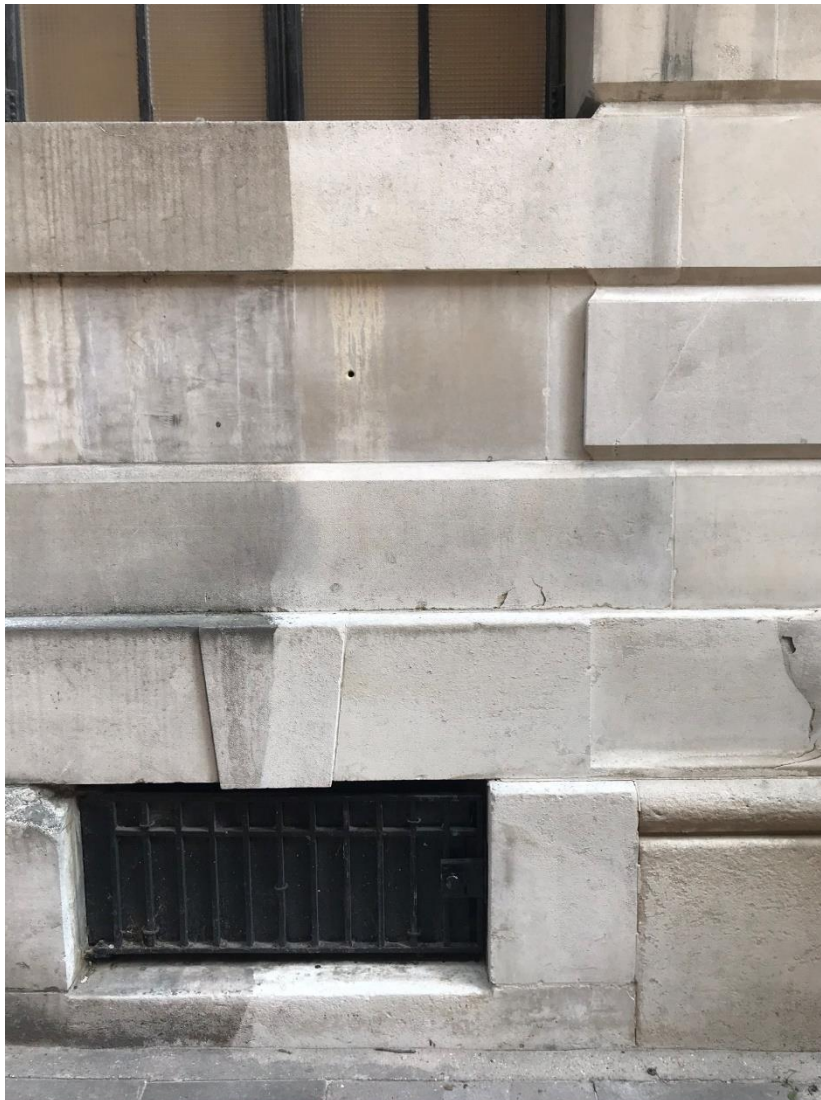
Image of the **Doff** water-based cleaning sample

CH requested an additional cleaning sample to be undertaken using the Torc cleaning method (to be applied only in minimal highly polluted areas of the façade). The below images show the original sample of the standard water based doff cleaning method and the newly requested Torc cleaning sample. It is noted that the abrasive cleaning method has not caused further damage to the existing stone in this location.

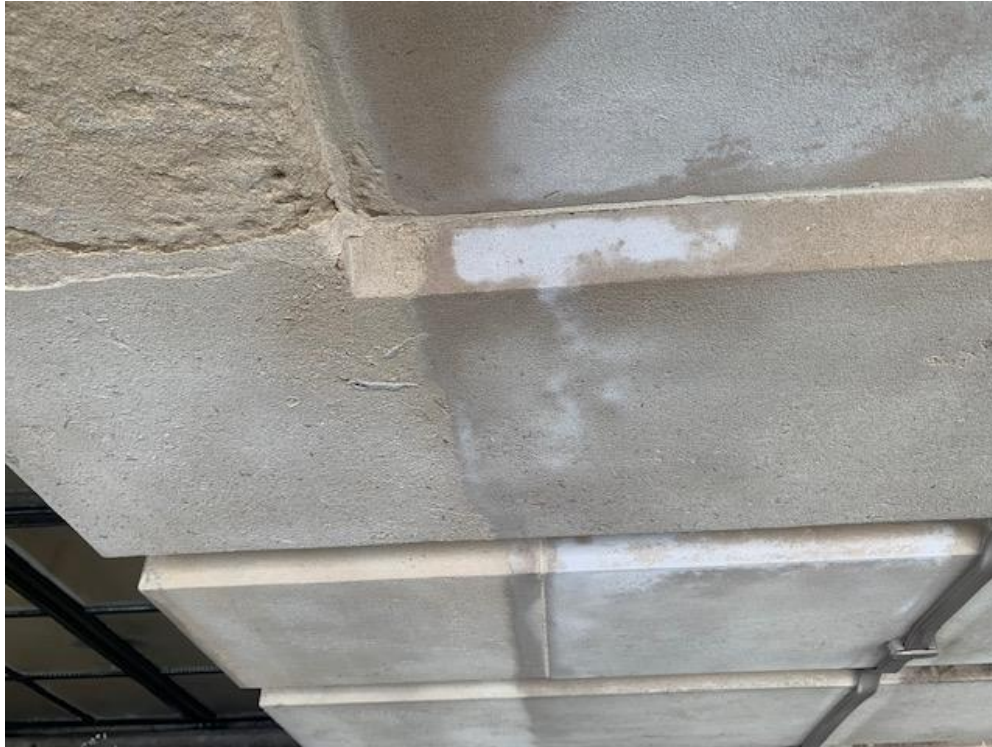
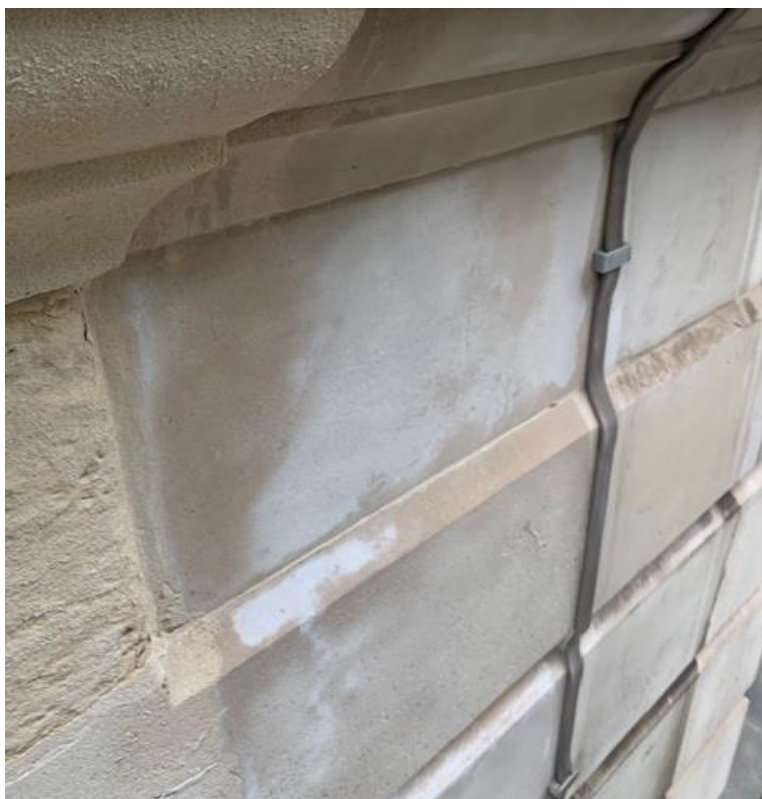
Please note that the colour differentiation in the Torc sample image is due to the stone still drying out at the time the photo was taken.

Images of **TORC** abrasive cleaning sample – note finish is not due to TORC – existing condition
