2132 – Flat 3, 15 New End

Images 2, Street scene / front facades - degree of preservation as original: Nos. 1-21 New End

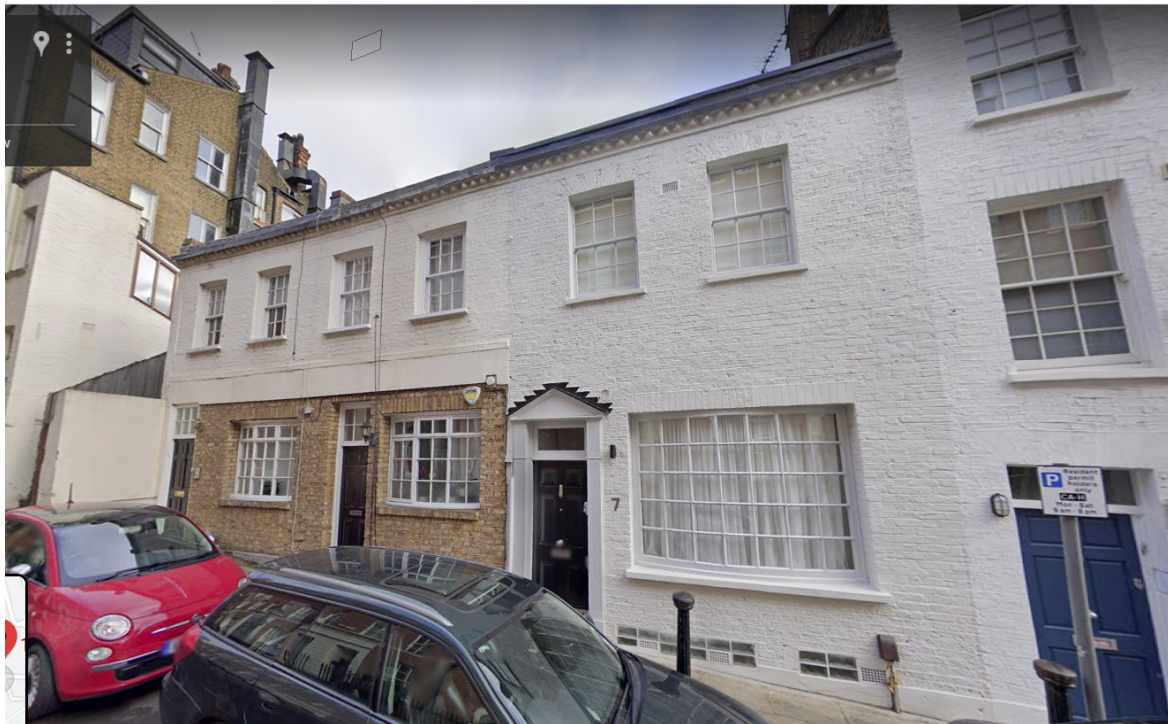
Nos. 3, 7 and 9 - Soldier brickwork and concrete lintels in replacement of original timber bressumers and shopfront detailing?)

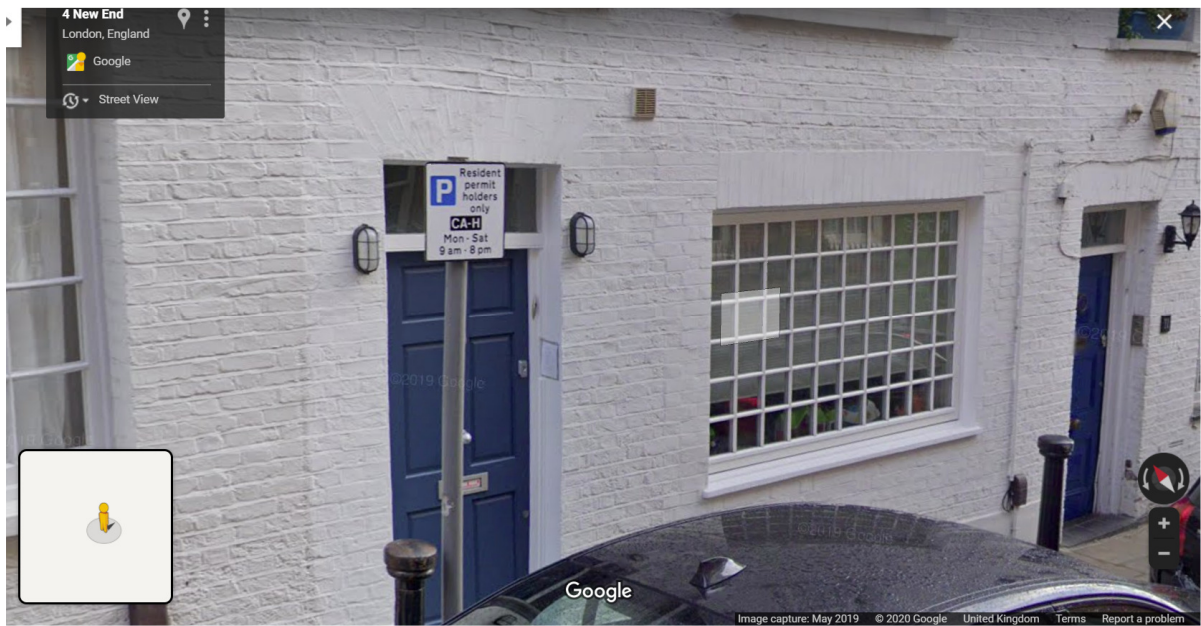
No 9 – Soldier brick course in replacement of original shopfront bressumer? Note disturbance in brickwork on either window jambs

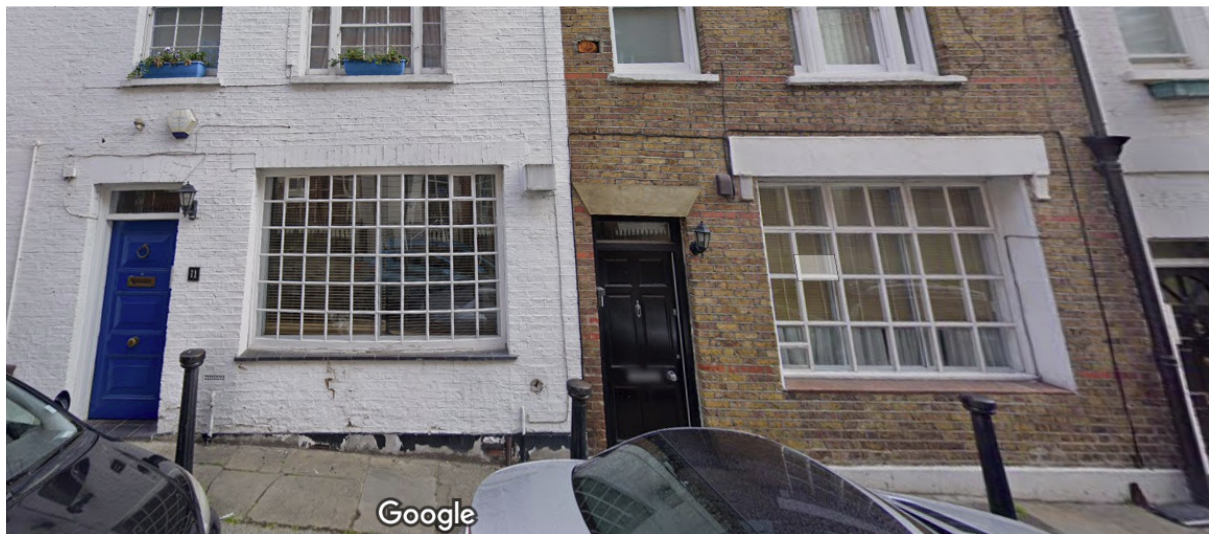
Nos. 11 and 13 (exposed brickwork) – soldier course and concrete lintels in replacement of original shopfront bressumers?

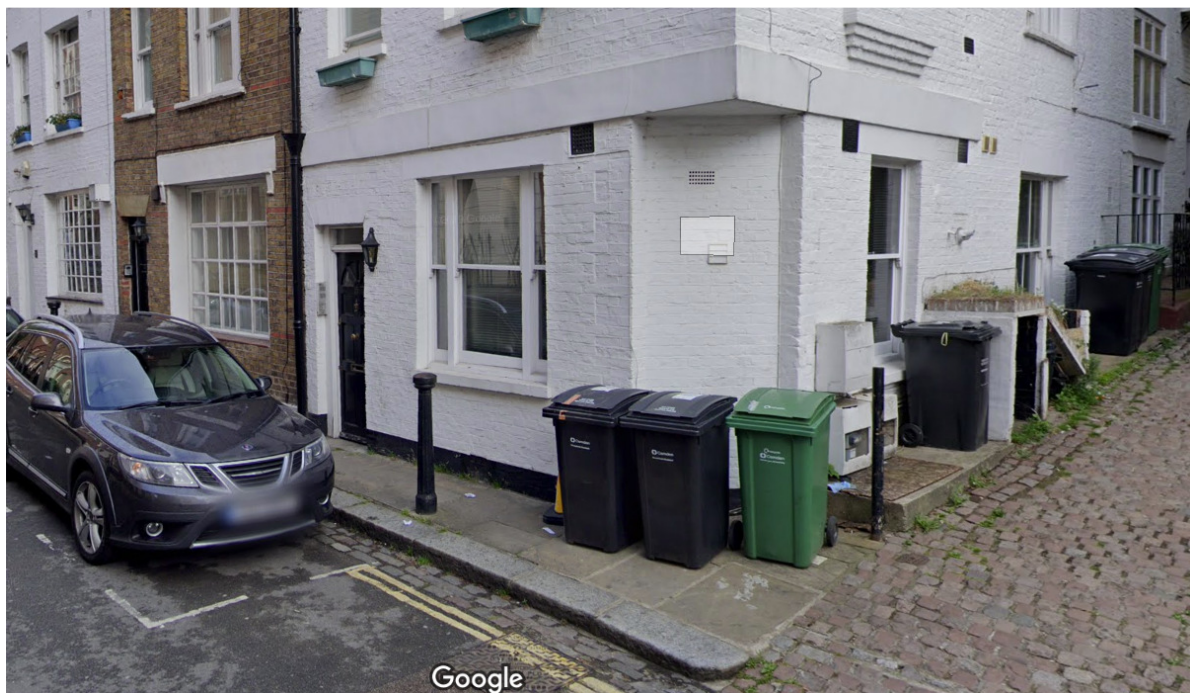
Nos. 13 and 15 – Concrete lintels in replacement of original shopfront bressumers? Note disturbed brickwork on front façade adjoining cut corner at ground floor level (original shopfront entrance?)
