PROJECT 23 Gloucester crescent

SUBJECT Roof plan existing

NUMBER GC 106 REVISION A SCALE 1:50 @ A3

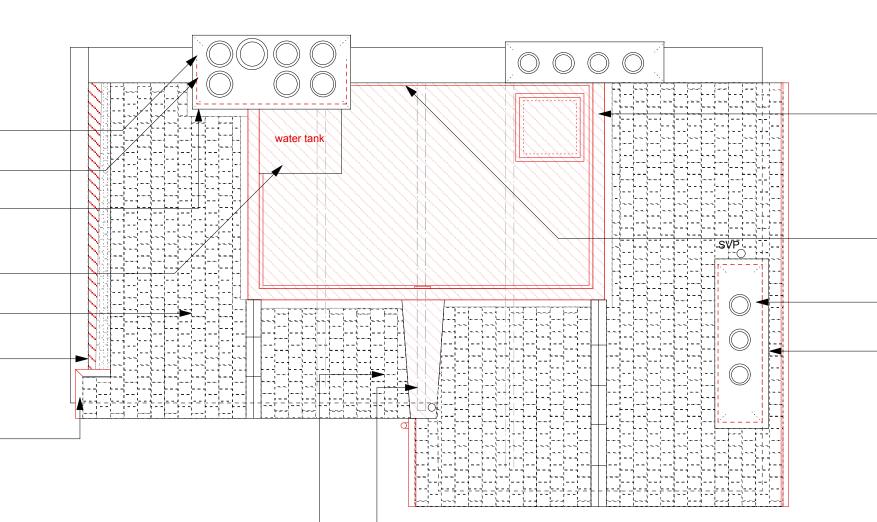
remove modern lead valley

carefully set aside slates for re-use
following mapping of location and pattern of tiles

reinstatement of valley will require tilting fillet and details as per LSA guidance

remove PVC guttering

remove redundant SVP

retain flaunching following confirmation of extent of cracking if substantial flaunching removed to be replaced with Roman cement

retain existing pots in situ

prepare for reinstatement of moulded projection under flaunching taking existing fragment as precedent

remove water tank and associated flashings and pipework

ensure ALL pitched roof timbers are retained in situ, full inspection of structural and moisture integrity

remove and replace parapet gutter - requiring the setting aside of lower courses of slates. check integrity of battens prior to reinstatement in their original location - open up access panel between existing rafters

remove PVC guttering for equivalent iron gutter reinstatement

remove timber structure to existing flat roof/terrace, remove cut-in joists to the original valley beam piece in matching timber as directed by the structural engineer remove lead flashings to ridge remove cement render to party wall, retain concrete copings in situ
 investigate flaunching, if cracked remove and replace with Roman cement retaining pots in situ
 if an air vent is not present for the redundant flue an airbrick will be required

proping of valley beam during securing works, engineer-led method statement for removal of inset terrace roof including propping arrangement and sequence of dis-assembly. Full scaffolding to secure opratives working at height, protect floor boards to second floor - ref Dwg. GC 105A-107A

Cutting into fibreglass waterproofing will require approriate breathing apparatus in addition to regular PPE - ensure waste mamagment policy in place for removal. Lead to be handles carefully and recycled

Inspect all rafters prior to operative stripping slates or renewing pareapet gutter to ensure ability to support operatives during roofing works - ensure appropriate storage spac for slate to allow their reinstatement in the original location

All battens and nails to be renewed using copper nails and preserved timber tile battens. Ridge tiles are ceramic and handling requires two operatives.

Remove portland cement render from chimneys and party wall using controlled use of cutting wheels by trained operatives ensuring no scoring of brick surfaces, use of hand held bolsters rather than mechanical breakers required to remove render.
