KOKO – EXTERIOR PAINT

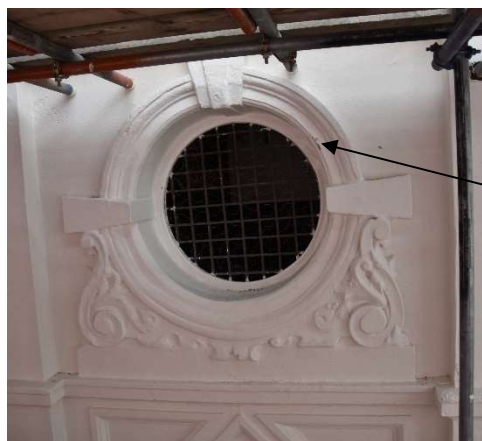
At the front of the building, above ground floor level, a very thin coat of cream or stone-coloured plaster was applied to all surfaces to create a uniform finish. It was also applied to the cement window surrounds and string courses on the south elevation.

The surface of the plaster was sealed with some kind of clear organic coating.

This plaster finish was left untouched until the second half of the twentieth century

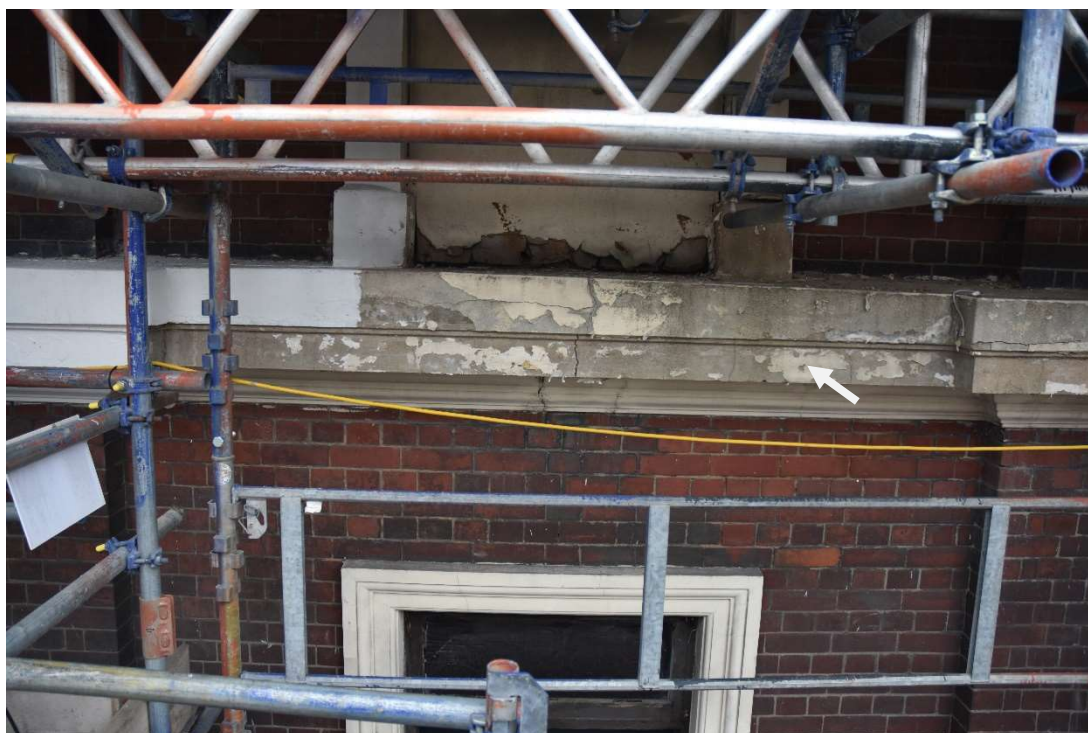
Some scraping down took place and then a sealing coat was applied. This was a light brown in colour. The whole façade was then painted with a buff-coloured, textured masonry paint.

Remains of that paint can be seen today on parts of the south string course

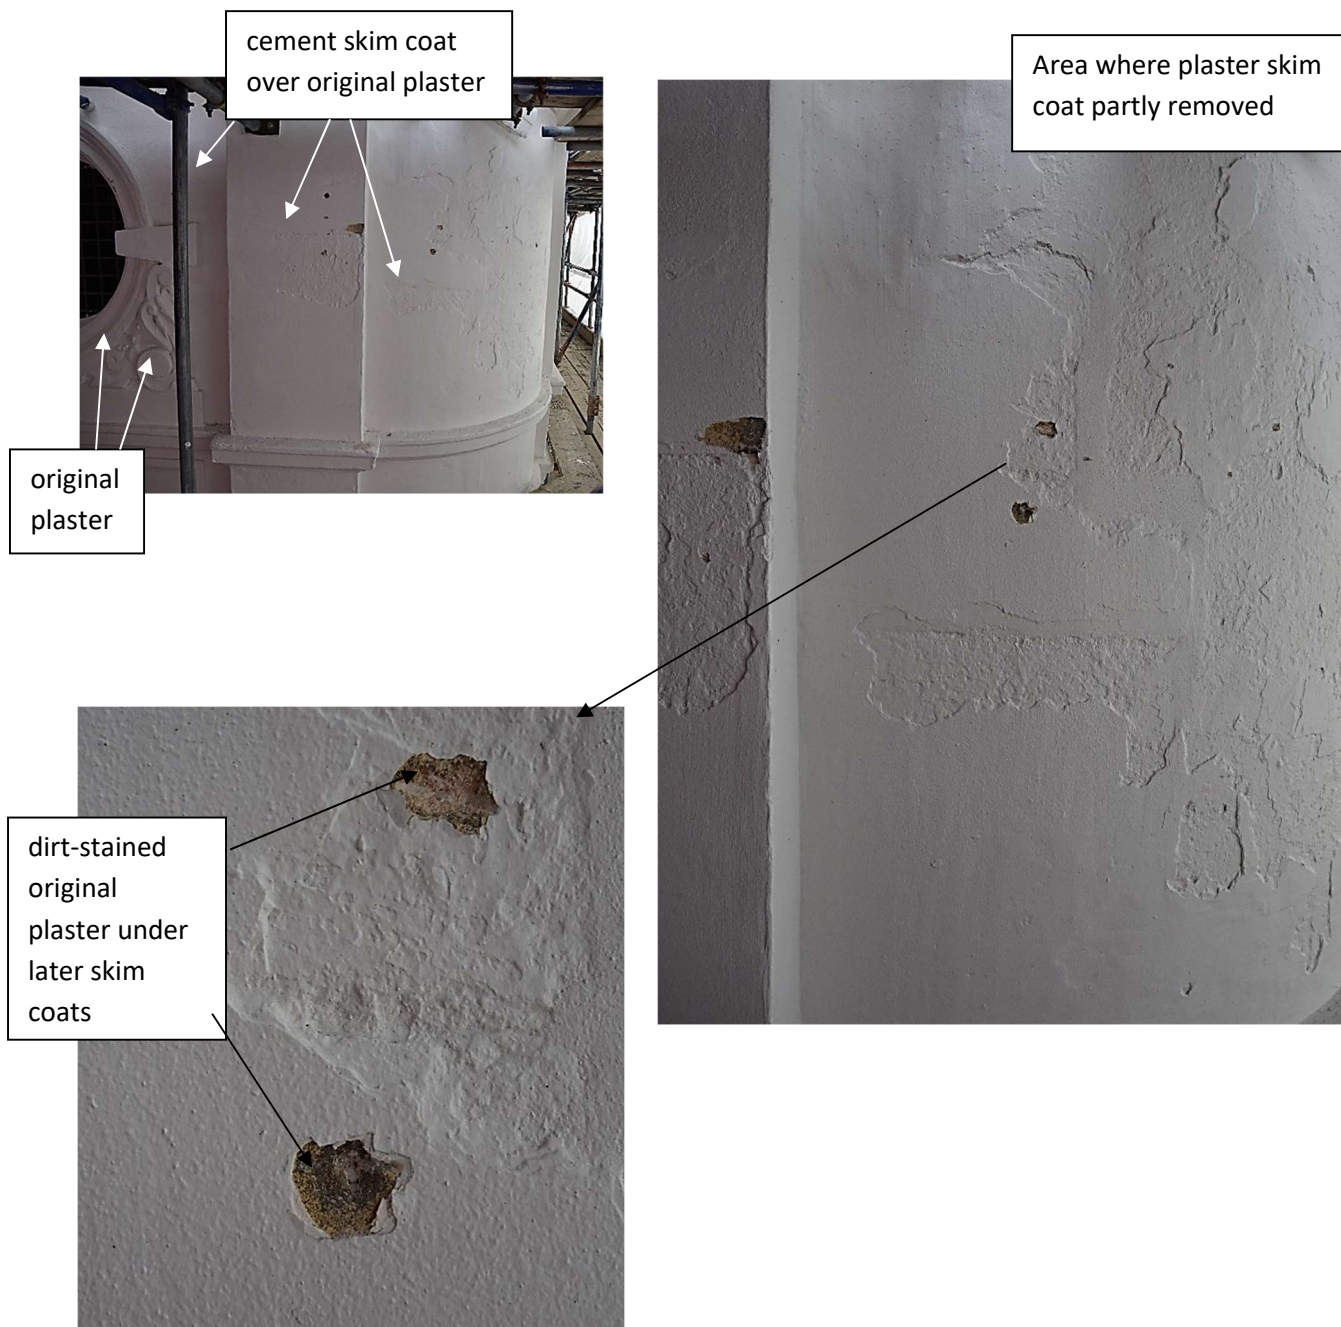
At some point in the recent past, earlier layers were partly scraped off, and then a thin skim coat of cement was applied to some flat areas of walls. It was not applied mouldings such as those around the circular windows.

On the SW corner of the building, attempts appear to have been made to remove this coating.

The penultimate time the building was decorated a white plaster skim coat was applied to flat parts of the walls.

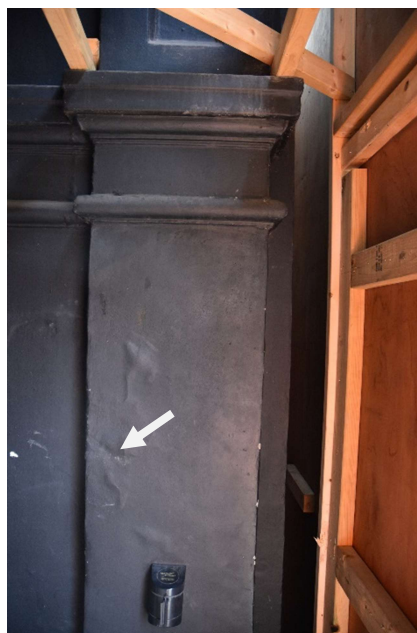
Ground floor

- 3 pilaster to right of entrance door
- 4 entrance door

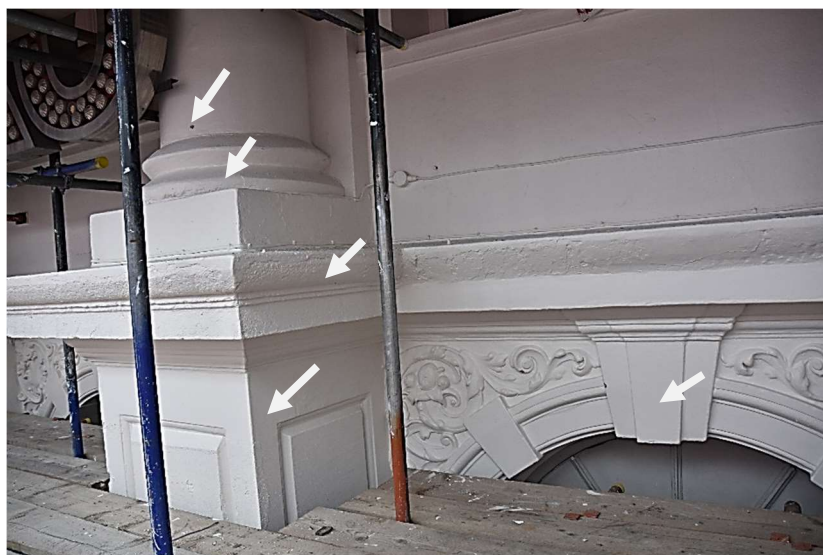
Second floor

- 5 keystone
- 6 string course
- 7&26 column
- 8 column base
- 9 pilaster

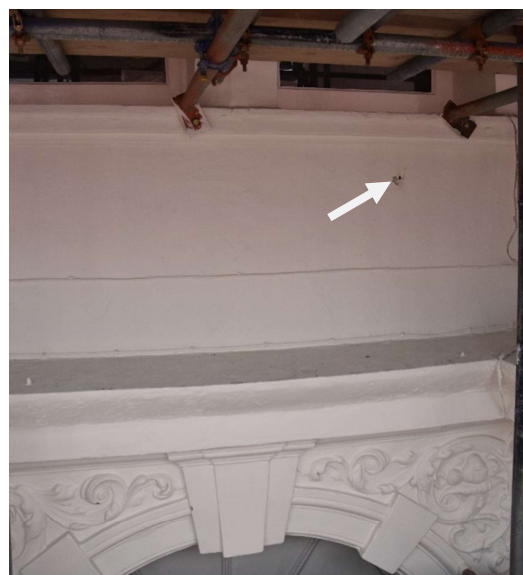
- 27 wall below upper windows – early layers
- 28 layers over first scheme
- 29 first scheme

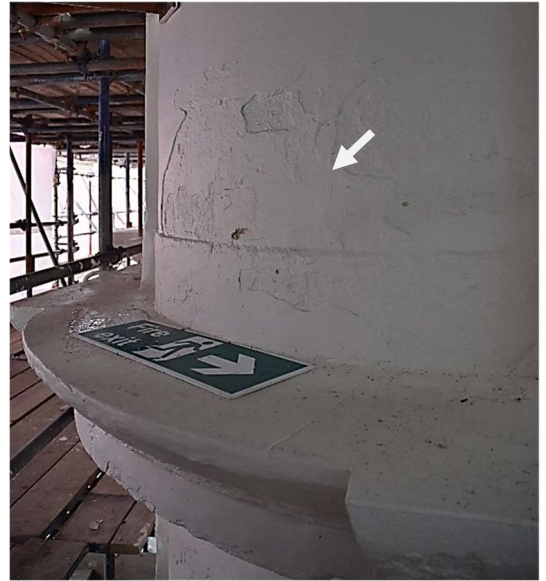
- 10 layers on curved corner

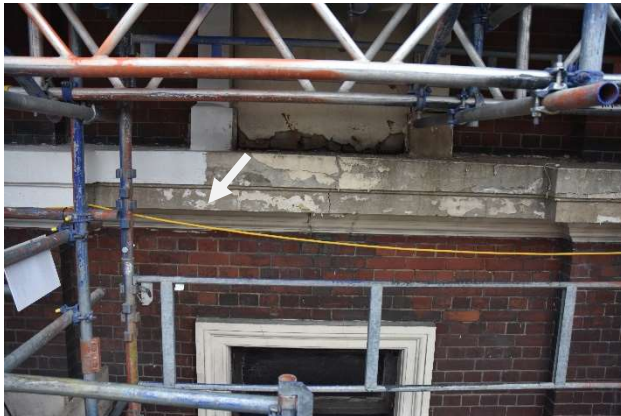
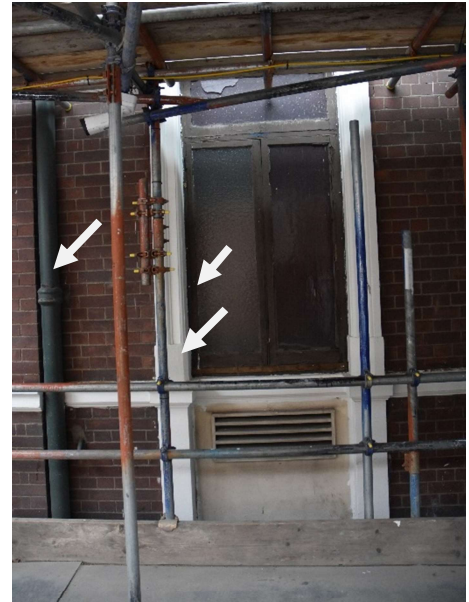
South side

- 12 string course
13 wooden window
14 rain pipe
15 window surround

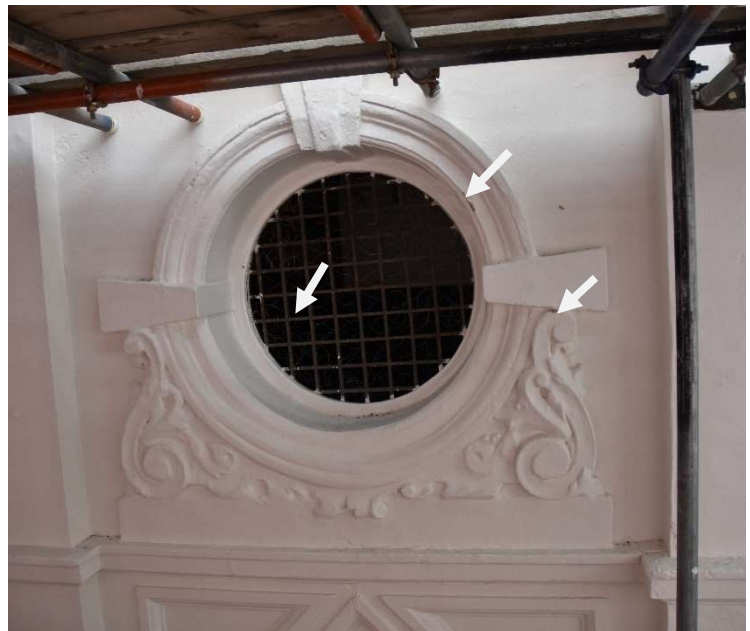
Third floor, west

- 16 iron grille
17&18 circular border
scroll moulding
19&20 intermediate layers revealed by scraping
21 original scheme

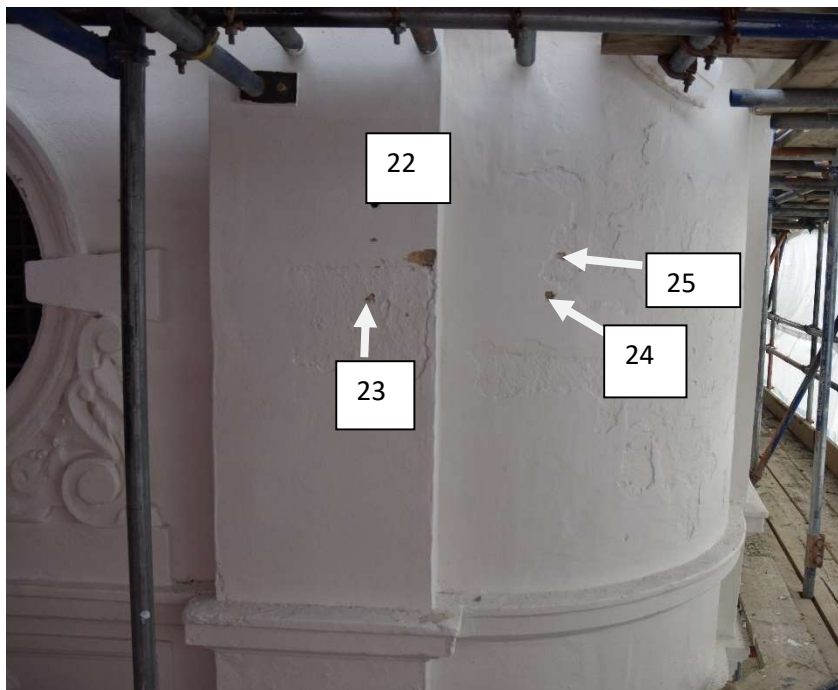
Third floor SW corner

- 22 cement skim on pilaster
- 23 layers below cement skim
- 24 white plaster over cement skim
- 25 original plaster
