**Report of a Basement Impact Assessment
for a
Proposed Basement Extension of
31 Willoughby Road London NW3 1RT
Ref. G1808-RP-01-E3**

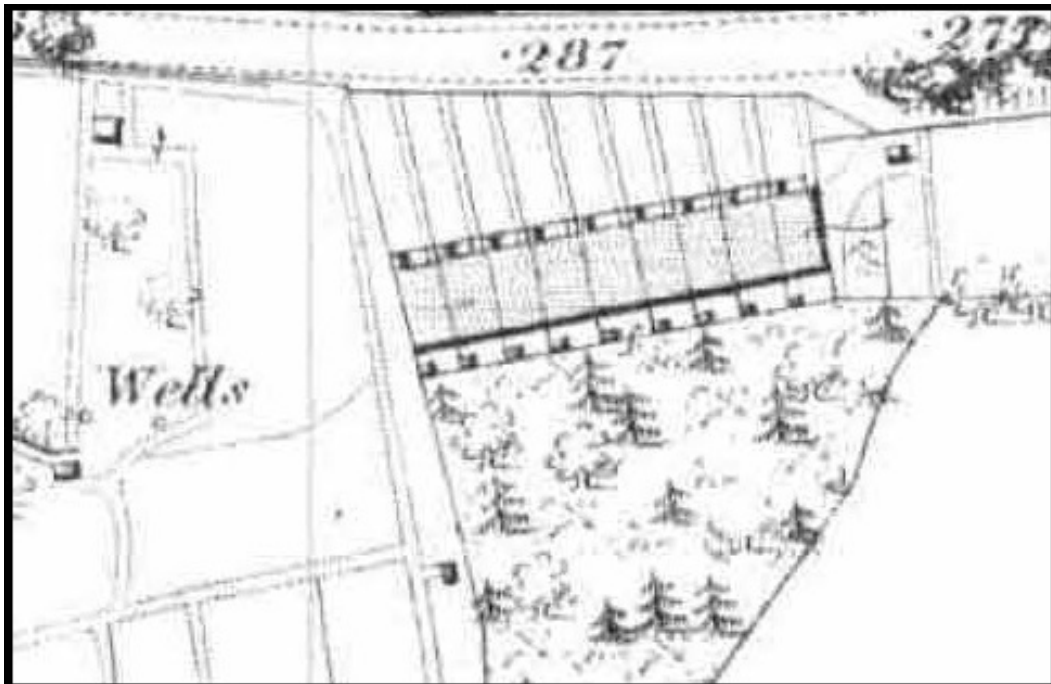
Plate 3 Willow Cottages 1866

51. Plates 3 and 4 provide enlarged extracts from the 1:2500 scale O.S. maps published respectively in 1870 and 1954. The 1870 publication, based upon an 1866 survey, provides more detail than later editions; paths to the front entrances of the cottages and small outbuildings (probably sanitary installations) in the back yards are evident. It is also clear that all the party walls then extended to divide the plots and support the retaining wall. The party wall extensions are just visible on the 1949 aerial photograph in Appendix A but those separating Nos.33 to 39 Willow Road had been removed by the time of the survey for the 1954 publication. Drawing G1808-PA-001-E1, based upon the 2014 measured survey, shows a 102mm thick partial dividing wall has since been built between Nos 38 and 39 and that the more recent retaining wall to the east is set forward of the wall at No.39
