A2 Dominion

156 West End Lane, West Hampstead

Geotechnical and Geoenvironmental Interpretative Report – Phase 2

Revision 2

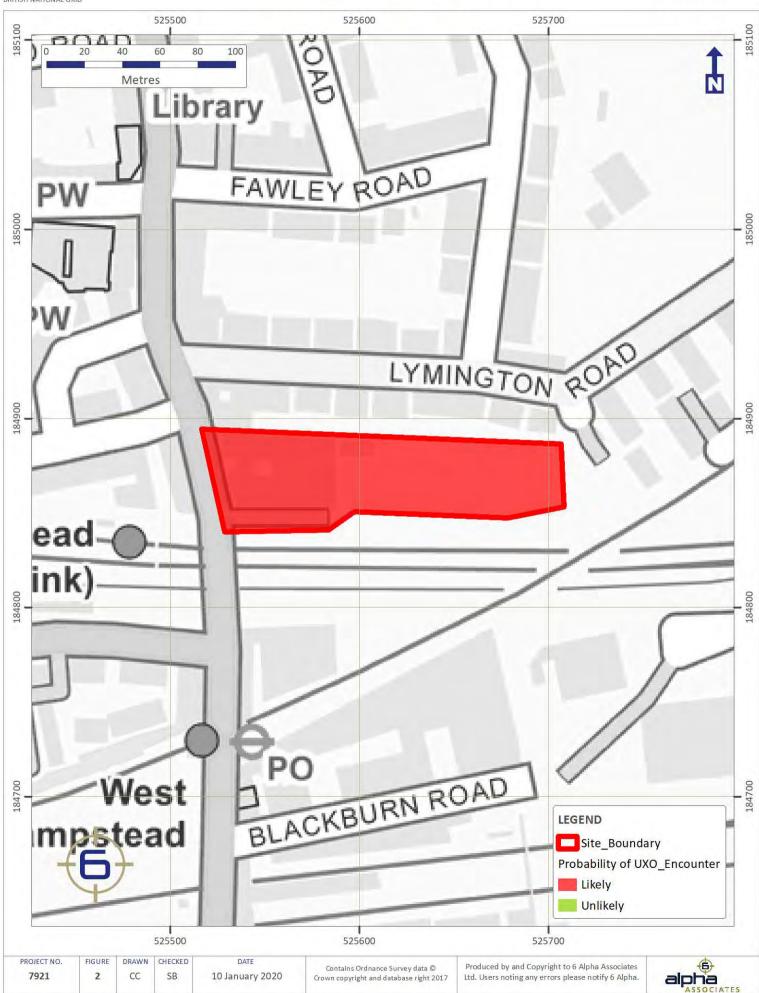
Probability of UXO Encounter

The potential for a UXO hazard to occur, and more specifically, the potential for unexploded WWI and WWII ordnance to exist at this site is assessed as being LIKELY (*Figure 2*).
