Arboricultural Report

29th September 2020

Site: 7 Rosecroft Avenue, London NW3 7QA

Trial dig - BS5837:2012: Trees in relation to design, demolition and construction – Recommendations.

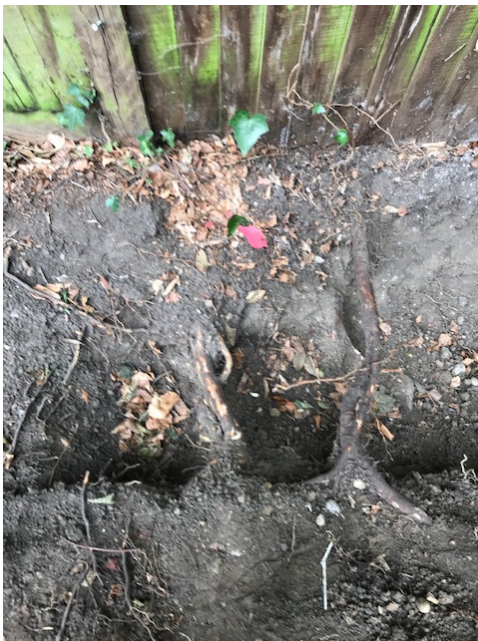
Photo 1:

Trial pit 1: Dig on south boundary uncovered x3 <50mm roots growing from T4 and X1 <100mm root growing from T6 green beech. See updated drawings (*A/02/501*) for locations and photos for illustrations of these roots.

Photo 1 illustrates x3 roots with a diameter less than 50mm, whilst one slightly larger root measured at 100mm grows from T6 as illustrated in photo 2.

Despite a small loss of fibrous root system from T4 and T6 the beech trees should not be impacted by the proposed installation of foundation pads to support the floor structure of the garden room.

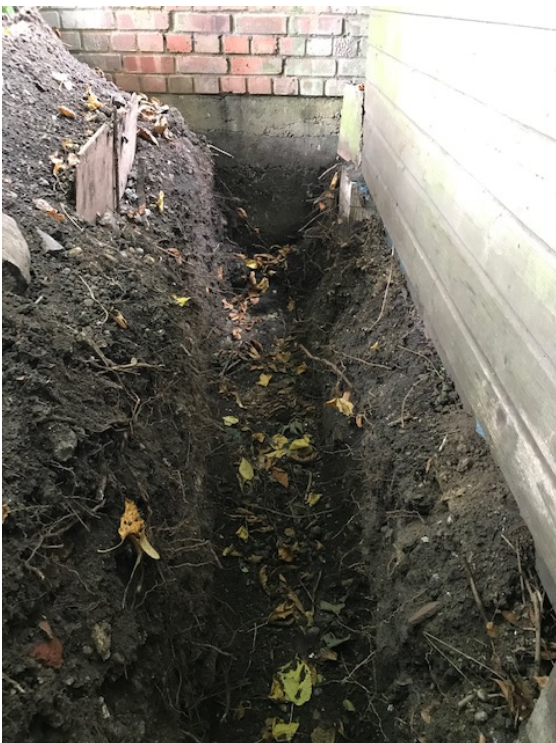
Photo 1:

Trial pit 2: A trial trench has been dug to a depth of 700mm. Findings uncovered no structural or woody roots. Fibrous root system is present from previously removed vegetation such as ivy. The rear boundary wall drops down by another 200mm to meet 15 Hollycroft Avenue property where the three Lime trees grow. It would seem the roots of these lime trees haven't grown under the presumed 400mm wall foundation and up into the mass of soil in the rear garden of 7 Rosecroft Avenue. See photos below for clarification.

With regards to the roots of the Lime trees in 15 Hollycroft. The findings along the rear boundary wall (south west boundary) were not surprising as tree roots are hydrotropic and there is plenty of available soil / lawn in the rear garden in which they grow. Therefore excavation in this vicinity would be permissible not encroaching more than 20% into the RPA of T6. Heavy machinery is not permitted or accessible so excavation would be by hand dig and I am in touch with the contractor should they encounter any substantial rooting activity along the rear boundary where the proposed climbing wall is to be installed. I do not foresee a detrimental impact on trees numbered 1-9 during the project so long as the tree protection plan is to be followed and communication is maintained at this current level.
