# KOKO DOME SHAB SURVEY (RAVA 25/06/20)

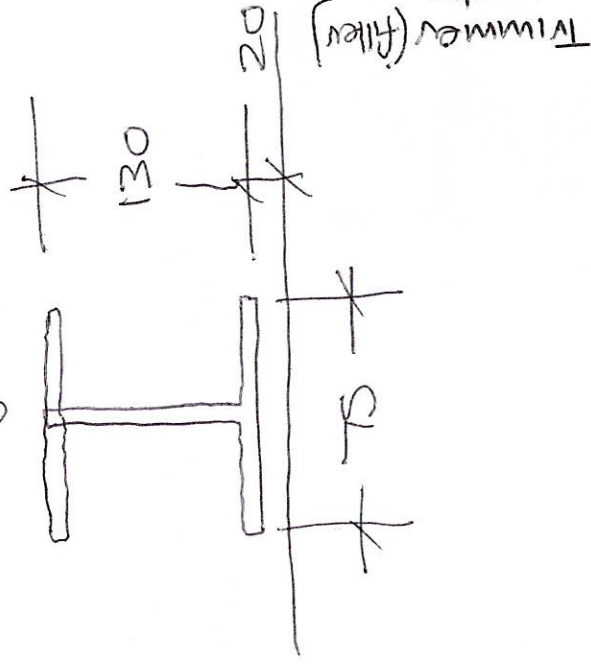
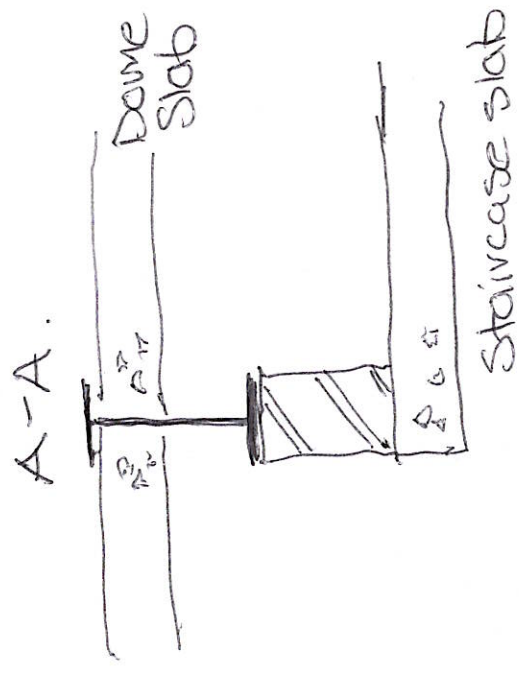
Filler joist

Concrete slab below roof slab  
No access

Camden High St Beams sitting on walls  
Elevation.

Beam on brick wall  
in concrete slab  
see above A-A

lowered ceiling  
over stair lobby  
Concrete slab
