Job Number: 8240
Reference: 8240 – FN 003
Title: 26 Netherall Gardens- Response to BIA Audit Update
Date: 20th October 2020

Following comments from 'The Heath & Hampstead Society' on the proposals at No.26 Netherhall Gardens outlined in the Basement Impact Assessment (BIA) complete by Sinclair Johnston/Byrne Looby (BL), Campbell Reith, who prepared the BIA Audit report ref 12985-5,1 updated their BIA Audit RevF2 Oct 2020, which requested further information to satisfy their requirements. This additional information can be broadly defined as below:

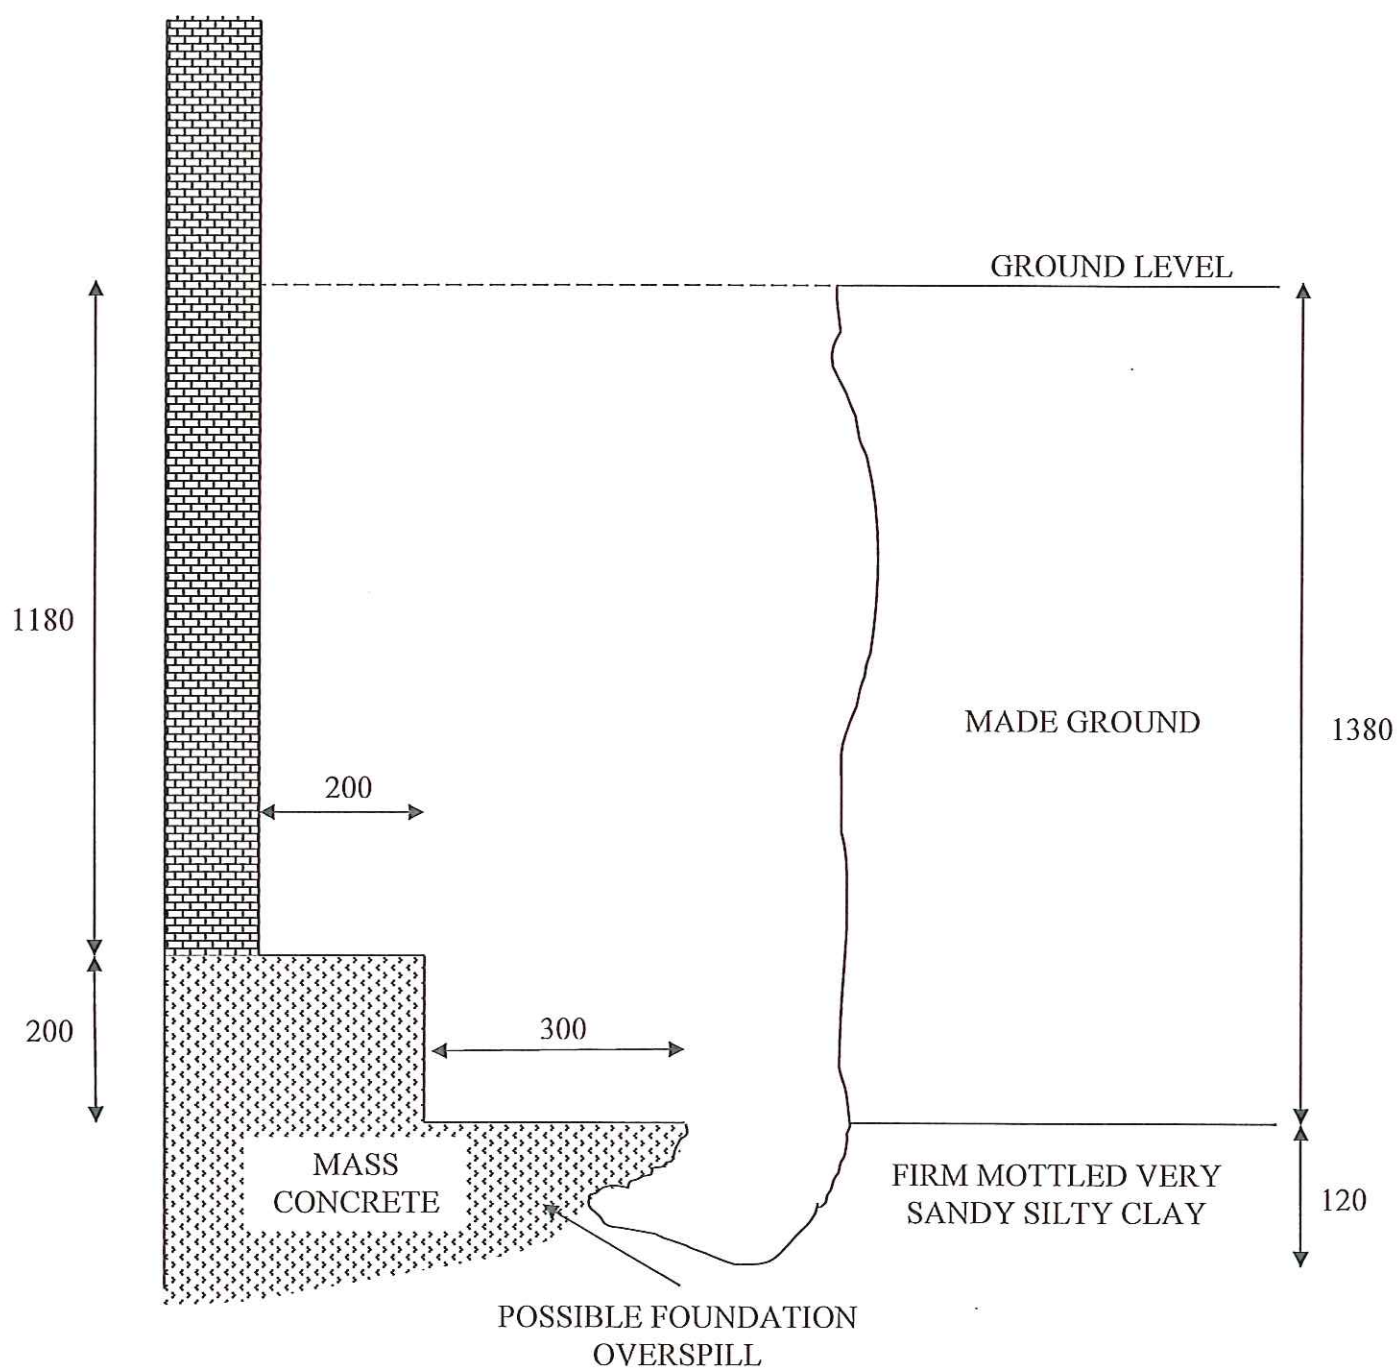
FIG: 2

TITLE: Trial Pit 1

END OF TRIAL PIT 1 AT 1500mm DEPTH

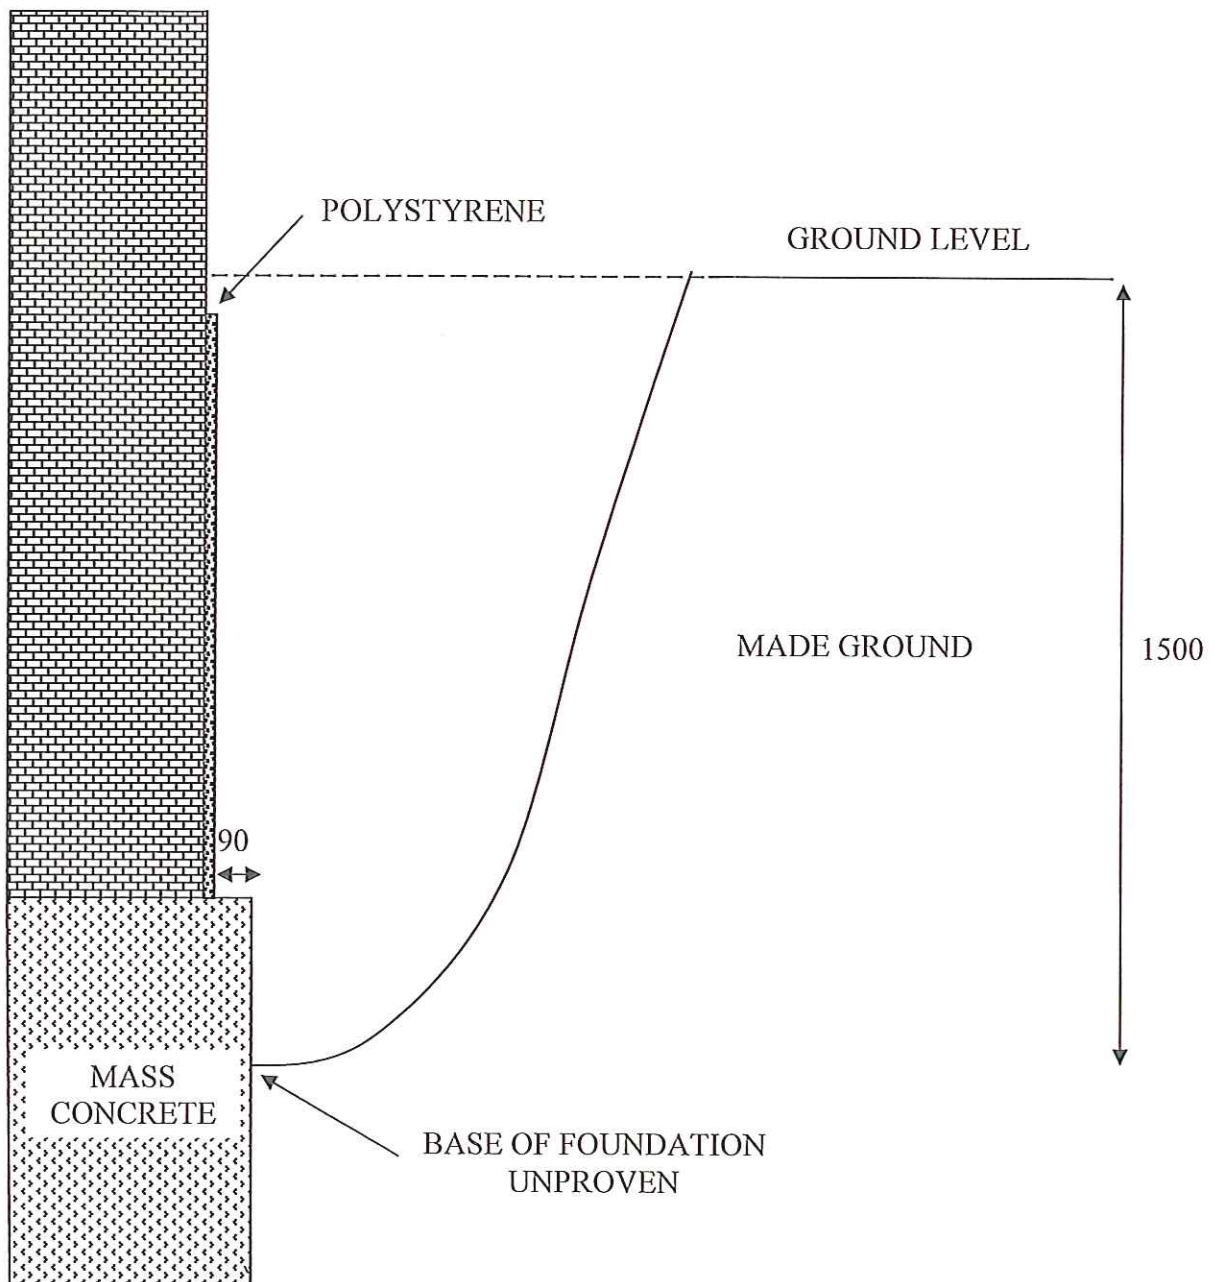
FIG: 3

As part of the SI, a trial pit was excavated to the 24A NG extension building (TP2), please refer to Appendix A of this File Note where the Trial Pit Location Plan has been provided as well as the subject trial pit section sketches. TP2 was excavated to a depth of 1.5m which was still within the Made Ground, however, the underside of the foundation was not discovered, although the top of the mass concrete base had. TP1, a trial pit located approximately 5-6m away was also excavated to 1.5m depth, this trial pit struck the clay at a depth of 1.38m from a similar ground level. Based on the proximity of TP1 to TP2, the clay layer being close and the fact that 24A NG foundations go deeper suggests that the foundations to 24A NG are in fact founded within the clay layer. It is acknowledged, as it is in the 'Heath & Hampstead

TITLE: Trial Pit 2

BL do not believe further analysis is required based of the SI findings suggesting 24A foundations are founded within the clay, which demonstrates that the hydrogeology & land stability of/below the neighbouring foundations is acceptable which satisfies Query No.8 in Campbell Reith's BIA-Audit Tracker.

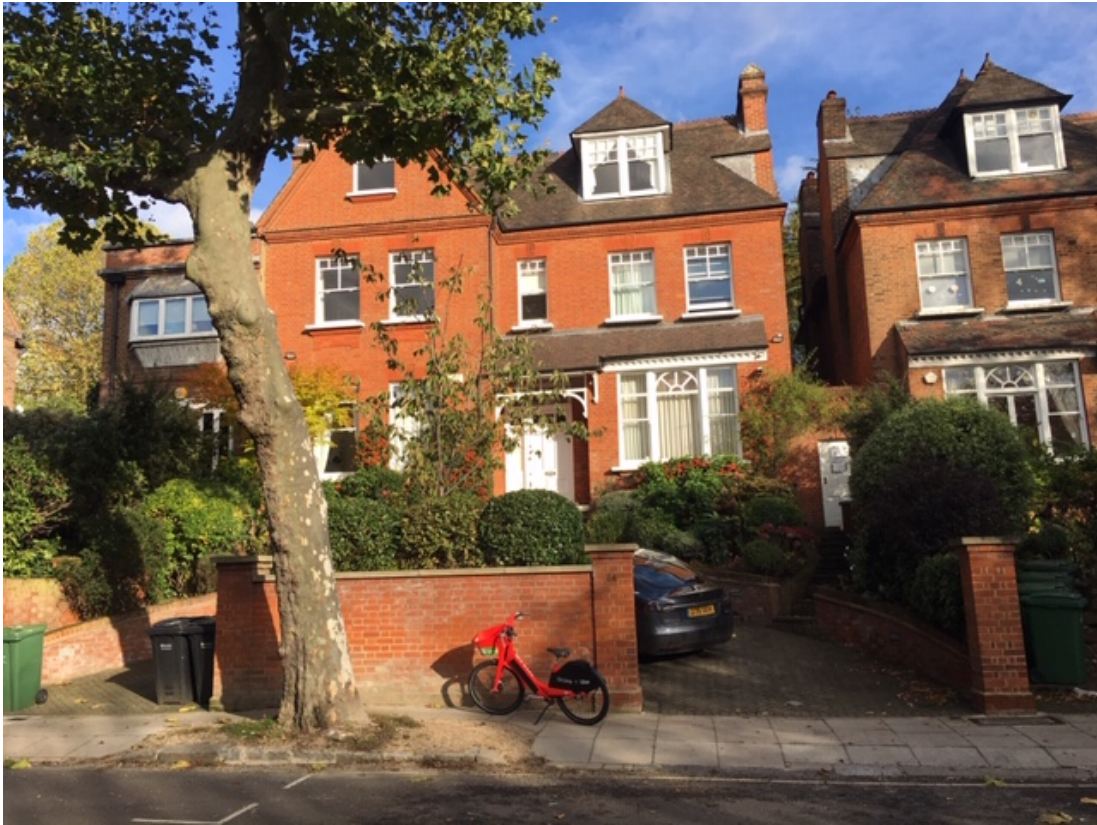
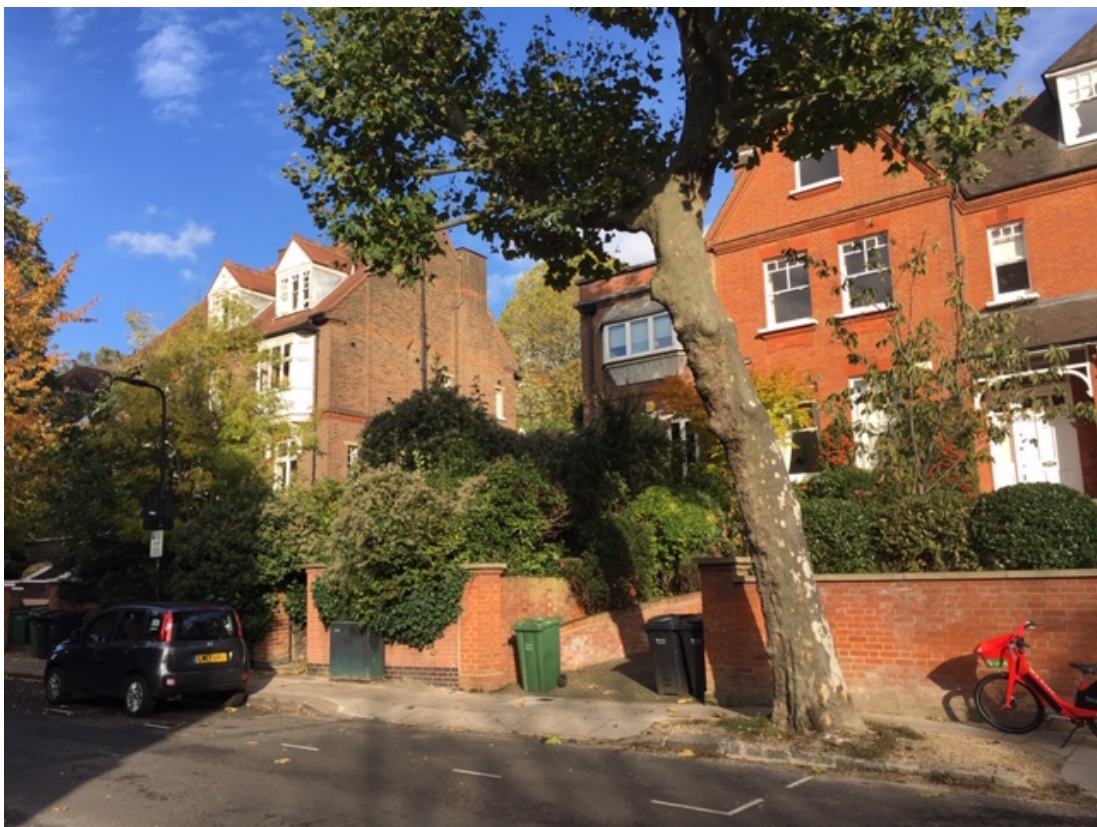
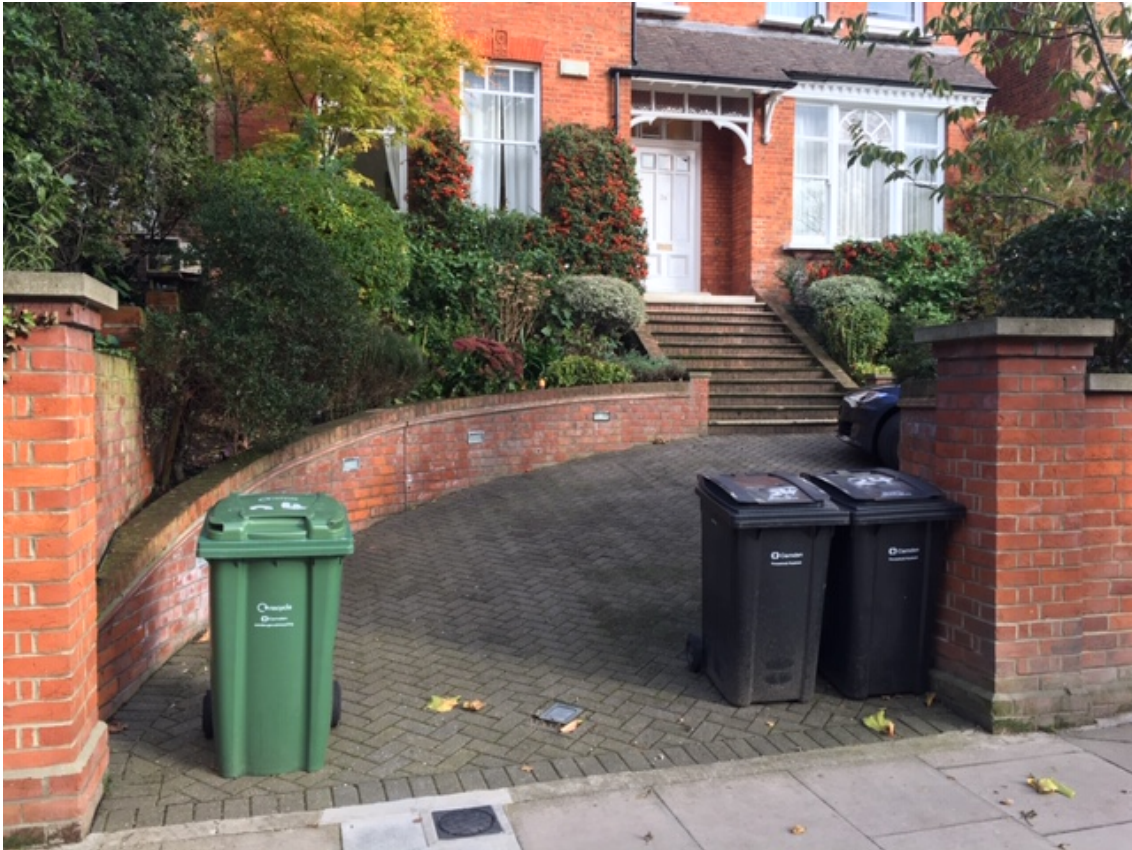
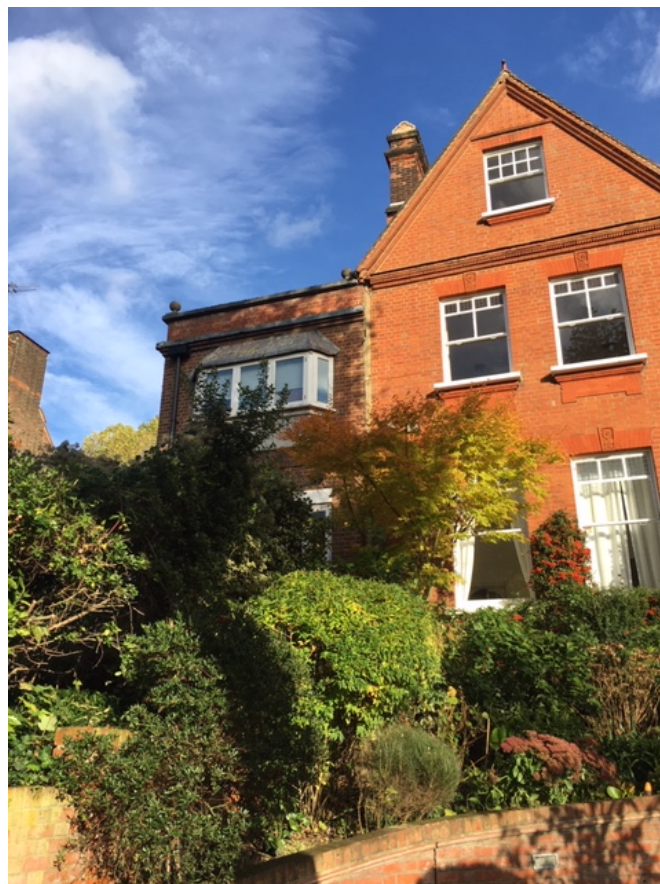
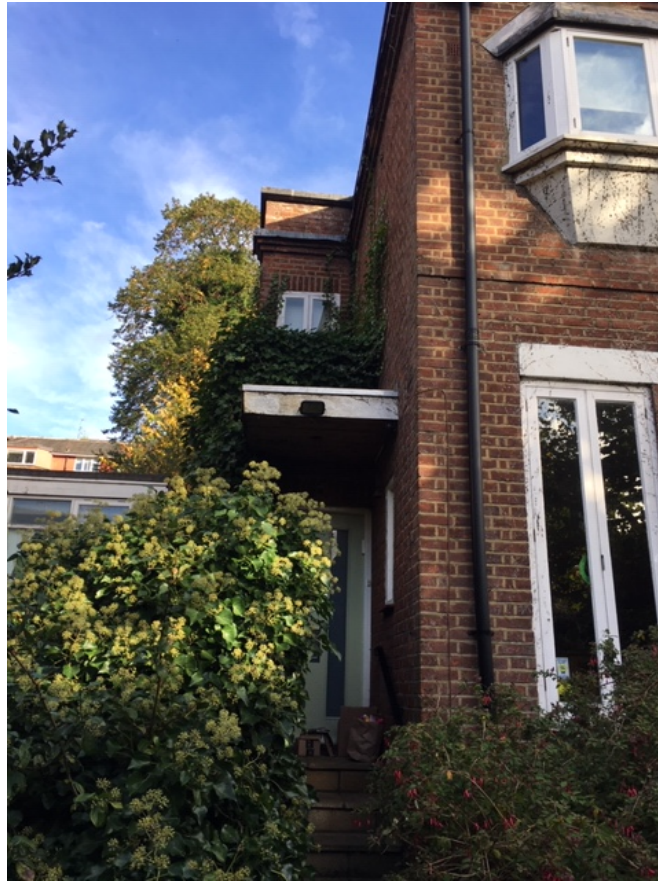
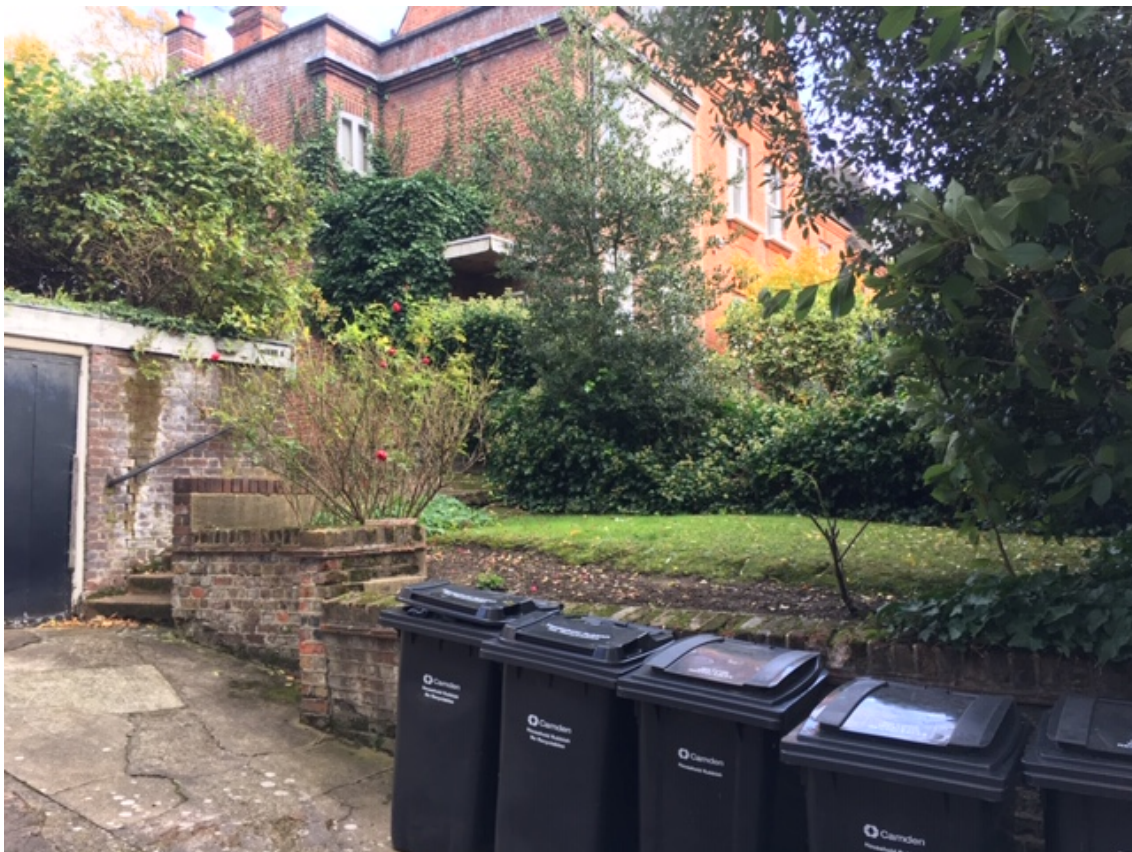
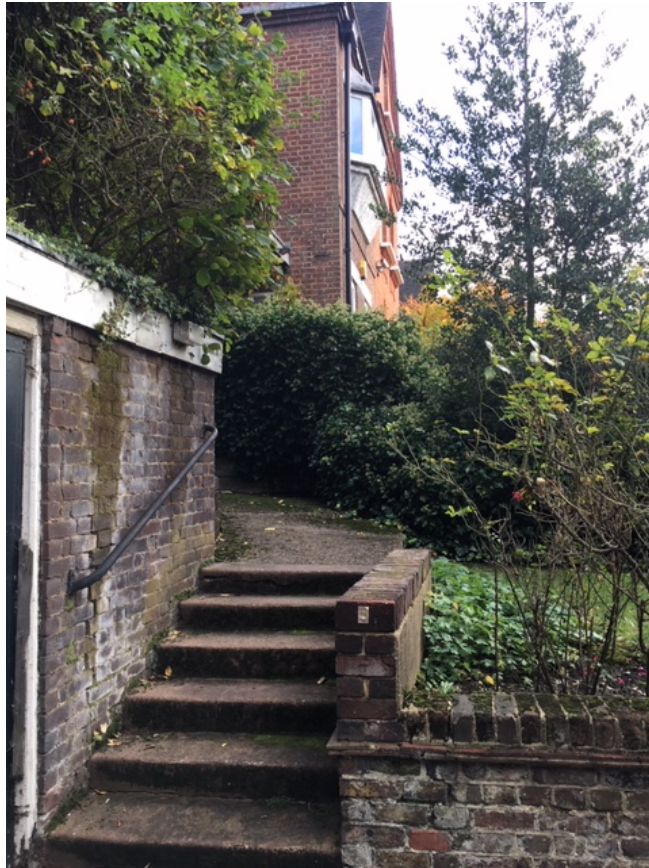
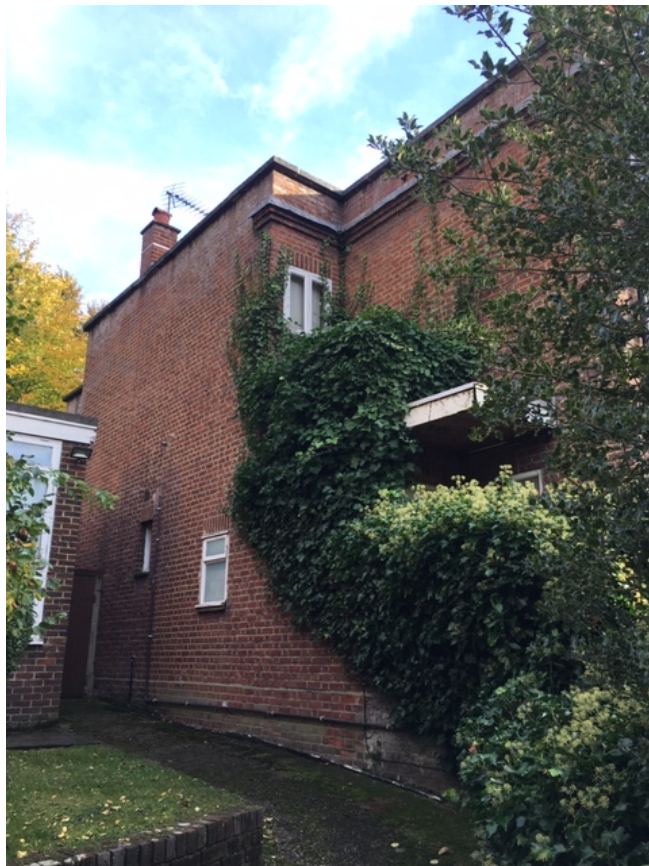
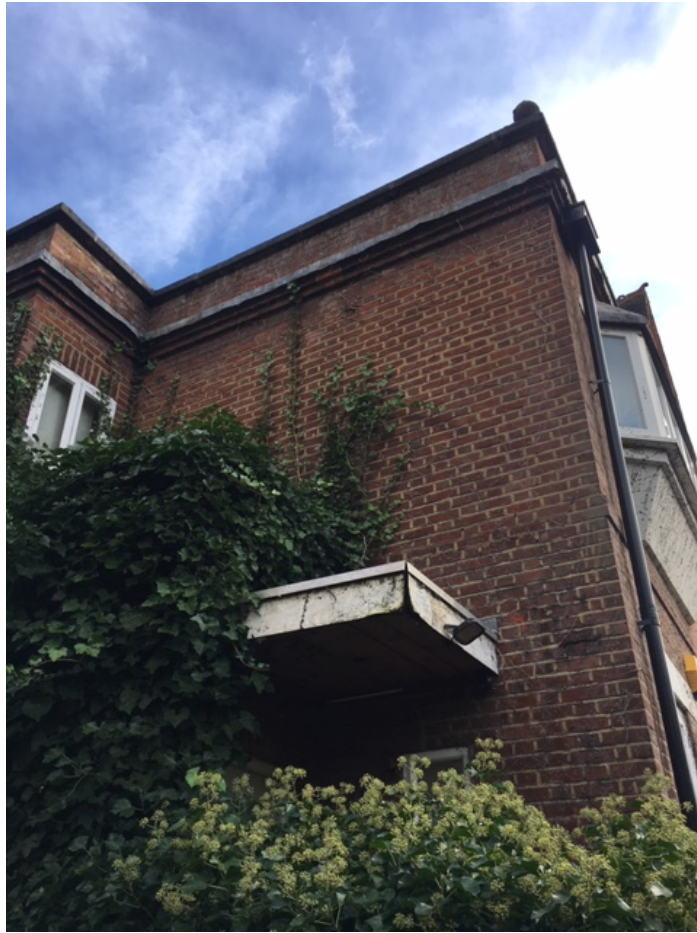
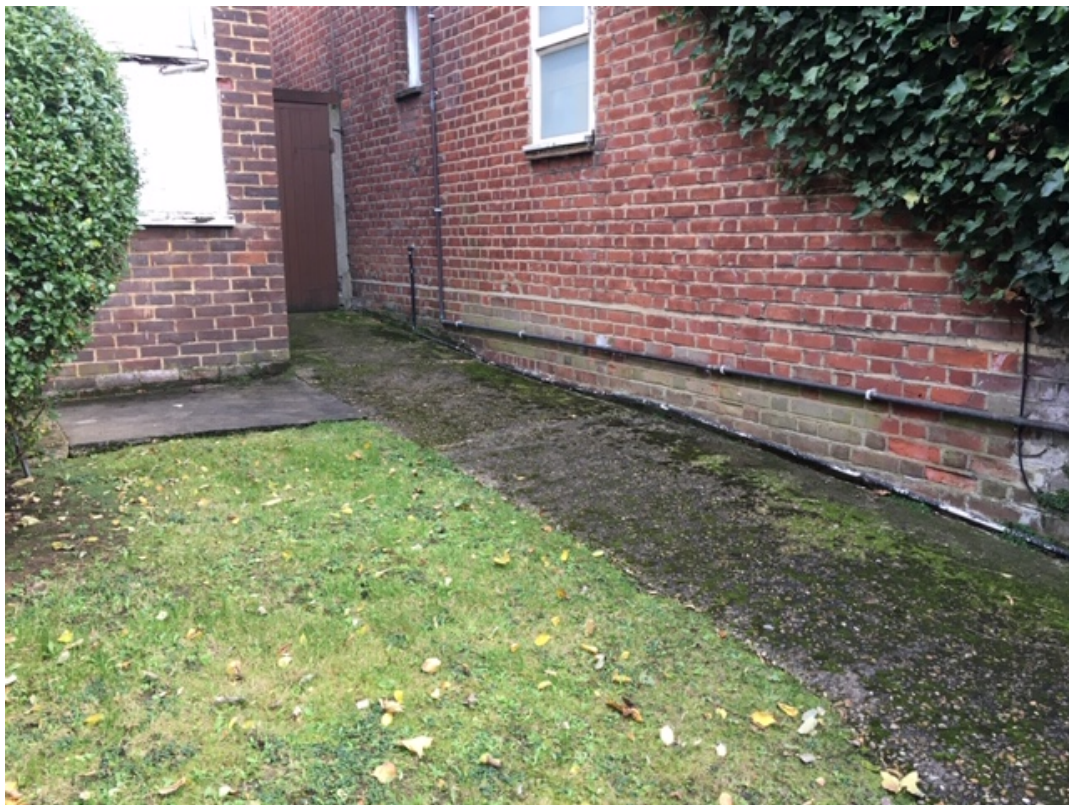
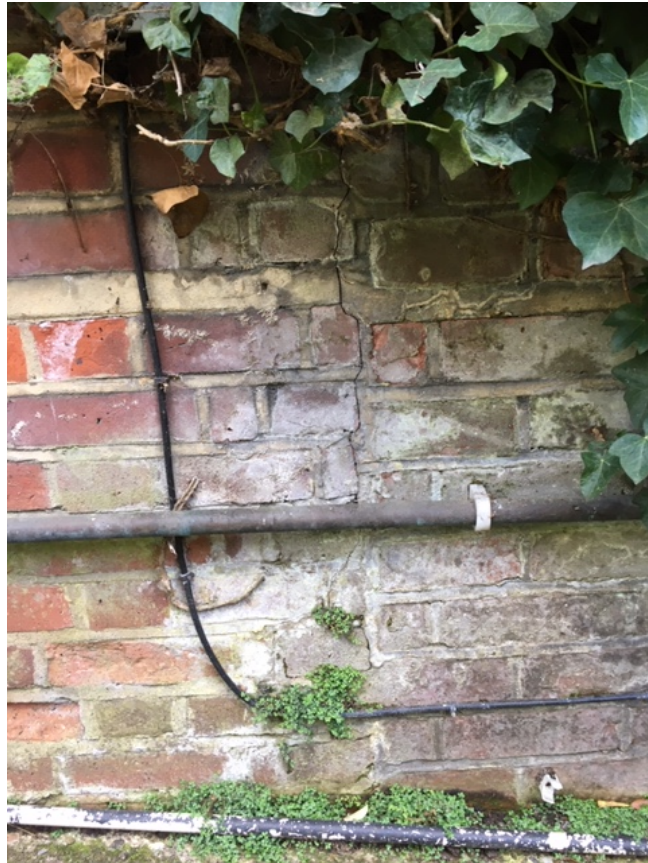
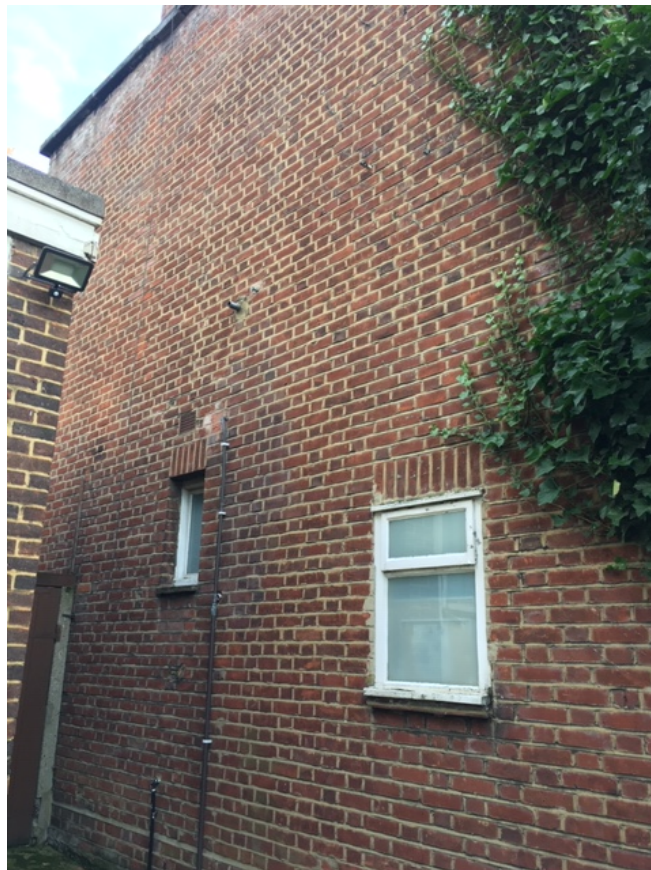
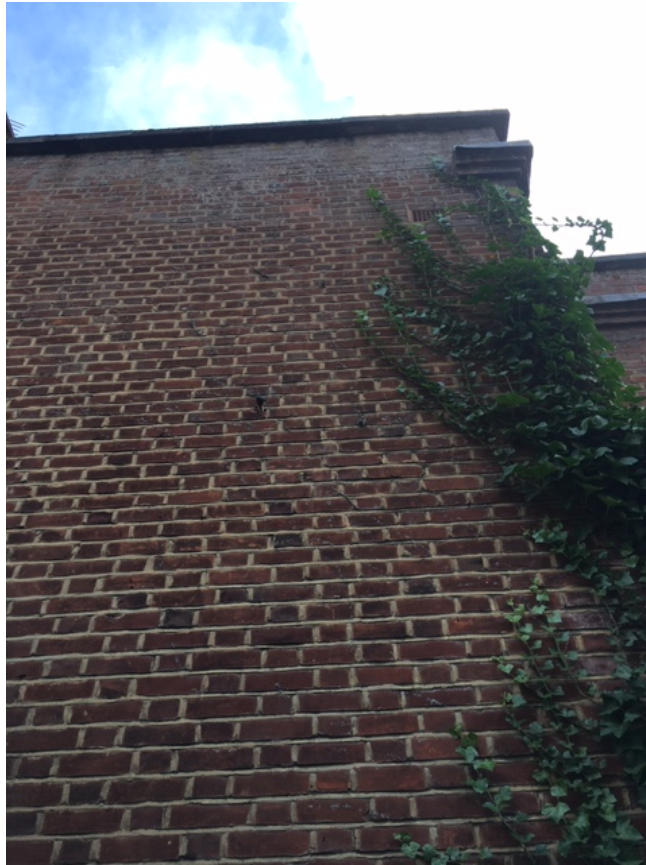
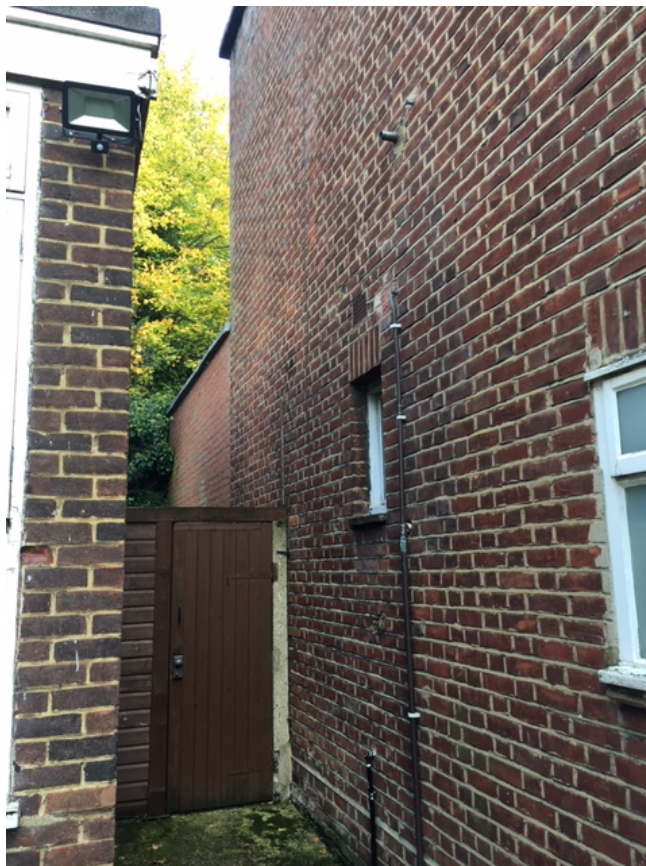
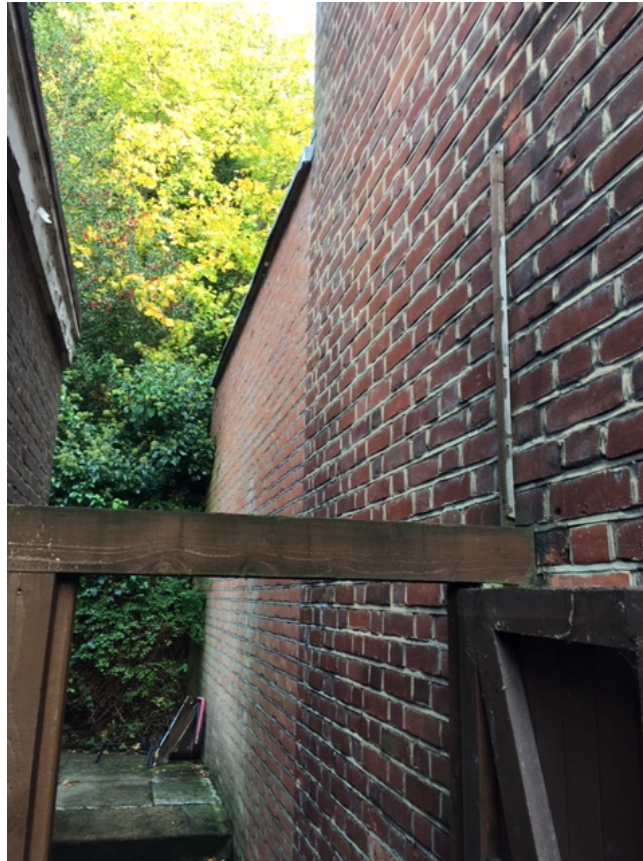
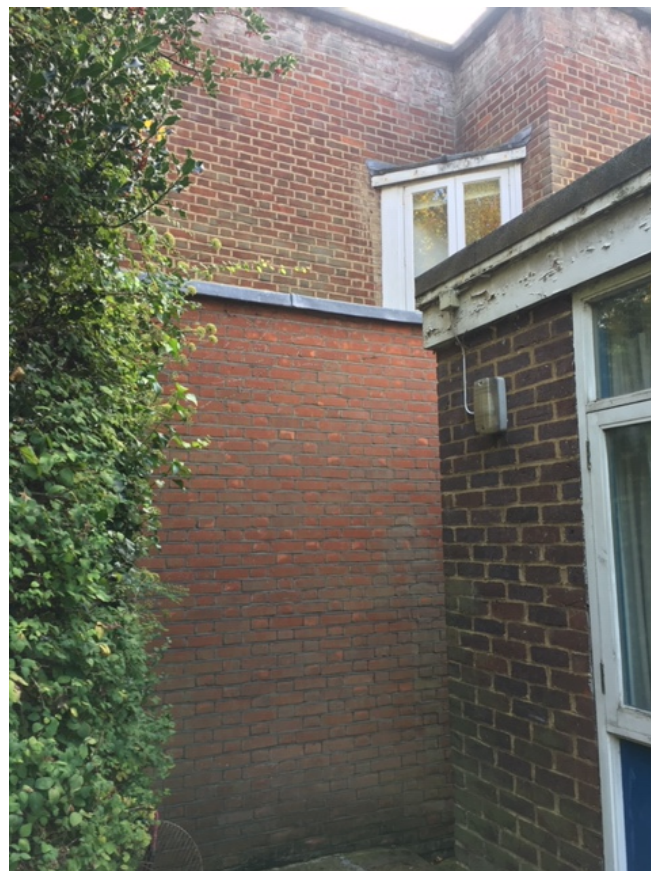
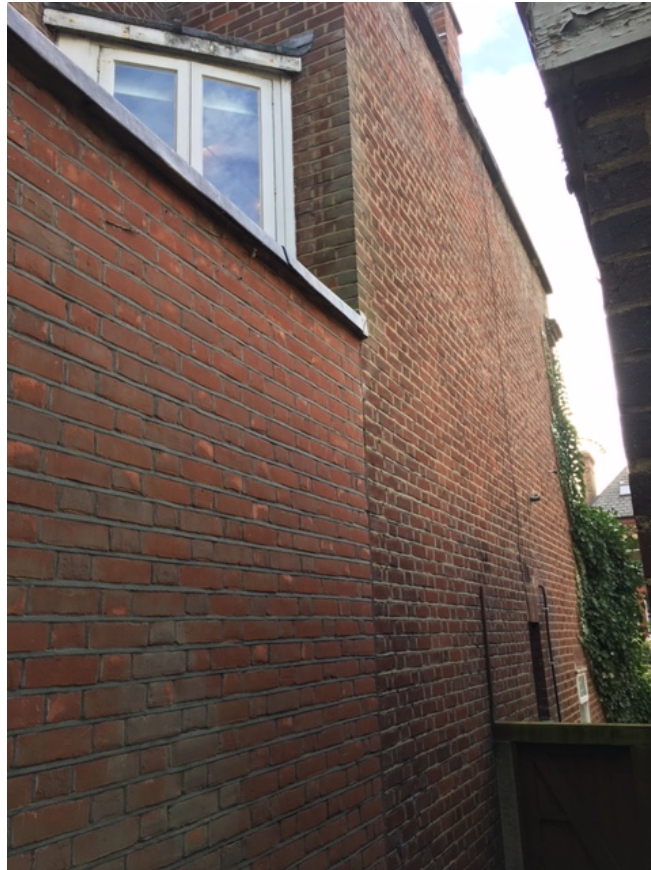
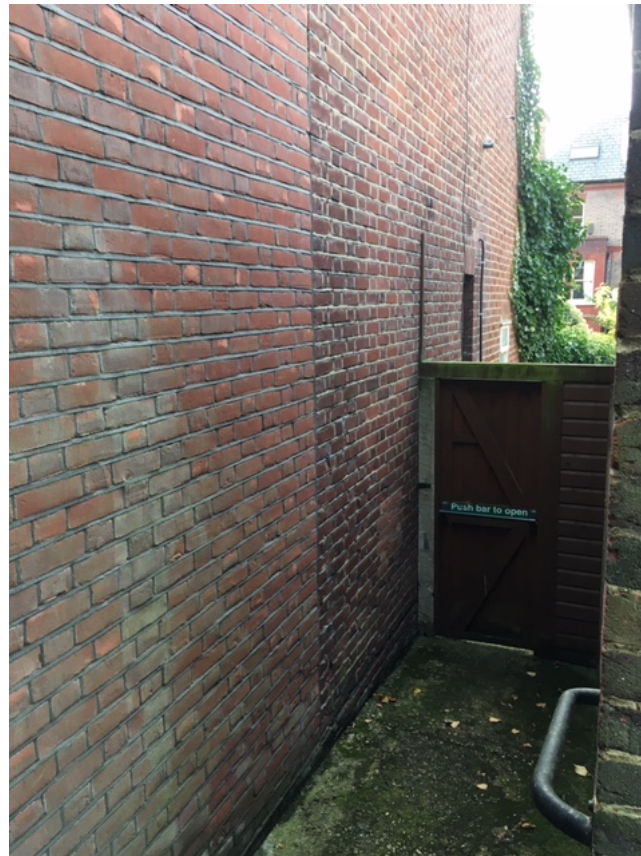
BL carried out a site visit on 20th October 2020 to externally inspect the neighbouring building 24A NG (*Photos 1-18*) for which photos can be found in Appendix B of this File Note. The brickwork to the main extension building/s appears to be in very good condition with no signs of cracking, excessive settlement, subsidence or structural movement of any kind. Some minor cracking was noted (*Photo 11*), however, this was at the junction between the main house wall and the half-height garden/porch wall which is not unusual bearing in mind they do not appear to be properly jointed and of different heights and construction. The junction between 24A NG and 24 NG also show some minor cracking to the jointing material (presumed concrete mortar) (*Photo 4*), again, this is not necessarily unusual as the newer-build 24A NG naturally settles under its own weight and would not be classed as damage or an issue. This demonstrates that the land stability of/below the neighbouring 24A NG building is acceptable which satisfies Query No.9 in Campbell Reith's BIA-Audit Tracker.

BL do not believe further review is required based of the findings of our site visit noting that the building appears to be in very good condition.
