# SITE INVESTIGATION & GROUND MOVEMENT ASSESSMENT REPORT

8 Oakhill Avenue London NW3 7RE

J19232

September 2020

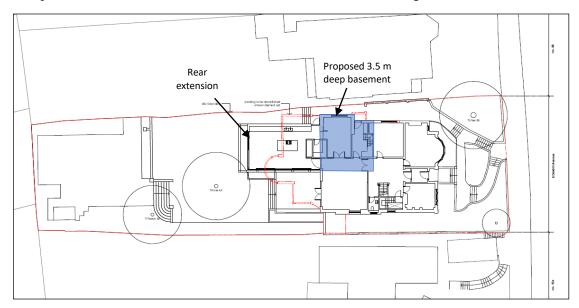
It is understood that it is proposed to remodel the existing building through internal alterations, to construct a single level basement beneath part of the house and to replace the rear part of the house with a new extension, as shown on the drawing below.

It is understood that it is proposed to remodel the existing building through internal alterations, to construct a single storey basement at the rear of the building, along with a new rear extension that will replace part of the existing house.

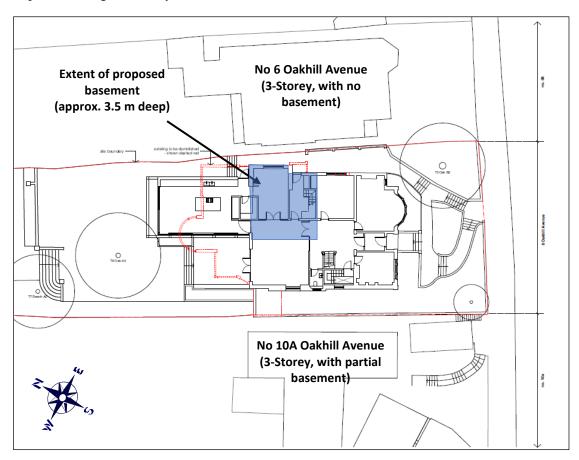
A plan showing the nearby sensitive structures is shown below.

Sensitive structures relevant to this assessment include No 6 Oakhill Avenue and No 10A Oakhill Avenue, to the east-northeast and southwest respectively.

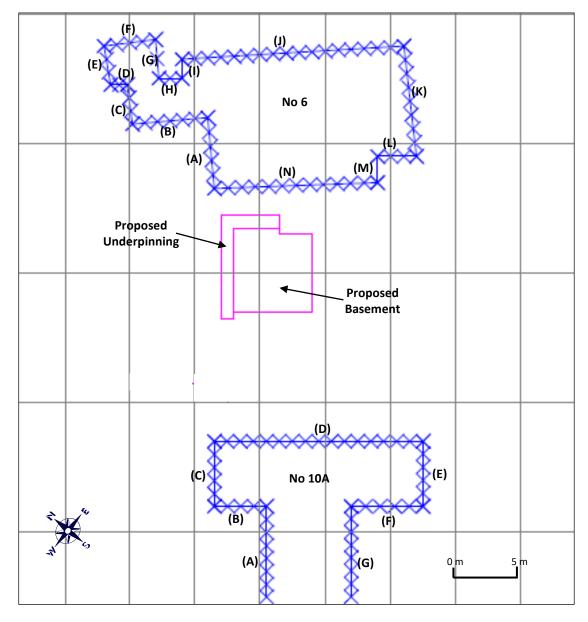
The sensitive structures of Nos 6 and 10A Oakhill Avenue have been modelled as a series of displacement lines, as detailed on the plan below, along which the damage assessment has been undertaken.

As per the comments in Section 9.1, a foundation depth of approximately 1.00 m below existing ground level has been assumed for the purpose of the analysis.

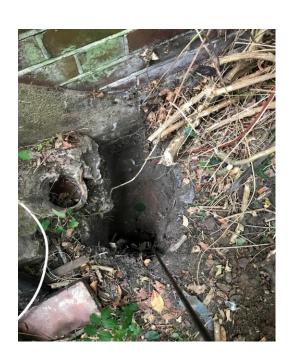
Made ground (dark brown clayey fine to coarse sand with abundant roots and rootlets and brick fragments)

Remarks:	Scale:
All dimensions in millimetres	1:20
Groundwater was not encountered	Logged by:
	SZ

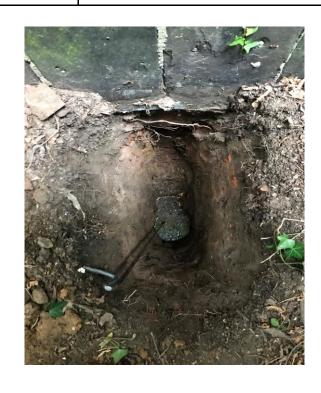
# Section A-A'

Made ground (brown sandy clay with occasional roots rootlets and brick fragments)

Remarks:	Scale:
All dimensions in millimetres	1:20
Groundwater encountered at 1.00 m	Logged by:
	SZ

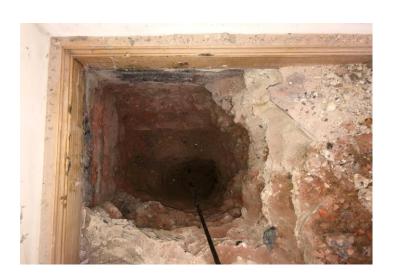
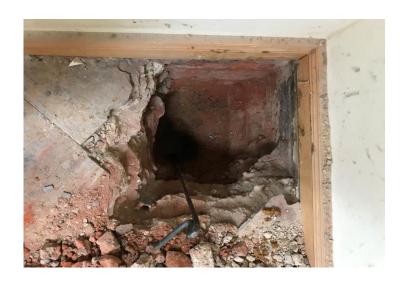
# Section A-A'

# Section B-B'

Remarks:	Scale:	
All dimensions in millimetres	1:20	
Groundwater was not encountered	Logged by:	
	SZ

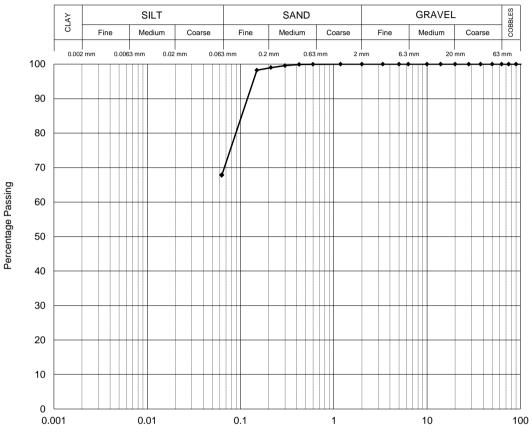
Siev	е
Size	% Pass
200.0 mm	100
125.0 mm	100
90.0 mm	100
75.0 mm	100
63.0 mm	100
50.0 mm	100
37.5 mm	100
28.0 mm	100
20.0 mm	100
14.0 mm	100
10.0 mm	100
6.30 mm	100
5.00 mm	100
3.35 mm	100
2.00 mm	100
1.18 mm	100
600 µm	100
425 µm	100
300 µm	100
212 µm	99
150 µm	98
63 µm	68

Particle Proportions						
Cobbles	0					
Gravel	0					
Sand	32					
Silt & Clay	68

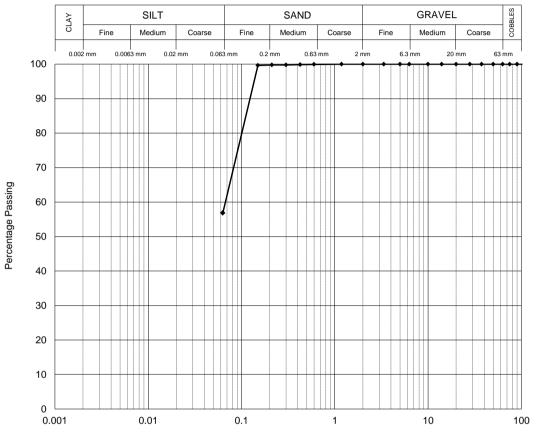
Sieve					
Size	% Pass				
200.0 mm	100				
125.0 mm	100				
90.0 mm	100				
75.0 mm	100				
63.0 mm	100				
50.0 mm	100				
37.5 mm	100				
28.0 mm	100				
20.0 mm	100				
14.0 mm	100				
10.0 mm	100				
6.30 mm	100				
5.00 mm	100				
3.35 mm	100				
2.00 mm	100				
1.18 mm	100				
600 µm	100				
425 µm	100				
300 µm	100				
212 µm	100				
150 µm	100				
63 µm	57

Particle Proportions						
Cobbles	0					
Gravel	0					
Sand	43					
Silt & Clay	57
