11 Briardale Gardens NW3 7PN2

Trial Dig

(Ref. 101 559)
Date: 26/11/2020

**11 Briardale Gardens NW3
Bike Store
Trial Dig**

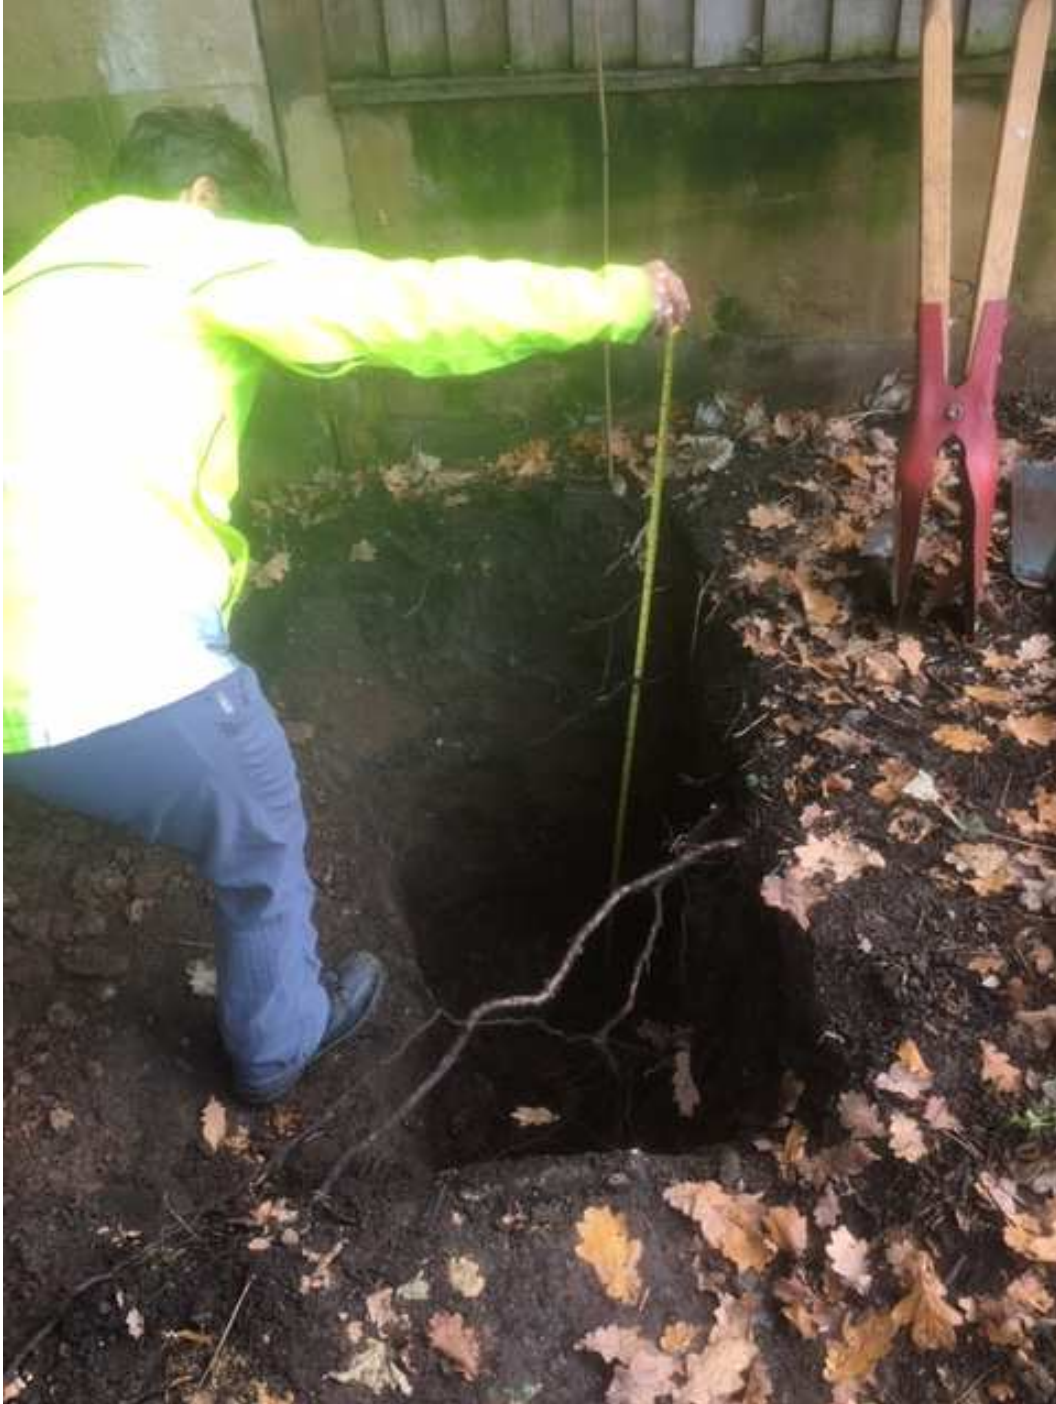
Mini-pile Dig No. 1

Within Trench 1: Depth 1.0m with *MP location in corner* against the boundary fence

No significant tree roots (> 2.5cm dia.) found

1 x surface root 1.0cm dia and 3 x 0.5cm dia. (likely from removed shrubs or the previously removed silver birch T4)

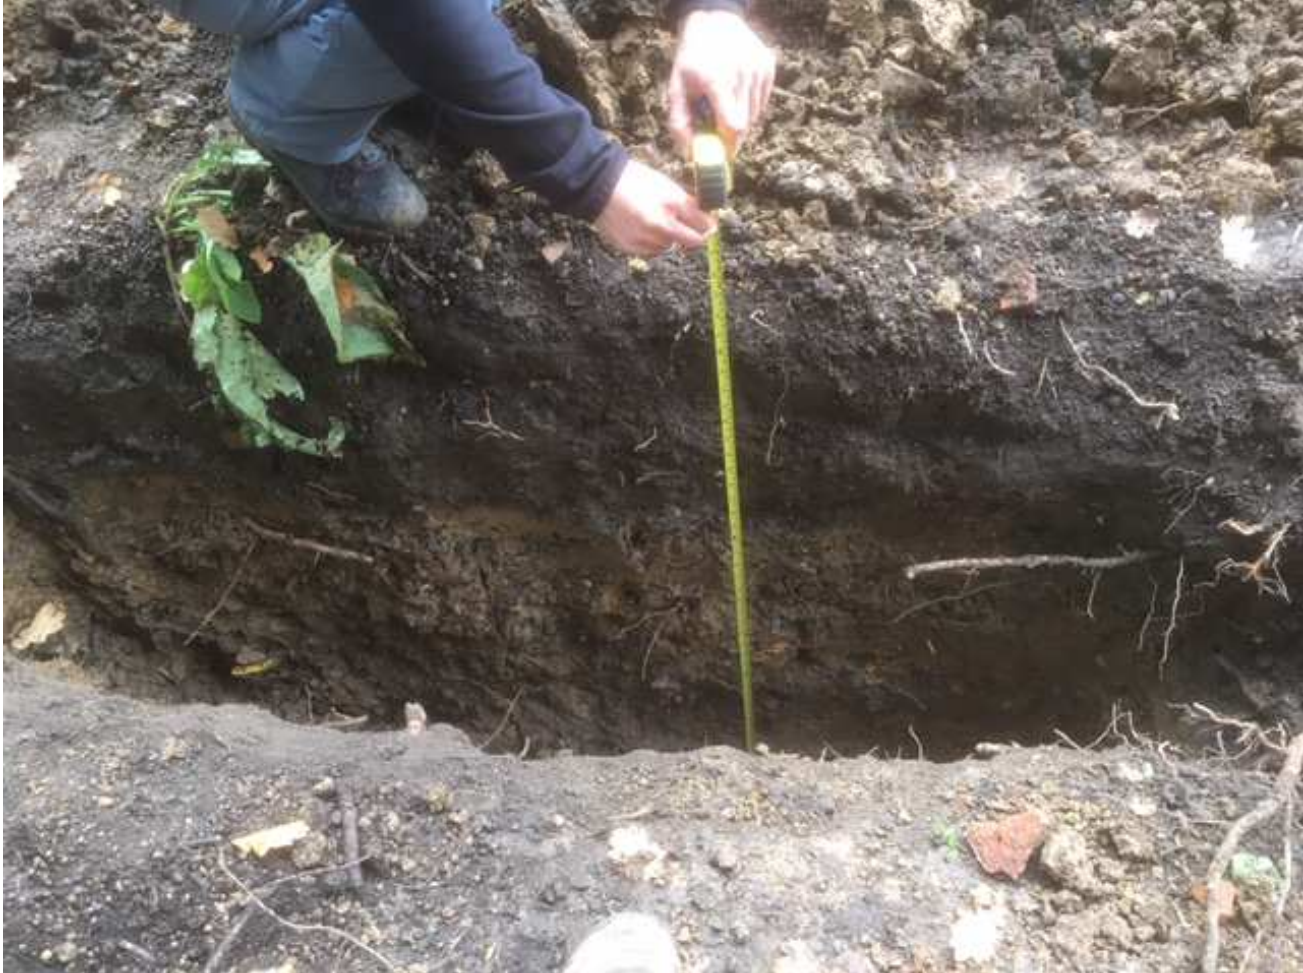
Mini-pile (MP) Dig No. 2

Within Trench 2: Depth 1.0m with *MP location on right-hand side* of trench

No significant tree roots (> 2.5cm dia.) found

2 x ash roots 1.0cm dia. (likely from the previously removed ash T3)

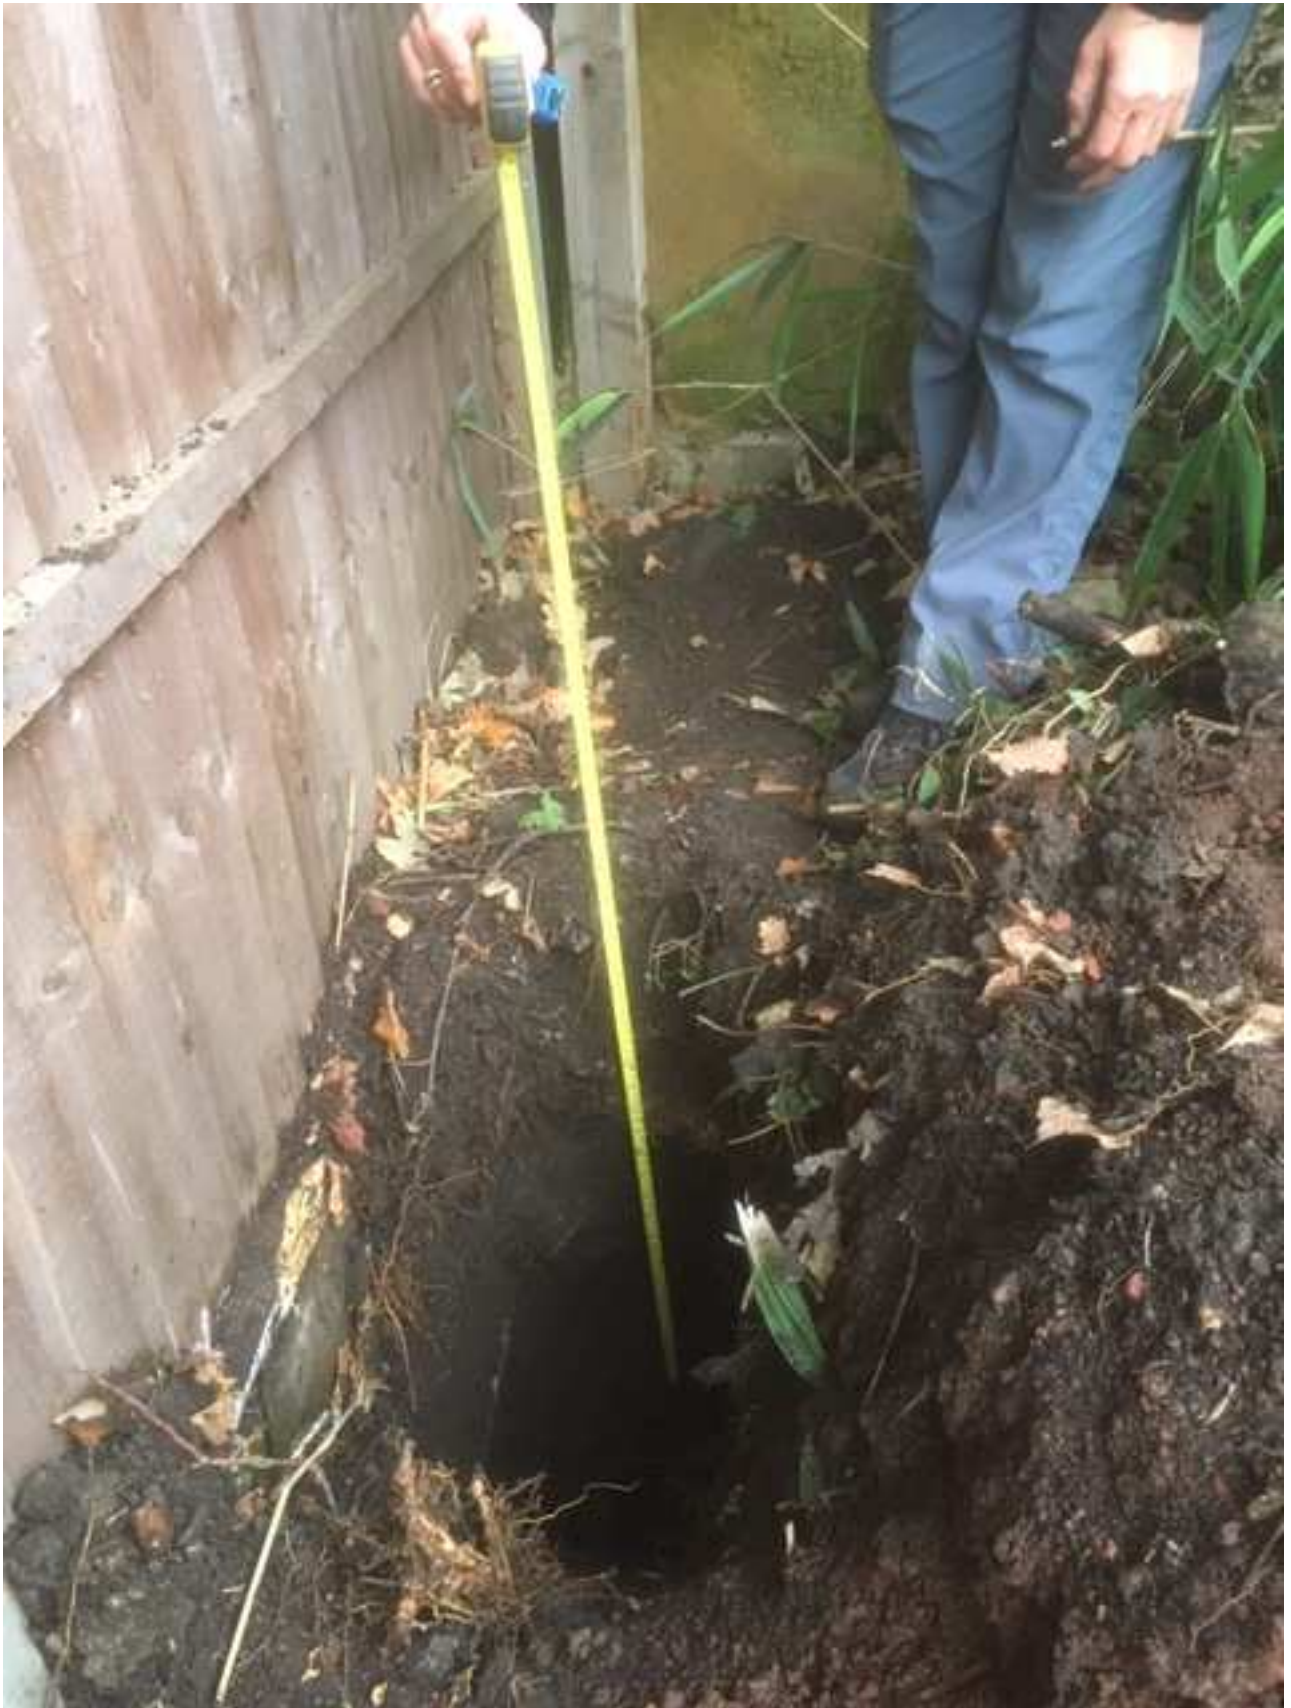
Mini-pile Dig No. 3

Depth 60cm

No significant tree roots ($> 2.5\text{cm}$ dia.) found

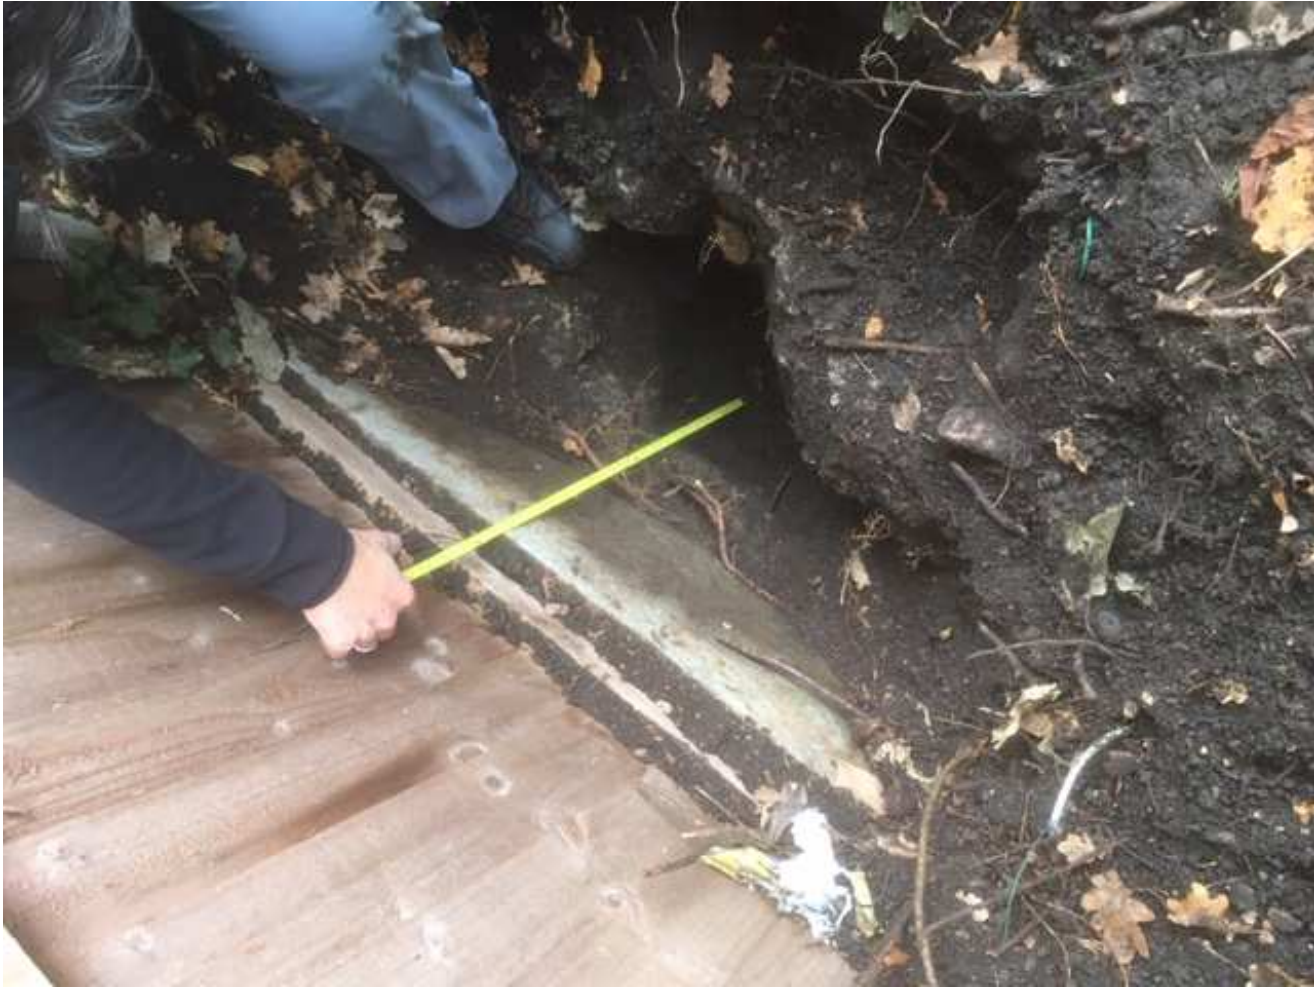
Mini-pile Dig No. 4

Depth 60cm

No significant tree roots (> 2.5cm dia.) found

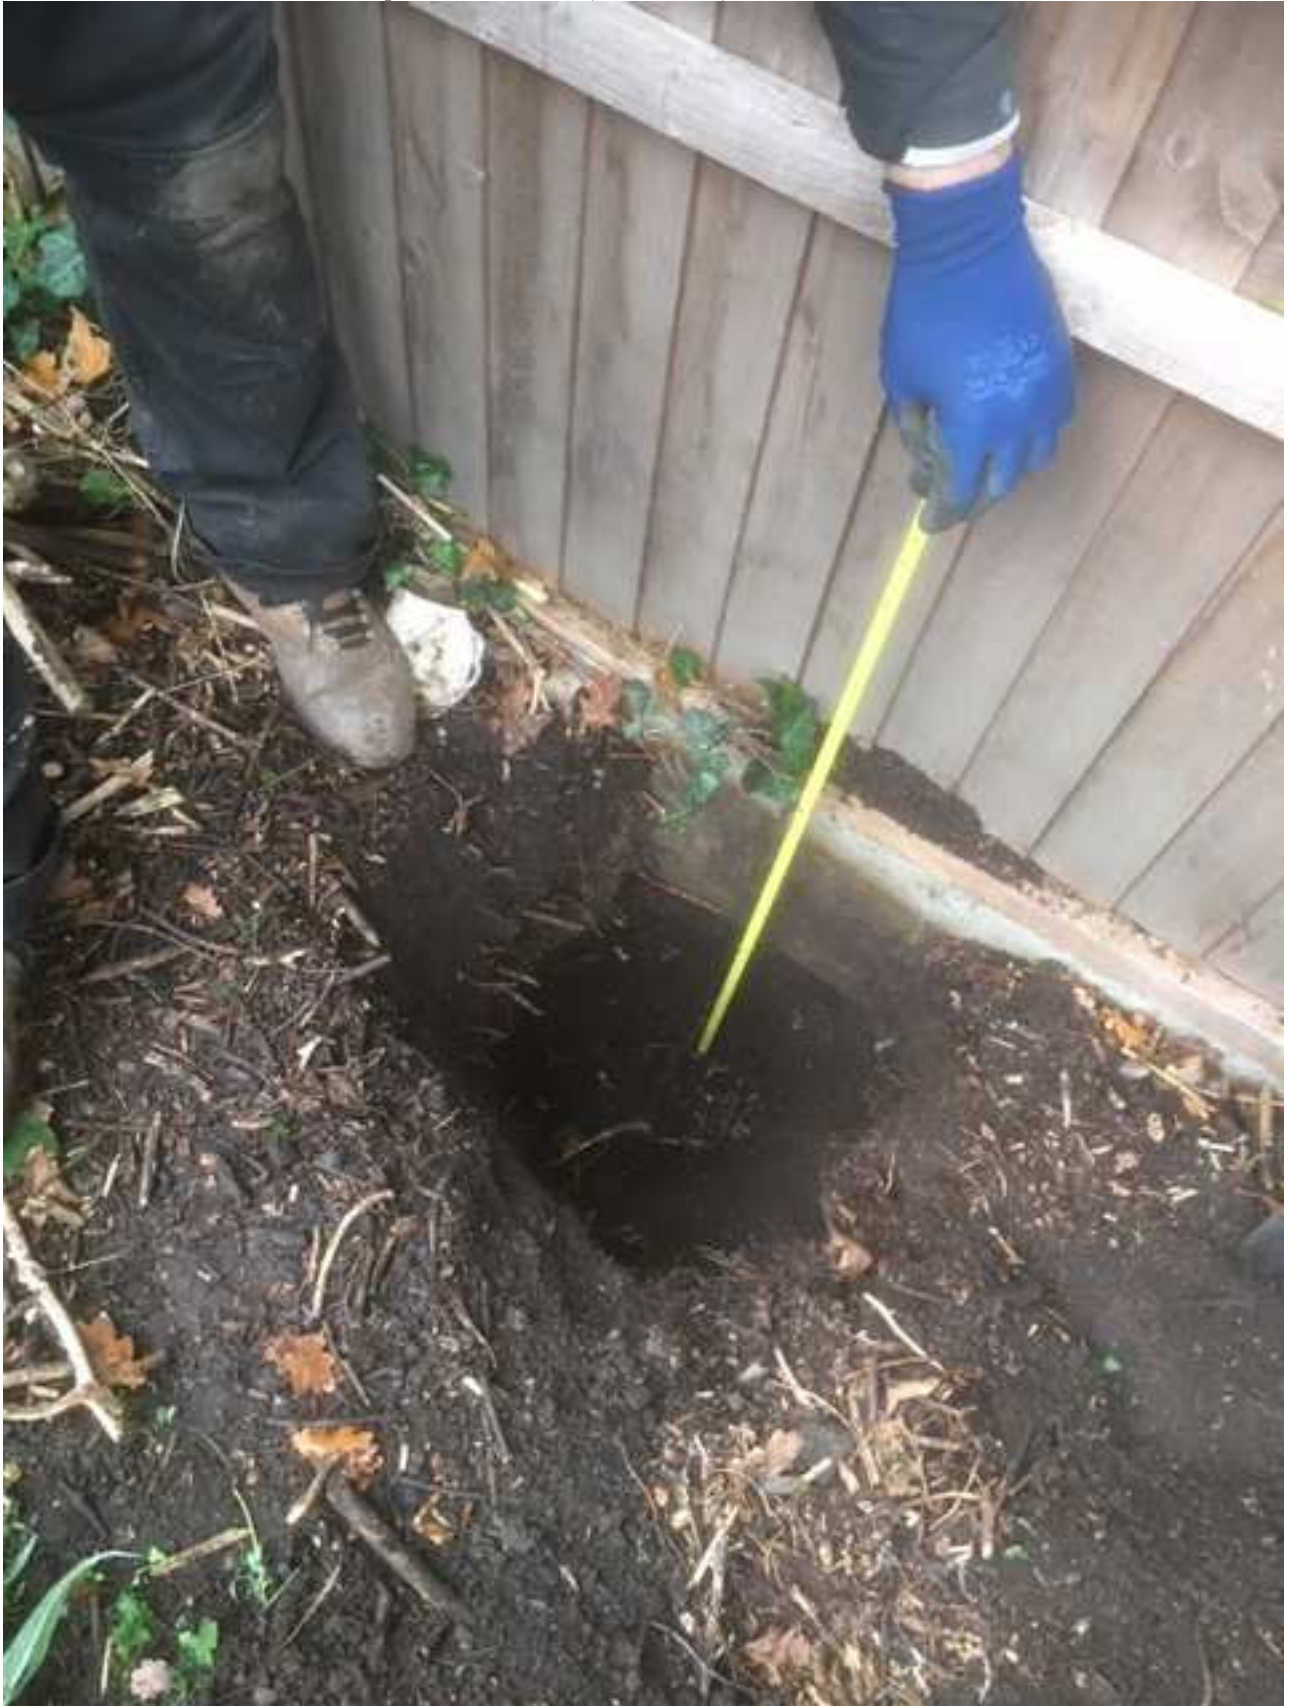
Mini-pile Dig No. 5

Depth 60cm

No significant tree roots (> 2.5cm dia.) found

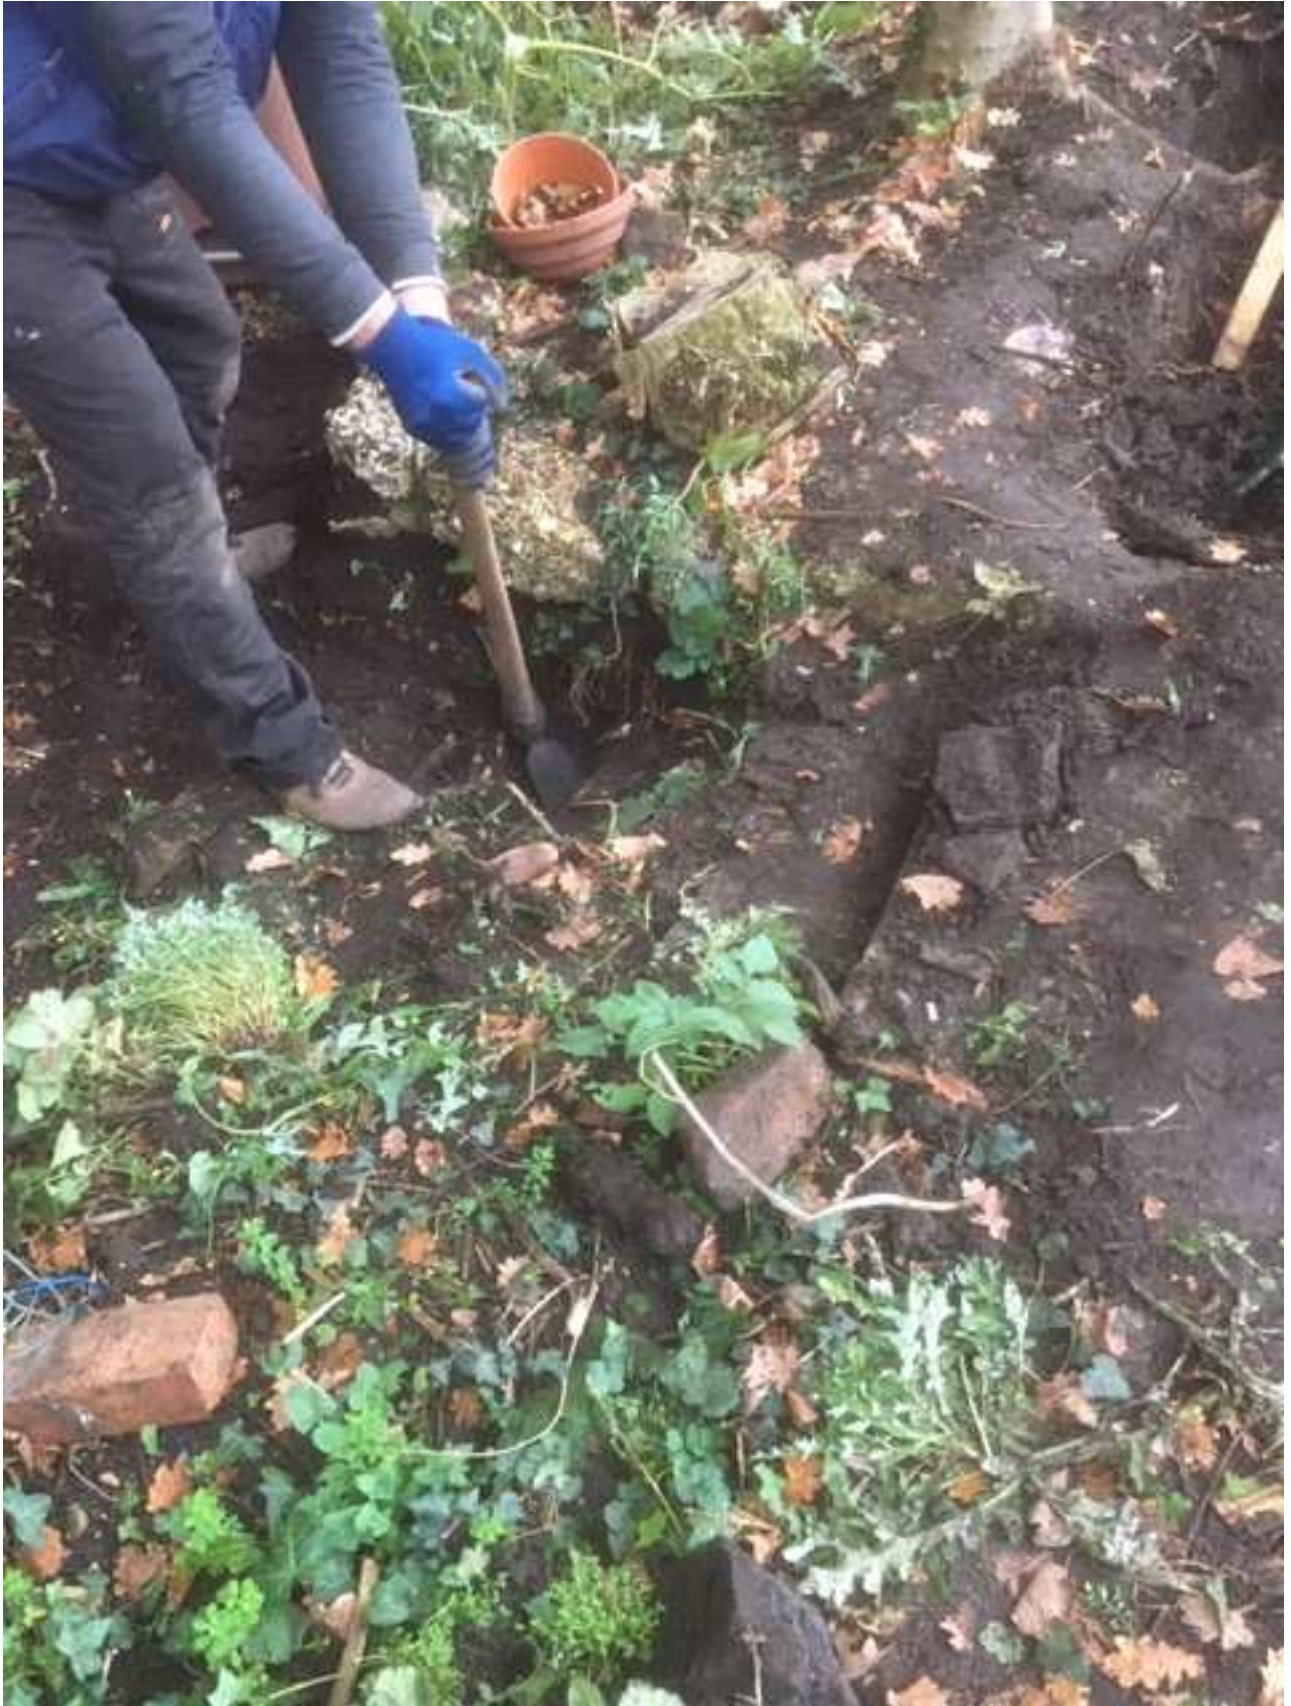
Mini-pile Dig No. 6

Aborted due to large paving slabs that could not be lifted using hand-tools

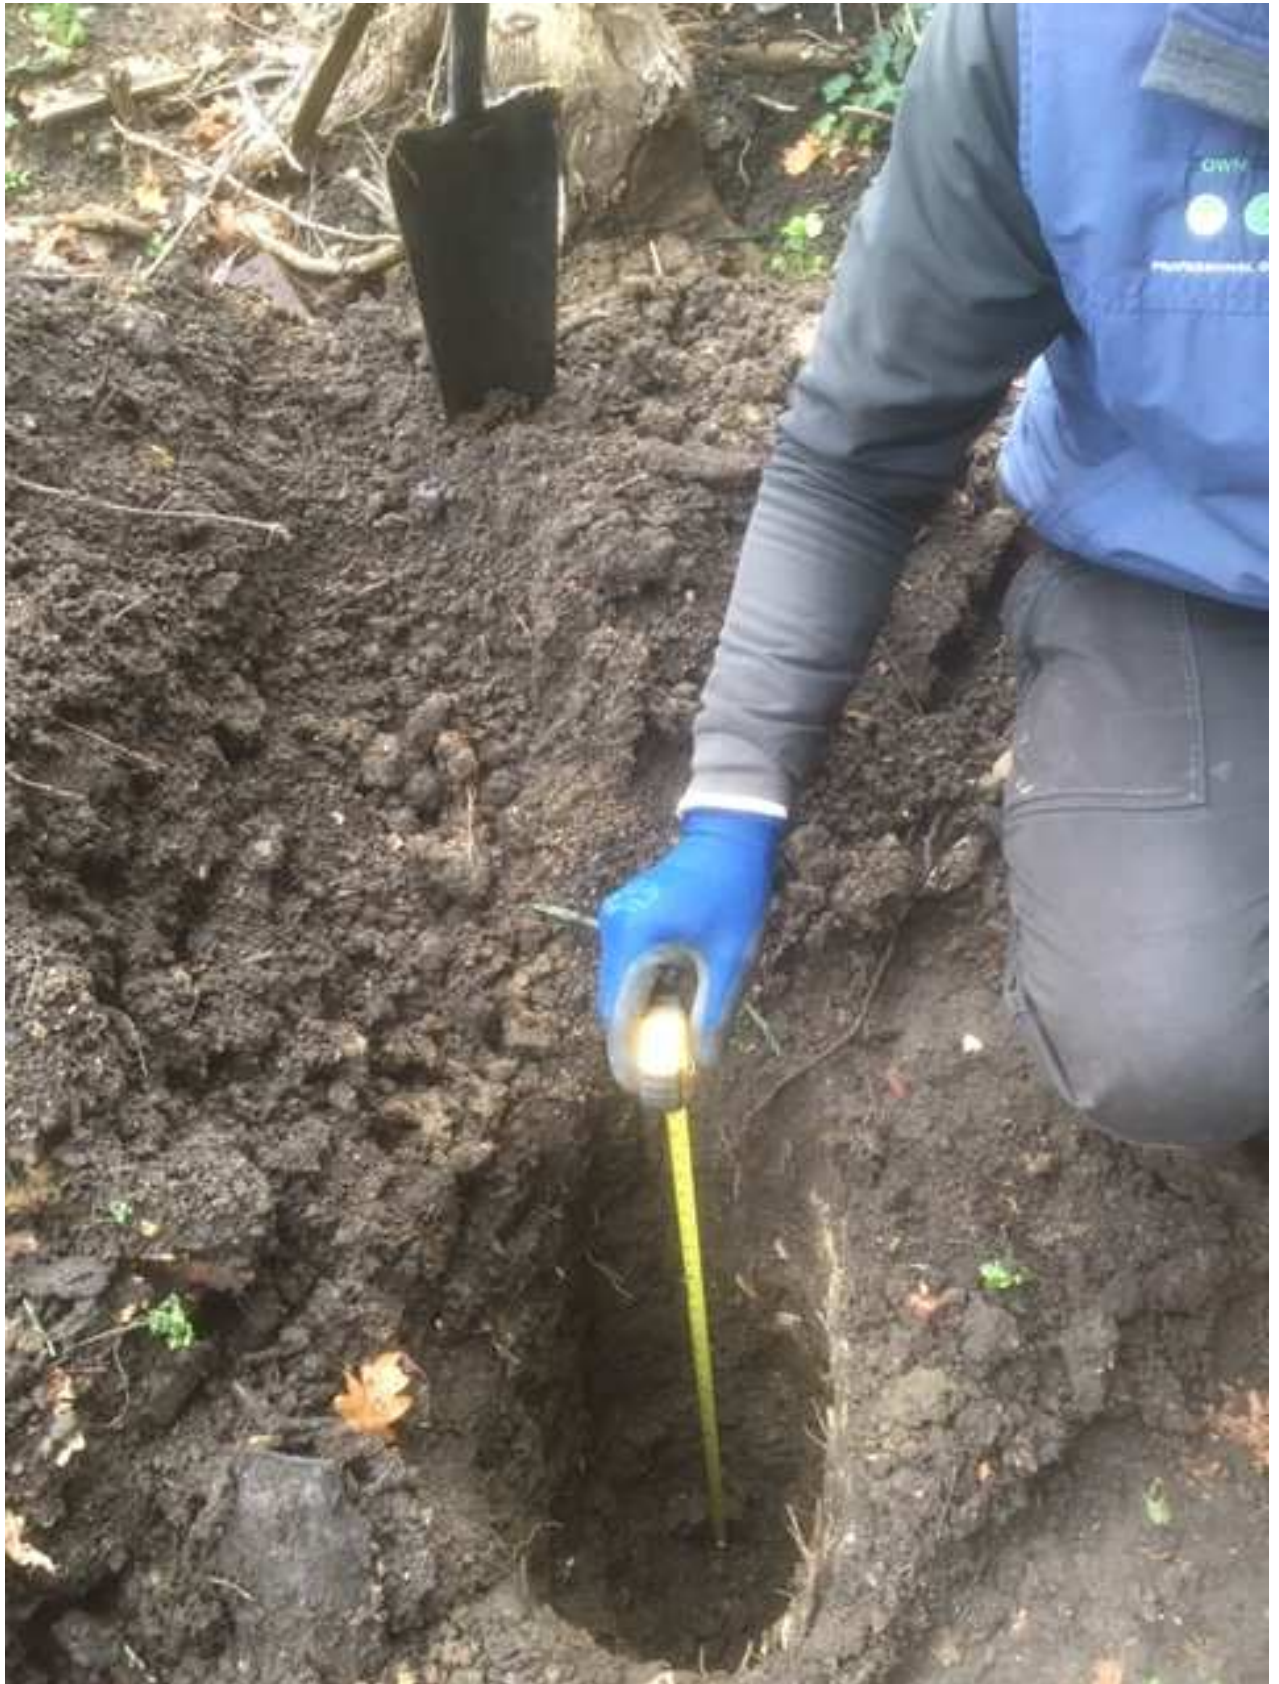
Mini-pile Dig No. 7

Depth 70cm

No significant tree roots ($> 2.5\text{cm}$ dia.) found

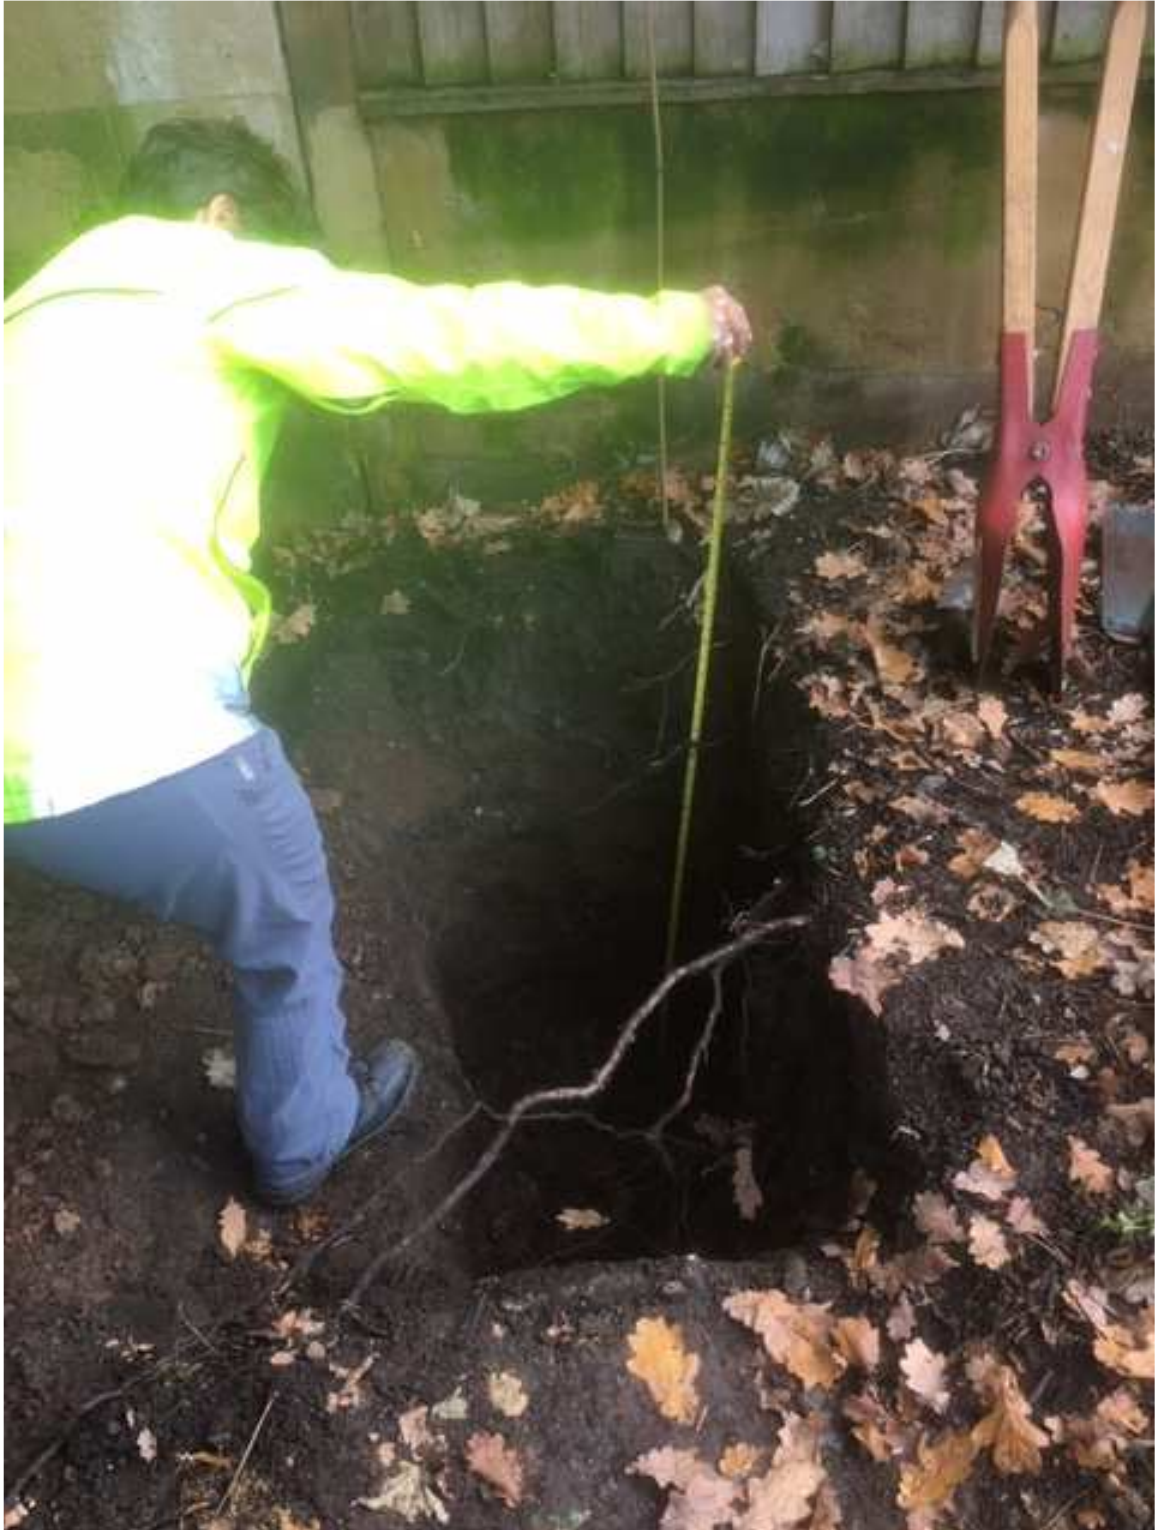
Trench 1

Depth 1.0m x 1.2m long

No significant tree roots (> 2.5cm dia.) found

1 x surface root 1.0cm dia and 3 x 0.5cm dia. (likely from removed shrubs or the previously removed silver birch T4)

At bottom of photo note the large paving slabs of a footpath that impeded the trench dig running towards Trench 2

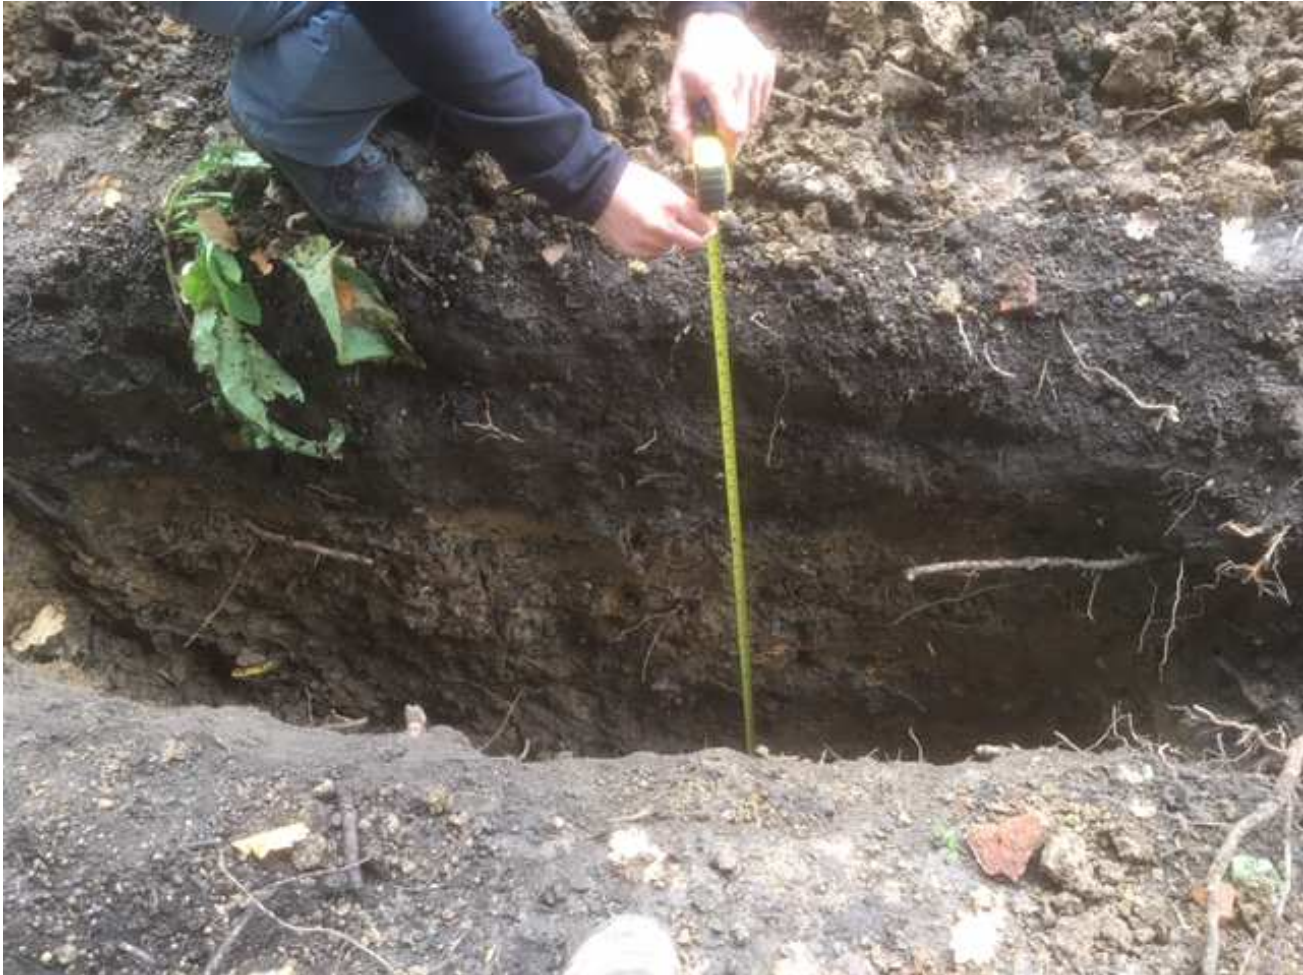
Trench 2

Depth 1.0m x 1.7m long

No significant tree roots (> 2.5cm dia.) found

3 x ash roots 1.0cm dia. (likely from the previously removed ash T3)

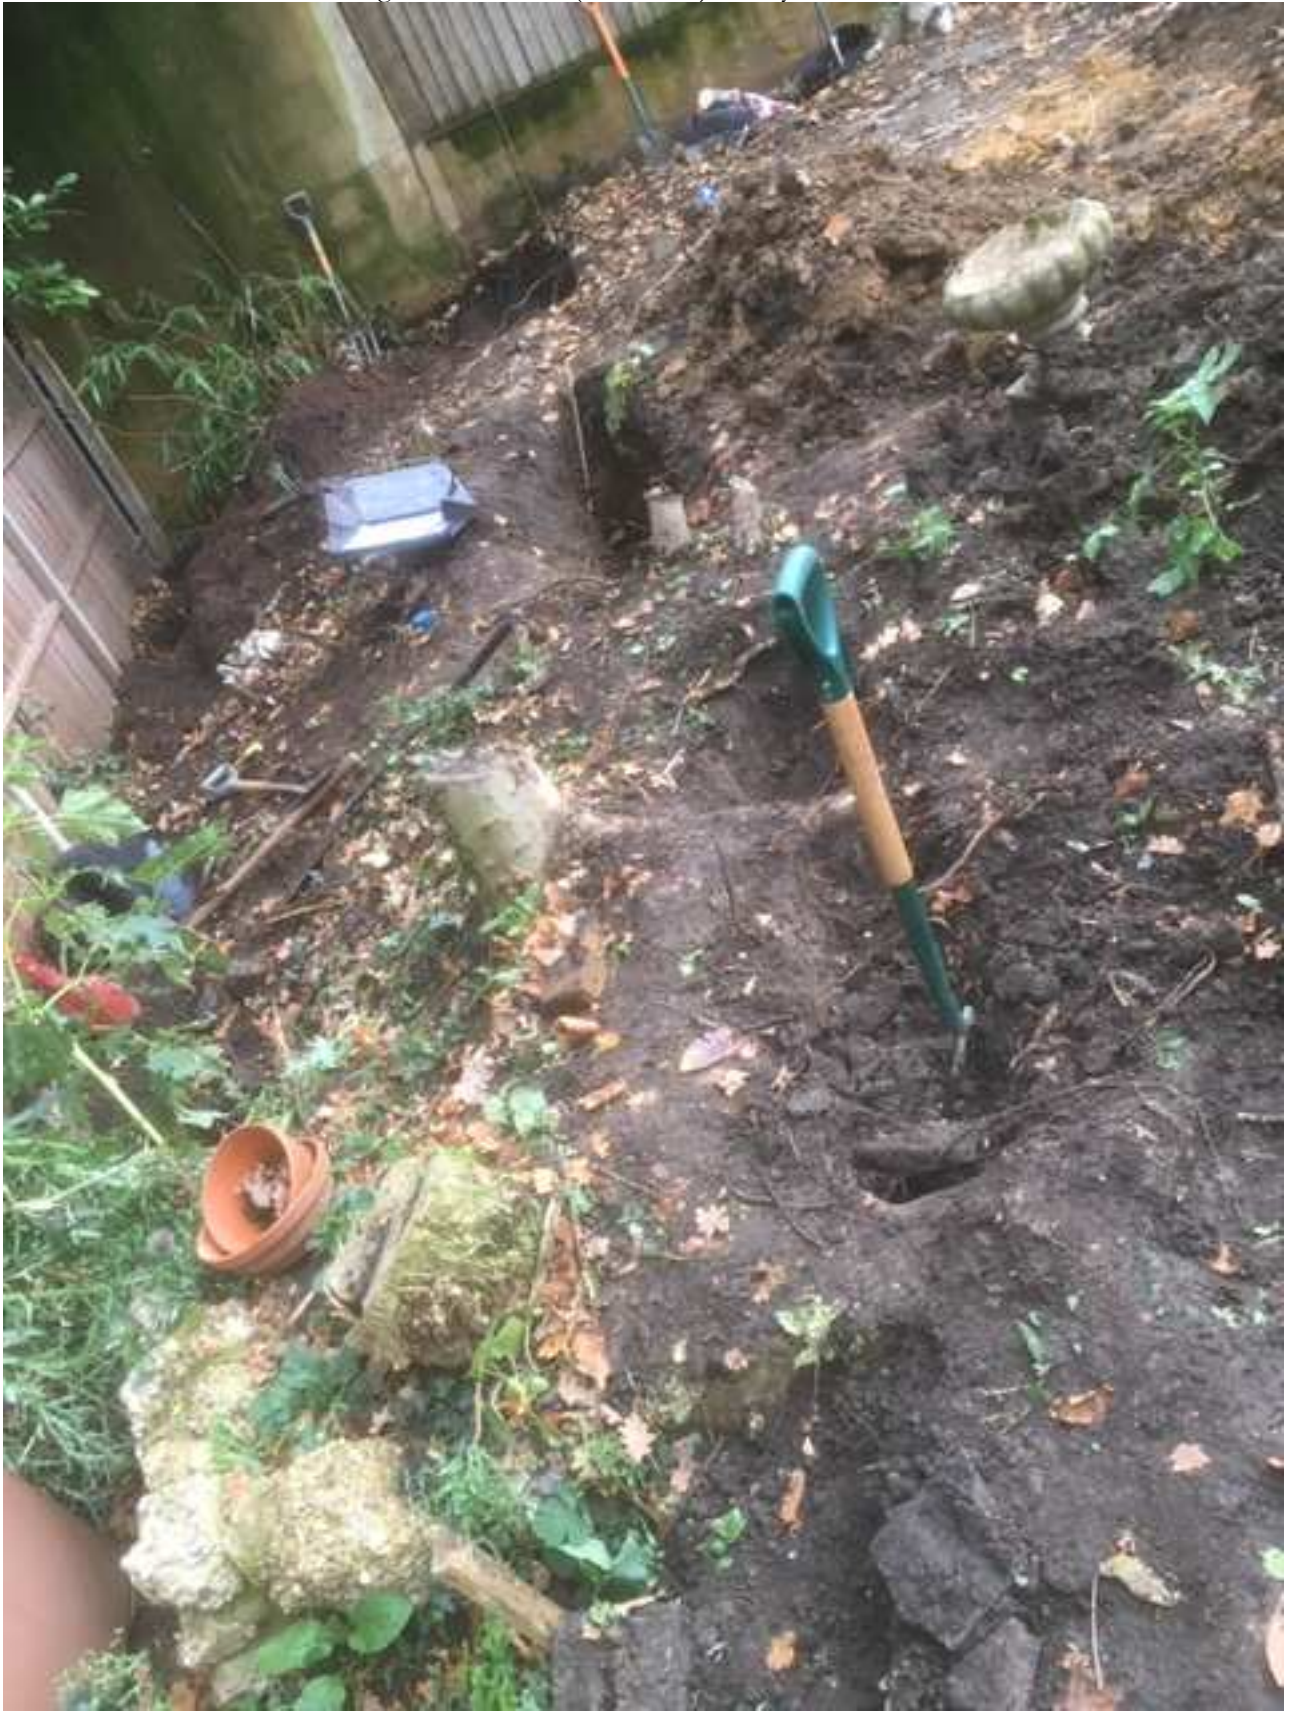
From Trench 2 looking south from (aborted) MP hole 6 towards MP hole 1
Trench dig aborted due to (T2 and T3) woody roots
