Basement Impact Assessment

15 Lyncroft Gardens, London NW6 1LB

Hydrogeology, Land Stability and Ground Movement Assessment

MGC-BIA-19-29-V3

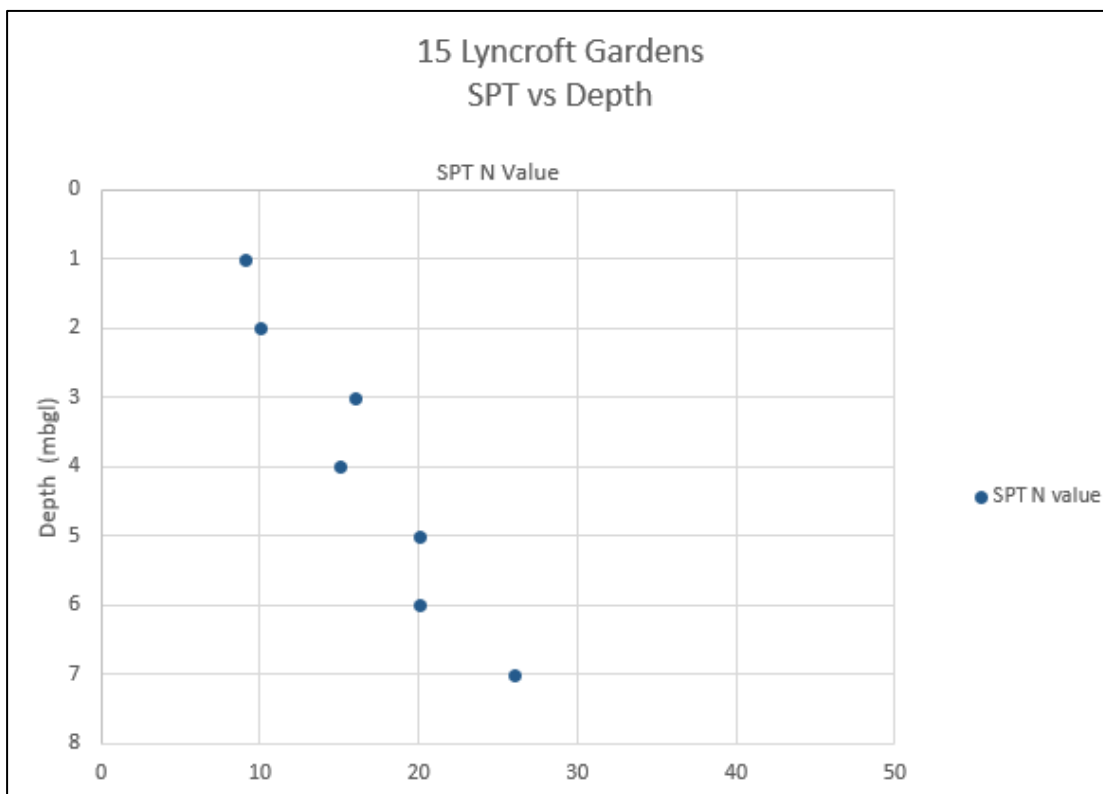
Figure 5.1 SPT N values for London Clay Formation

The London Clay Formation (LCF) was encountered during the site investigation at a depth of 0.8 m bgl to termination of BH01 at 7.95 m bgl. A plot of SPT N values against depth is shown in Figure 5.1 which shows N values ranging between 9 and 26, with a clear pattern of N values increasing with depth.

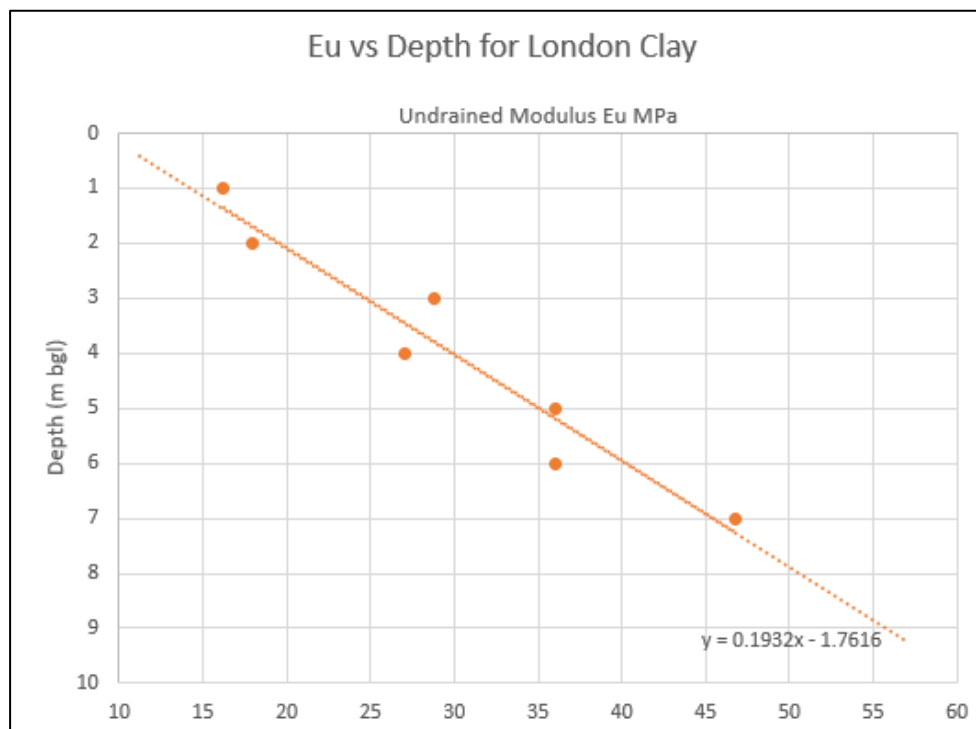
Figure 5.3 Relationship of stiffness with depth in London Clay Formation

Figure 5.3 shows the undrained stiffness profile based on correlation with SPT N values.

The deformation moduli (E_u and E') of the LCF has been cautiously estimated from the relationship between undrained cohesion for an axial strain of 0.1% and plasticity of the LCF where E_u is based on a PI of 38% and an OCR >4 giving a $E_u/C_u \sim 400$ (after Jamiolkowski et al. 1979). and E' is $0.75 E_u$ after Burland, Standing J.R., and Jardine F.M. (eds.) (2001). Poisson Ratio is taken as $\nu_u = 0.5$ undrained and $\nu' = 0.2$ drained.

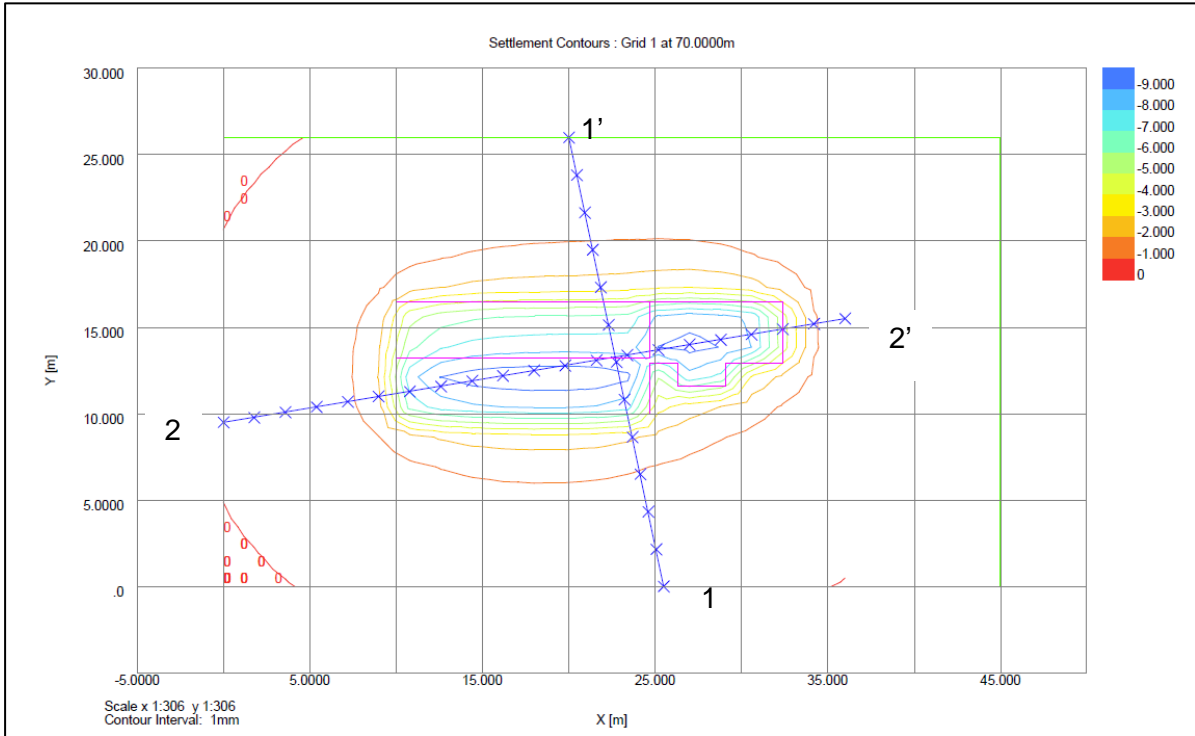
Figure 6.1 Heave- short term undrained condition

The heave has been evaluated using Pdisp version 20.12, which shows a maximum heave of up to - 9.6 mm¹ under short term undrained conditions as shown in Figure 6.1 below in which location of adjacent properties 13 and 17 Lyncroft Gardens are diagrammatically indicated. Long term drained conditions are shown in Figure 6.2 where up to -6.3 mm was determined. As can be seen from Figures 6.3 and 6.4 the short term displacement becomes less than -4.0 mm and -5.2 mm at the boundary with the nearest properties of 13 and 17 Lyncroft Gardens respectively, reducing to less than 1 mm within those properties for each case. Similarly, long term movements reduce to less than +0.5 mm and -0.75 mm at the boundary (Figure 6.5 and 6.5). The combined movements are discussed further in Section 9 and 10.

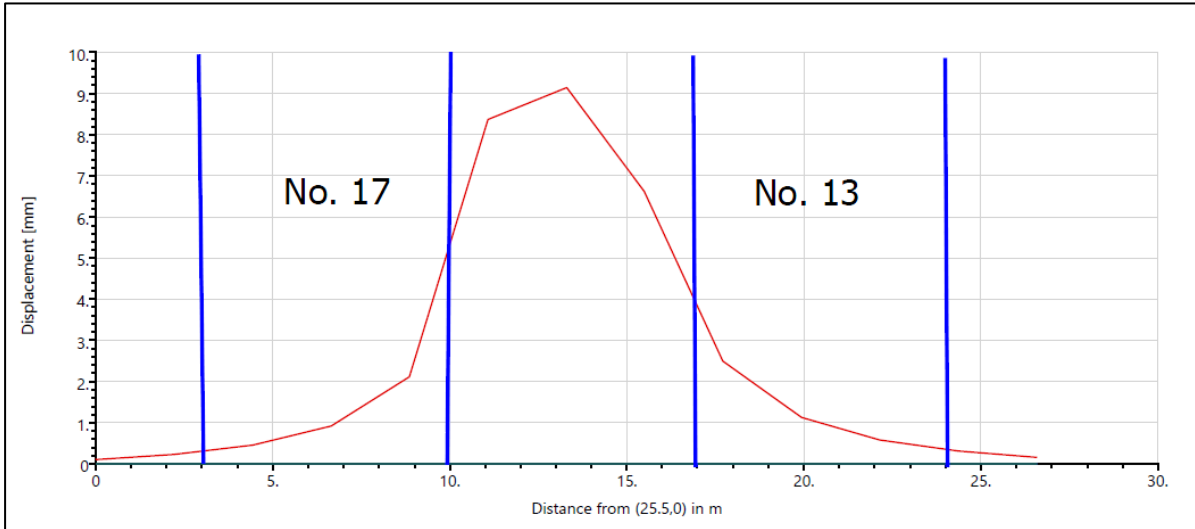
Figure 6.3 Heave- short term undrained condition in excavation- Section 1-1'

Cross sections of the effects of the basement excavation and construction are shown in Figures 6.3 and 6.4, in which the boundaries with 13 and 17 Lyncroft are diagrammatically indicated. These models have been used as a basis for the ground movement assessment and damage assessment in Section 9 and 10 respectively.

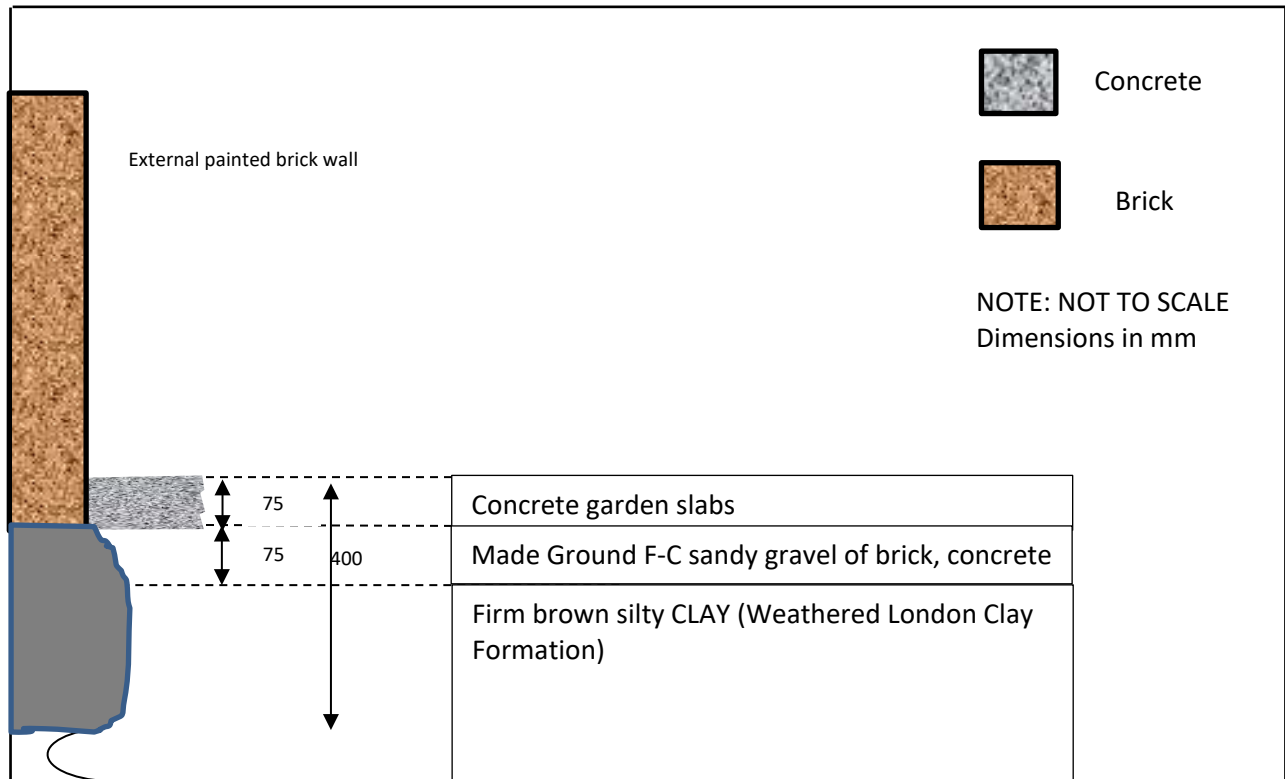
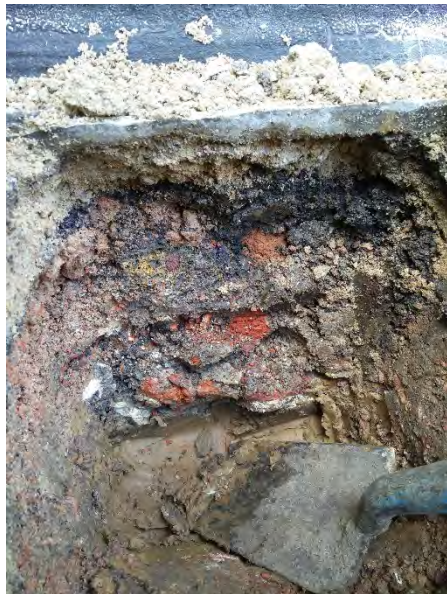
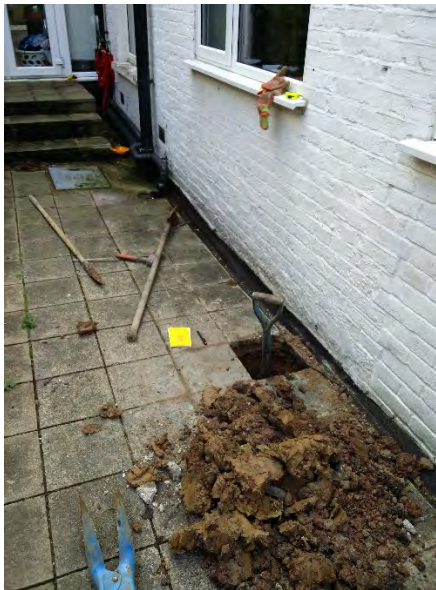
The foundation comprises a rubble of brick and clinker to a depth of 400mm below top of slab.

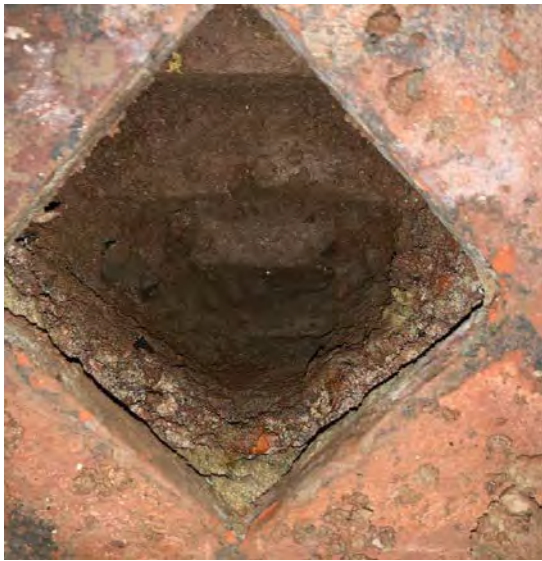
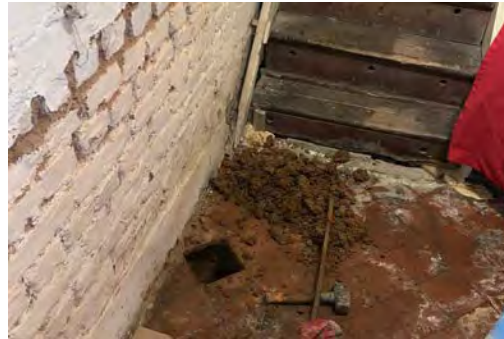
Drawing Number:
MGC-19-29-002

The foundation comprises brick corbels extending 150mm from the wall to a depth of 340mm below top of tiles.
