DESK STUDY & GROUND INVESTIGATION REPORT

5-17 Haverstock Hill
London NW3

J15316

January 2016

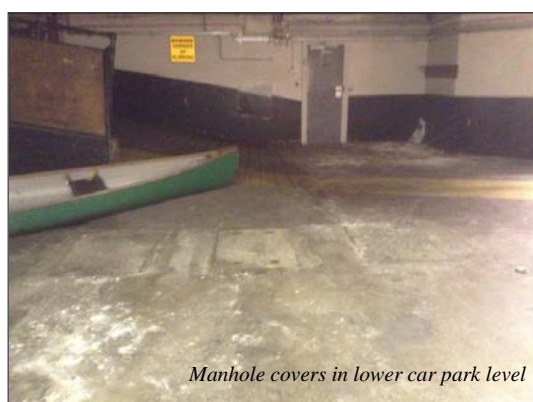
Manhole covers in lower car park level
