**77 C ARLINGTON ROAD, CAMDEN NW1 7ES (GRADE II LISTED)**

**CONDITION REPORT**

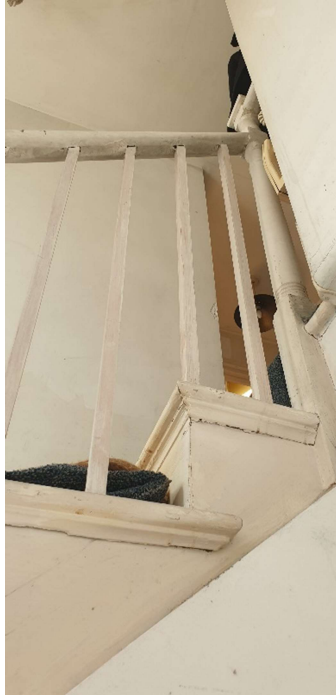
1. The existing staircase leading up to the studio flat appears to be an original feature of the property (see photograph below). This staircase will therefore remain in place.

Existing staircase string, balustrade and handrail detail

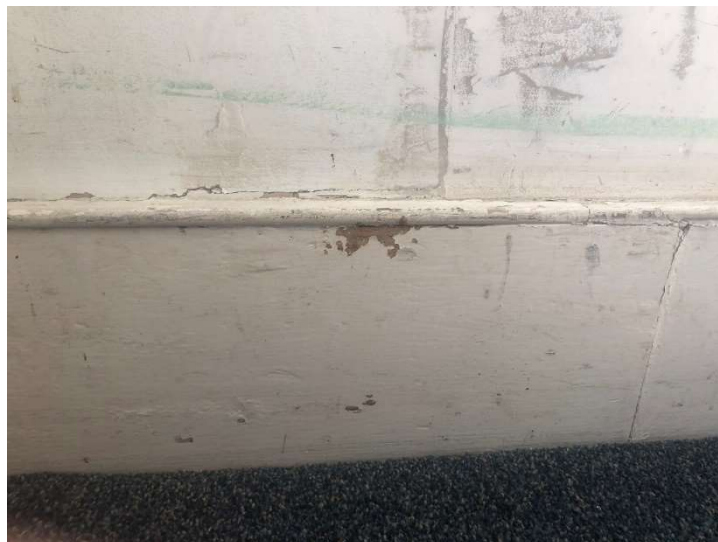
2. The skirtings on the staircase, which appear to be original, are different from the rest of the skirtings in the flat which are a mixture of modern torus and bullnose profiles, see following photographs:

Staircase skirting

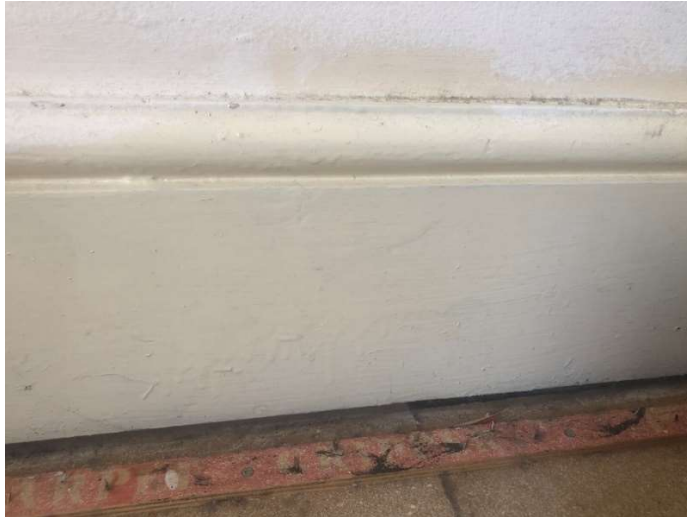
Existing skirtings to external walls & party walls

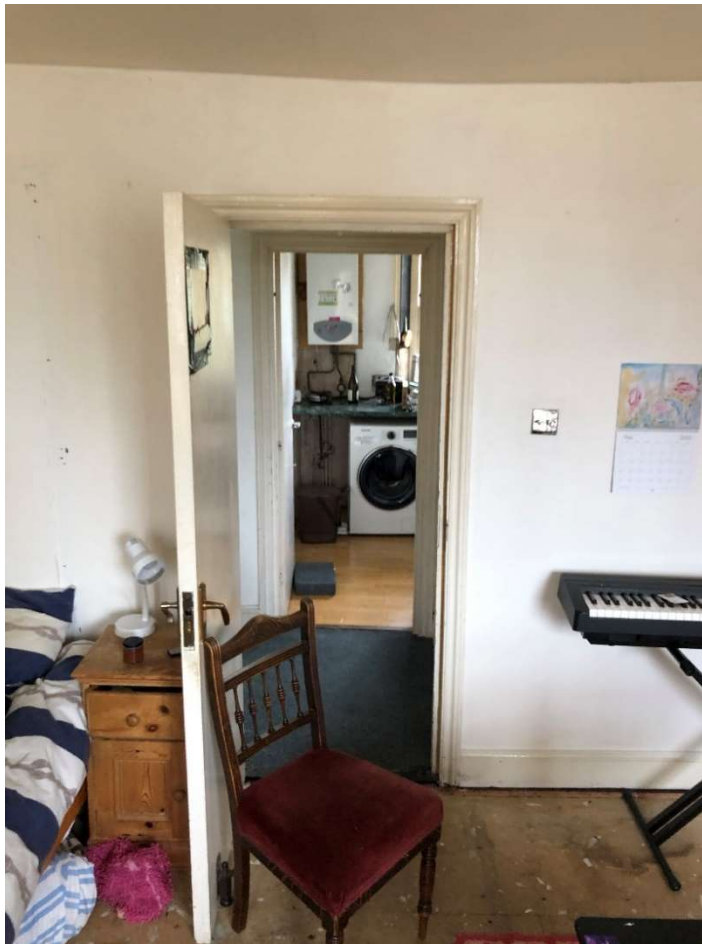
Intermediate stud wall with bullnosed skirtings on chipboard flooring

3. The original floorboards have been removed, throughout the flat, and replaced with chipboard. The chipboard flooring can be seen on the above photograph.

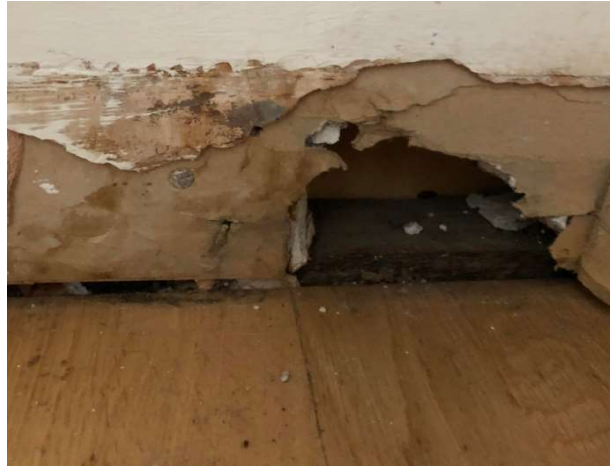
4. All internal partition walls are modern stud construction comprising plasterboard linings on a timber frame. There are no plaster and lathe partition walls. The walls forming the upper stairwell/landing area are also stud partition walls.

Base of stud wall showing plasterboard construction

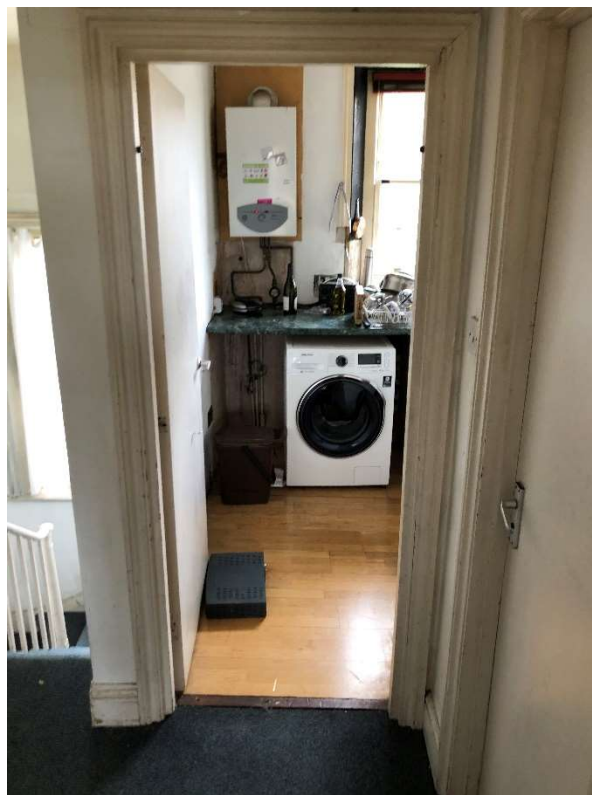
5. All internal doors are modern flush doors

Existing doors onto landing area

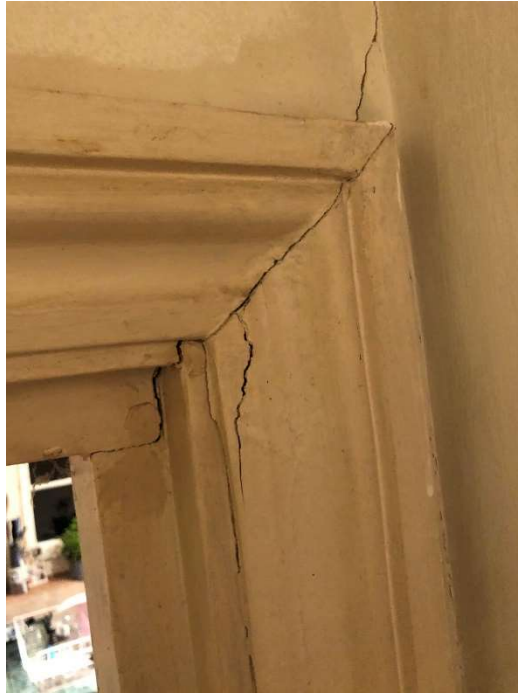
6. All architraves to door openings and window surrounds appear to be modern OG profile, see photographs below:

Window surround

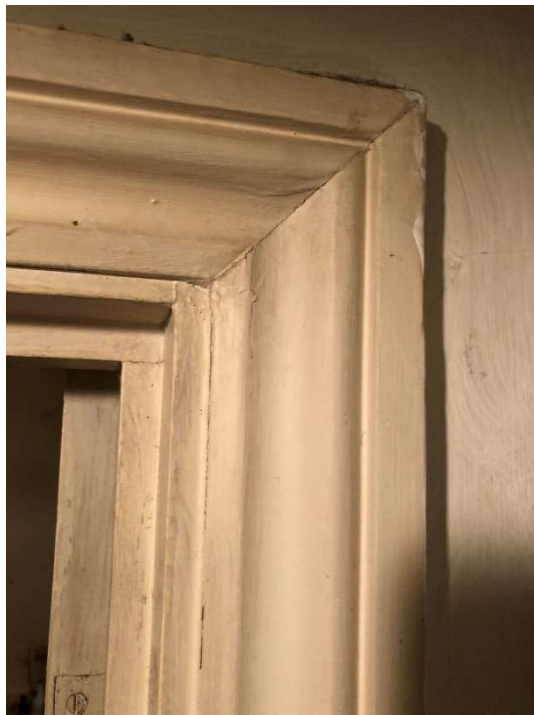
Internal door surround
