Murphy's Yard, Kentish Town

Bat Surveys

Folgate Estates Ltd

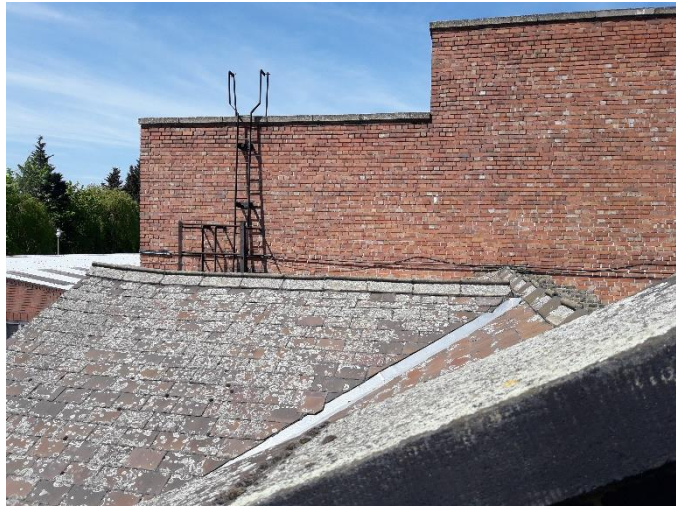
Photograph 1

3.12 *Building 4: Results.* The building was generally in good condition, with all roof tiles and ridge tiles noted to be tight. However, there were several gaps noted in the brickwork on the eastern elevation of the building, where the existing sign is bolted to the wall (Appendix 2, Photograph 3). There is also a brick that has twisted on the north-eastern corner of the building, and upon inspection was found to be an access point into a cavity within the wall and around the parapet wall (Appendix 2, Photograph 4). These gaps in the brickwork would provide potential roosting features for bats. There was also a gap in the brickwork at the apex of the parapet wall on the south-eastern elevation of the building, but this was large and exposed and considered unsuitable.

View of roof structure of Building B4, as viewed from the east, with B5 behind.

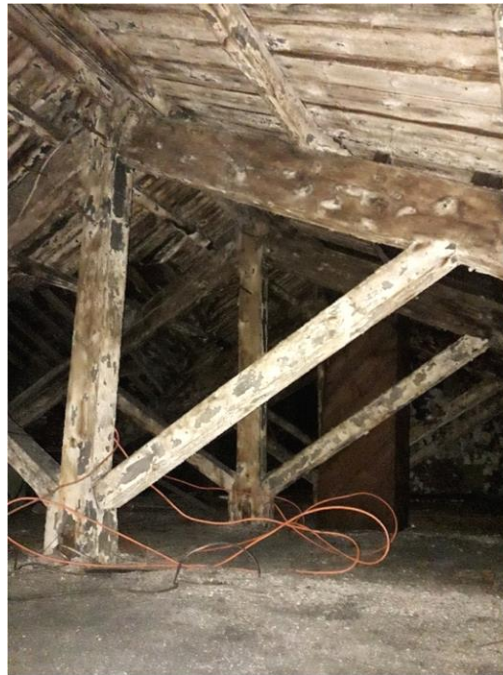
Photograph 2

- 3.13 The loft void was found to contain an abundance of cobwebs. There was no evidence of bats recorded within the loft void, on top of the suspended ceiling tiles or on the timber floor of the loft void. Mouse droppings were noted above the suspended ceiling at the eastern end of the building (Appendix 2, Photograph 5).

Representative view of interior of loft void of building B4, as viewed from atop a scaffold tower at the eastern end of the void.

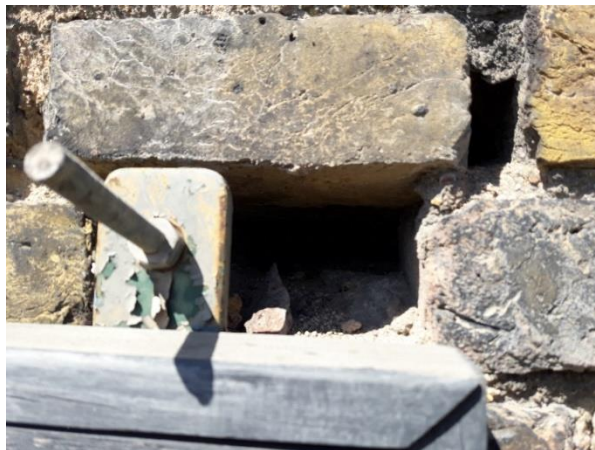
Photograph 3

Holes within brickwork where sign has been fixed to south-eastern elevation of Building B4.

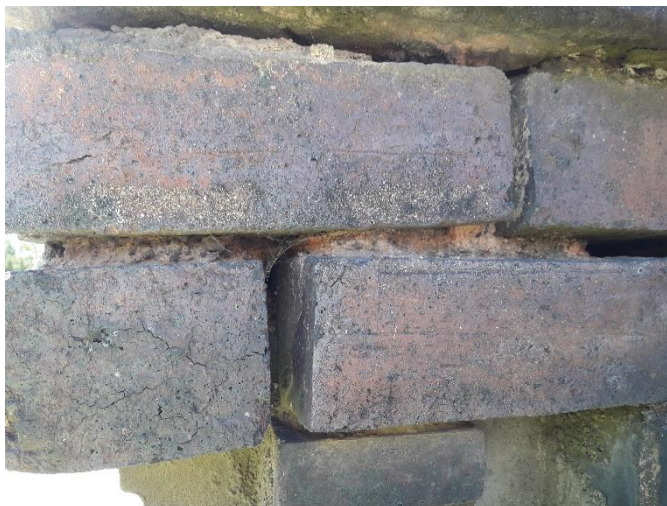
Photograph 4

Twisted brick on north-eastern corner of Building B4, creating an access point to cavity within parapet wall.

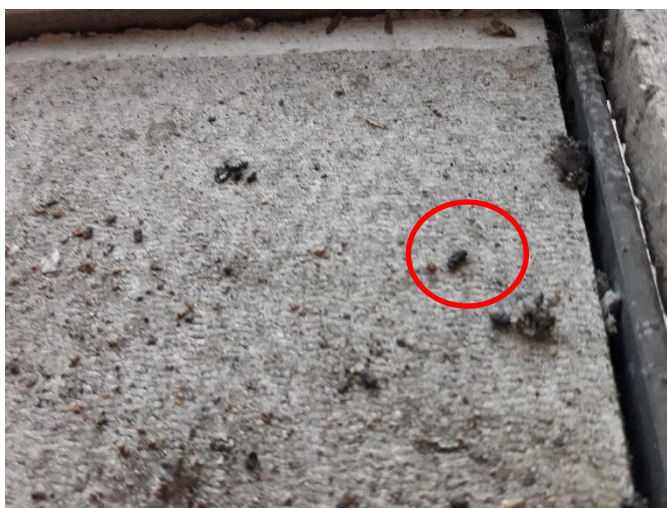
Photograph 5

Mouse dropping on upper side of suspended ceiling in Building B4.

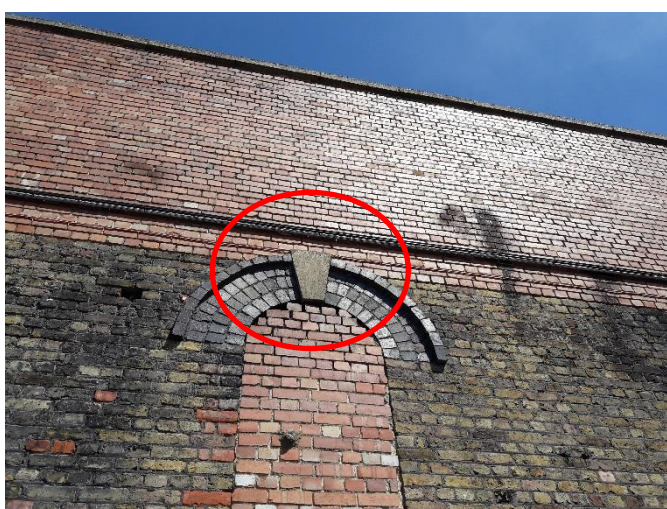
Photograph 6

- 3.16 *Building 5: Results.* The brickwork of the building is generally in good condition. There were no gaps noted within the brickwork, with the exception of some gaps around one of the bricked-up windows on the southern elevation (Appendix 2, Photograph 6). Gaps were also noted under the hanging tiles on the south-western corner of the building (Appendix 2, Photograph 7).

View of gaps around the bricked-up window on the southern elevation of B5.

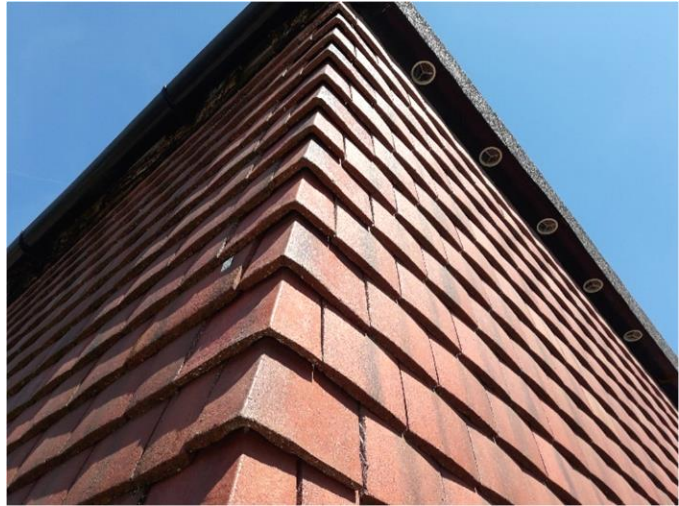
Photograph 7

View of gaps beneath hanging tiles on south-western corner of building B5.

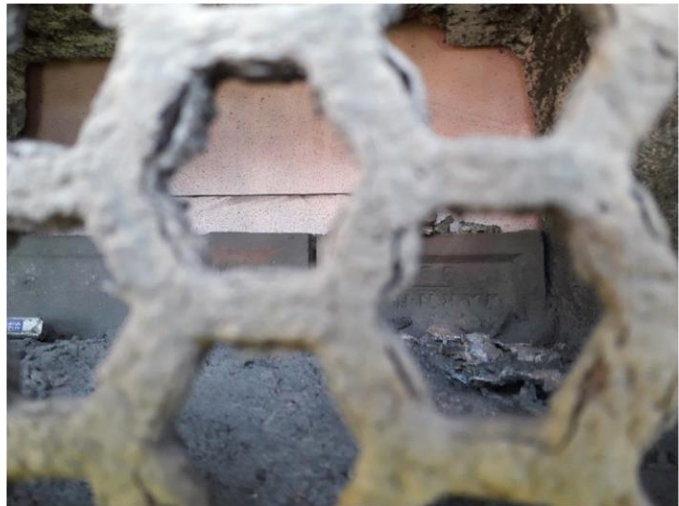
Photograph 8

- 3.19 *Building 6: Results.* The gaps within the stonework and the grill on the southern elevation were inspected using a MEWP. The cavity behind the grill, and the gaps within the stonework were found to be open and exposed and was considered to be unsuitable for roosting bats (Appendix 2, Photograph 9). No evidence of bats was noted within these features, and they were considered to have negligible potential for roosting. No further survey work is required on B6.

View into cavity behind grill on southern elevation of Building B6.

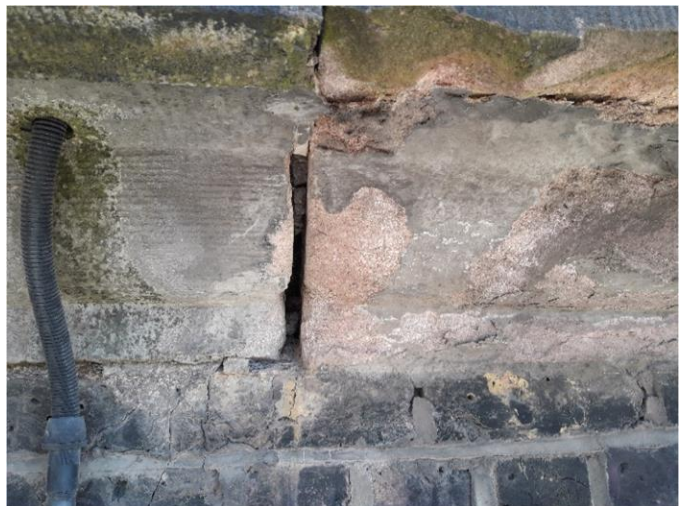
Photograph 9

View into cavity between stonework on southern elevation of Building B6.
