job title  
 Freemasons' Hall  
 Great Queen Street  
 London  
 WC2B 5AZ

dwg title  
 SECOND FLOOR TOILET 25 - Site plan  
 and site location plan.

dwg title  
 SECOND FLOOR TOILET 25 - Site plan showing fixtures, fittings and finishes locations.

dwg title  
 SECOND FLOOR TOILET 25 - General  
 Arrangement - Demolition

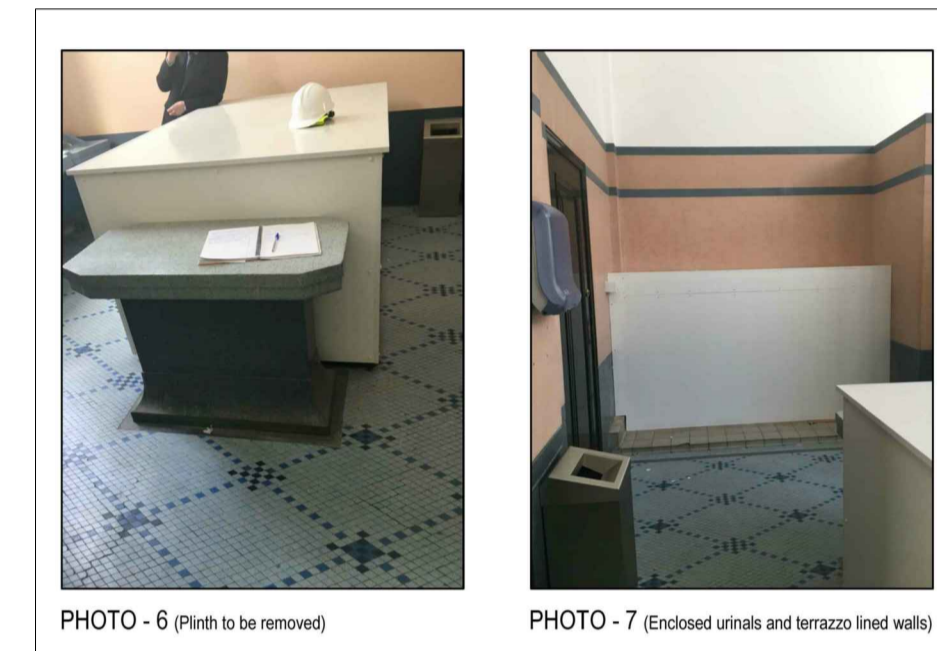
- D1. Remove mini trunking to ceiling.
- D2. Investigate existing electrical cable running horizontally over door to room. Remove if found to be redundant and make good to adjacent surfaces to match existing.

- D3. Remove temporary enclosure to central wash basins (see Photo - 6).
- D4. Cap off water supply, waste pipes and traps to central wash hand basins.
- D5. Carefully remove china wash hand basins and supporting structure. retain all components in useable condition for reuse/relocation.

- D9. Carefully remove existing terrazzo plinth and retain all components in useable condition for reuse/relocation (see Photo - 6 above).
- D10. Remove temporary enclosure to the urinals (see Photo - 7 above).

- D11. Existing pipes and traps from urinals (to external cast iron waste pipe) left in position buried within floor. External pipework (where connected to cast iron waste pipe) removed and external surfaces repaired.

- D12. Remove existing PIR control and leave wiring ready for new sensor in new location.
- D13. Cap off and remove existing lead pipes and traps below wash hand basins, remove existing metal cladding, carefully remove china wash hand basins and supporting structure. Retain all components in a useable condition.

- D15. Carefully remove the boarding to the head of the corridor wall and leave ready to receive new terrazzo edge detail.
